ERA24LA007

## INVESTIGATION PHOTOGRAPHS

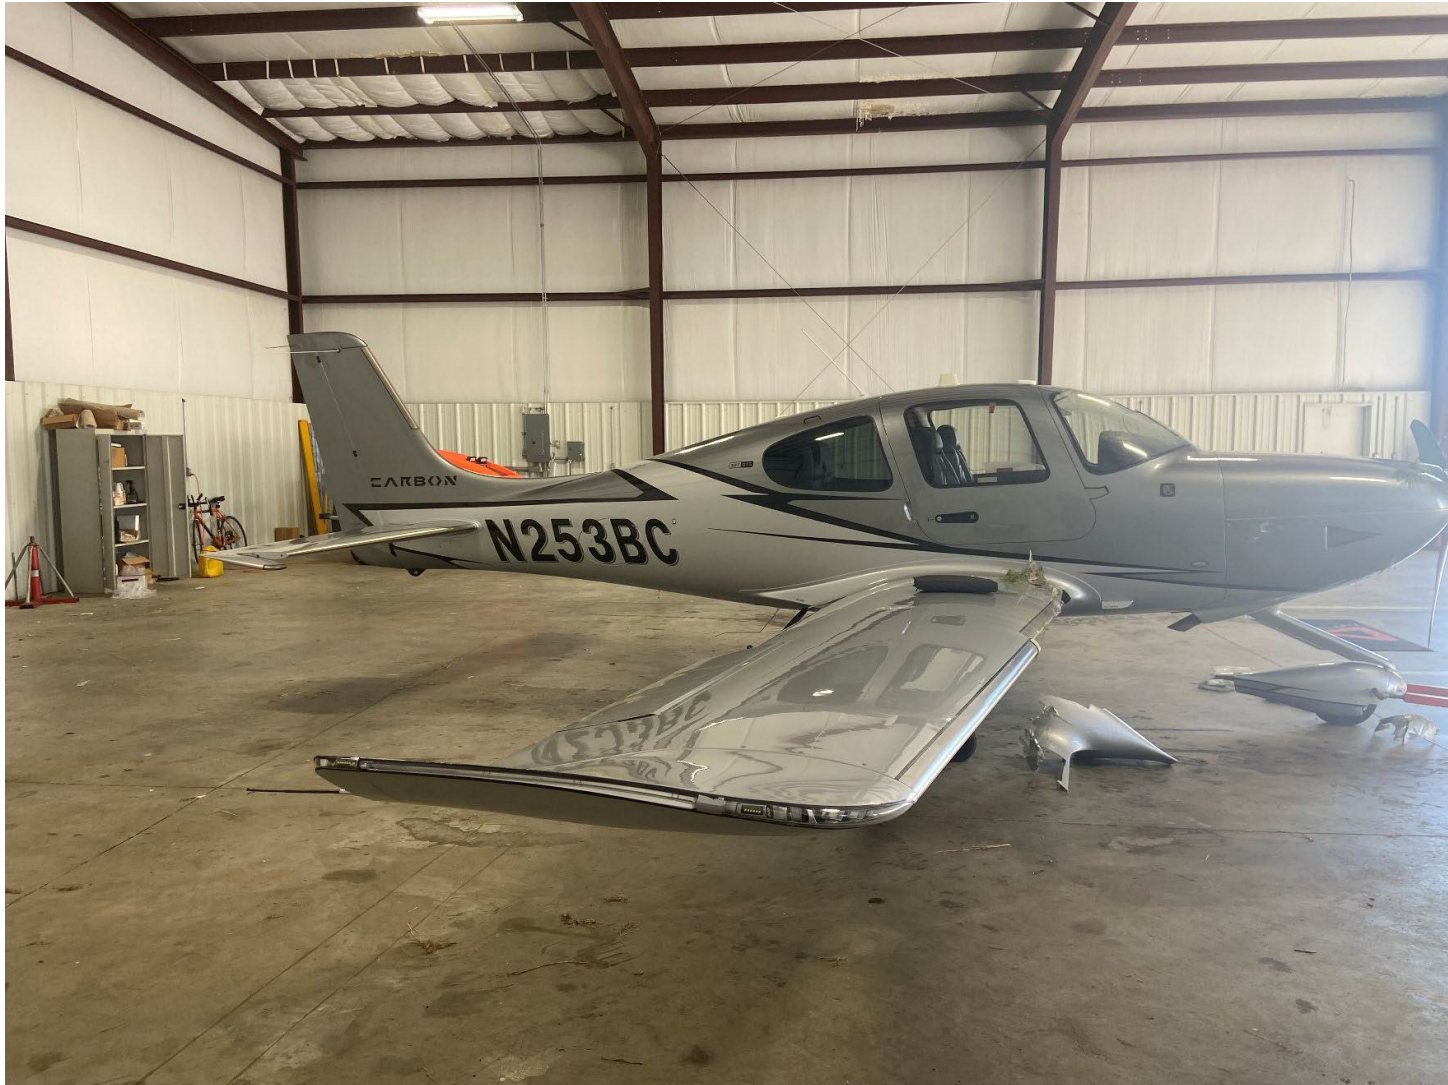
**Photograph 1 - Airplane overview (Courtesy of FAA)**

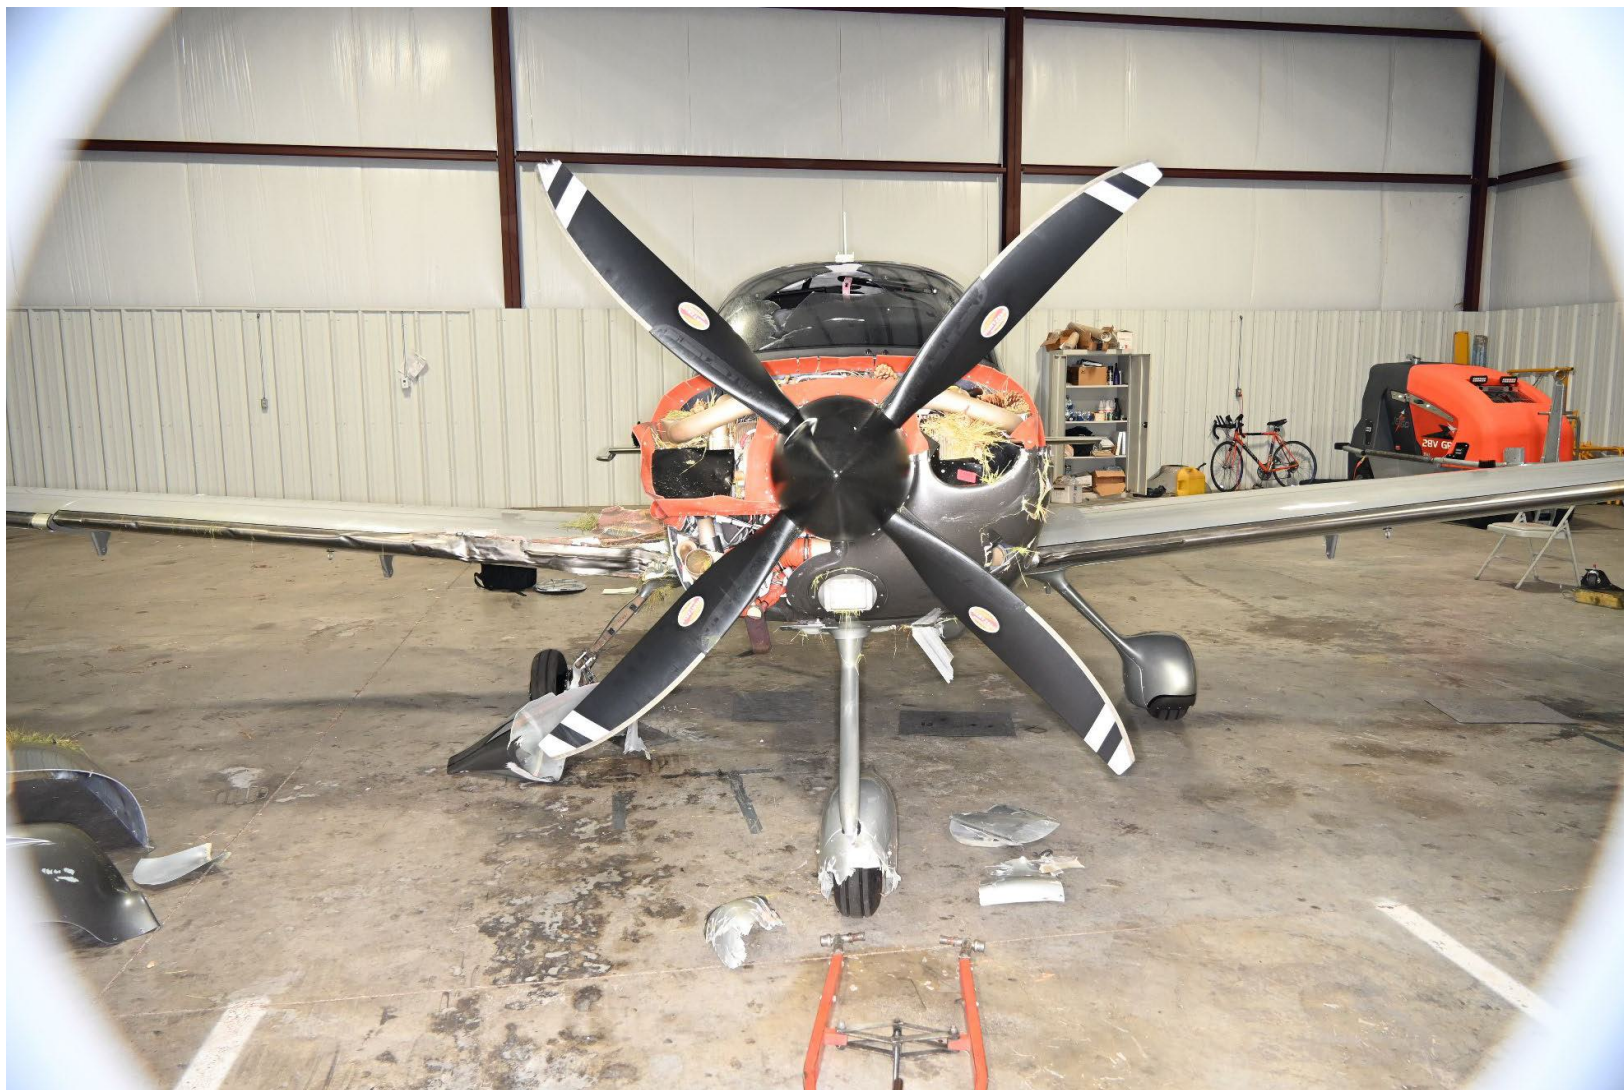
**Photograph 2 - Airplane overview (Courtesy of Cirrus)**

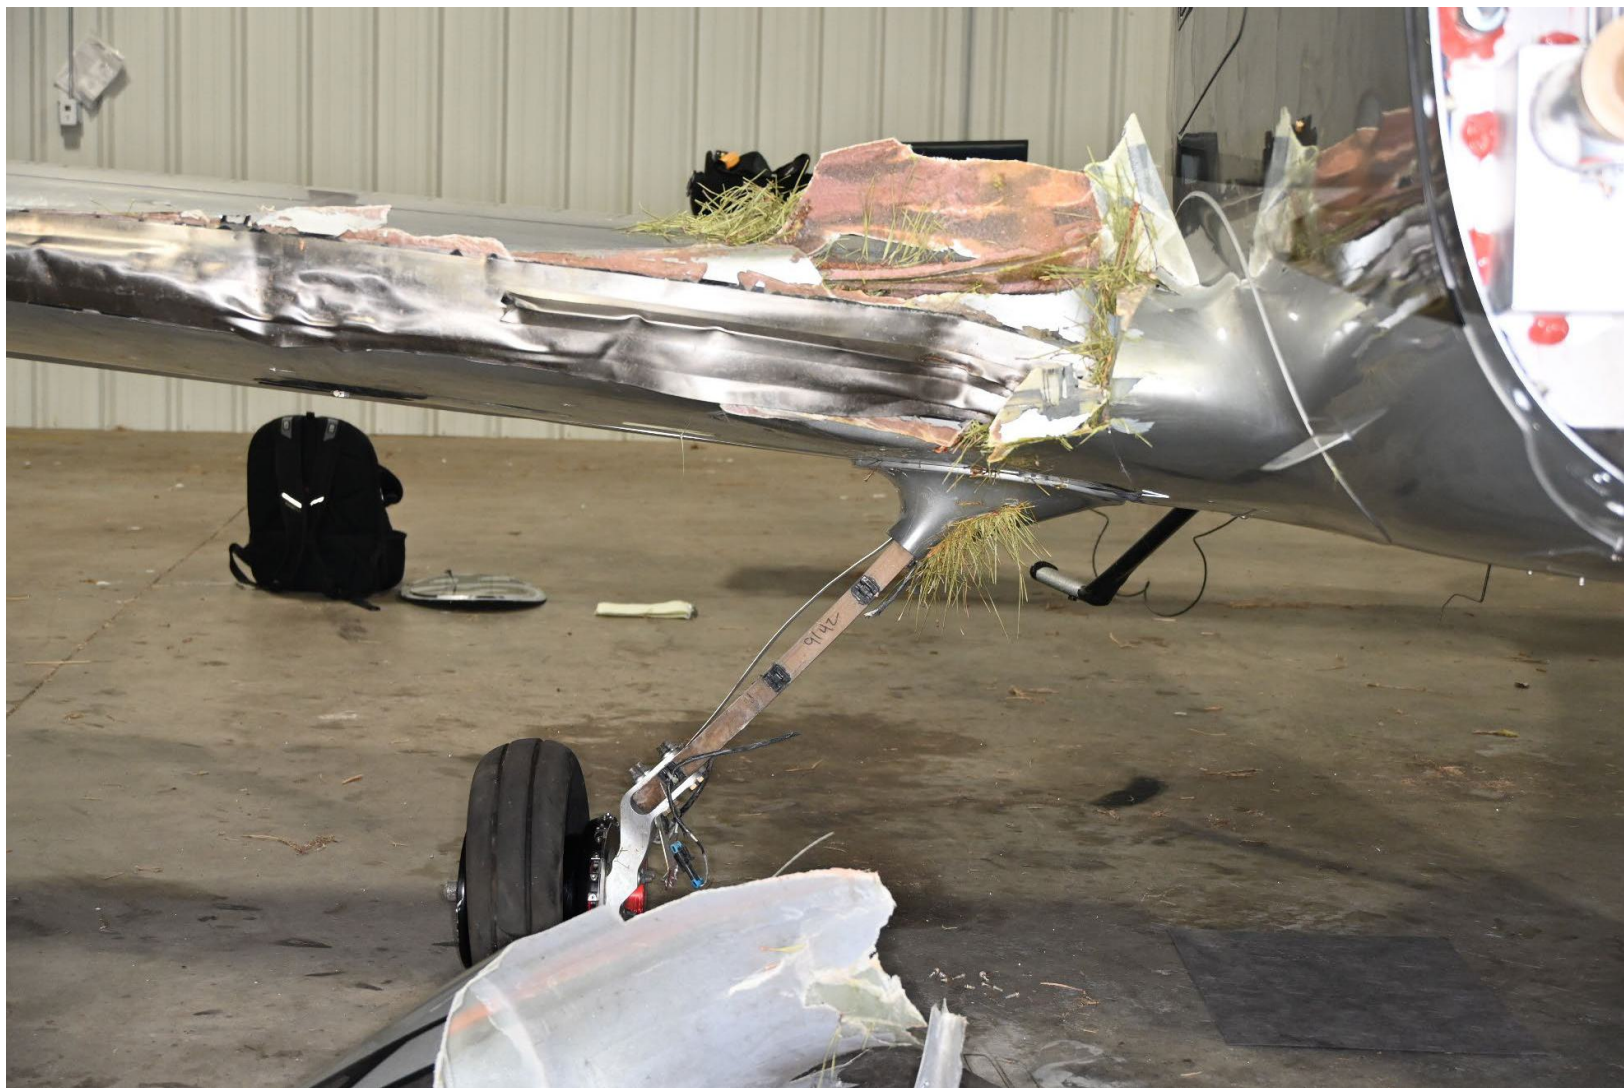
**Photograph 3 - Damage to the right wing (Courtesy of Cirrus)**

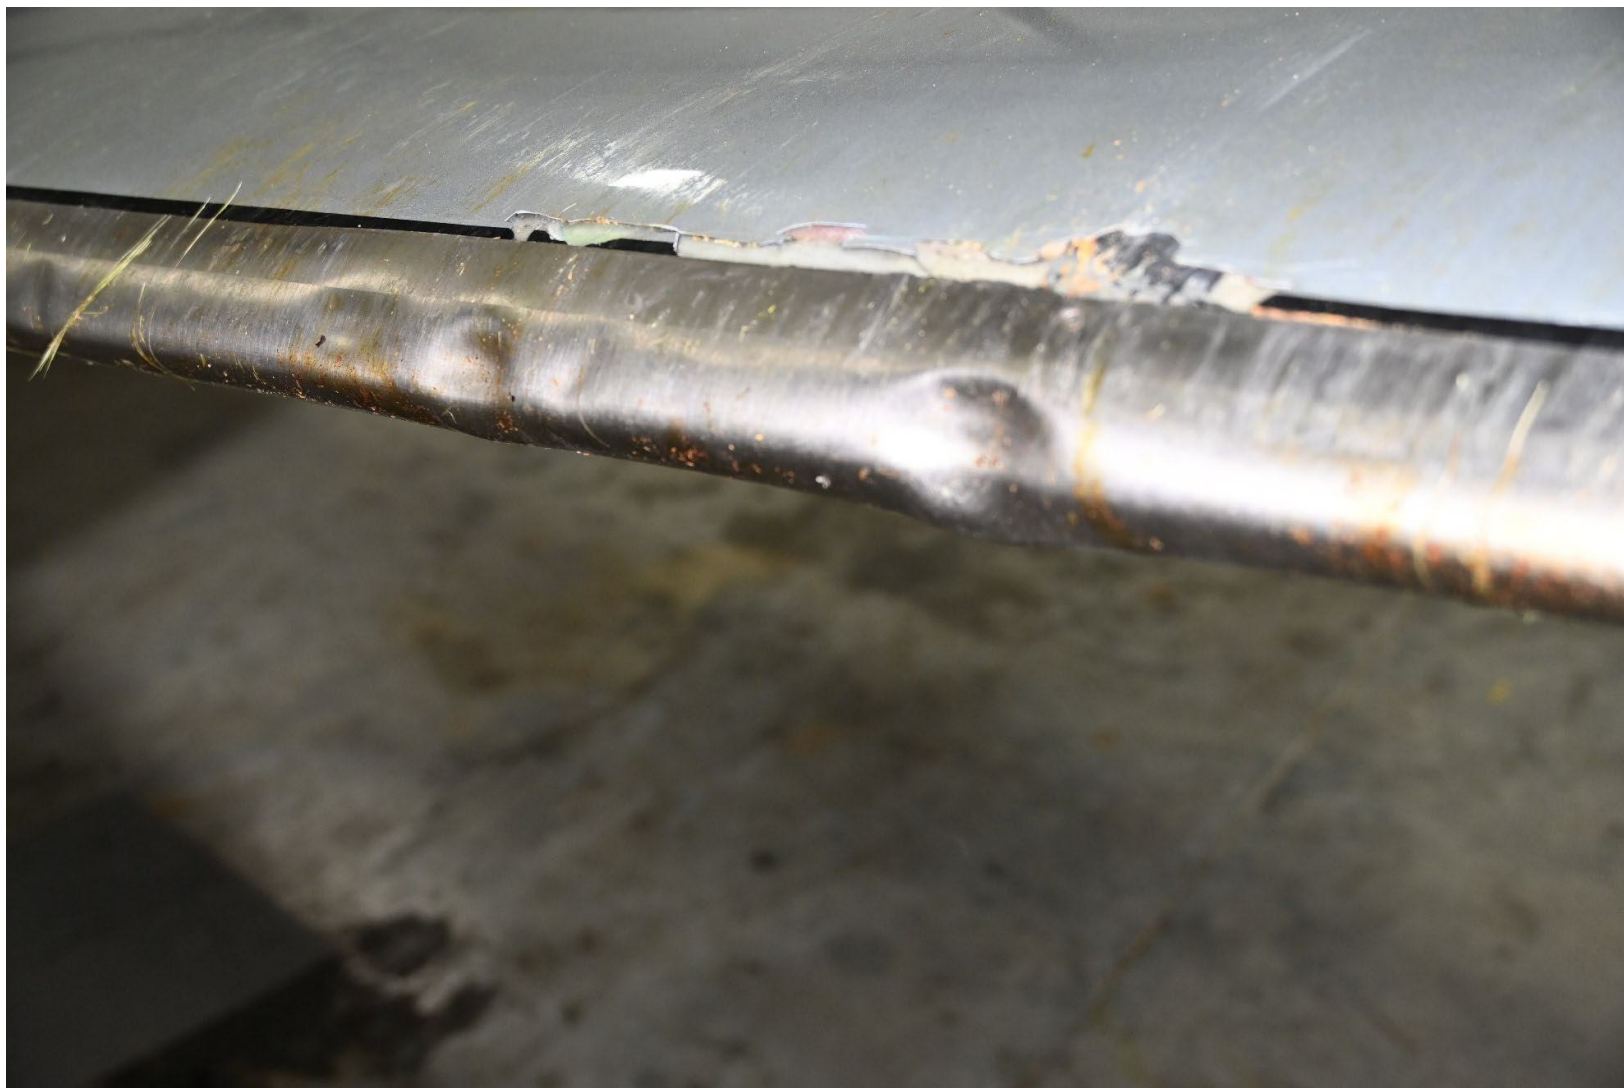
**Photograph 4 - Damage to the left wing (Courtesy of Cirrus)**

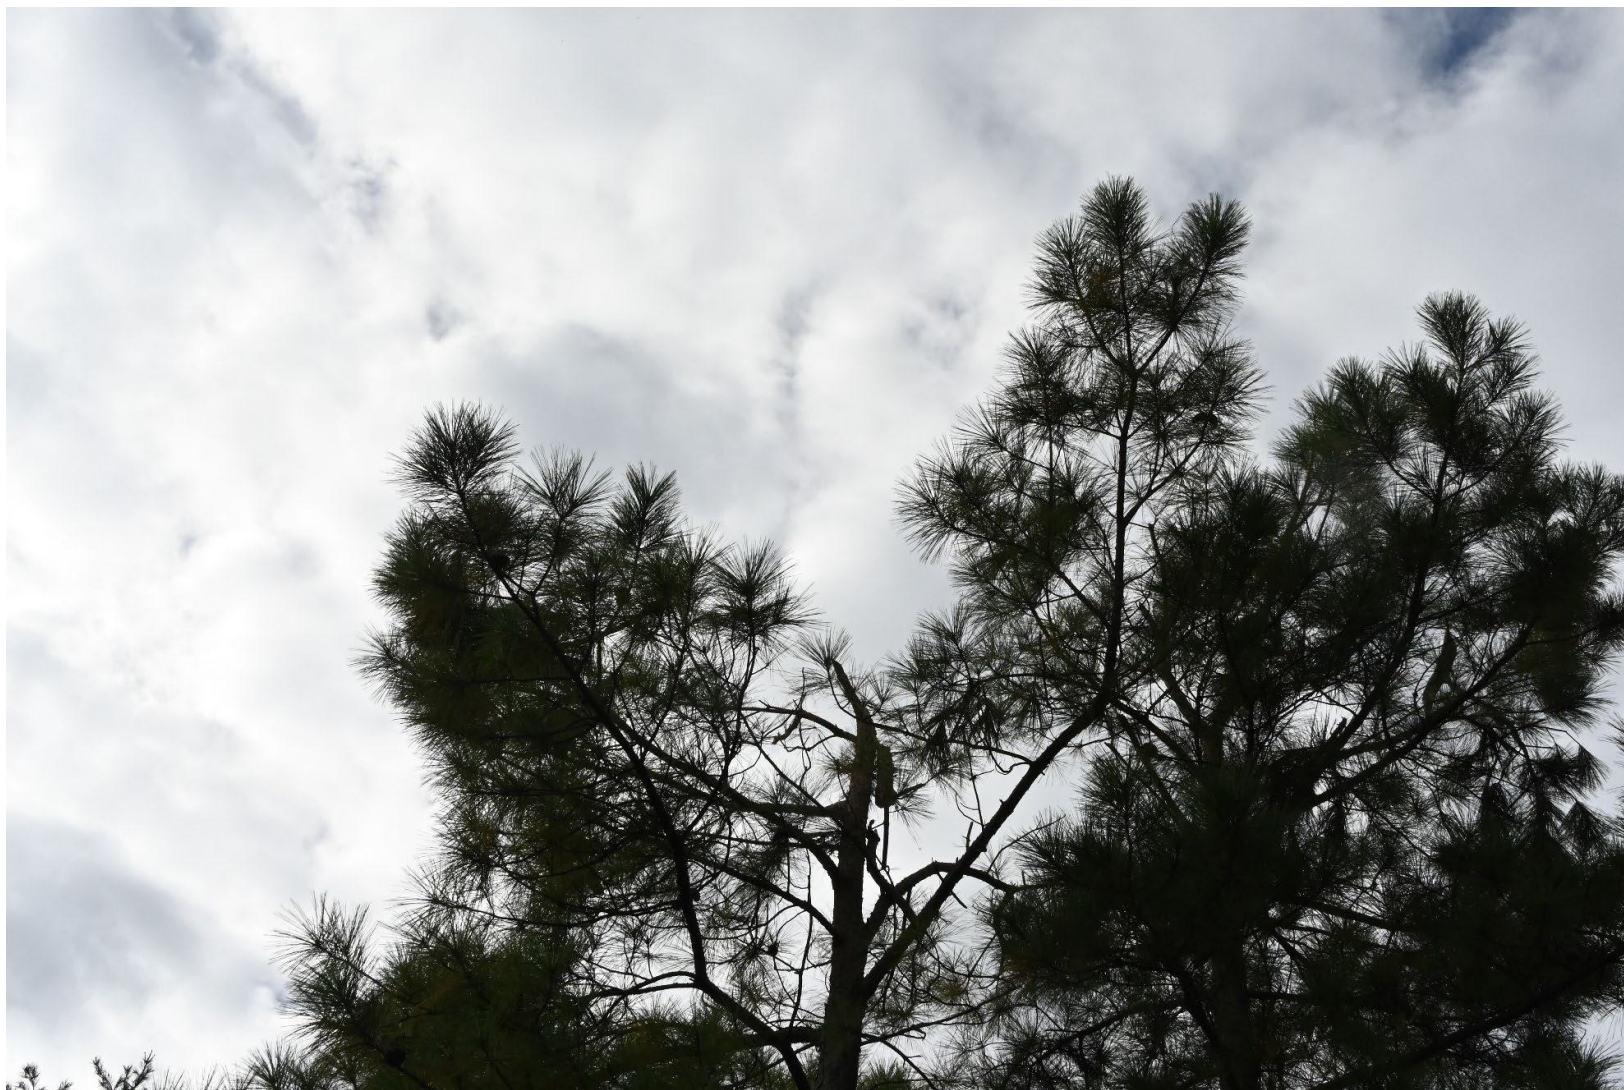
**Photograph 5 - Impact damaged tree (Courtesy of Cirrus)**

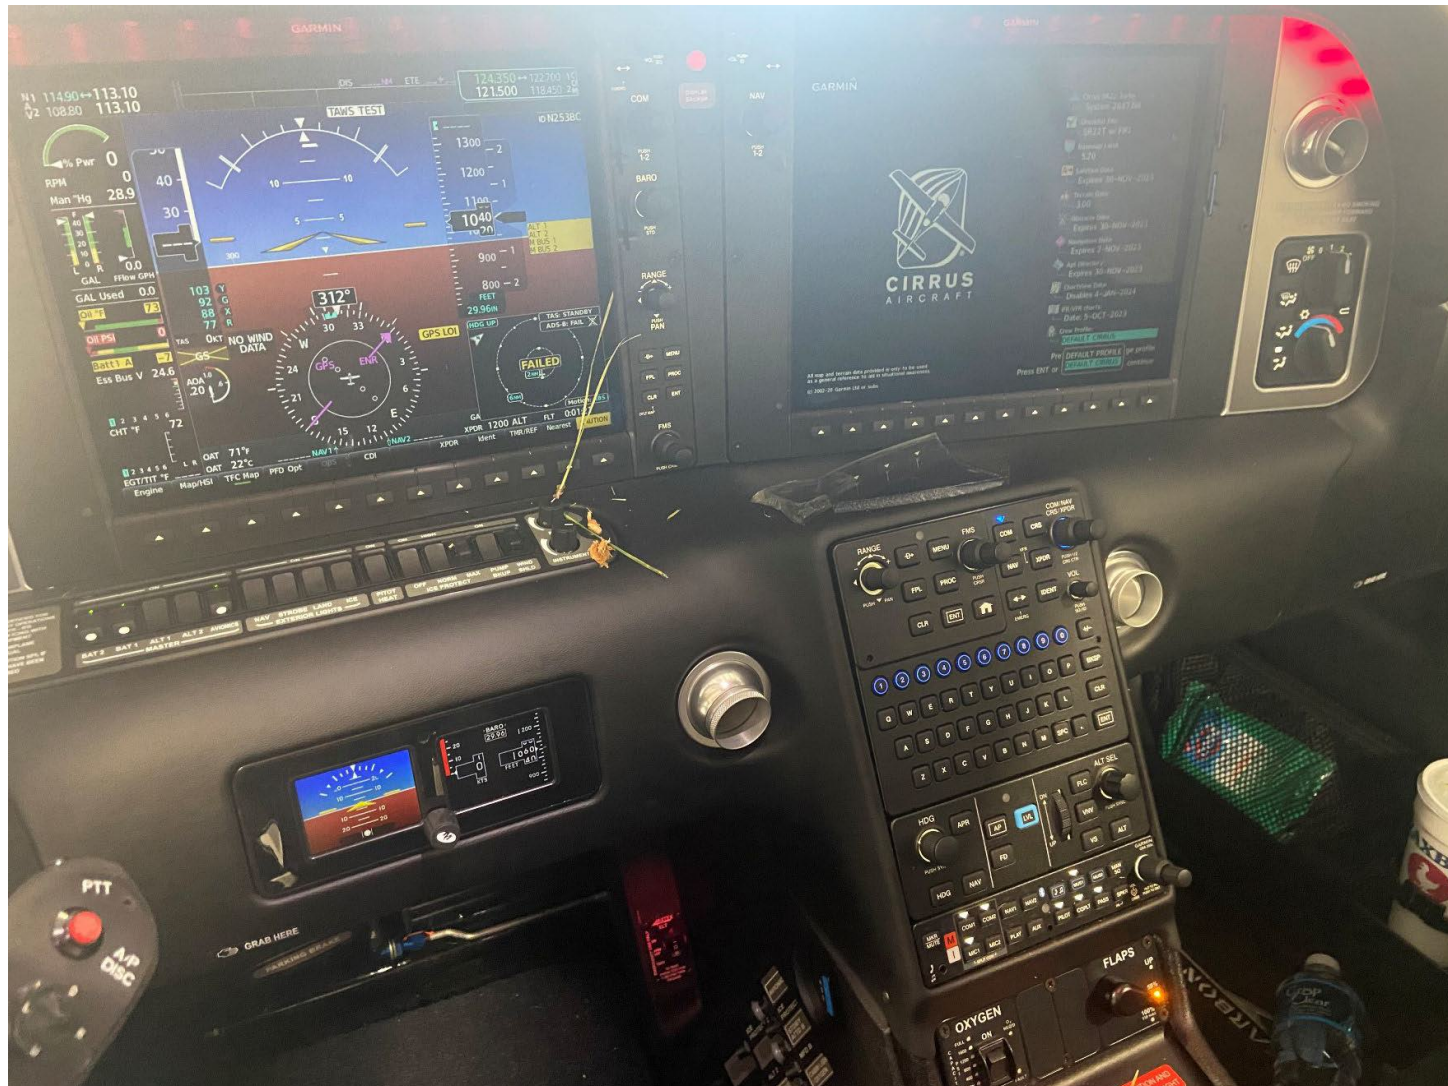
**Photograph 6 - PFD, MFD, and MD302 operating after accident (Courtesy of FAA)**

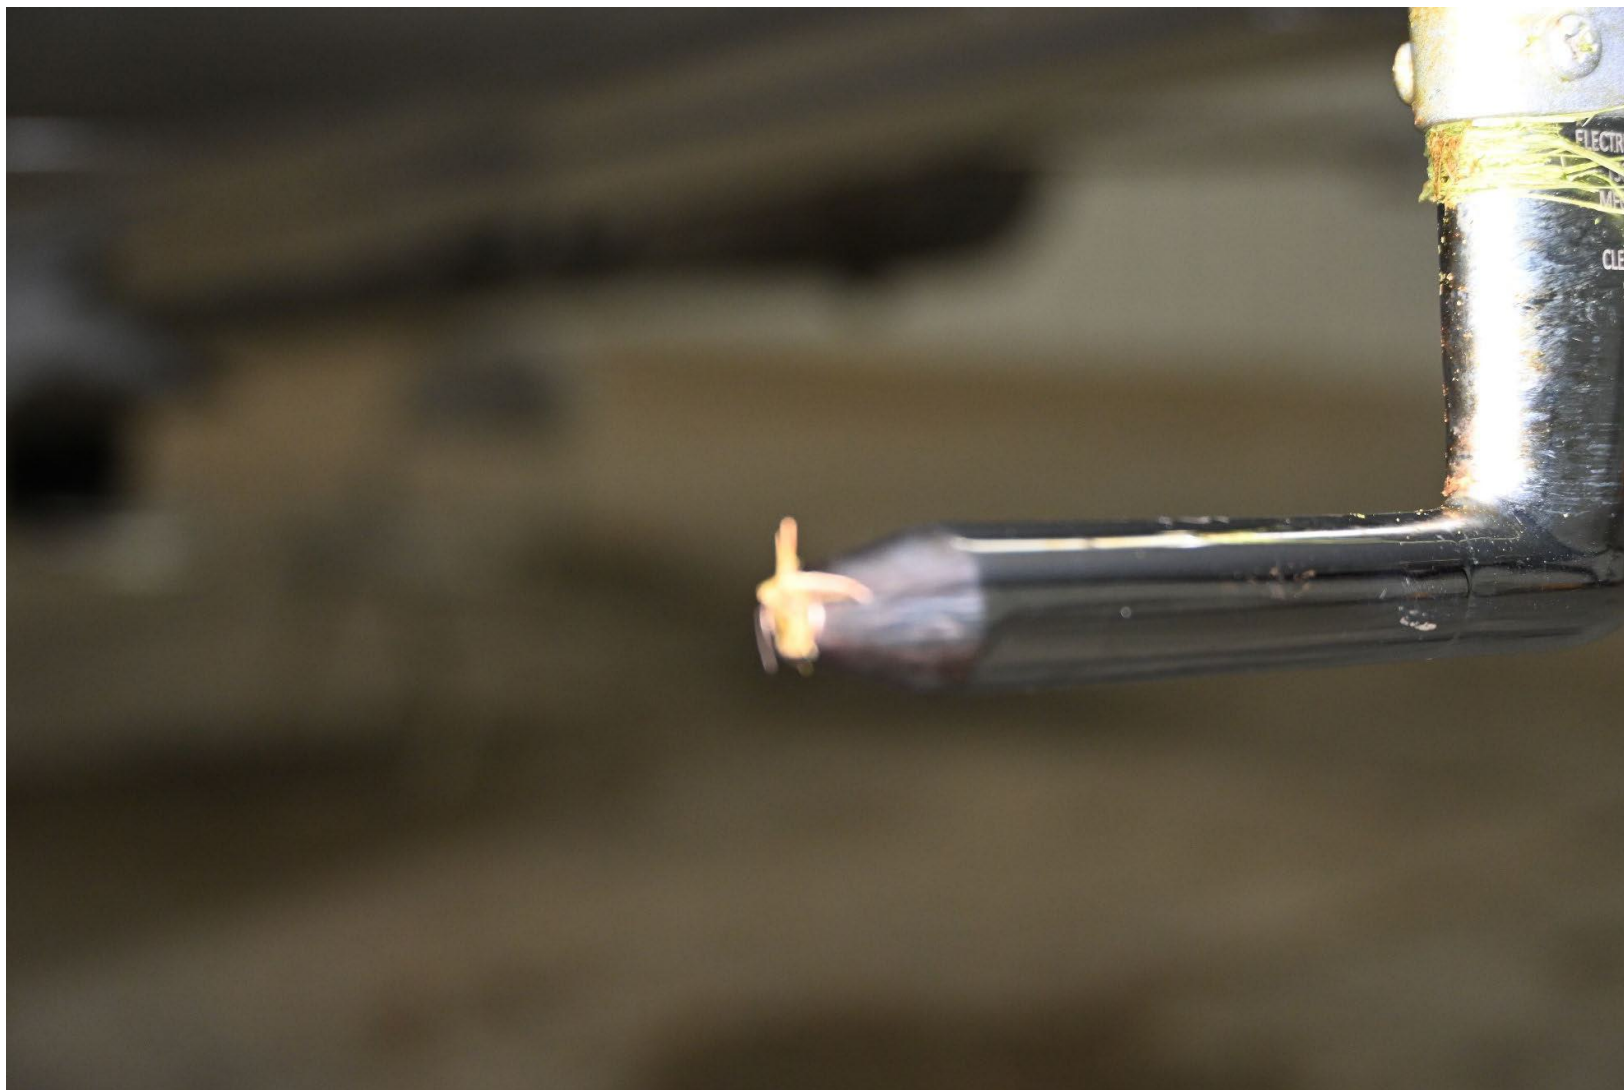
**Photograph 6 - Pitot tube with tree material plugging the pitot hole (Courtesy of Cirrus)**
