# National Transportation Safety Board

ERA24LA010

## **MATERIALS LABORATORY**

Factual Report 24-075

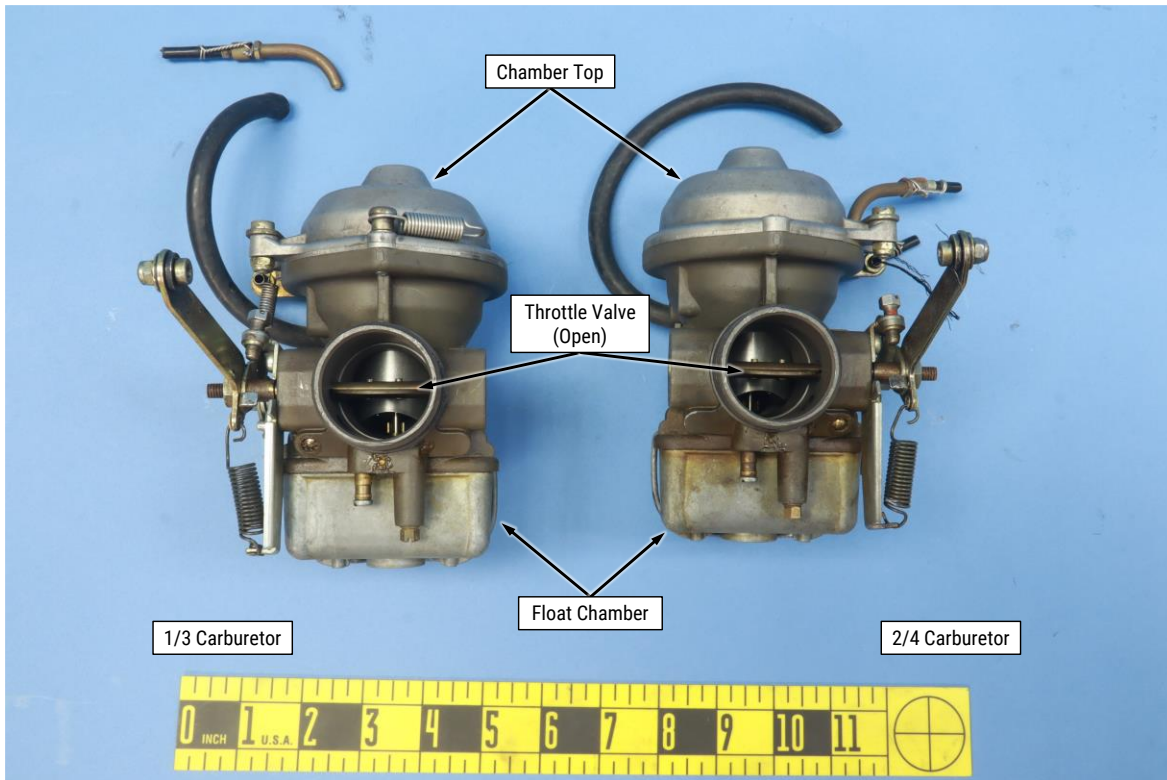
Figure 1 shows the 1/3 carburetor (left), and the 2/4 carburetor (right) viewed from the cylinder side as received. The fuel lines appeared to have been cut near the end of the inlet fitting. Approximately 6.5 inches and 8 inches of black rubber drain line extended from the 1/3 carburetor and 2/4 carburetor, respectively. The free end of the 1/3 carburetor drain line was locally bulged and exhibited radial cracks in the bulged area and at the free end. An imprint consistent with being secured with a cable tie was observed around the outer surface near the free end. The free end of the 2/4 carburetor drain line exhibited a flat smooth end with exposed fiber reinforcement, consistent with a cut end. The bent tube assembly for the choke cable, which retained a portion of the Bowden cable housing was fractured and separated from the 1/3 carburetor and neither the choke nor throttle cables were present. The choke cable for the 2/4 carburetor was not present and approximately 5.5 inches of the throttle cable was retained and was fractured near the throttle valve lever attachment. The remaining portion of throttle cable retained lubricant but exhibited evidence of internal and external cable wear. The throttle valve lever on the 2/4

**Figure 1.** Photograph of the 1/3 carburetor (left) and the 2/4 carburetor (right) viewed from the cylinder side, as received.

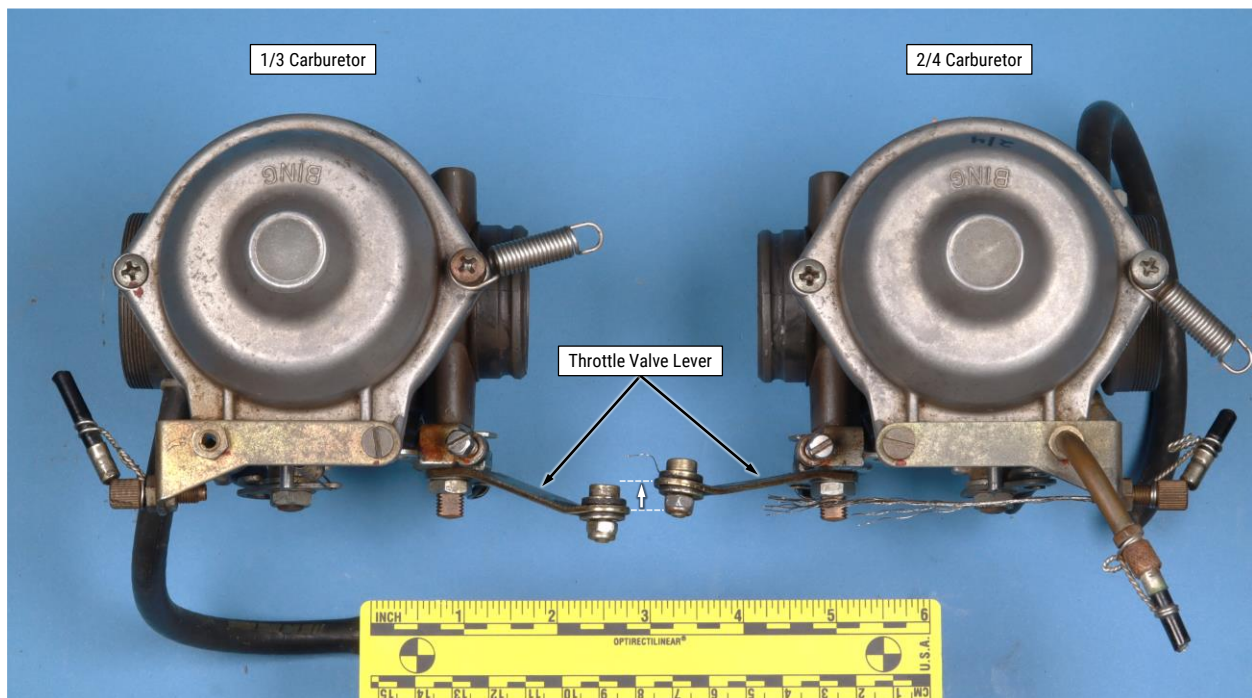
carburetor was bent towards the carburetor housing by approximately 0.3 inch relative to the 1/3 carburetor throttle valve lever as indicated in figure 2.

**Figure 2.** Top-view photograph of the carburetors indicating the bent throttle valve lever of the 2/4 carburetor relative to the 1/3 carburetor.

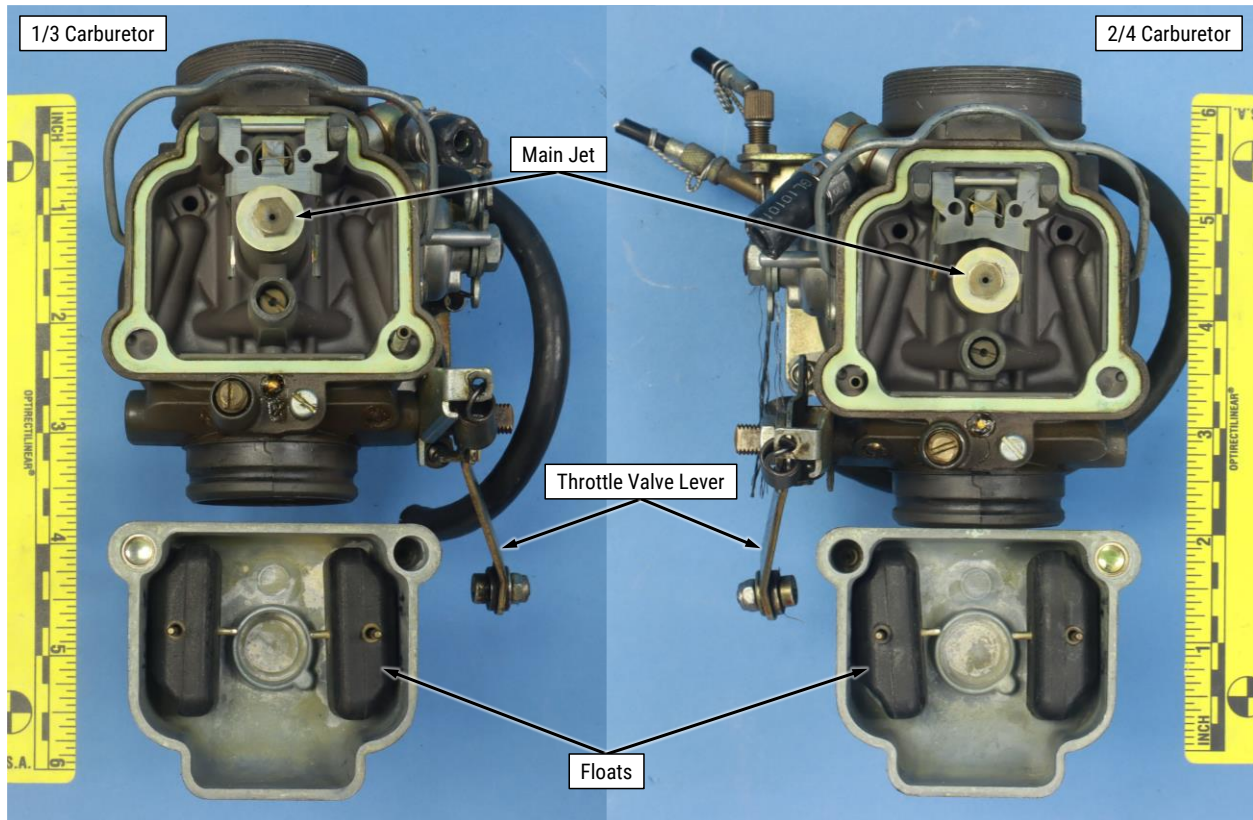
Figure 3 shows a view of both carburetors with the float chamber removed. Two black floats were present in each chamber and all four floats moved freely on their respective posts. A light green gasket was present at each float chamber interface and the gasket on each carburetor appeared continuous and intact. The float bracket on the 2/4 carburetor was bent and impinged against the main jet housing which restricted movement as shown more closely in figure 4. The float bracket on the 1/3 carburetor appeared undamaged and moved freely when manually actuated and returned to a neutral position with spring action.

**Figure 3.** Photograph of the carburetors with the float chambers removed.

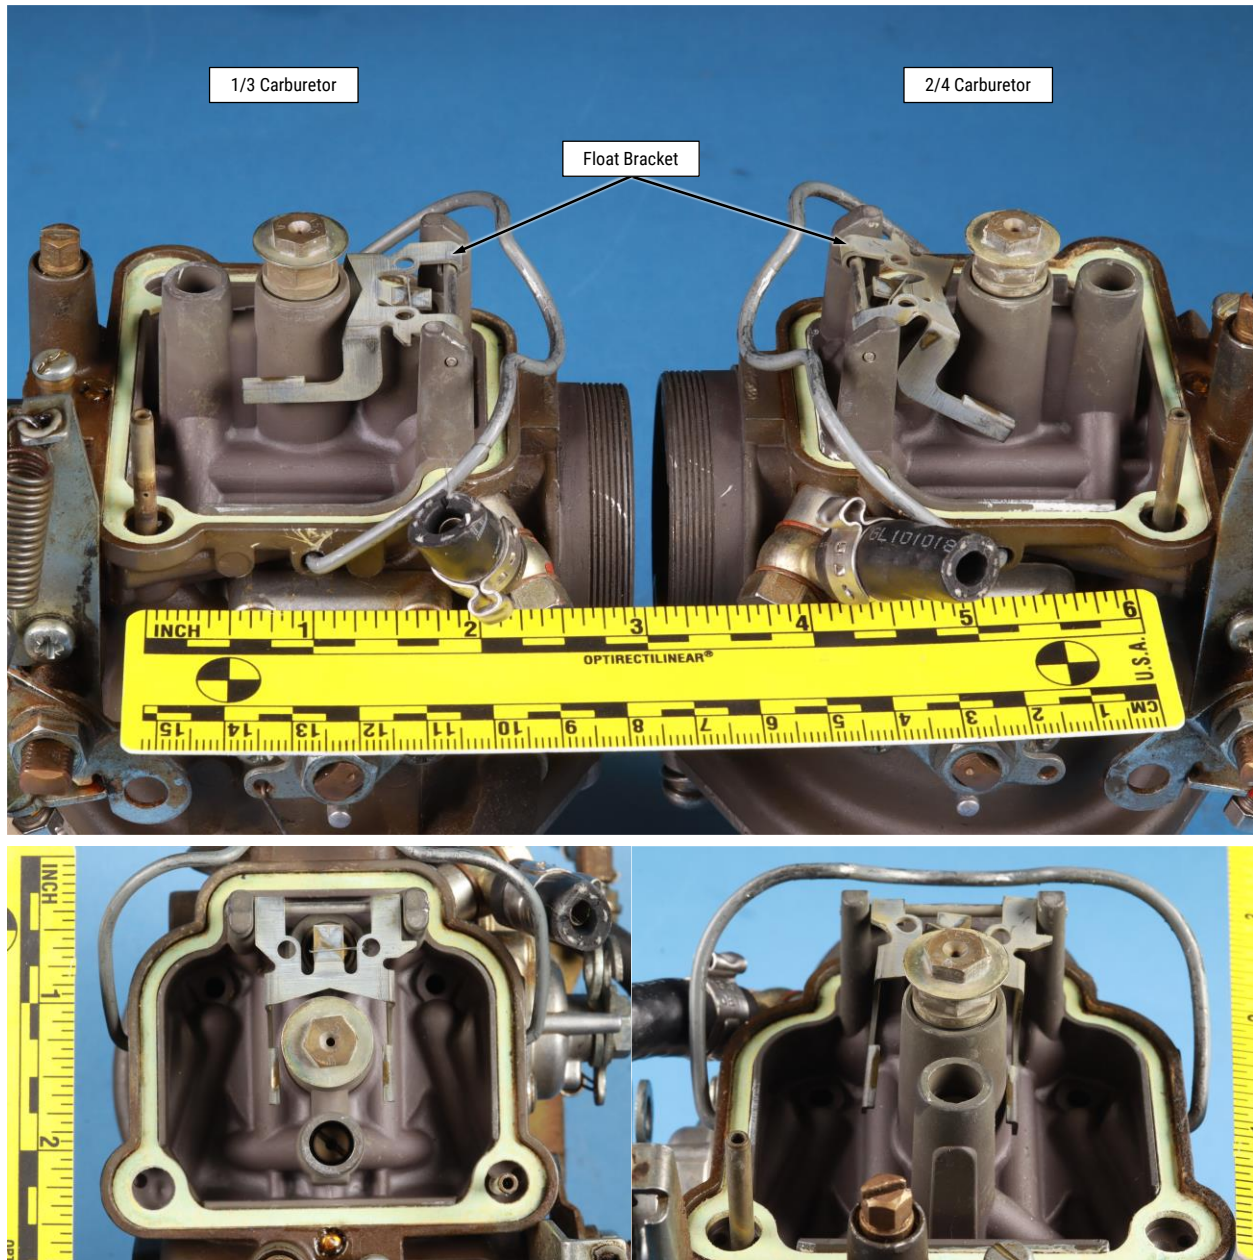
**Figure 4.** Photographs of the carburetors showing the bent float bracket observed on the 2/4 carburetor.

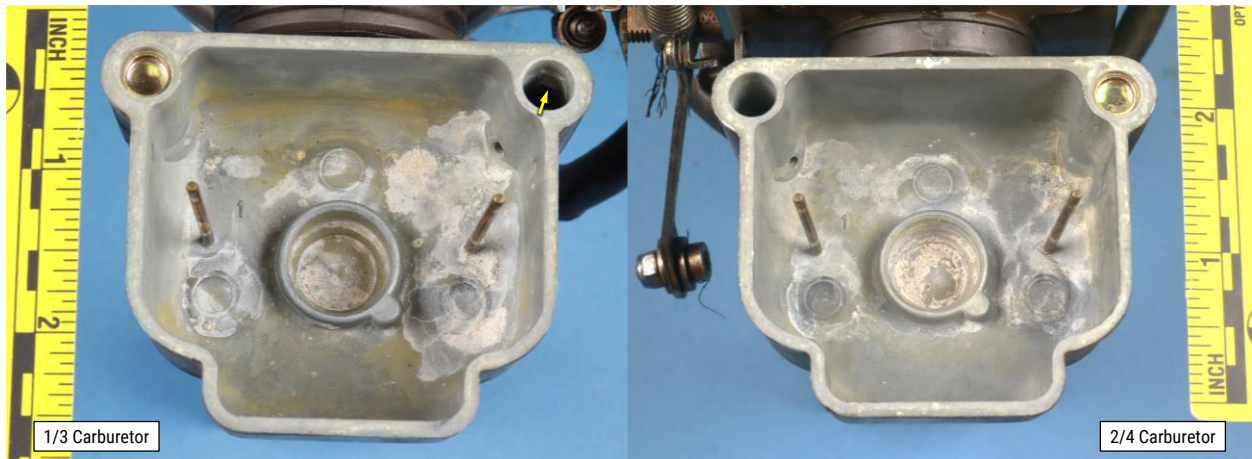
Figure 5 shows the interior surfaces of each float chamber after the floats were removed. Areas of white film and accumulations of white and yellow material deposits were observed, particularly around the base of the chamber. The float chamber from the 1/3 carburetor exhibited a greater degree of these white and yellow material deposits. A similar buildup of material was observed around the sidewall of the float chamber jet port on the 1/3 carburetor as indicated by a yellow arrow. Closer views of this area are shown in figure 6 where white deposits were observed on and around the float chamber jet and port sidewall as indicated by yellow arrows.

**Figure 5.** Closer photographs of the interior of the float chamber with the floats removed. Areas of white film and accumulations of white and yellow material deposits were observed on the base of both float chambers. Similar white deposits were observed around the sidewall of the 1/3 carburetor float chamber jet as indicated by the yellow arrow.

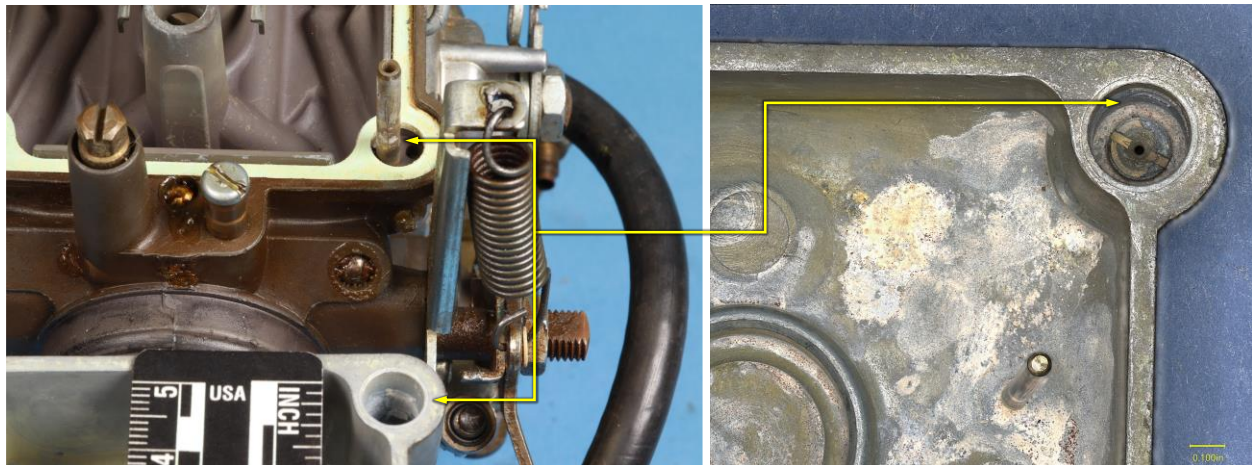
**Figure 6.** A closer view of the 1/3 carburetor float chamber jet showing closer views of accumulations of white and yellow material deposits on and around the float chamber jet as indicated by yellow arrows.

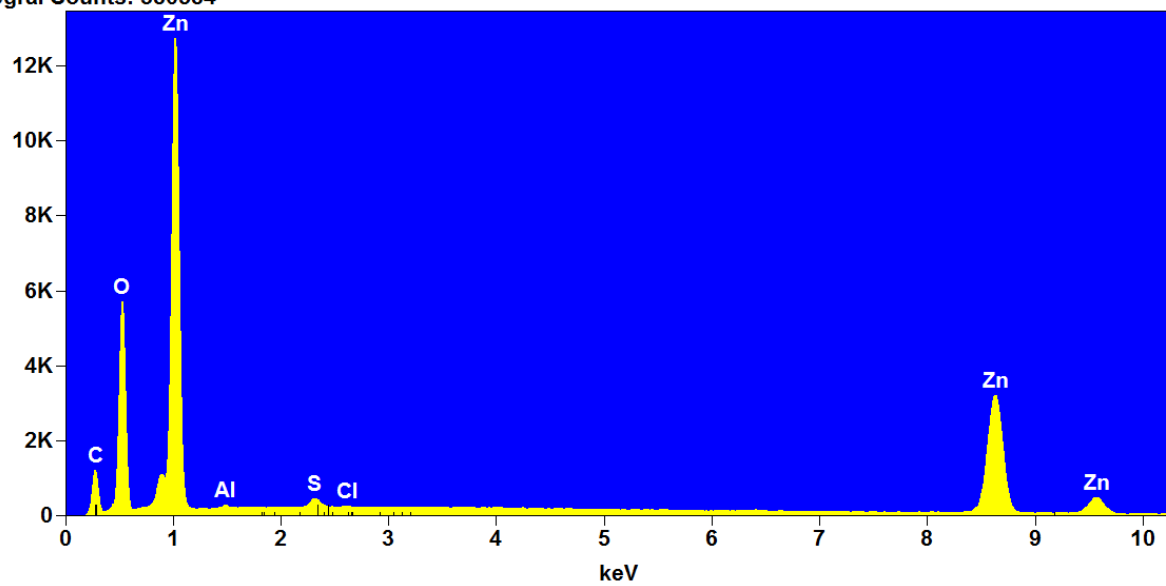
1/3 Carburetor – White Deposits

A sample of the white and yellow material deposits was removed from the 1/3 carburetor float chamber for closer examination. When disturbed with tweezers, the deposits broke down into a powdery consistency which was collected and affixed to carbon tape on an aluminum stub to facilitate compositional analysis using energy dispersive x-ray spectroscopy (EDS). Resulting spectra for the samples are shown in figure 6. Both samples exhibited large peaks of zinc and oxygen, consistent with oxides associated with the zinc float chamber. Both samples also exhibited smaller peaks of sulfur, aluminum, and chlorine, although these peaks were higher for the yellow deposits. The yellow deposits additionally exhibited smaller peaks of magnesium, iron, silicon, and calcium.

**Figure 7.** Representative spectra from EDS analysis of samples of white (top) and yellow (bottom) material deposits from the 1/3 carburetor float chamber.
