# National Transportation Safety Board

ERA24LA014

## WRECKAGE EXAMINATION

Location: Ottawa, Ohio  
Date: October 22, 2023  
Time: 1515 EST  
1915 UTC  
Airplane: N6757P, Piper PA-24-250

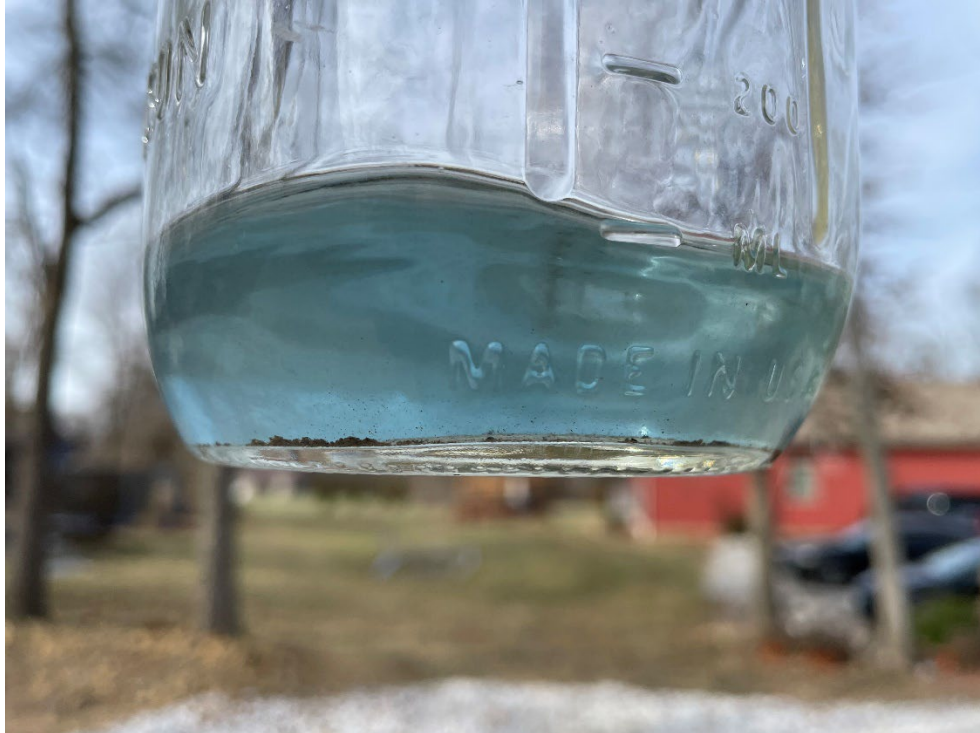
The inlet fuel line to the carburetor was removed; it contained a trace amount of blue-colored fuel. The gascolators were opened and drained. One gascolator contained about 2 ounces of blue-colored fuel. The other gascolator contained about 1 ounce of blue-colored fuel. Both samples contained a trace amount of gray particulates that resembled sand (photo 1).

Photo 1 – Fuel recovered from gascolator, note fine particulates

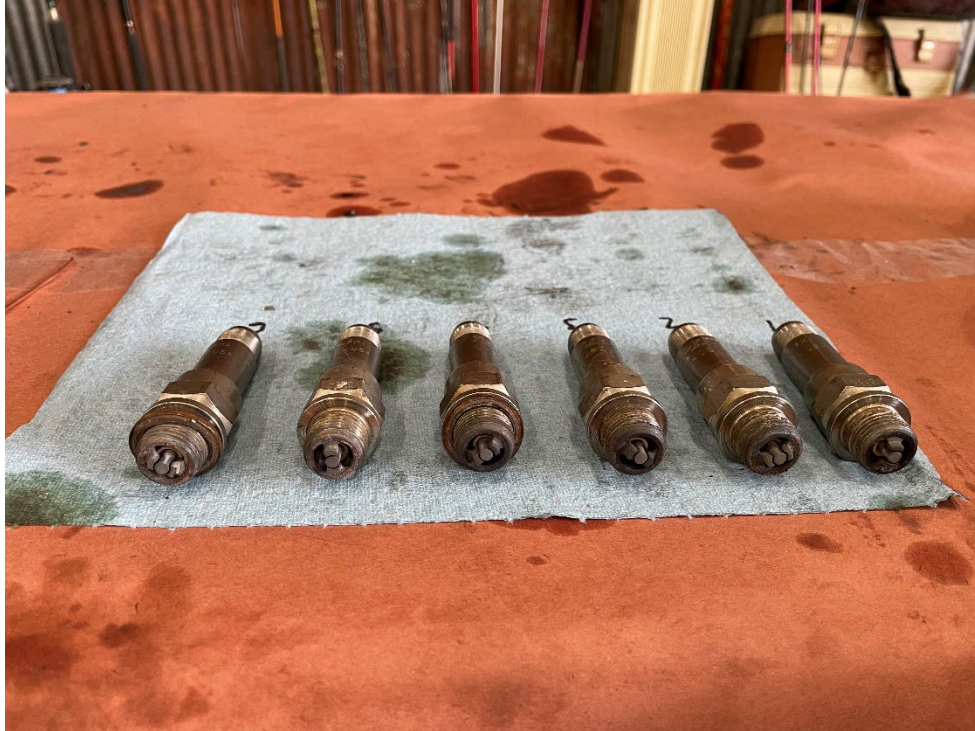
The top spark plugs were removed and examined. They exhibited normal wear and light gray, lean coloring as compared to a Champion Check-A-Plug inspection chart (figure 2). Internal engine continuity was verified by manually rotating the propeller. Compression and suction were confirmed on all cylinders using the “thumb” method. Valve action was correct and the rear accessory drive gears all rotated with propeller rotation.

Photo 2 – Top spark plugs

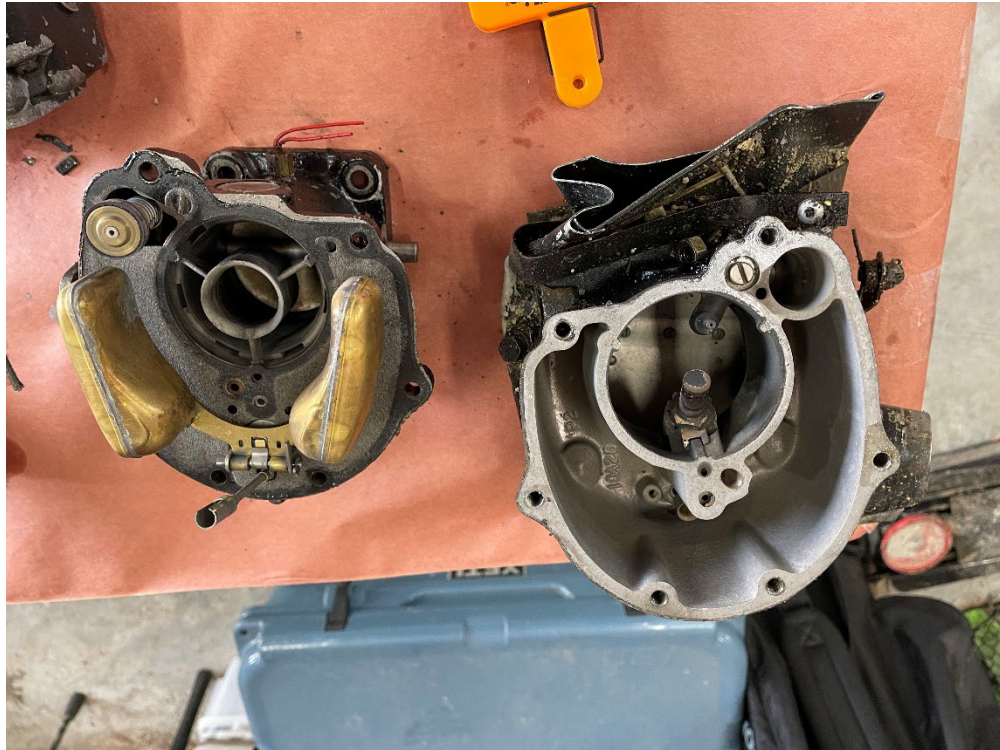
The carburetor was removed for examination. The bowl was dry and clean with no particulates observed (photo 3). The brass floats were intact and uncompromised. The carburetor inlet fuel screen was unobstructed and contained a trace amount of light gray particulates that resembled sand. The accelerator pump operated normally.

Photo 3 – Carburetor, disassembled

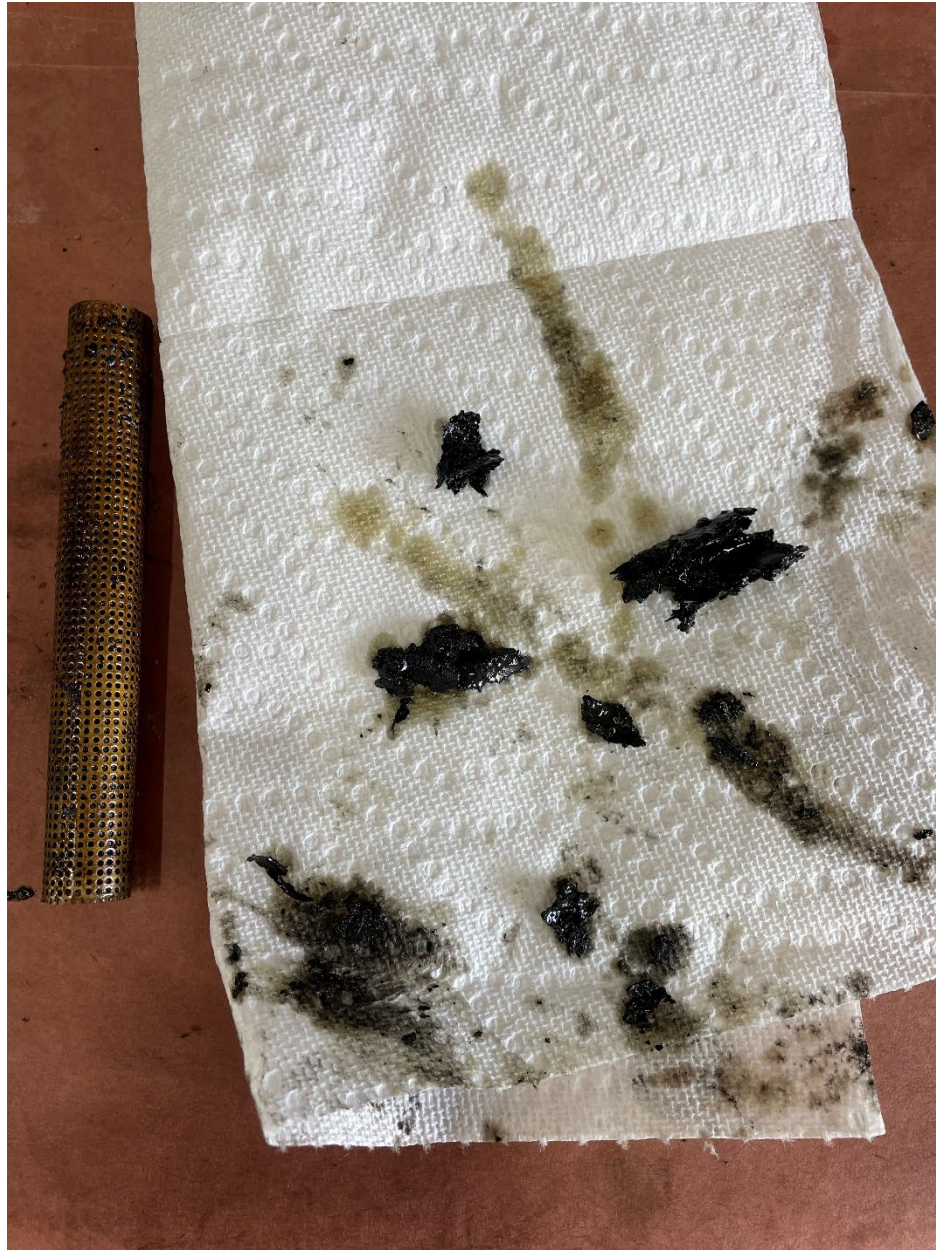
The oil suction screen was removed for examination. The screen was partially blocked and contained soft, black, sludge-like material that resembled carbon (photo 4). The material was not ferrous in nature when tested with a magnet. The oil filter was removed and opened using a cutting tool. The paper element was free of metallic debris or particulates.

Photo 4 – Sludge-like carbon material found in oil suction screen
