# National Transportation Safety Board

ERA24LA016

## **MATERIALS LABORATORY**

Factual Report 24-040

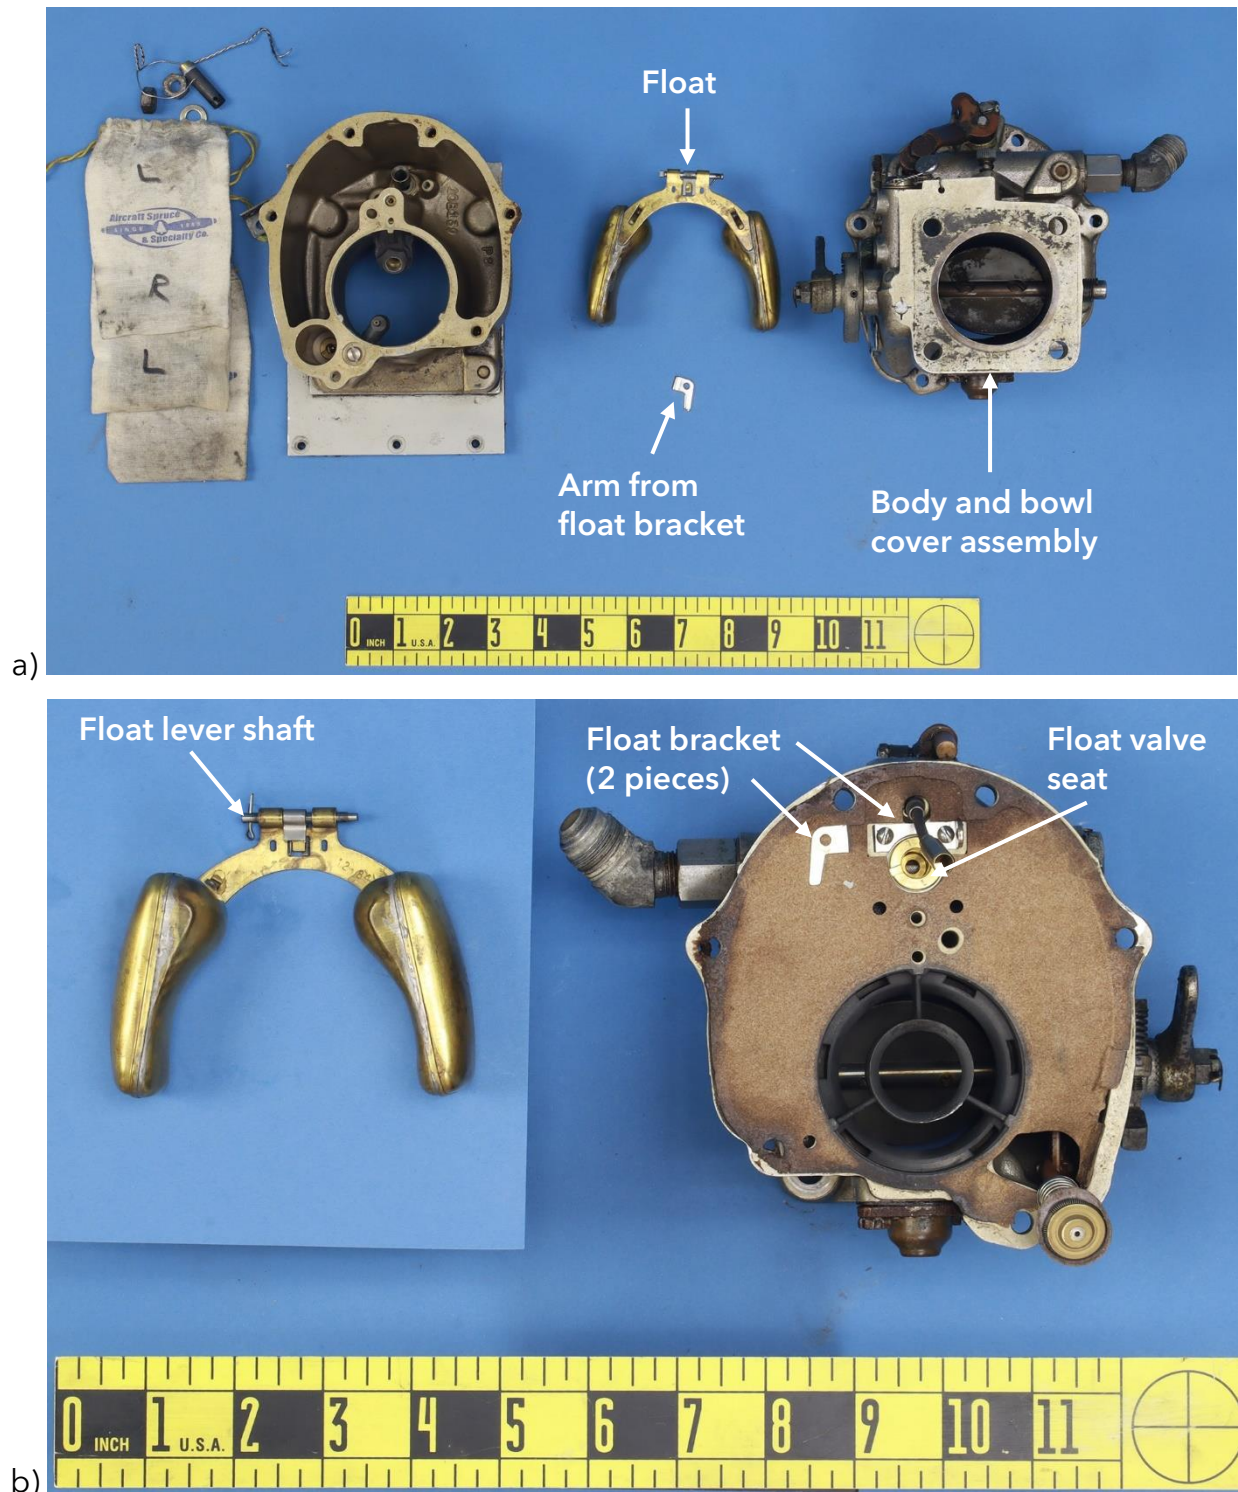
A partially disassembled carburetor, manufactured by Precision Airmotive Corp., was submitted to the NTSB Materials Laboratory for examination (figures 1 and 2). The float bracket had fractured into two pieces (figure 1b). By design, the float bracket was attached to the throttle body and bowl cover assembly by two screws. The float was attached to the bracket by a float lever shaft (figure 1b). A float valve (figures 2a and 2b) was coupled to the float by a clip that was also mounted on the float lever shaft. Rotation of the float about the shaft resulted in axial motion of the float valve inside the float valve seat (figure 3). When the valve was sealed against the seat, the flow of fuel into the bowl was restricted.

**Figure 1.** a) Partially disassembled carburetor as received and b) float and throttle body and bowl cover assembly with labels indicating the float bracket pieces and the float valve seat.

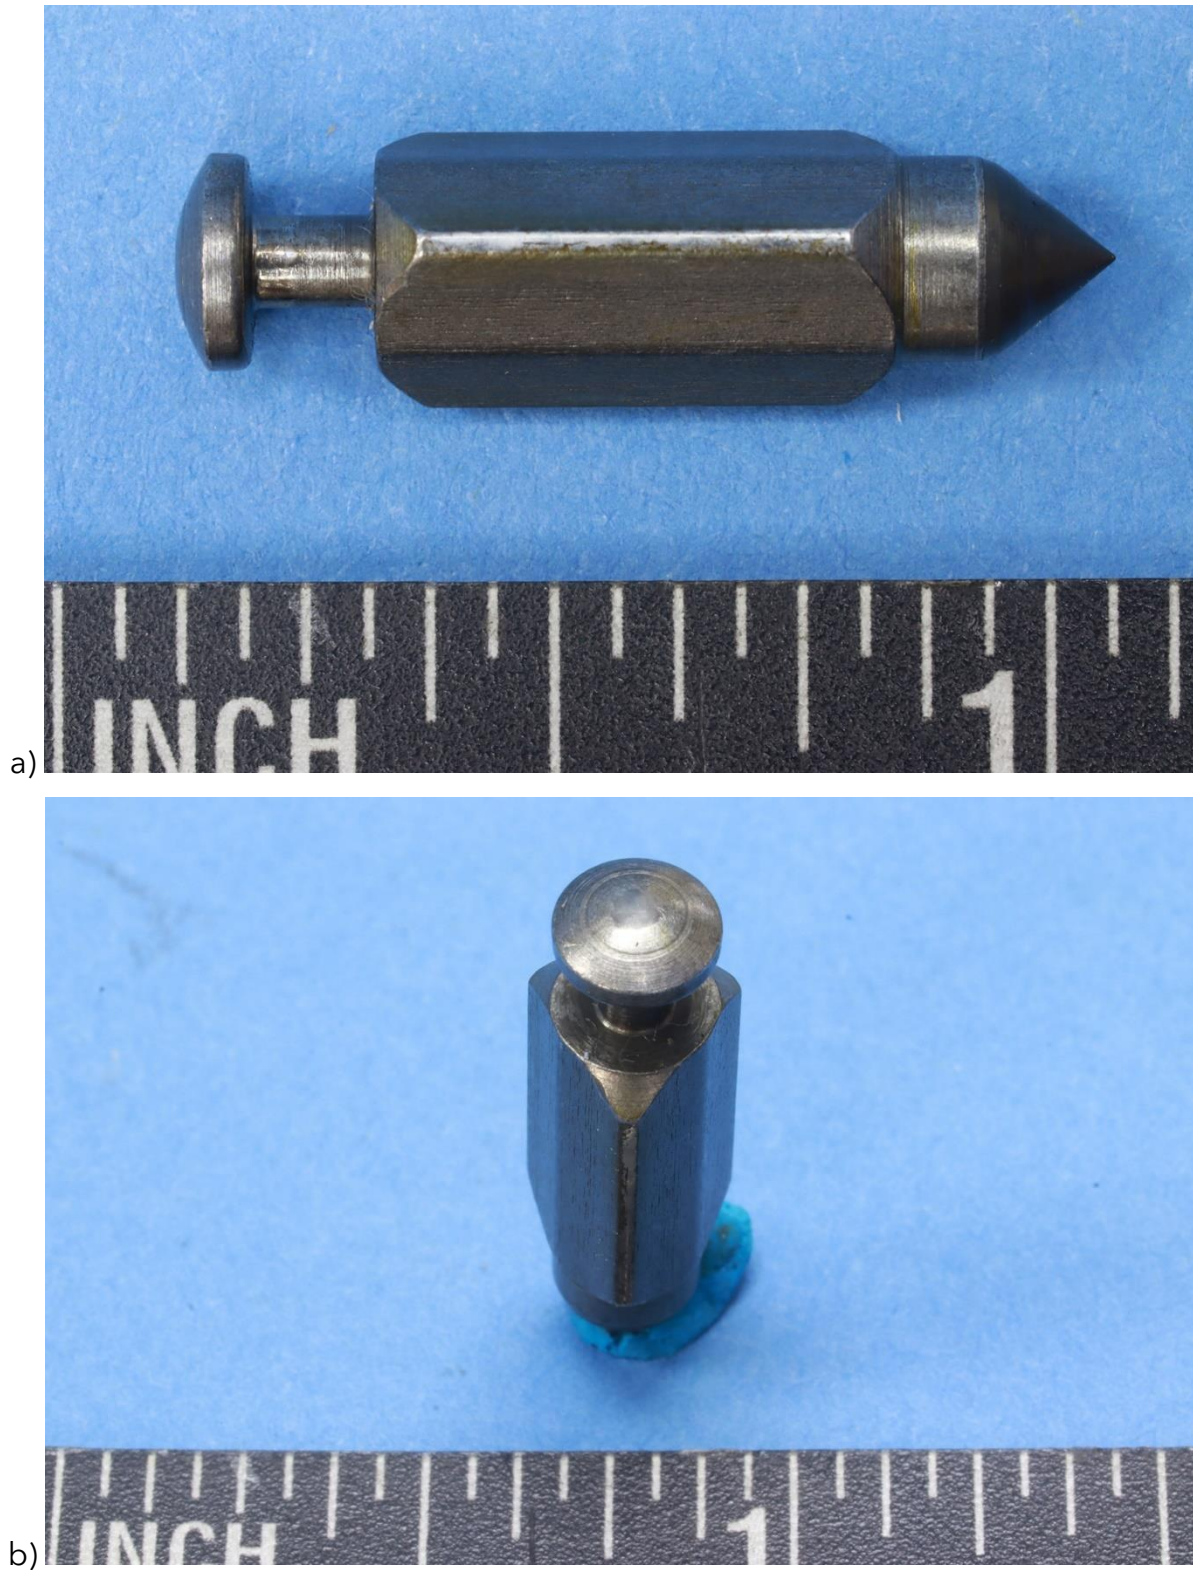
**Figure 2.** Images of the float valve: a) side view and b) isometric view.

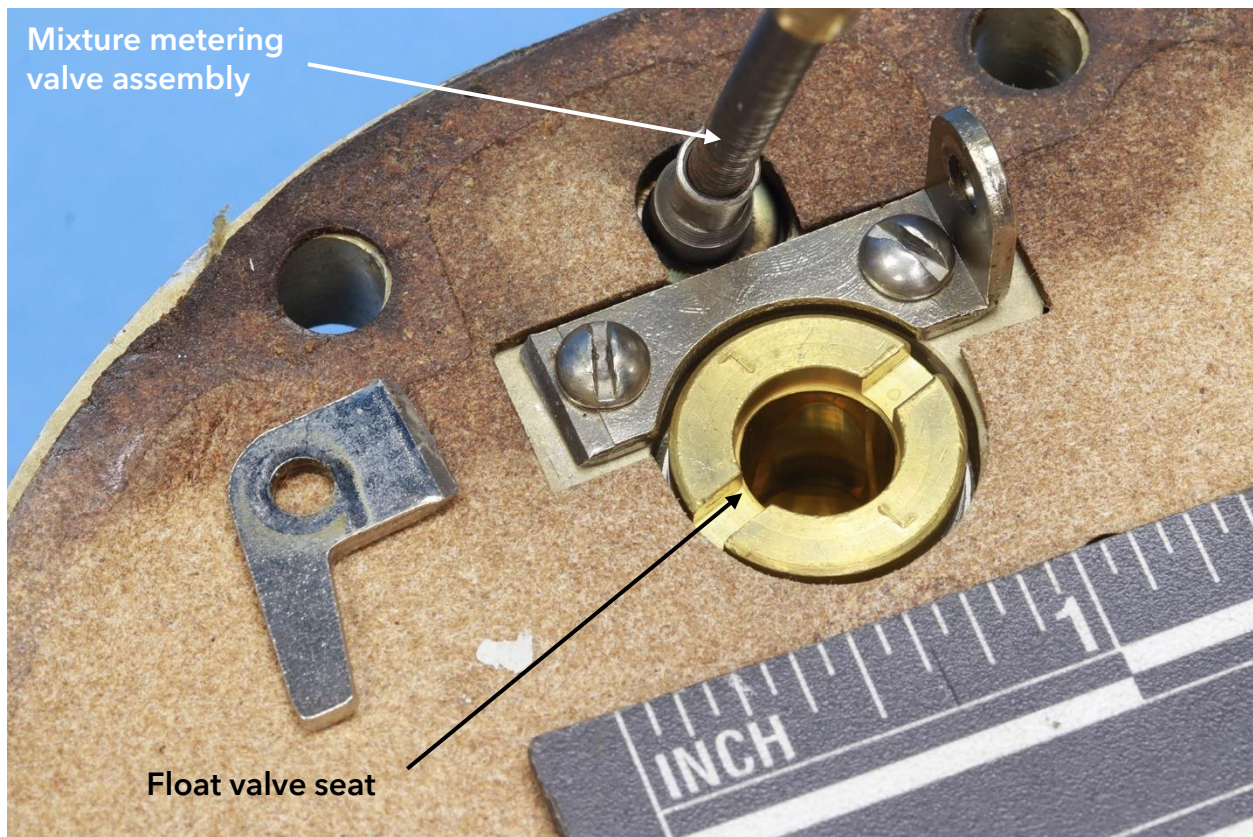
**Figure 3.** Image of fractured float bracket and valve seat.

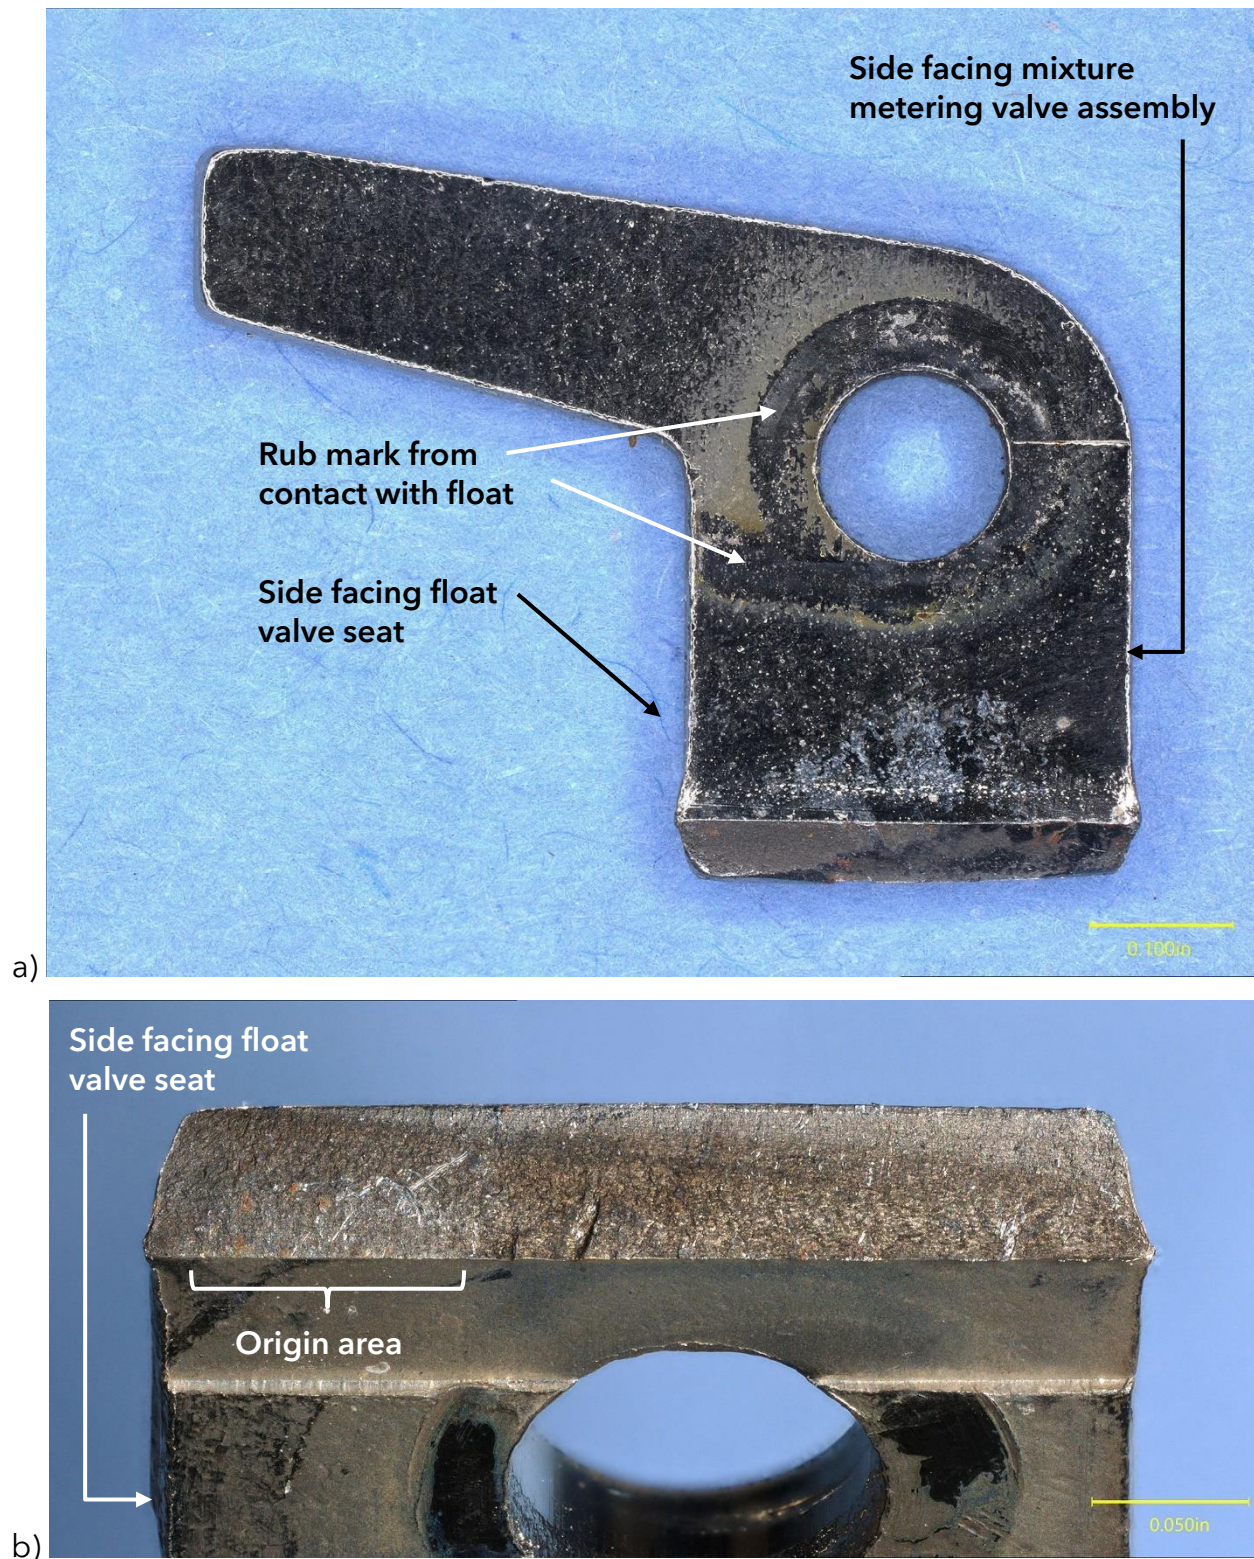
One of the float bracket arms had fractured as a result of cyclic fatigue and had separated from the rest of the bracket. The separated piece showed a light rub mark from contact with the float hinge (figure 4a). The fracture surfaces were flat and contained radiating lines and curved crack growth features that were consistent with the fracture originating along the interior edge where the arm intersected the base of the bracket (figure 4b). The origin was approximately 0.08 inch long and started about 0.015 inch from the side of the bracket closest to the float valve seat. The bracket was removed from the throttle body and bowl cover assembly, cleaned in acetone, and examined using a scanning electron microscope (SEM). The fracture surface exhibited either smearing features from fracture face recontact or fine feathery features consistent with high-cycle low amplitude fatigue (figures 5a - 5c). There were no apparent anomalies along the inner edge where the fracture originated.

**Figure 4.** a) Separated arm of the float bracket with a rub mark from the float's hinge and b) mating fracture face on the bracket piece attached to the body and bowl cover assembly showing the fracture origin on the interior bend near the side of the bracket closest to the float valve seat.

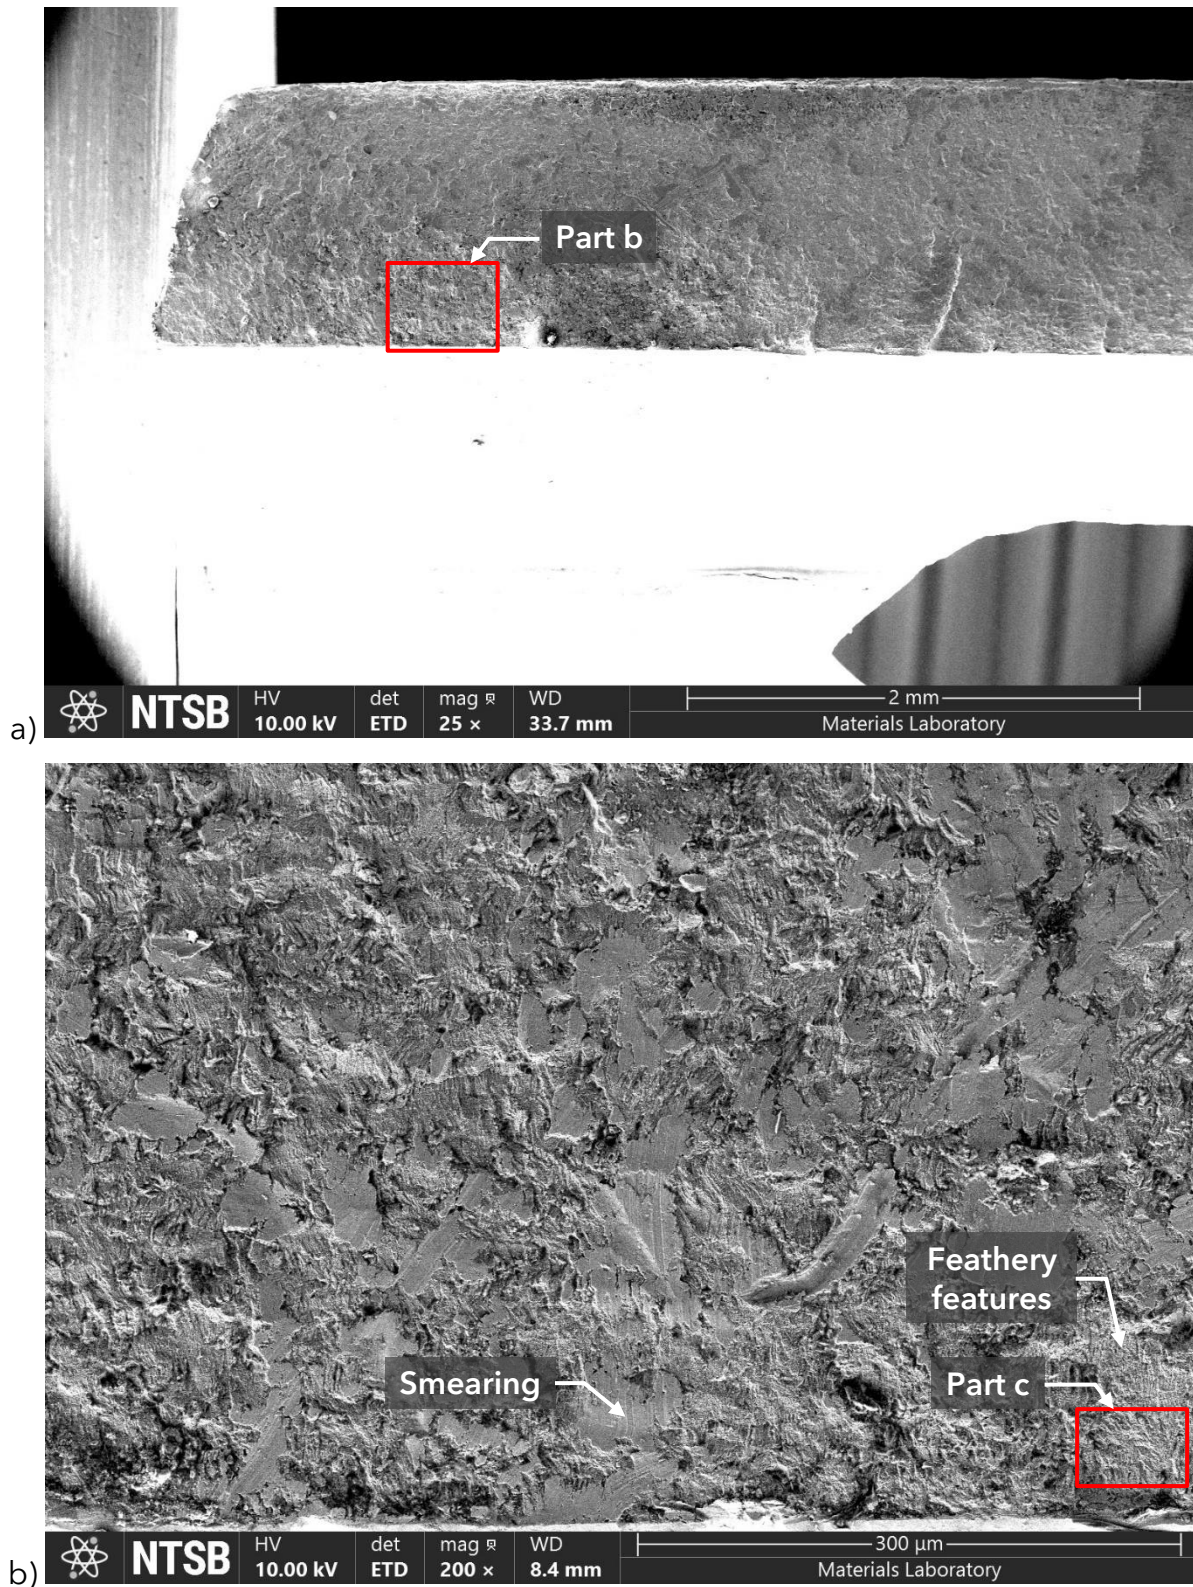
**Figure 5.** Scanning electron microscope images of the fractured float bracket: a) overview image; b) higher magnification image as indicated in part a; and

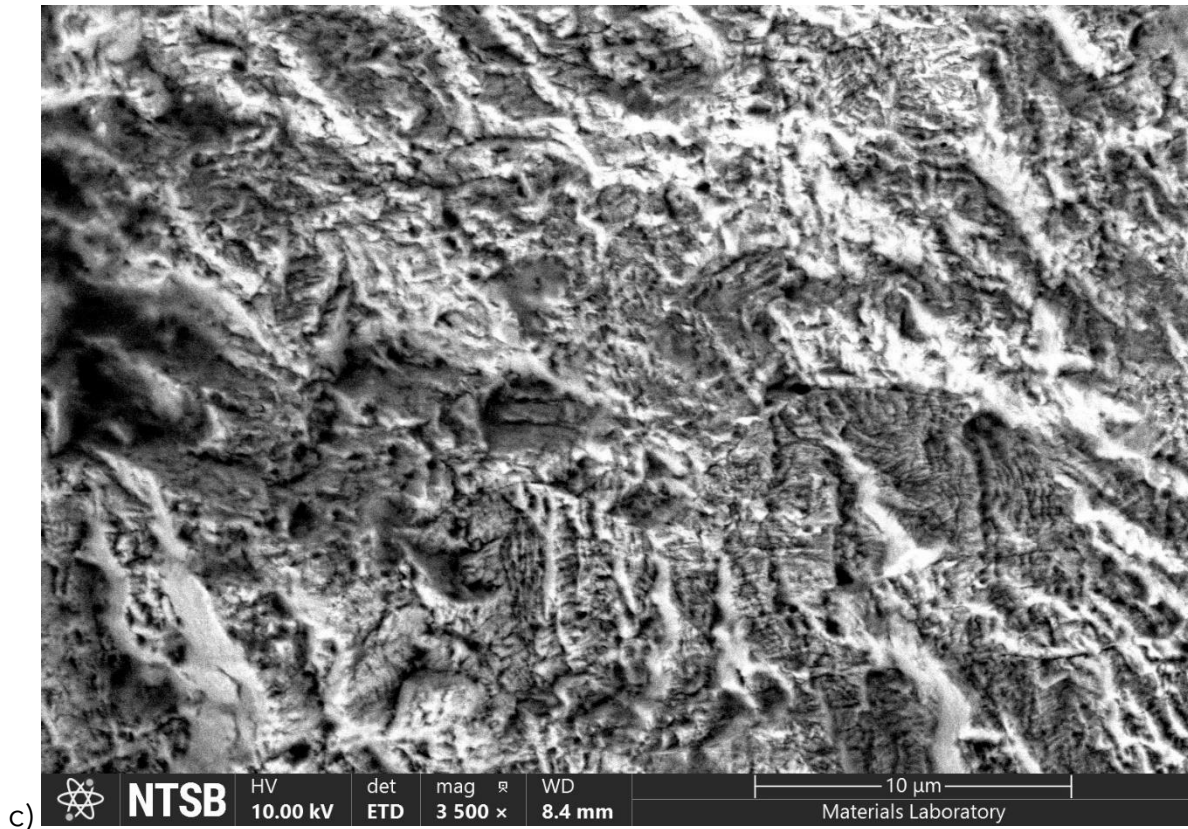
**Figure 5 (cont.).** c) higher magnification image as indicated in part b. The fracture has a feathery appearance consistent with high-cycle low amplitude fatigue.

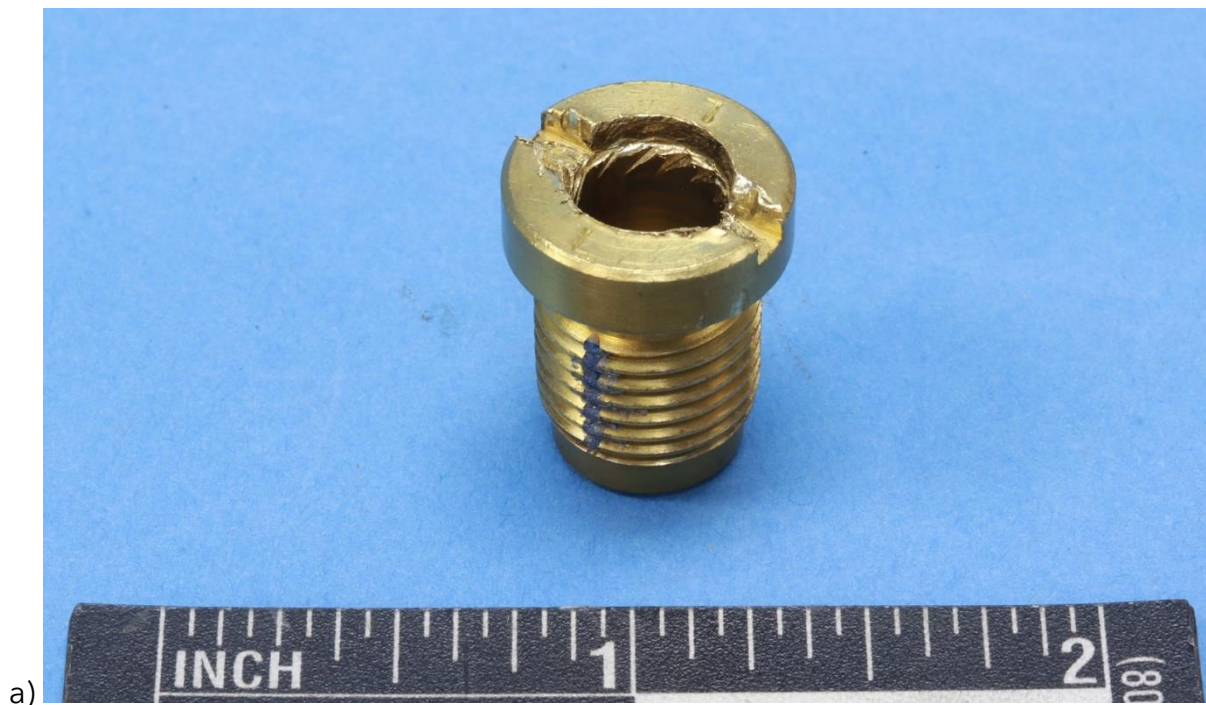
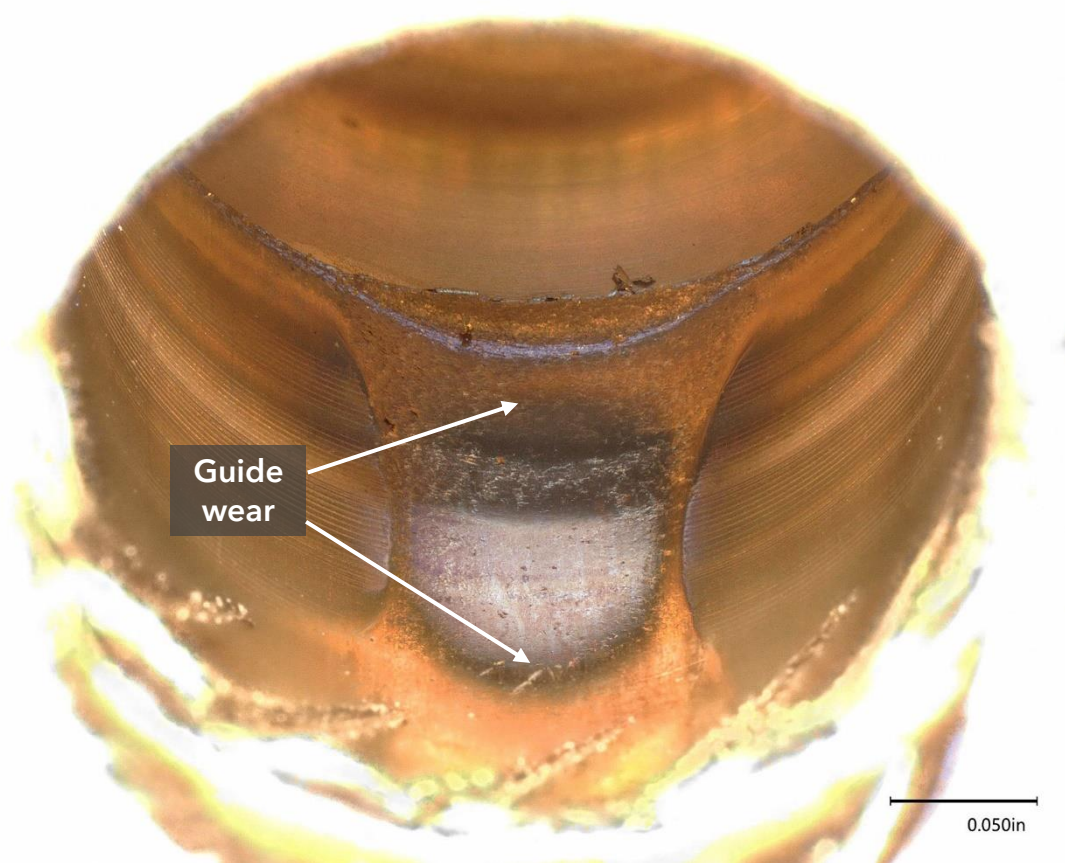
The float valve seat was worn. The seat was removed using a screw extractor (which created deformation marks at the opening to the seat) (figure 6a). The inner cylindrical valve guide surfaces contained longitudinal wear marks at three locations spaced 120° apart from one another (figures 6b and 6c). The spacing was the same as the three-lobed design of the float valve (figure 2b). Between the longitudinal wear marks, there was a circumferential wear mark close to the seat (figure 6c). The float valve surfaces were rubbed but did not appear worn.

**Figure 6.** Images of the float valve seat: a) float valve seat after removal from the throttle body and bowl cover assembly; b) image showing wear of the valve guide; and

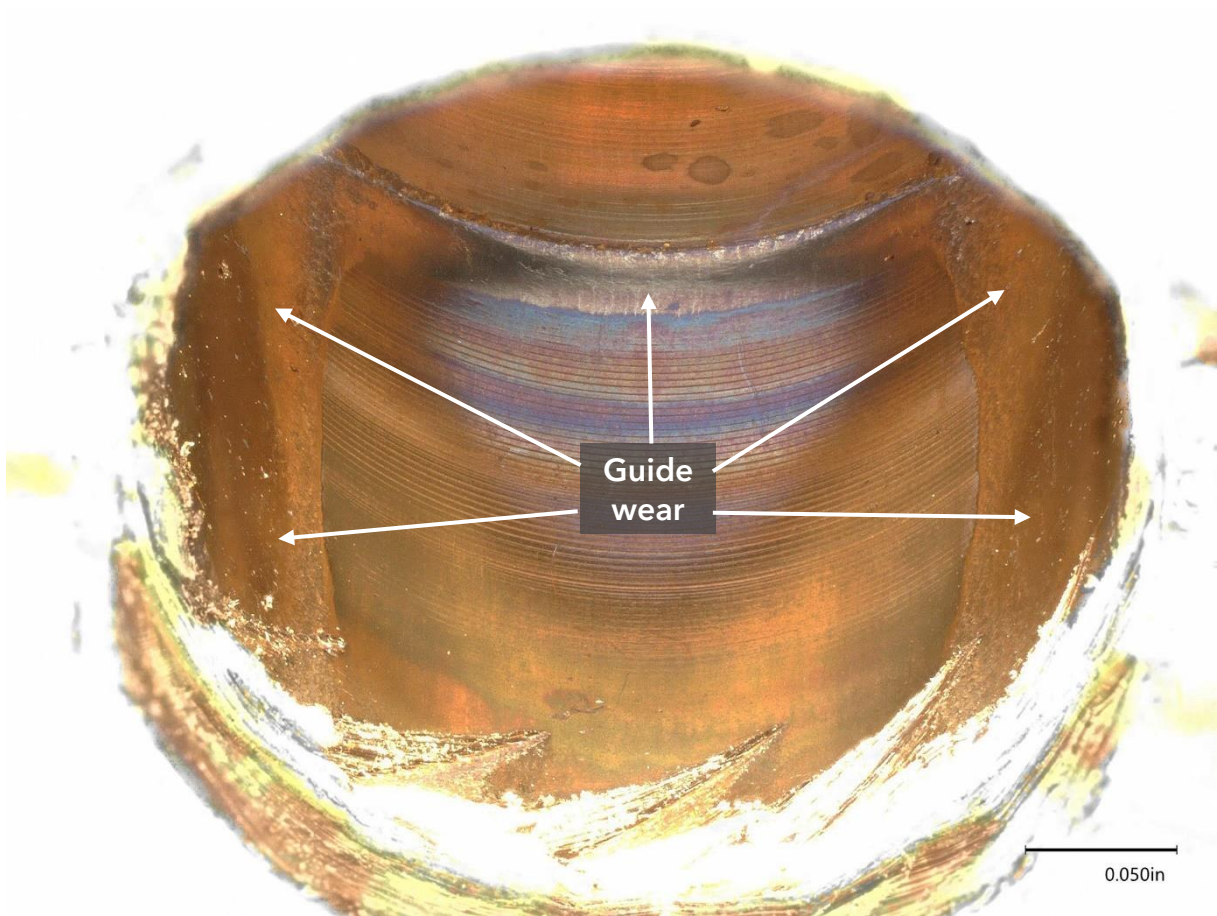
**Figure 6 (cont.).** c) image showing wear of the valve guide, rotated 60° relative to part b.
