ERA24LA020

## INVESTIGATION PHOTOGRAPHS

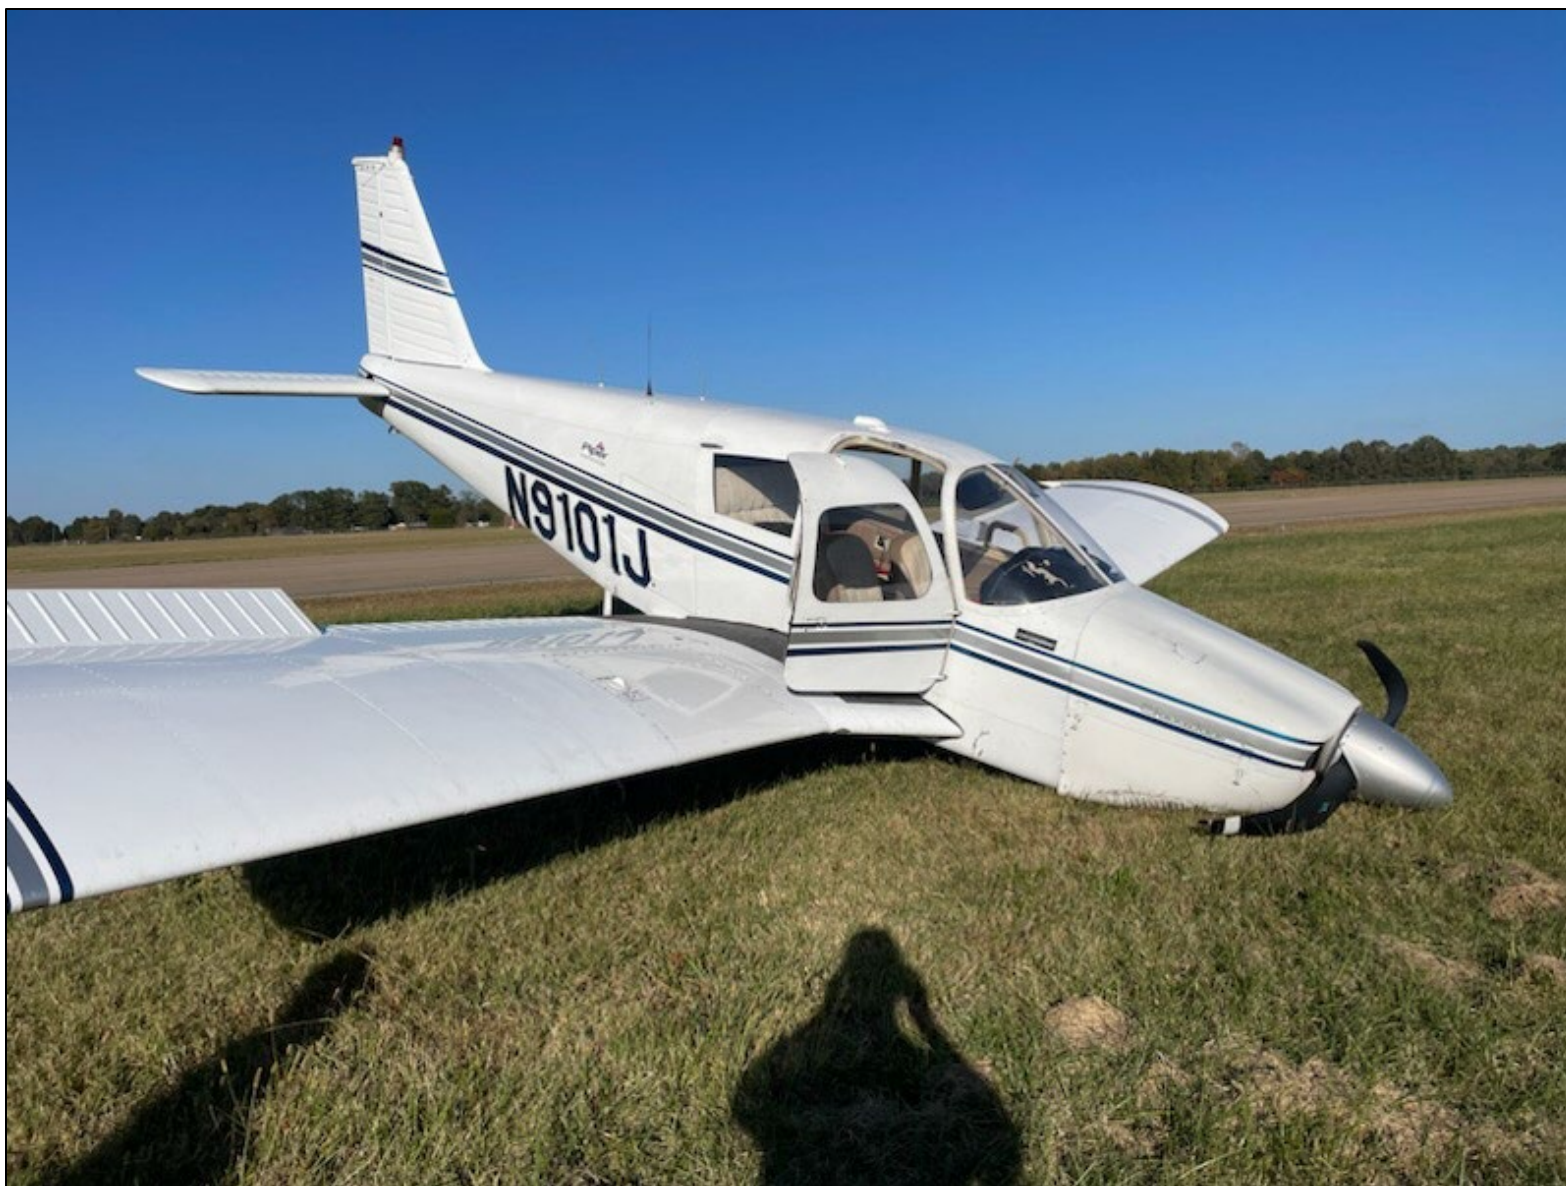
**Figure 1: Overview of the airplane at the accident site with a collapsed nose landing gear (Photo Courtesy of FAA)**

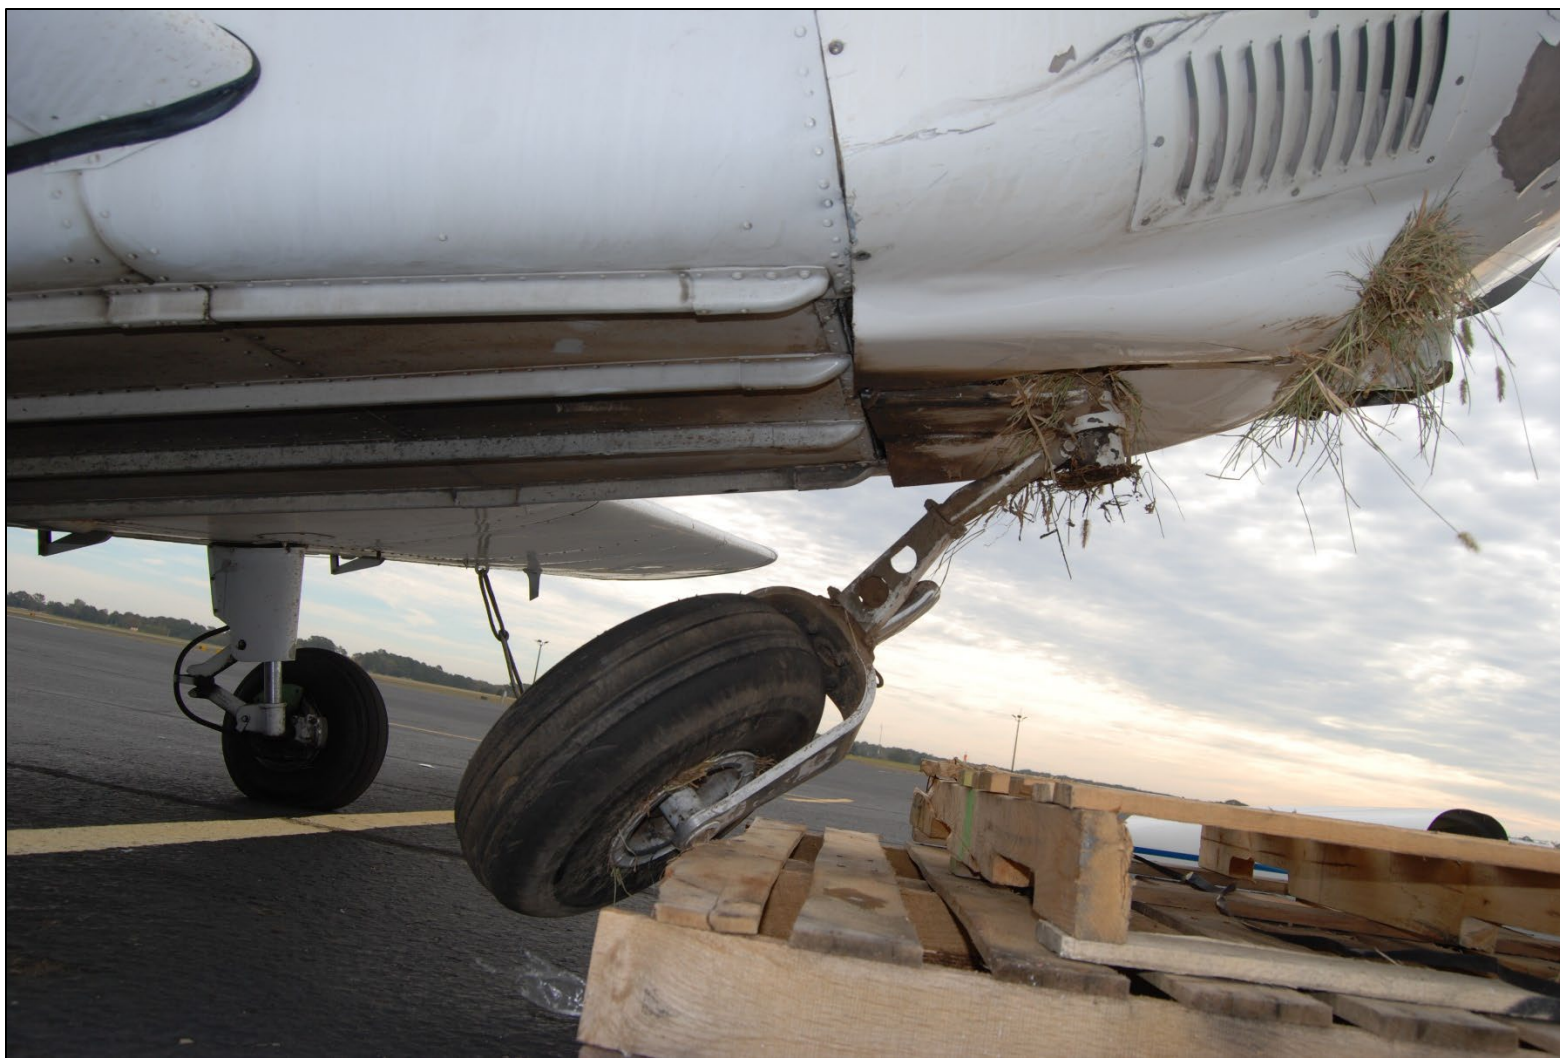
**Figure 2: View of the collapsed nose landing gear (Photo Courtesy of FAA)**

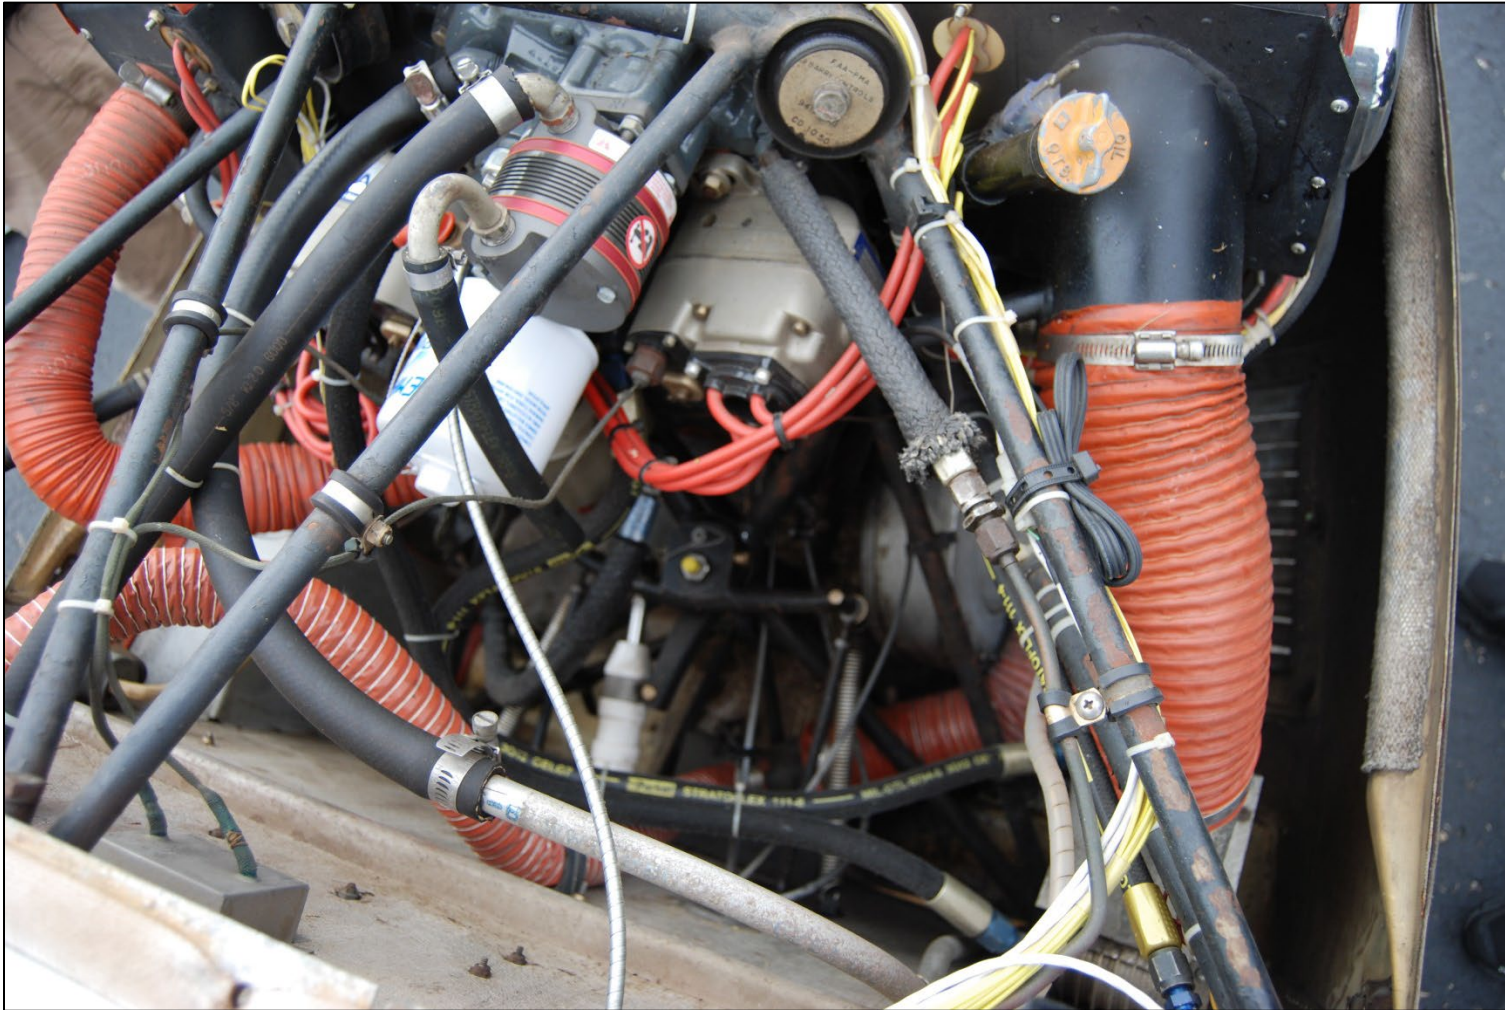
**Figure 3: View of the engine compartment. Note the engine mount was substantially damaged. (Photo Courtesy of FAA)**

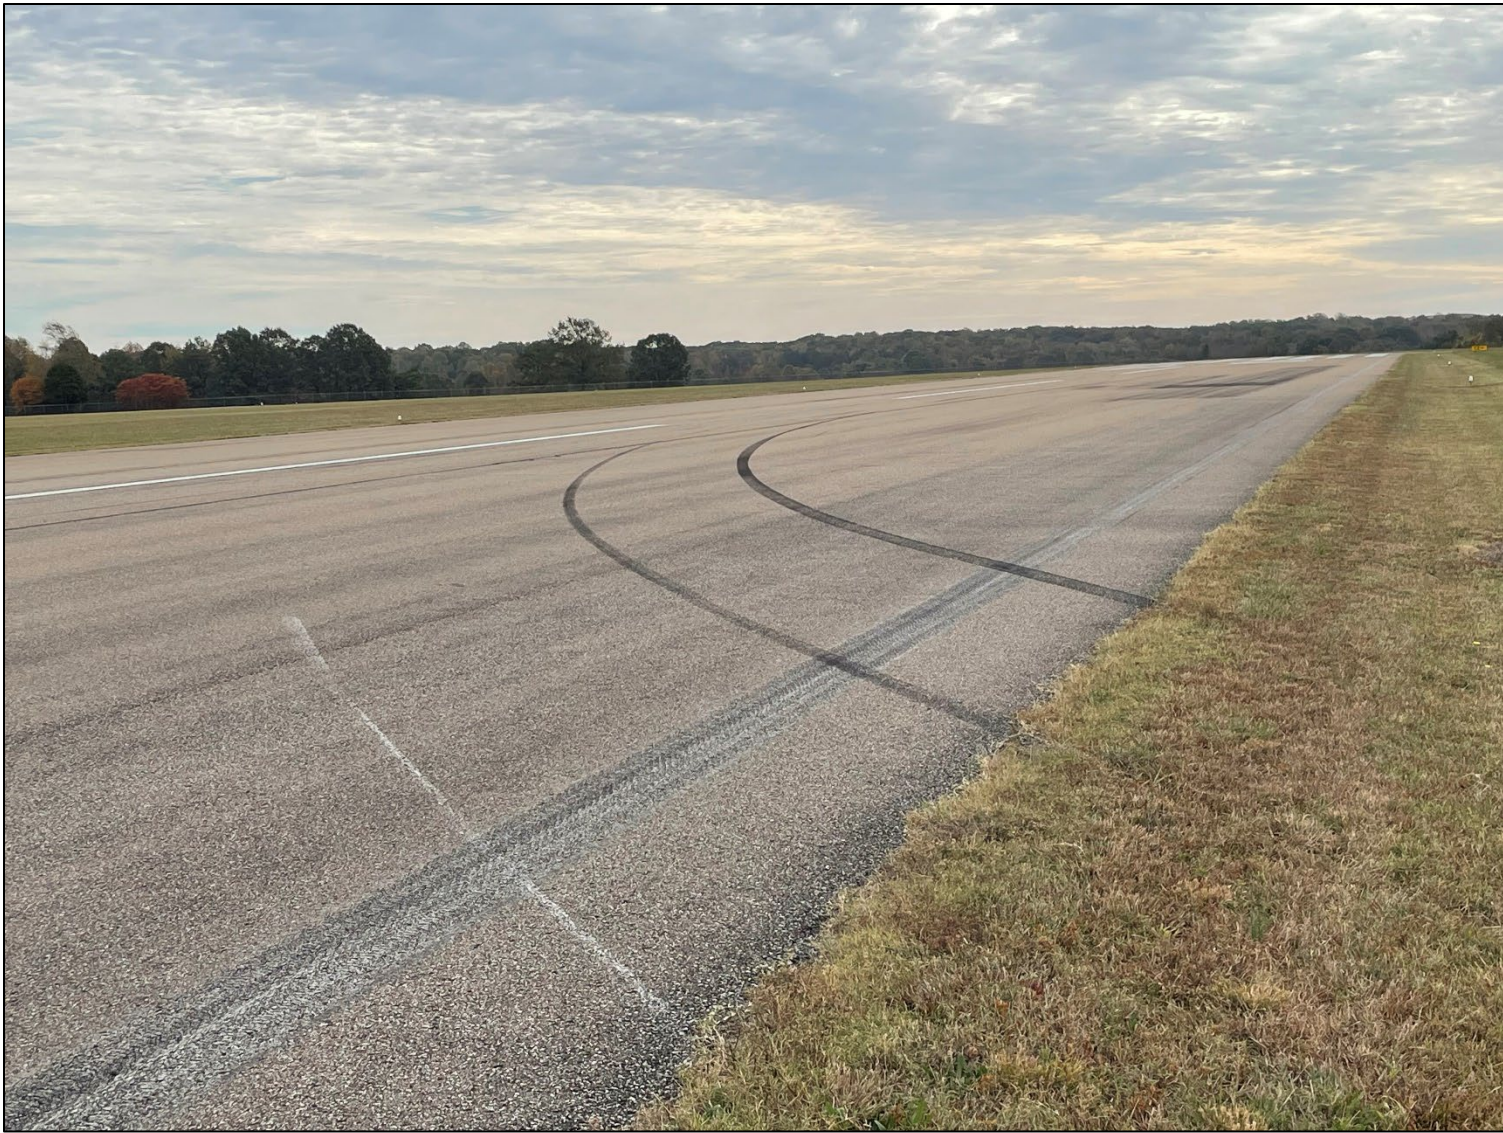
**Figure 4: View of tire tracks from the accident airplane, leading off the runway into the grass (Photo Courtesy of FAA)**
