ERA24LA022

## INVESTIGATION PHOTOGRAPHS

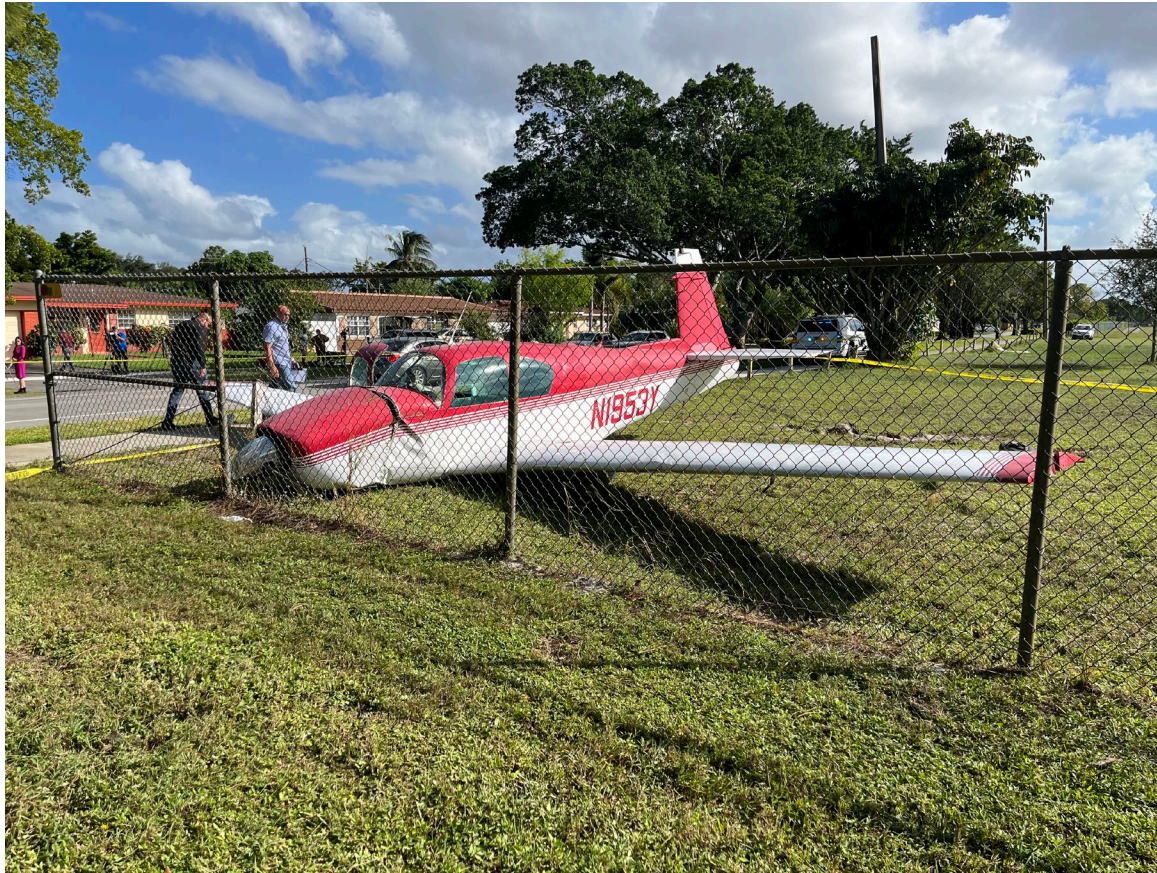
**Photograph 1 - Main Wreckage (Courtesy of FAA)**

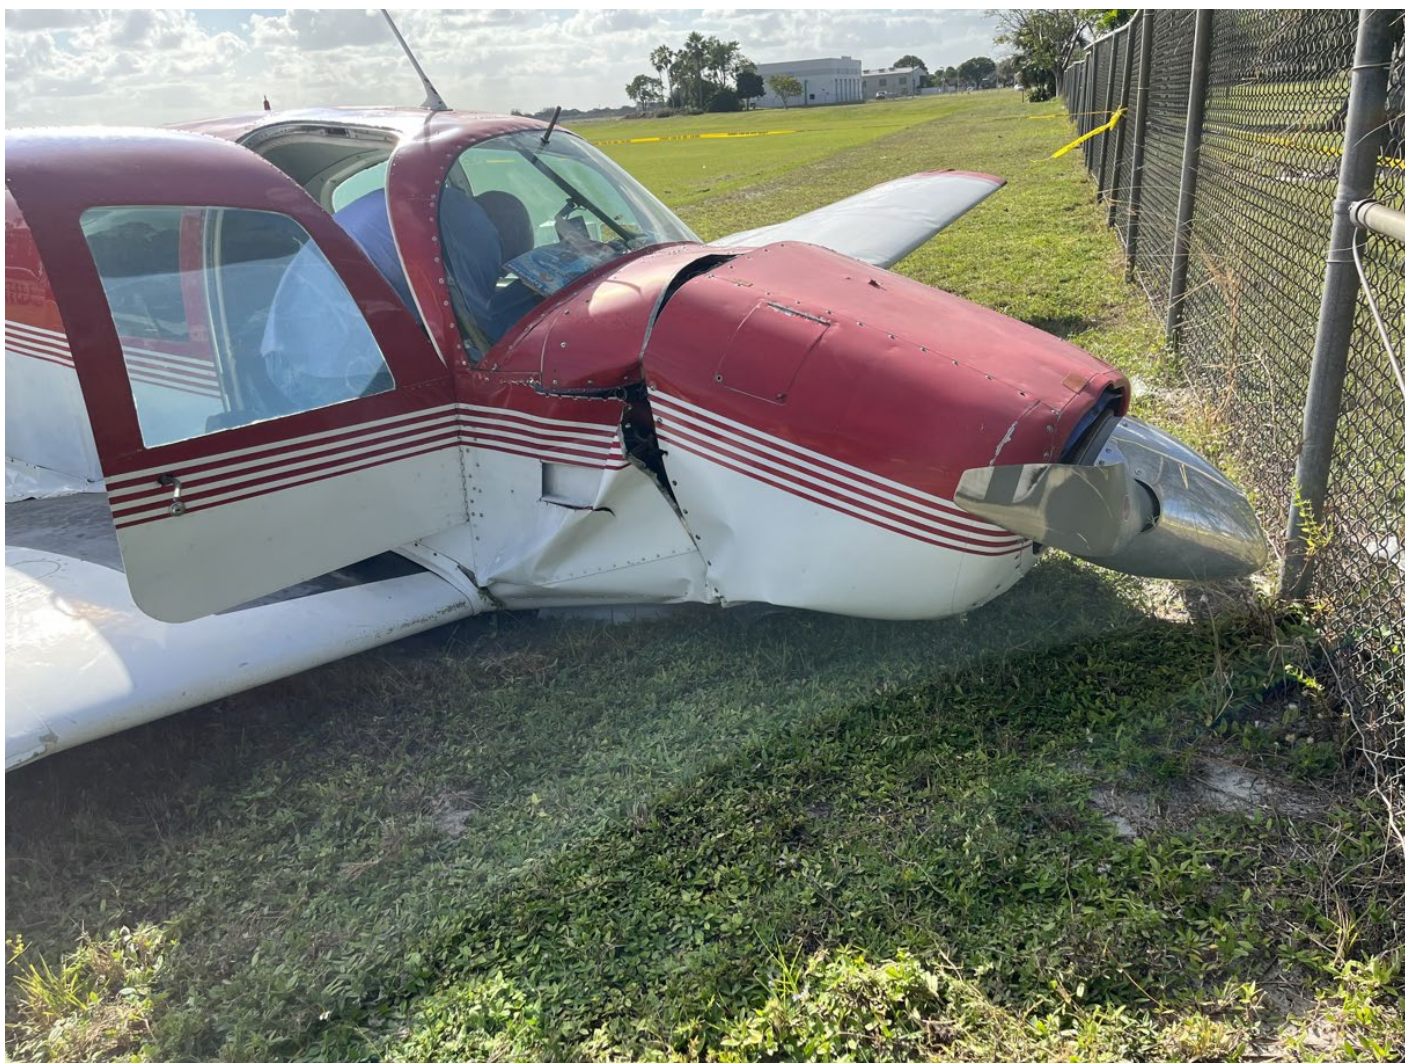
**Photograph 2 - Right Side of Nose Section (Courtesy of FAA)**

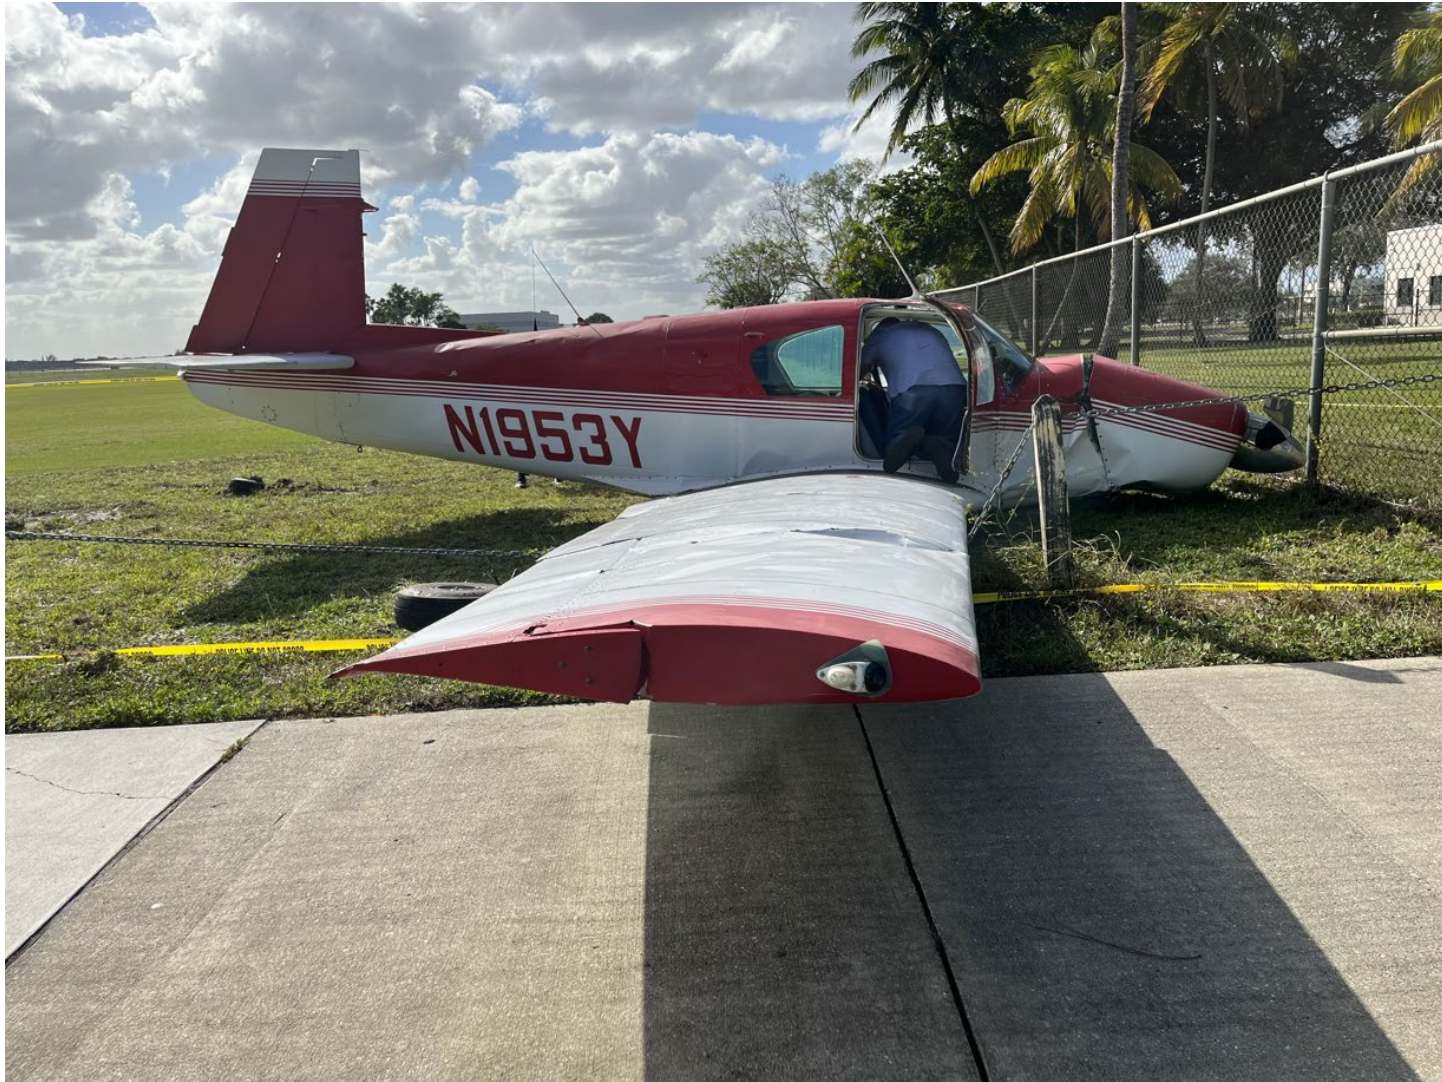
**Photograph 3 - Right Side (Courtesy of FAA)**

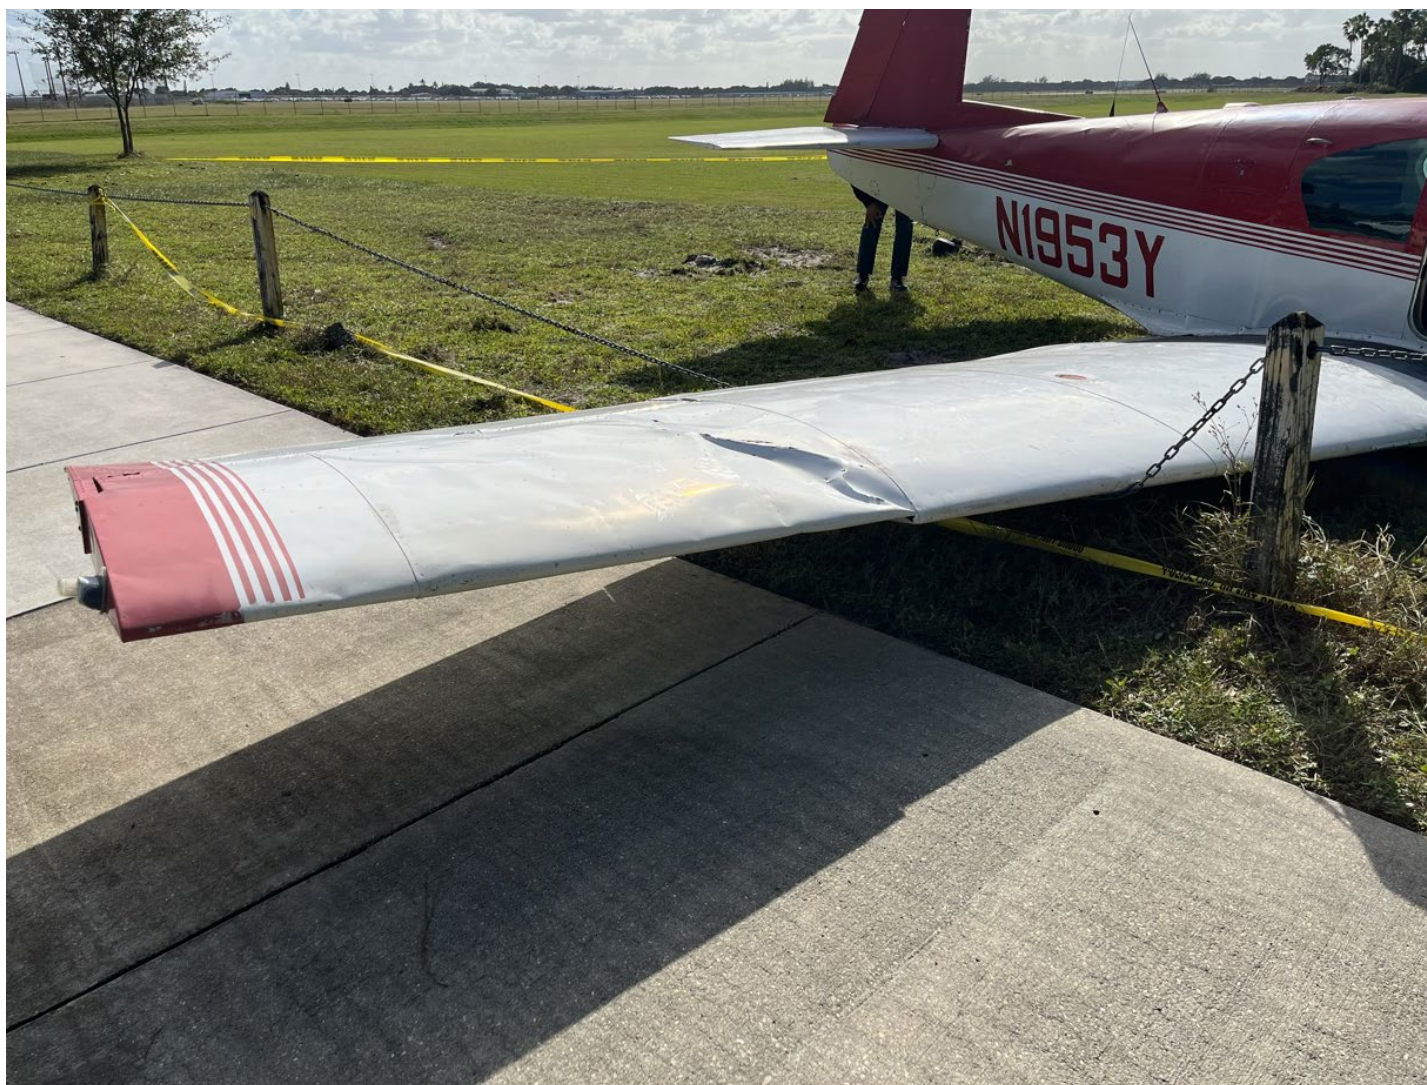
**Photograph 4 - Right Wing (Courtesy of FAA)**

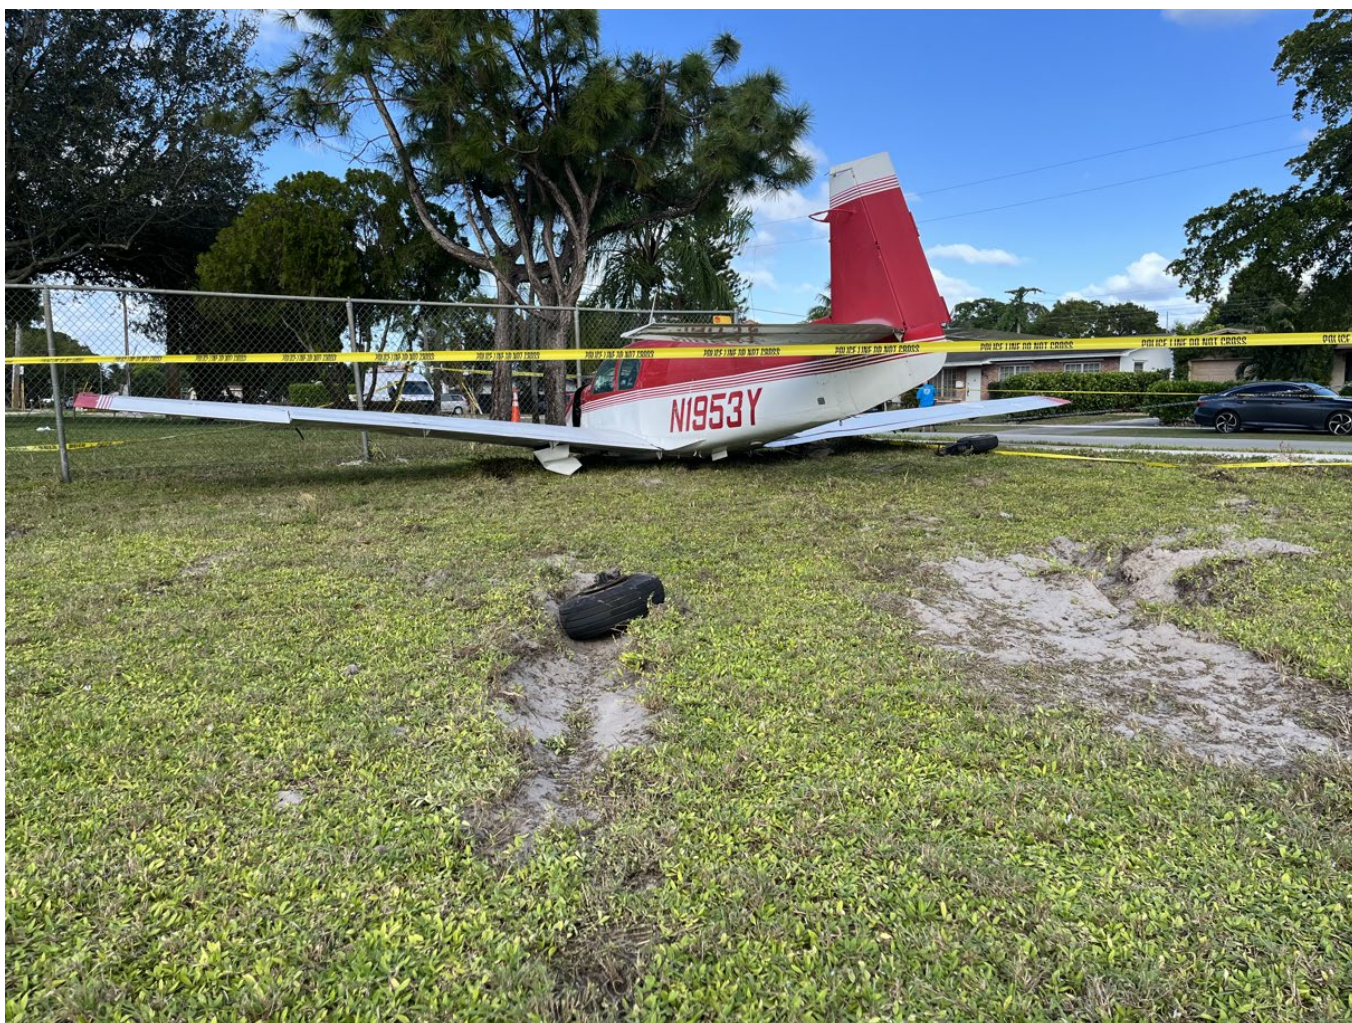
**Photograph 5 - Rear View (Courtesy of FAA)**

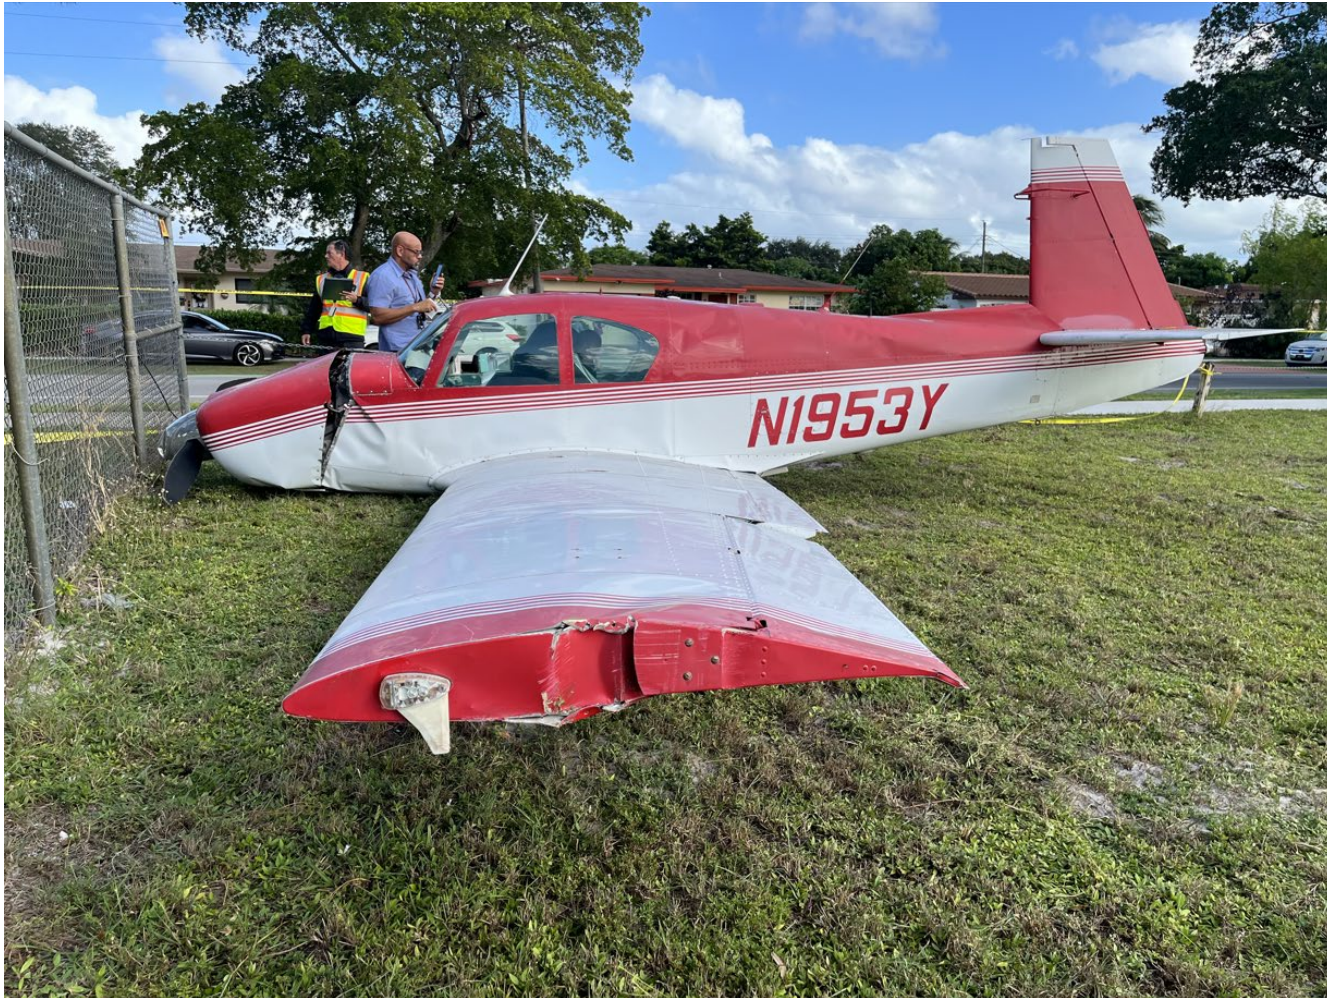
**Photograph 6 - Left Side (Courtesy of FAA)**

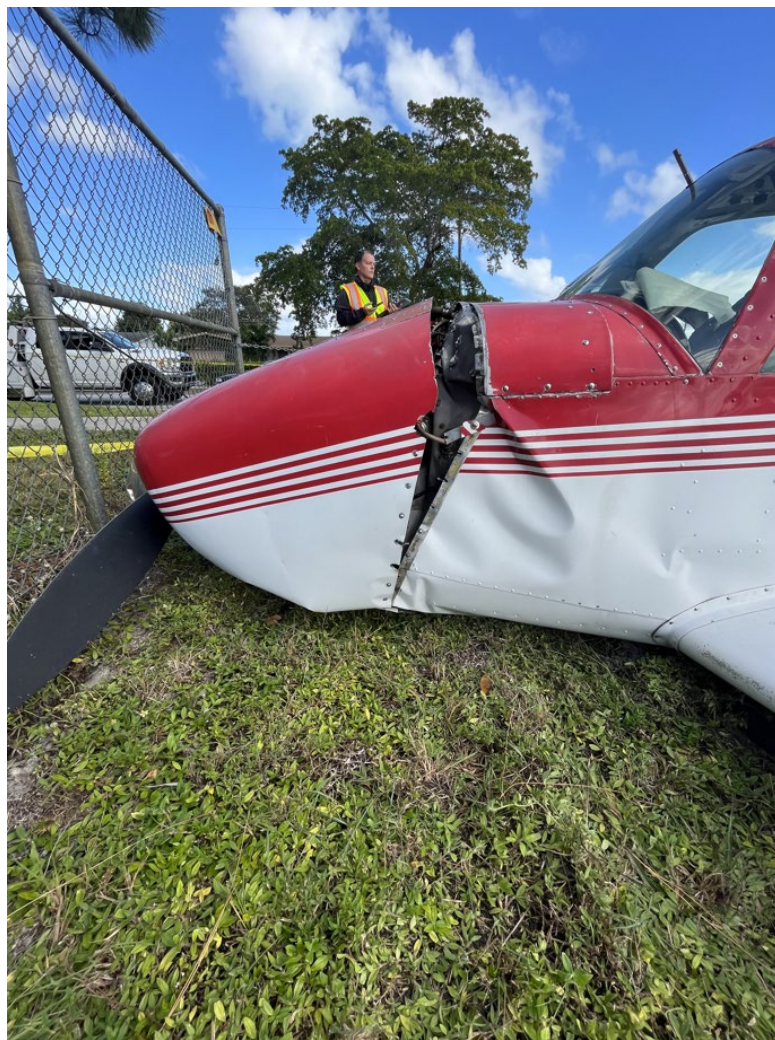
**Photograph 7 - Left Side of Nose Section (Courtesy of FAA)**

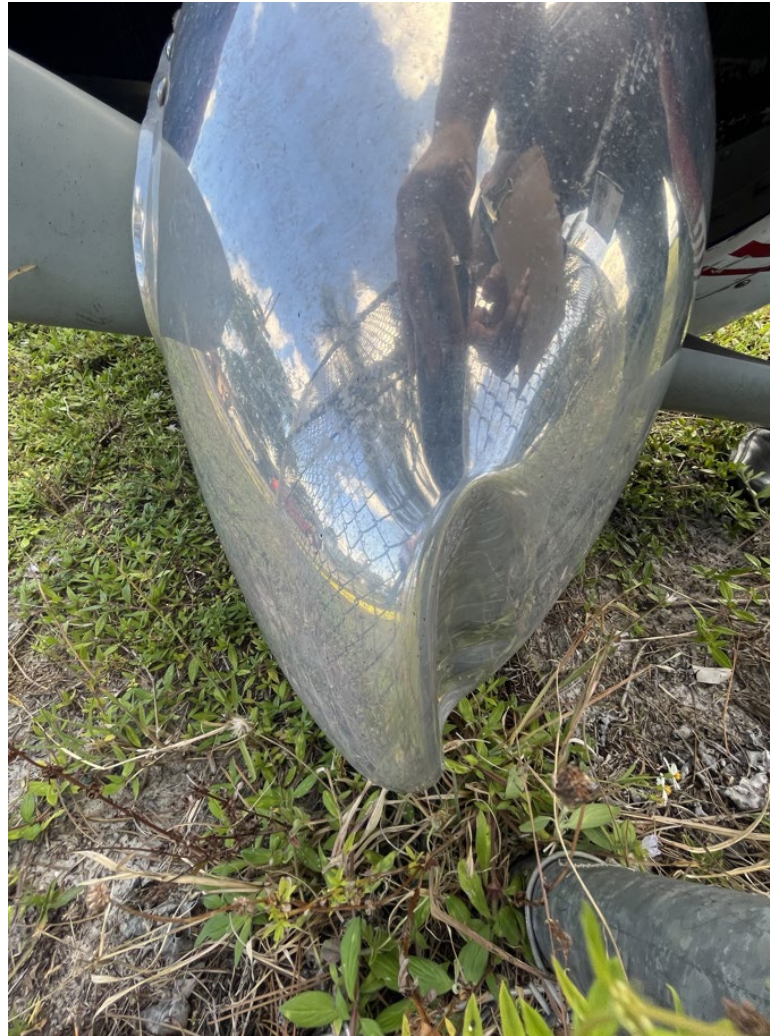
**Photograph 8 - Propeller Spinner (Courtesy of FAA)**

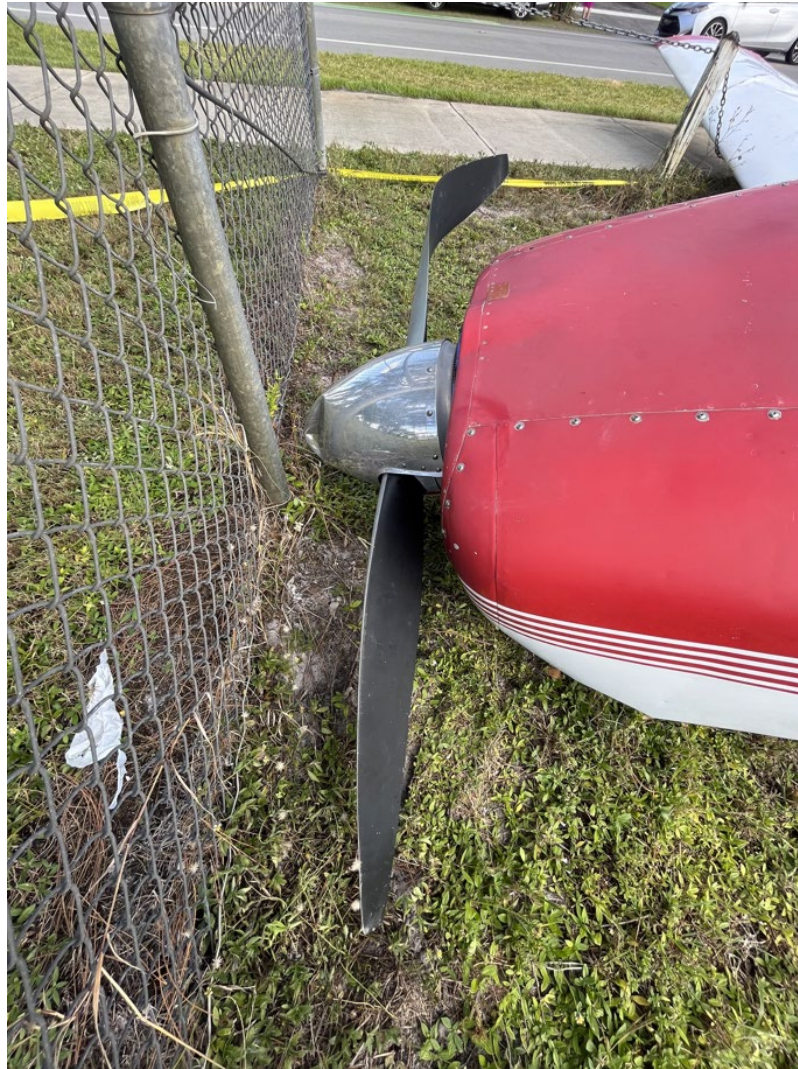
**Photograph 9 - Propeller (Courtesy of FAA)**

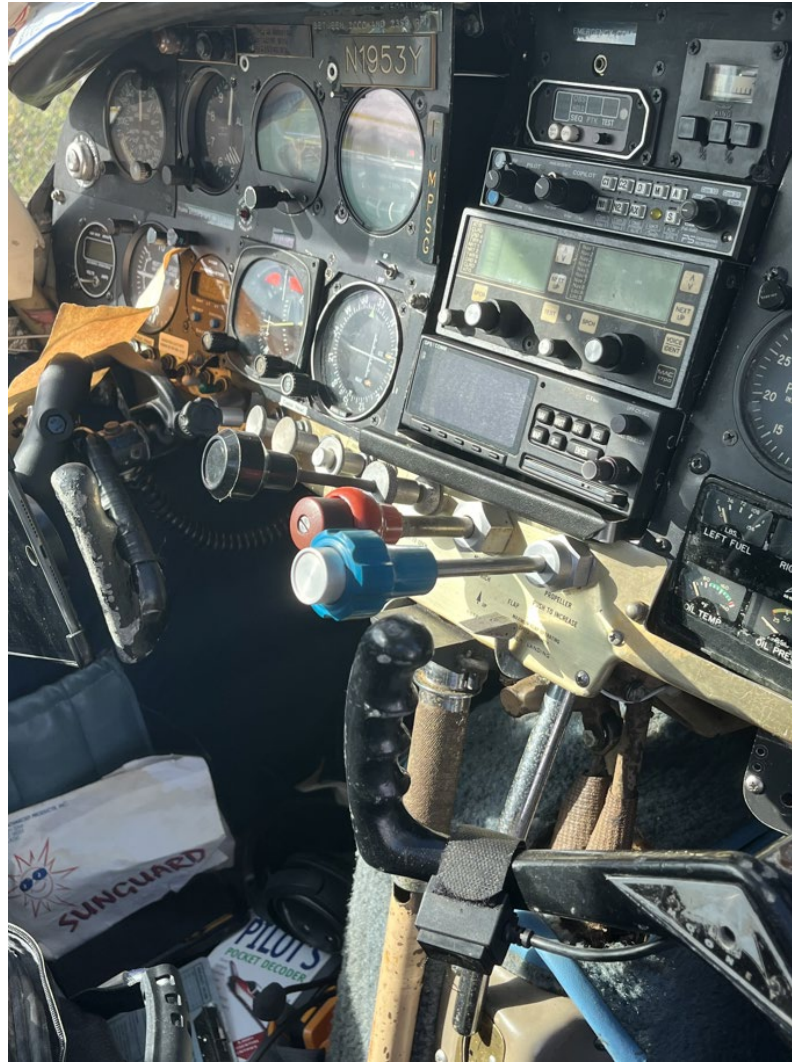
**Photograph 10 - Cockpit (Courtesy of FAA)**

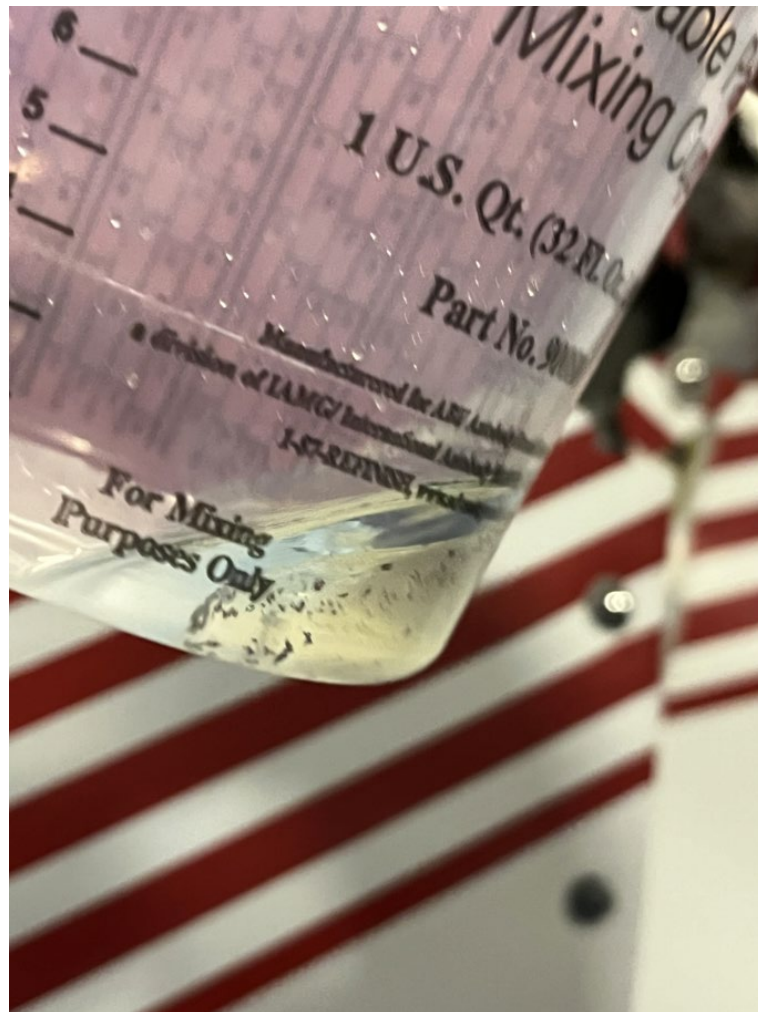
**Photograph 11 - First Post Accident Sump - Left Side (Courtesy of FAA)**

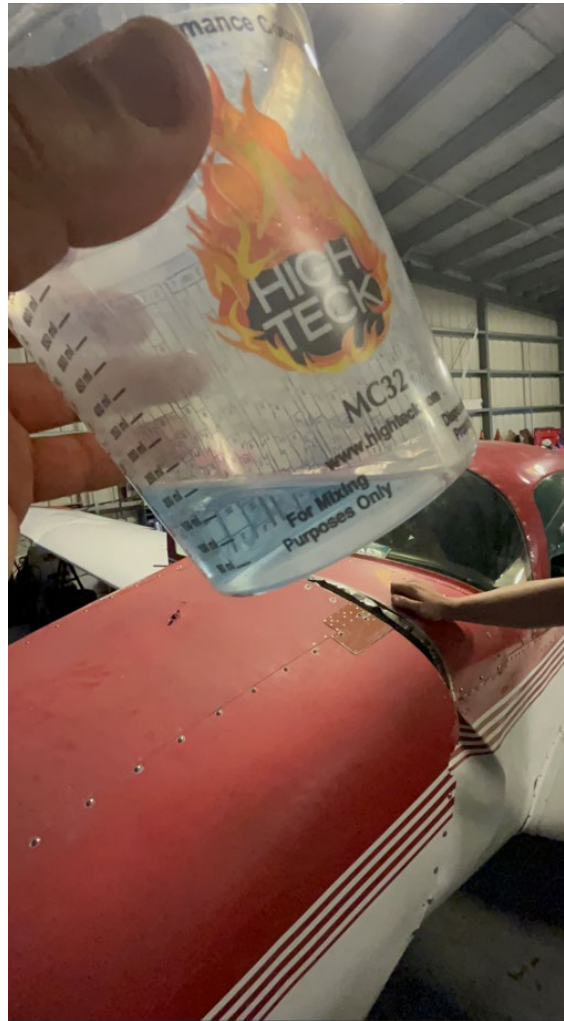
**Photograph 12 - First Post Accident Sump - Right Side (Courtesy of FAA)**

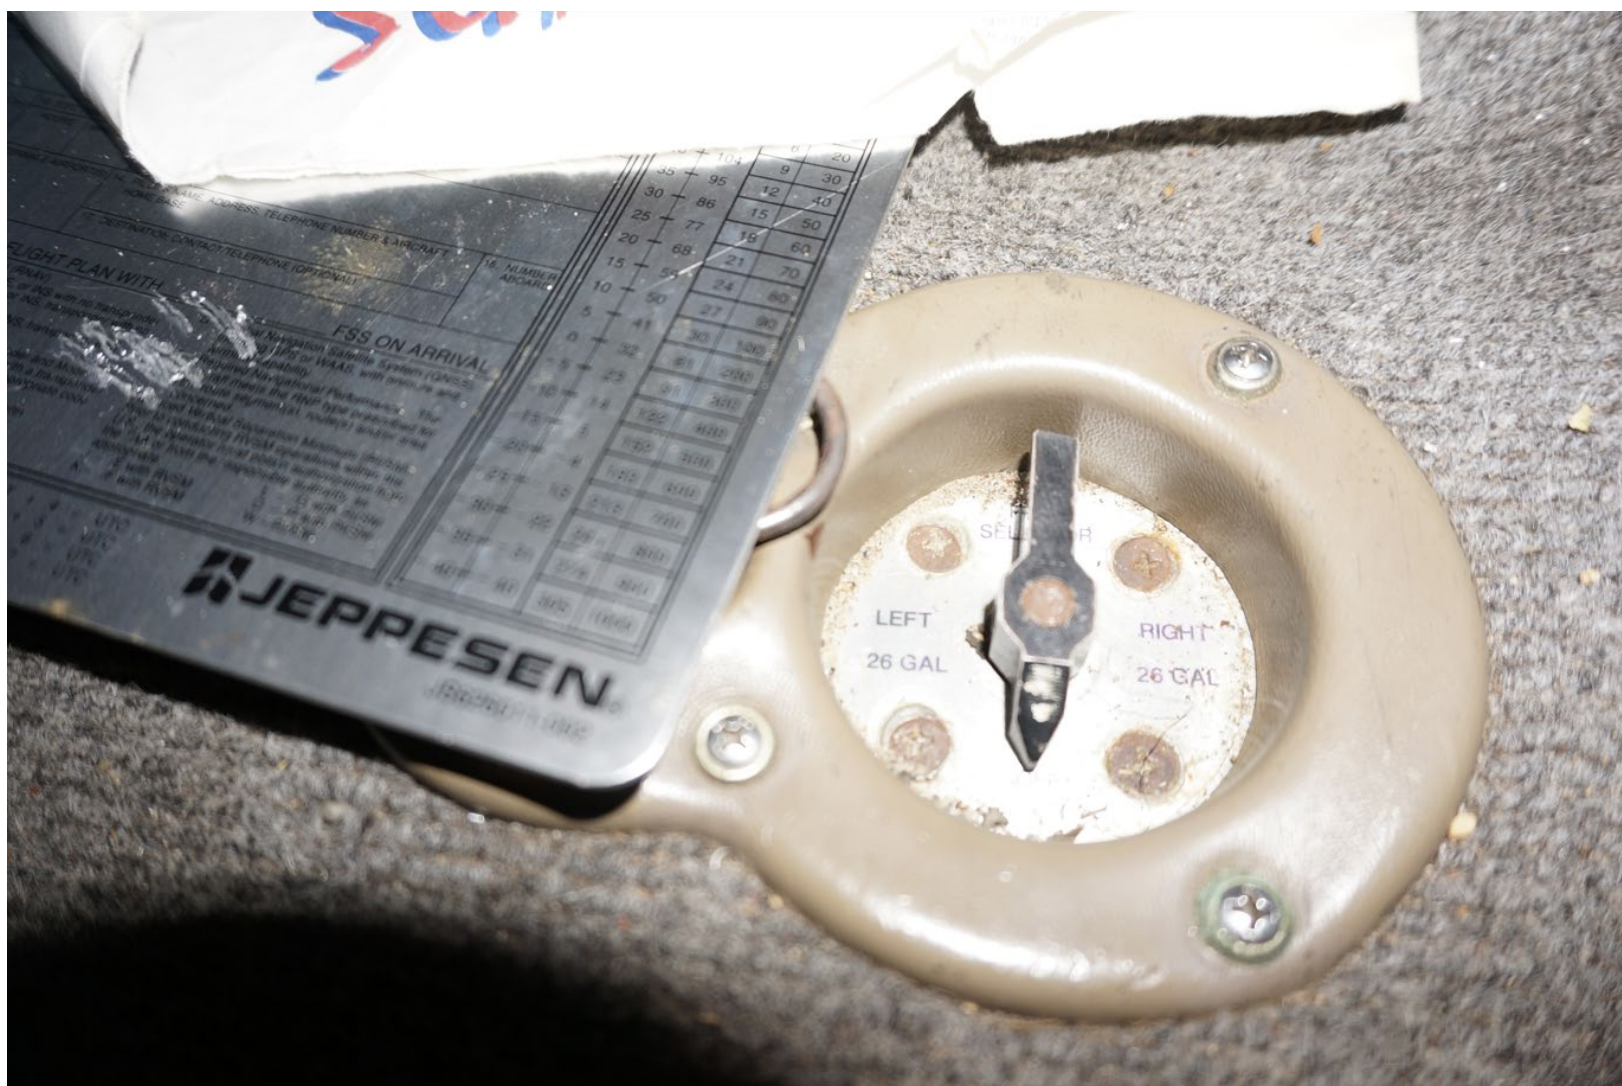
**Photograph 13 - Fuel Selector**

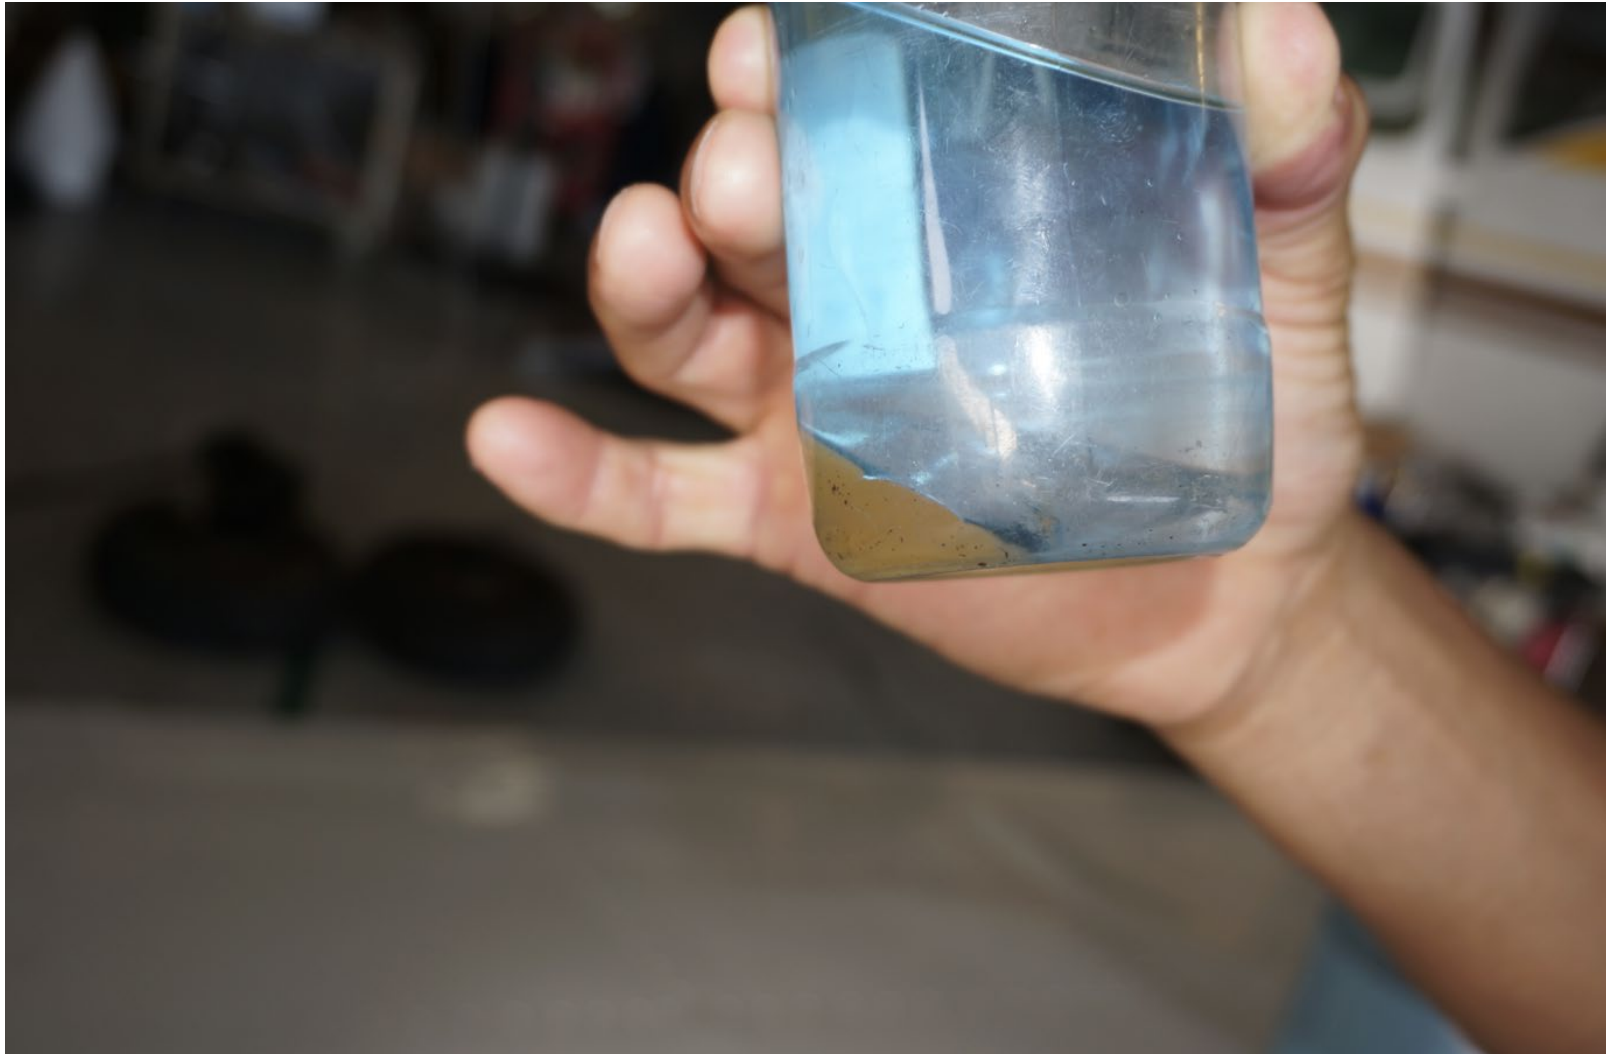
**Photograph 14 - Second Post Accident Sump - Left Side**

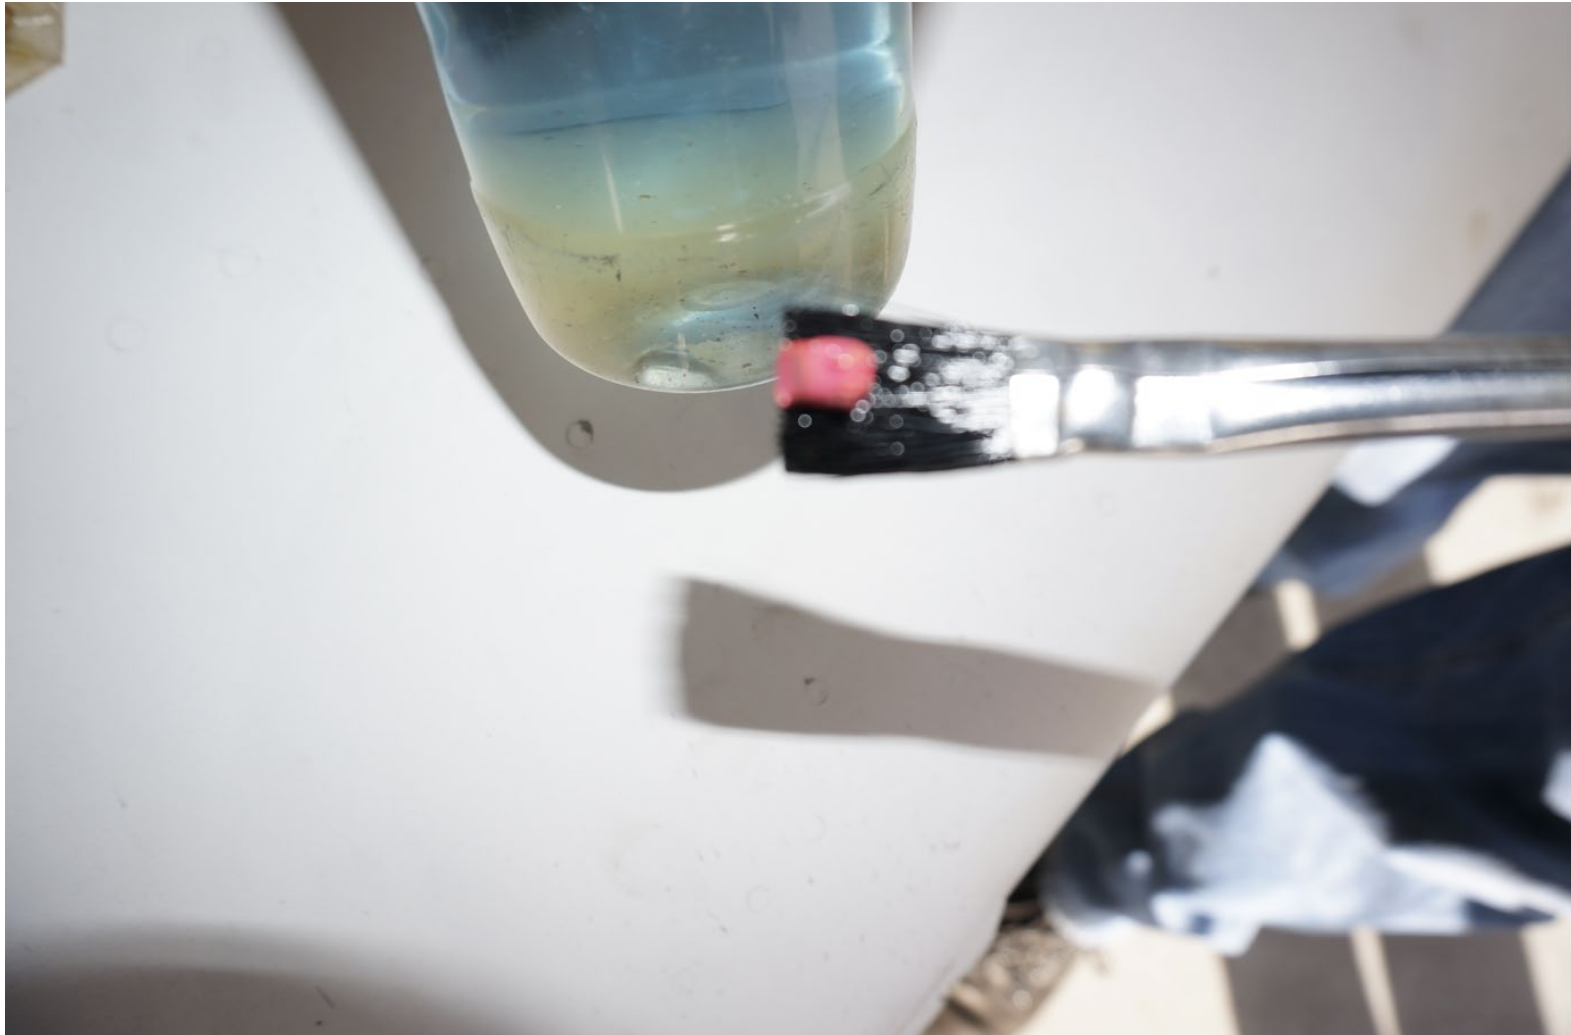
**Photograph 15 - Second Post Accident Sump - Right Side**

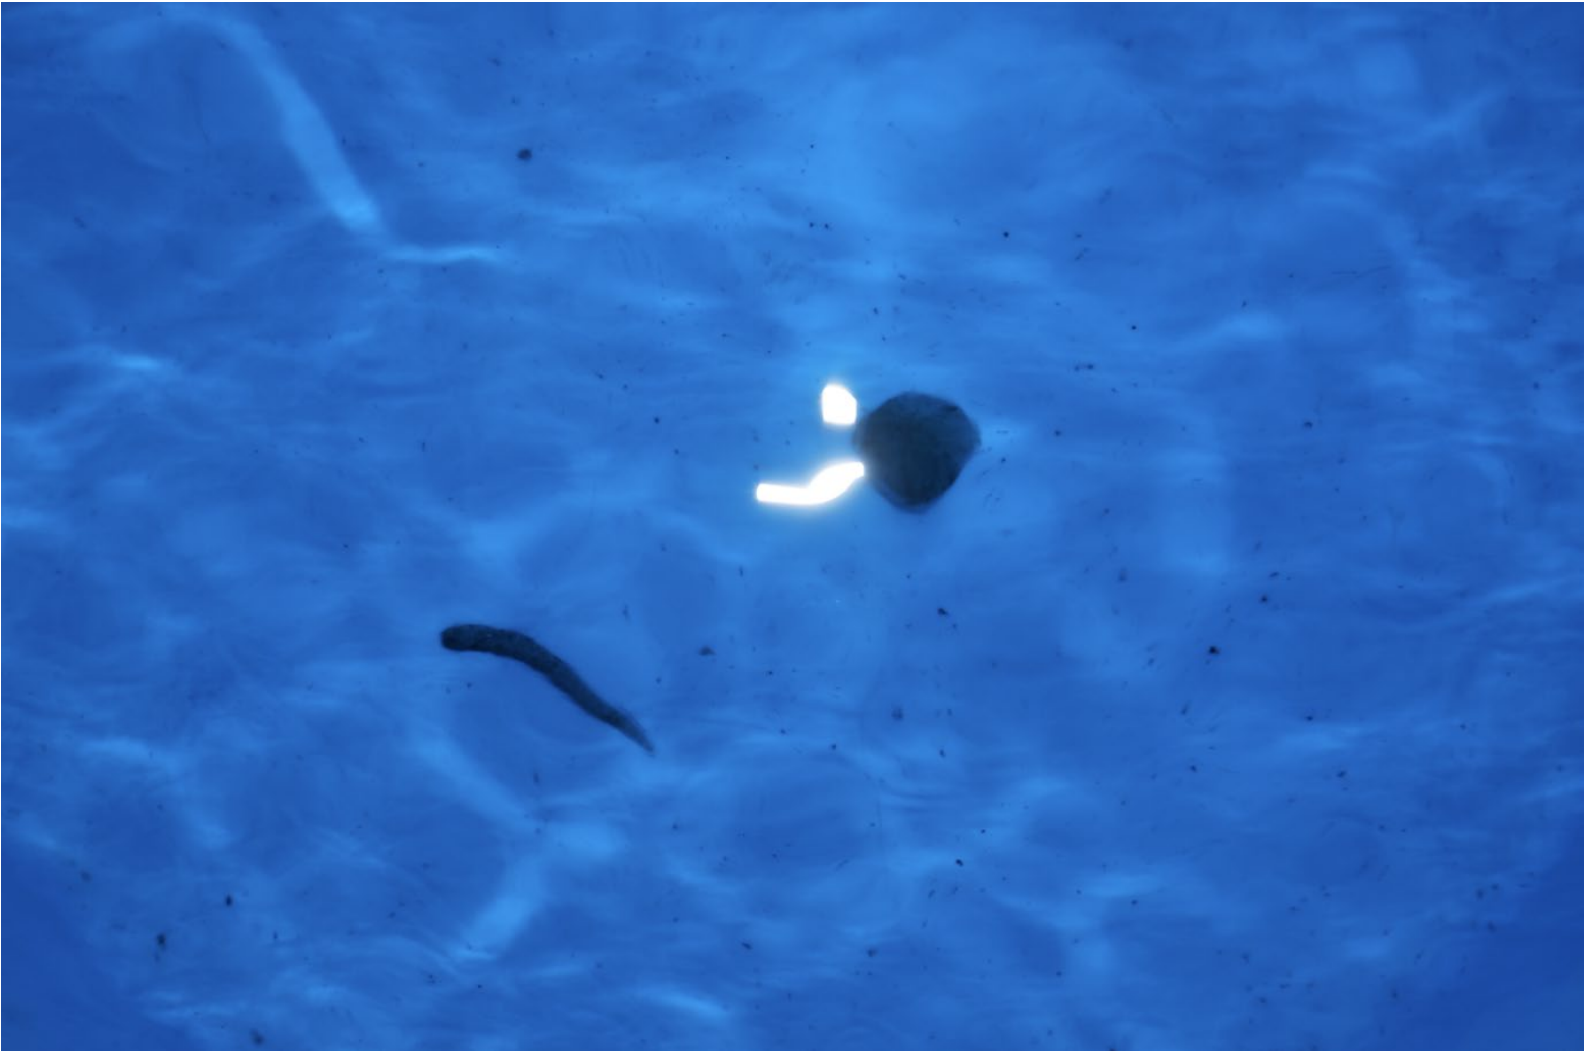
**Photograph 16 - Contents of Right Wing Fuel Tanks after Draining**

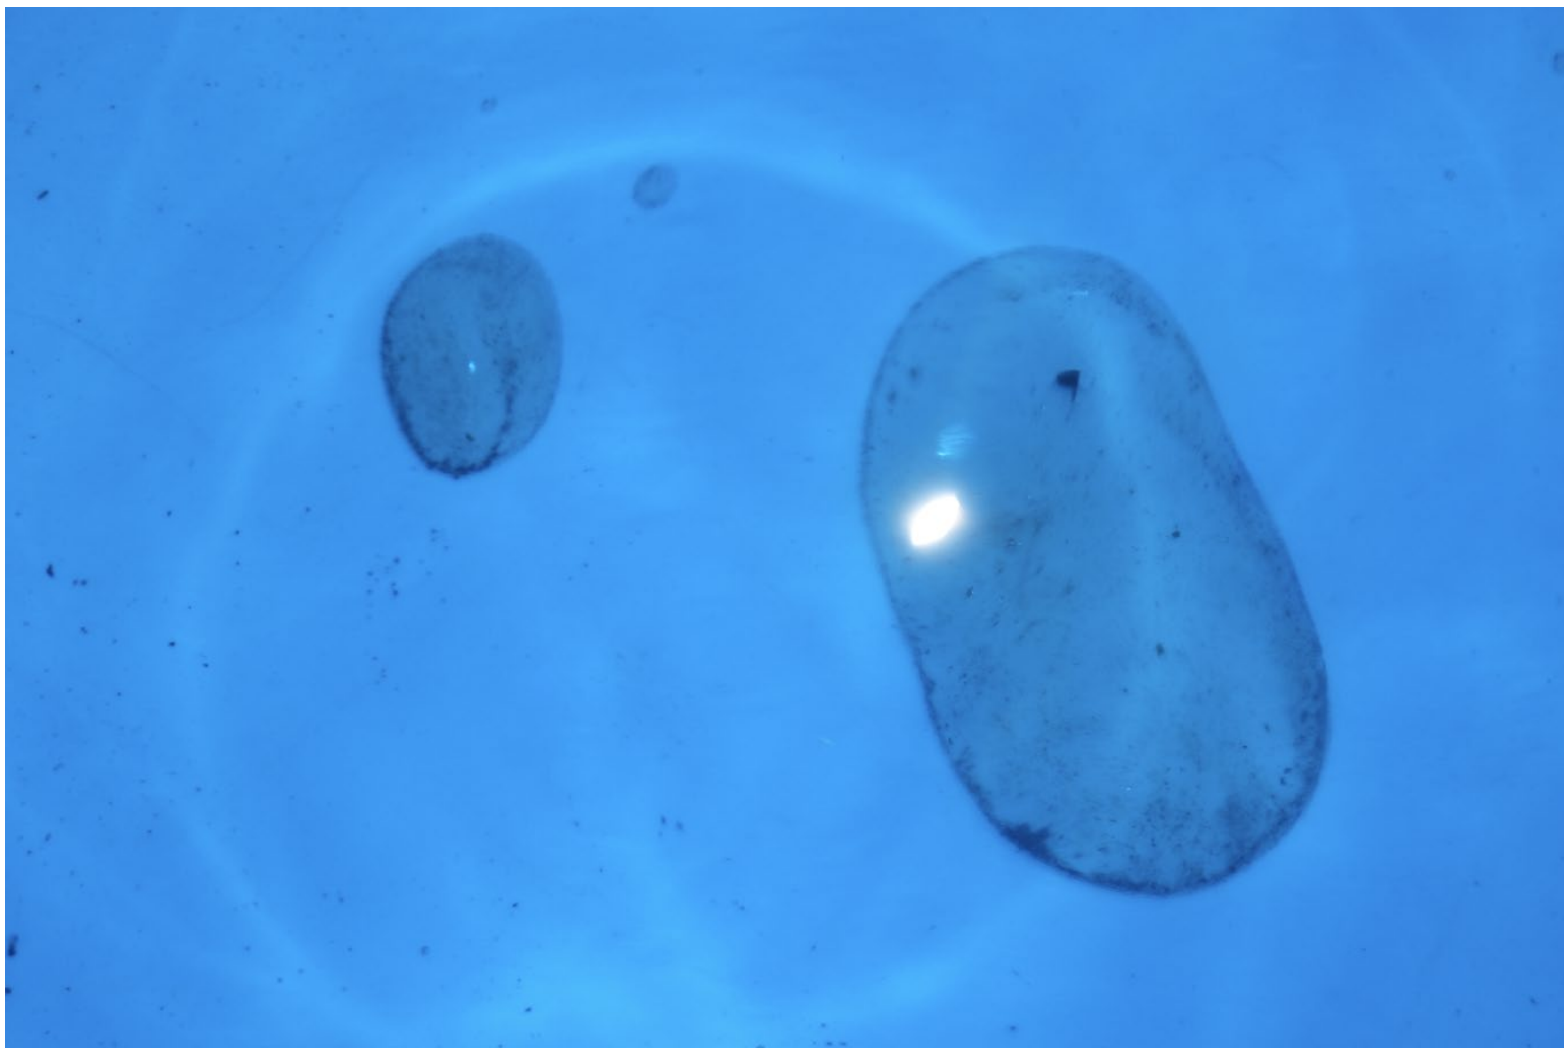
**Photograph 17 - Contents of Left Wing Fuel Tanks after Draining**

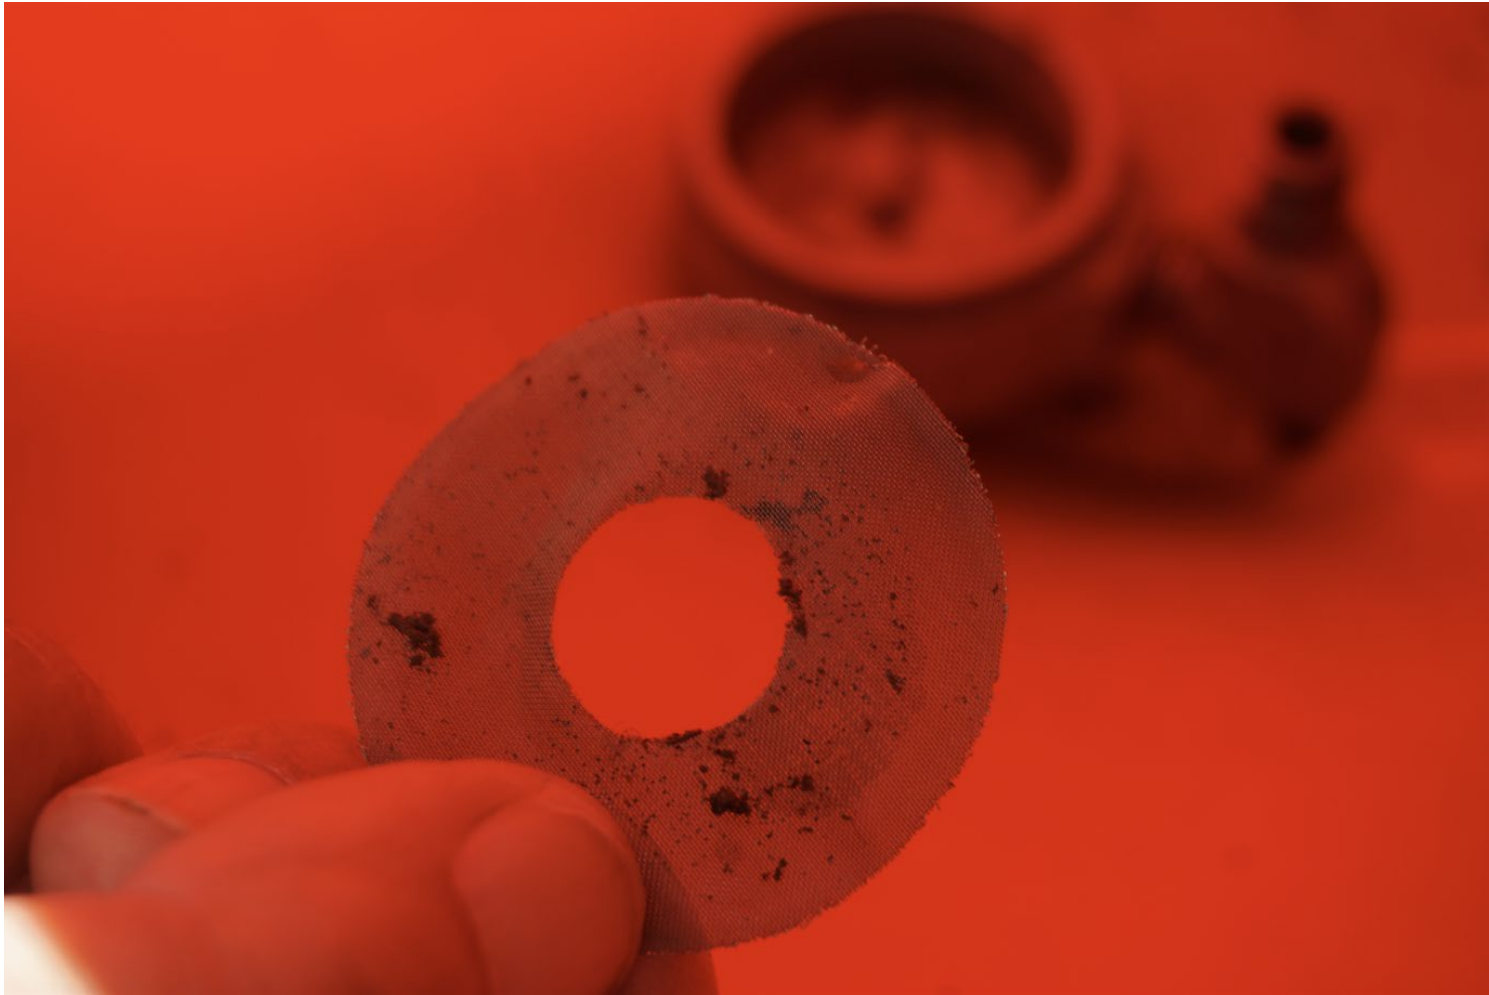
**Photograph 19 - Fuel Strainer Screen**
