ERA24LA022

## INVESTIGATION PHOTOGRAPHS

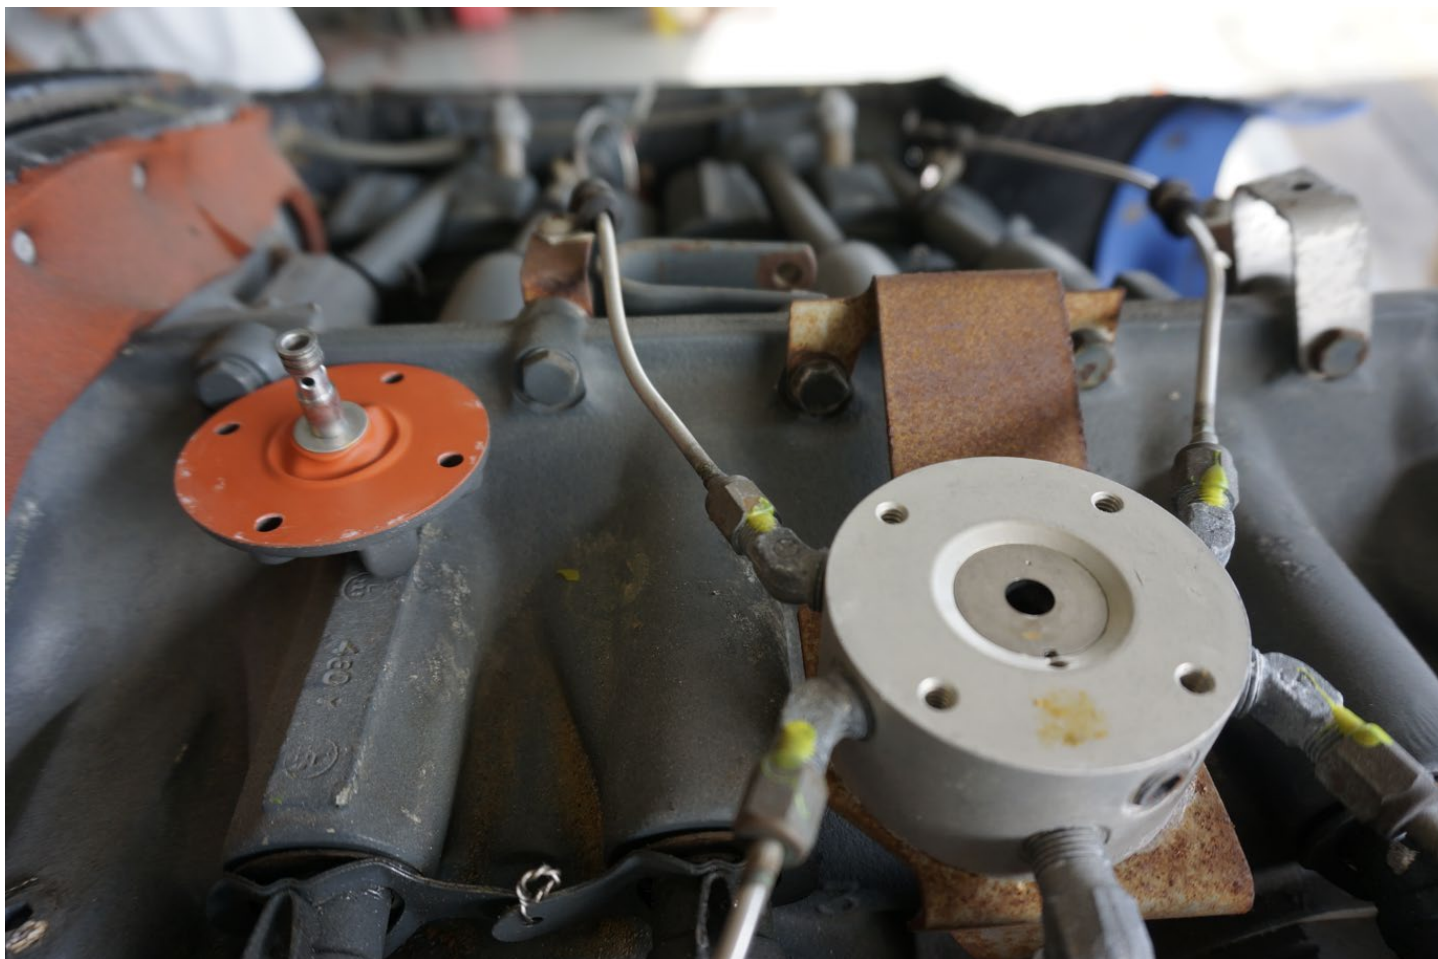
**Photograph 20 - Fuel Distribution Manifold**

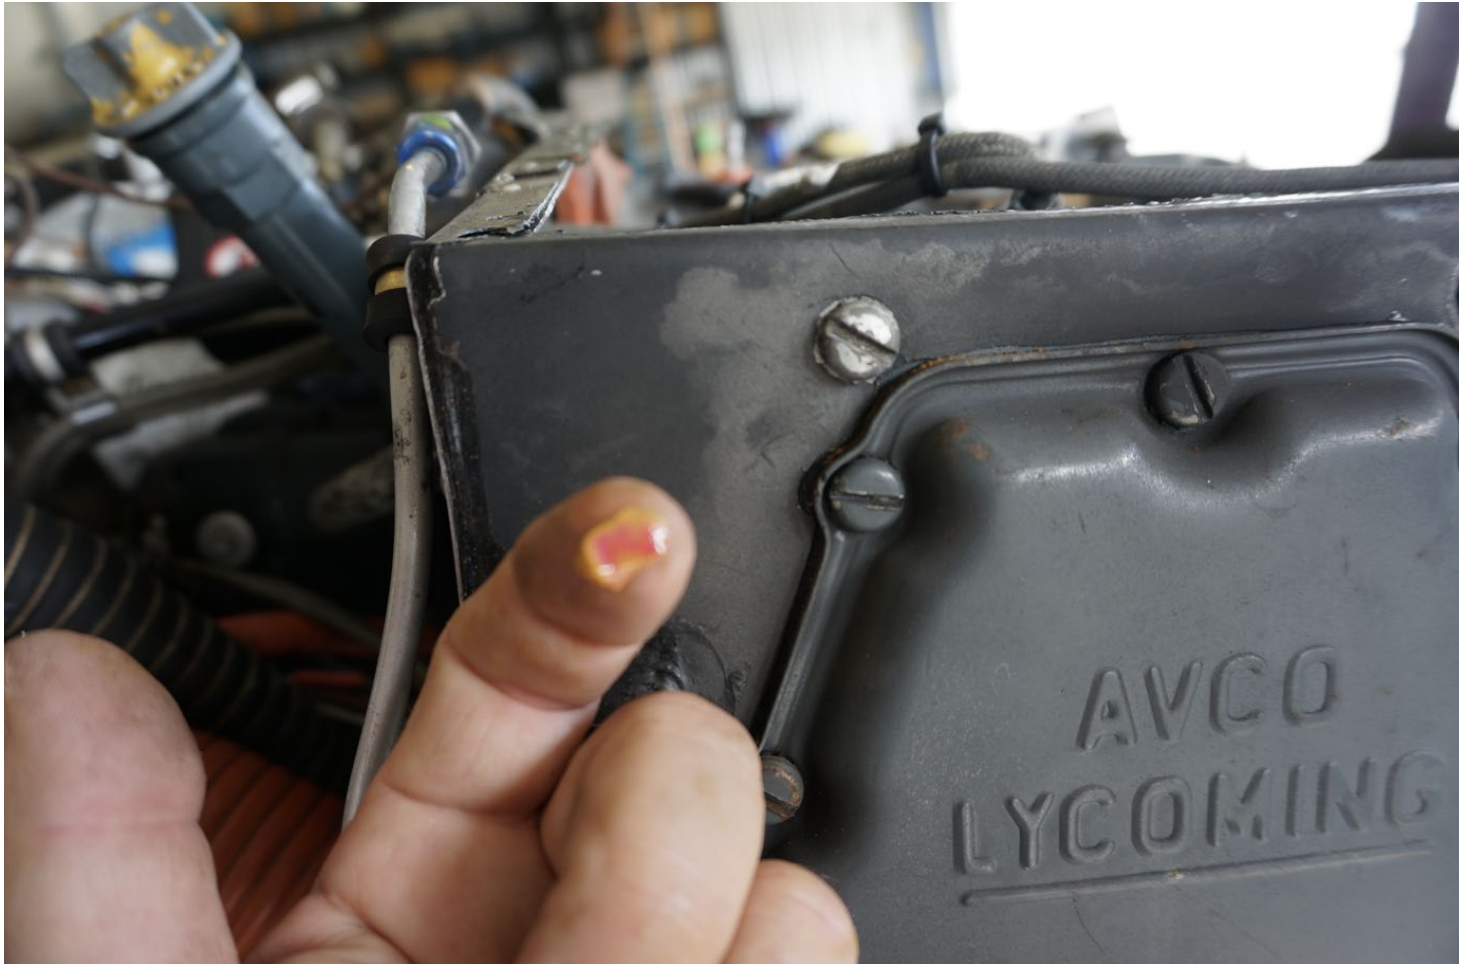
**Photograph 21 - Fuel Distribution Manifold - Positive Reaction for Water**

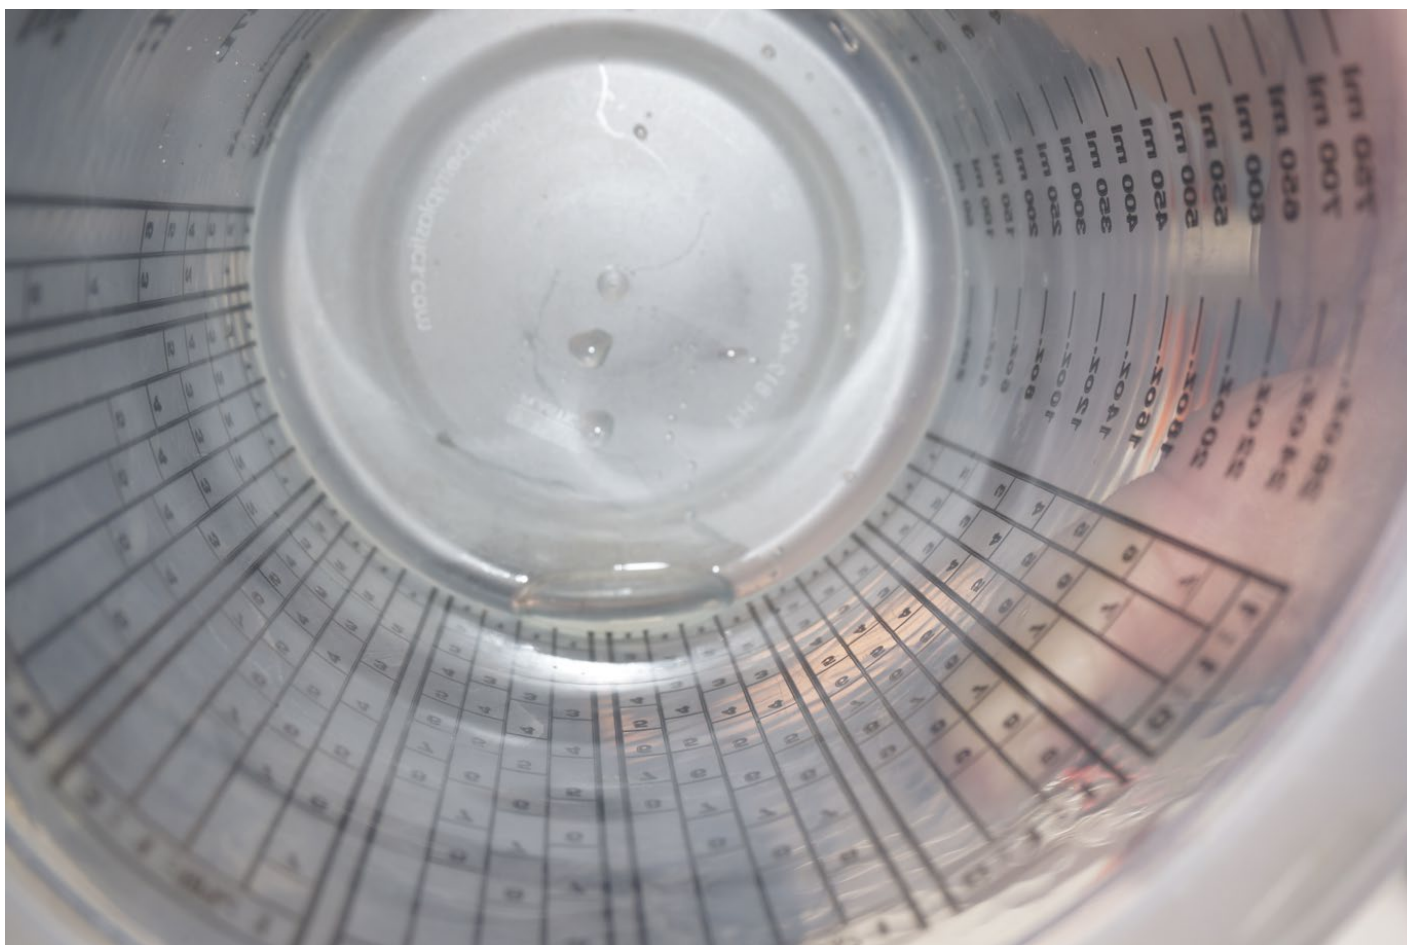
**Photograph 22 - Water from inside of Fuel Servo**
