ERA24LA023

## INVESTIGATION PHOTOGRAPHS

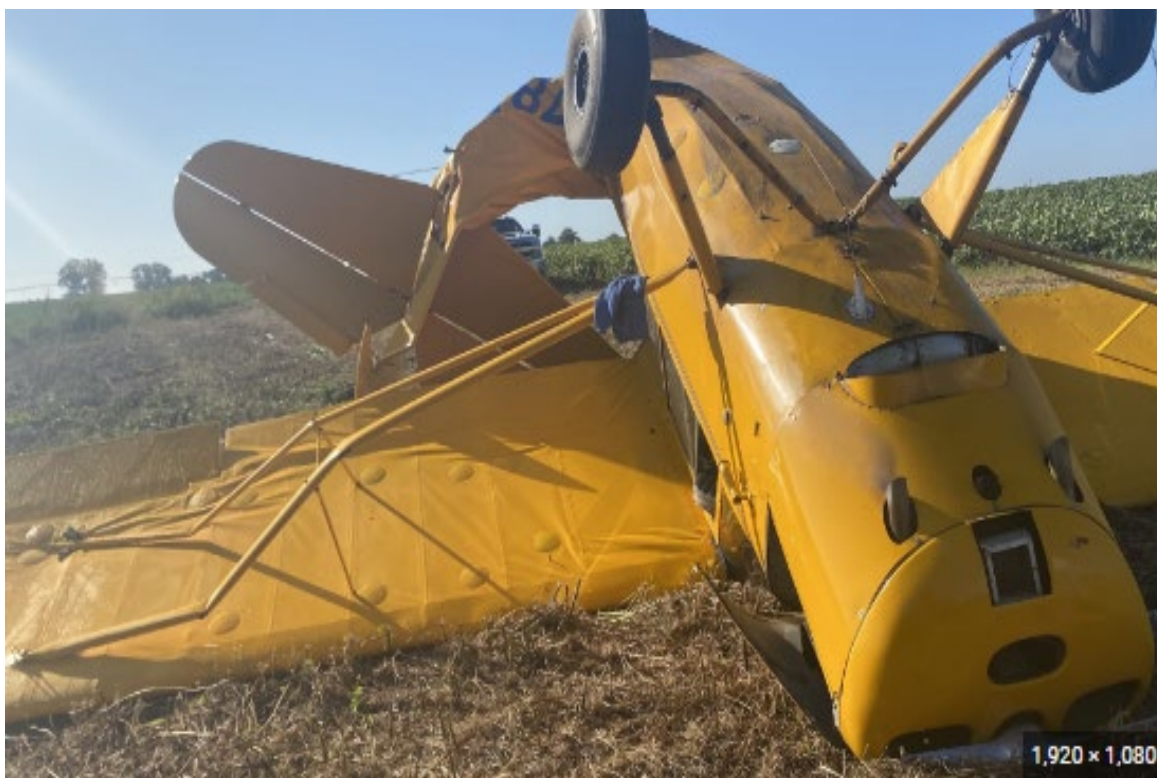
**Photograph 1 - Front view of the airplane wreckage (Courtesy of NTSB)**

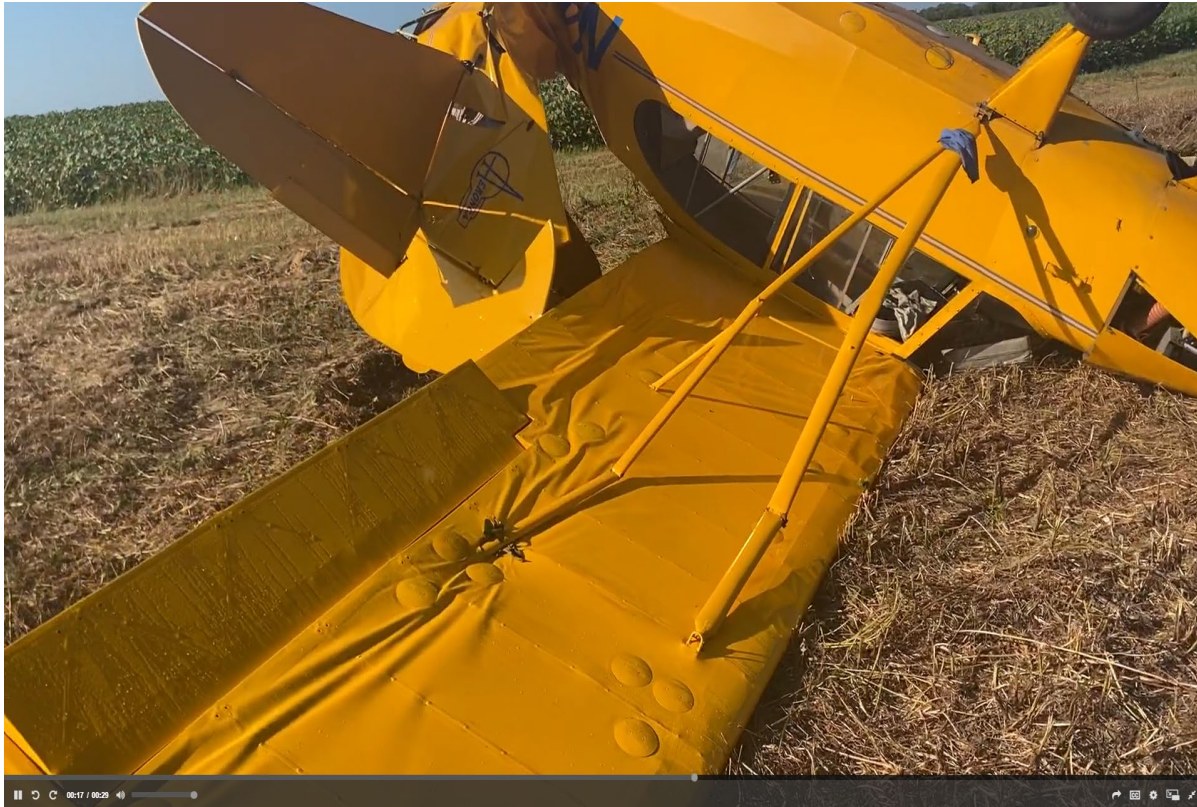
**Photograph 2 - Left side of airplane wreckage. (Courtesy of NTSB)**

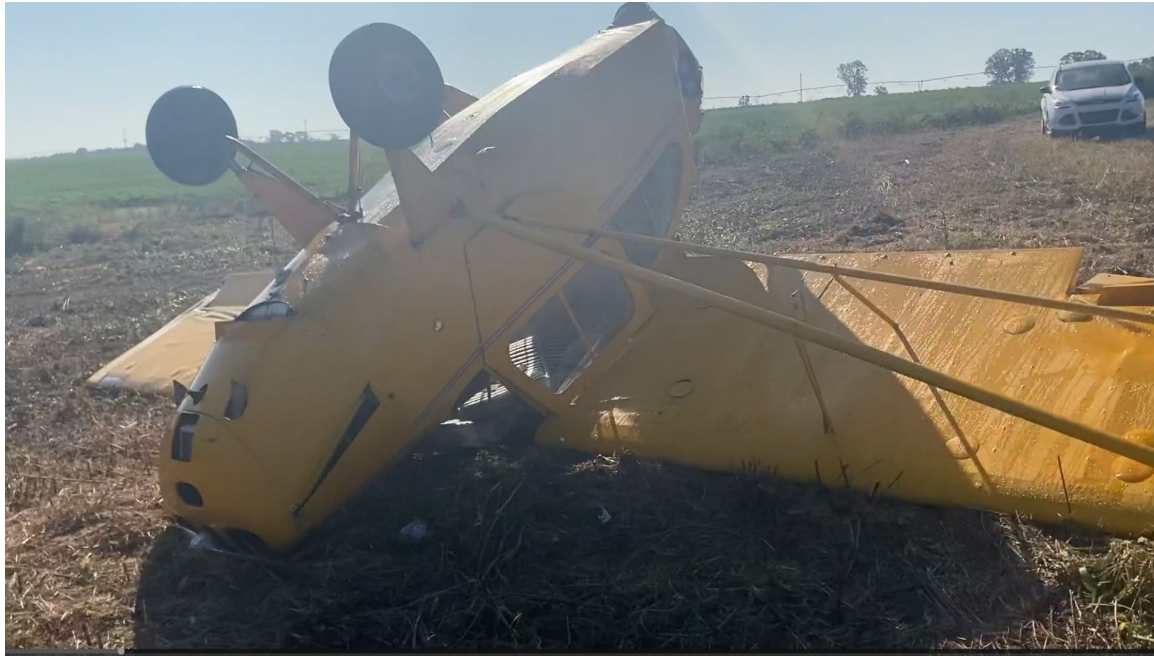
**Photograph 3 - Right side of airplane wreckage. (Courtesy of NTSB)**

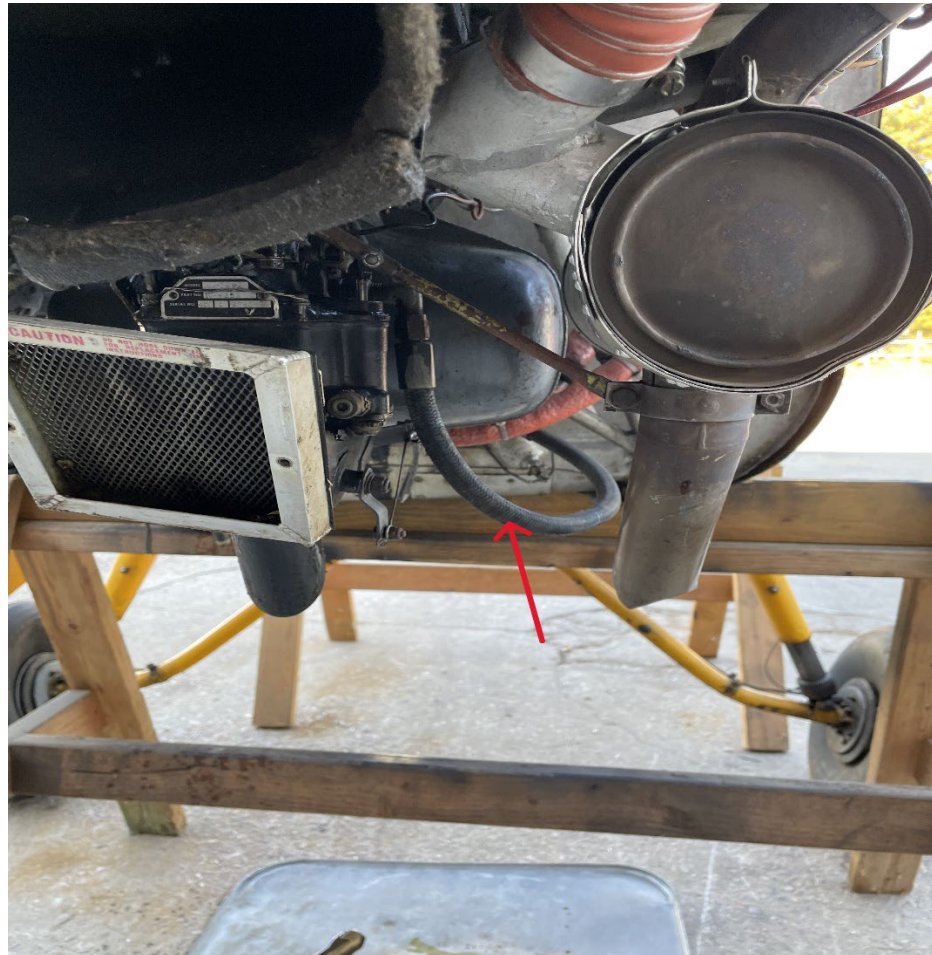
**Photograph 4 - Failed carburetor fuel line from (Courtesy of NTSB)**
