ERA24LA030

## INVESTIGATION PHOTOGRAPHS

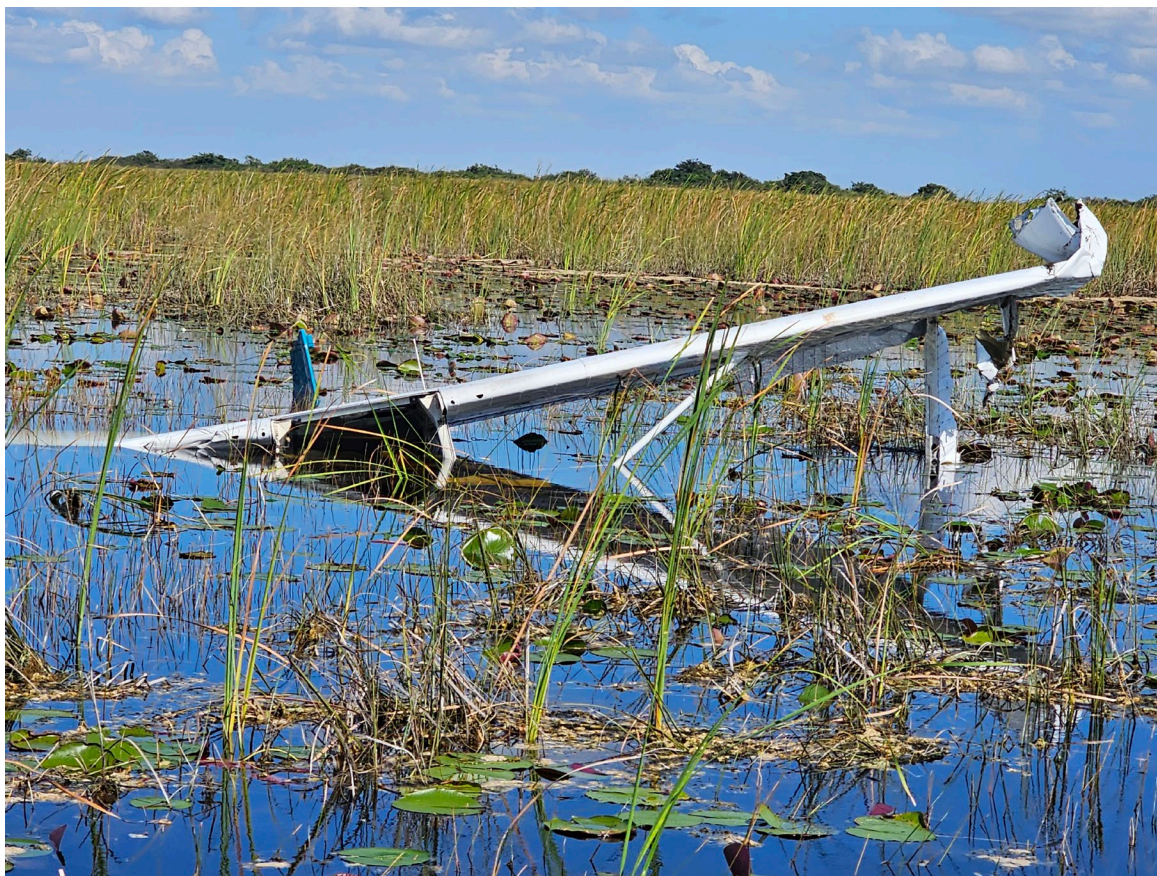
**Photograph 1 - FAA Digital Photograph Frontal View of the Nearly Fully Submerged Airplane at the Accident Site**

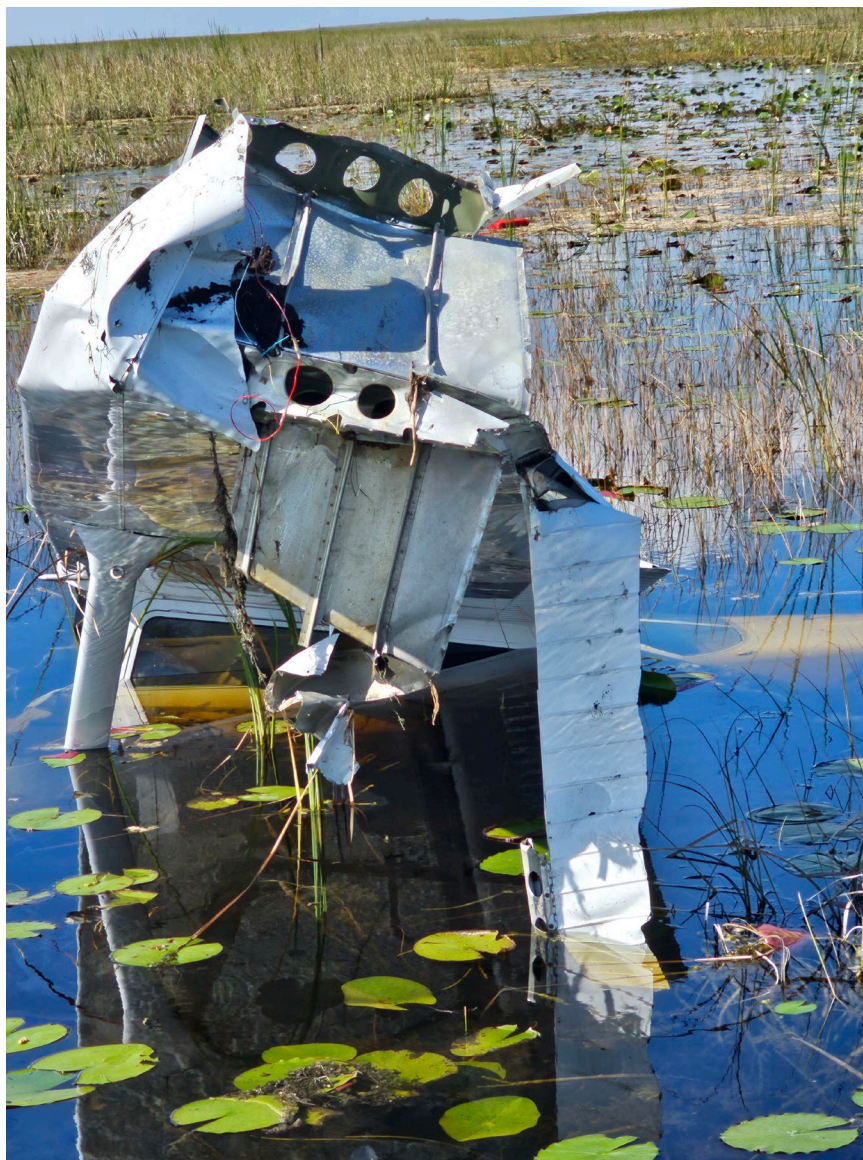
**Photograph 2 - FAA Digital Photograph Left Side View of the Airplane At the Accident Site.  
Note the damage to the Left Wing**

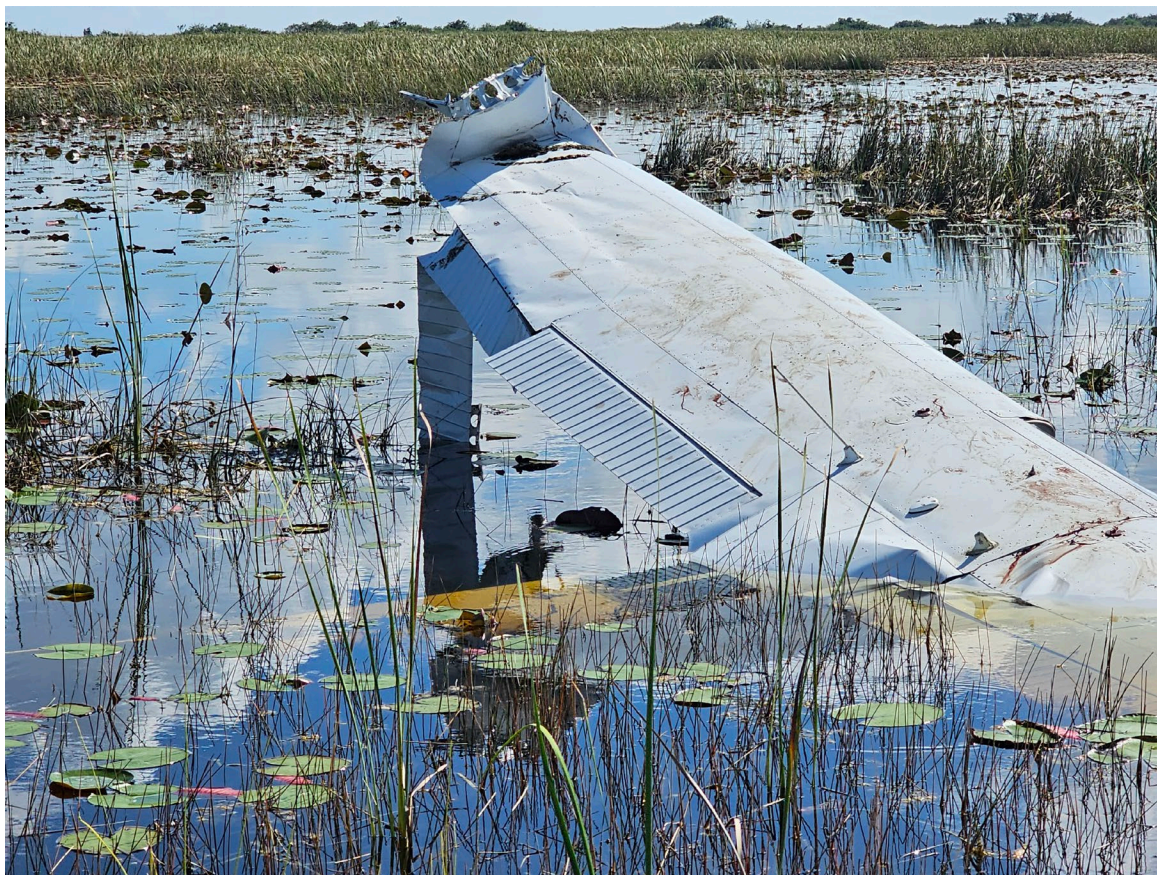
**Photograph 3 - FAA Digital Photograph View Showing the Upper Inboard Portion of the Right Wing and the Full Span of the Upper Portion of the Left Wing. Note the Compression Wrinkles in the Upper Wing Skins of Both Wings**

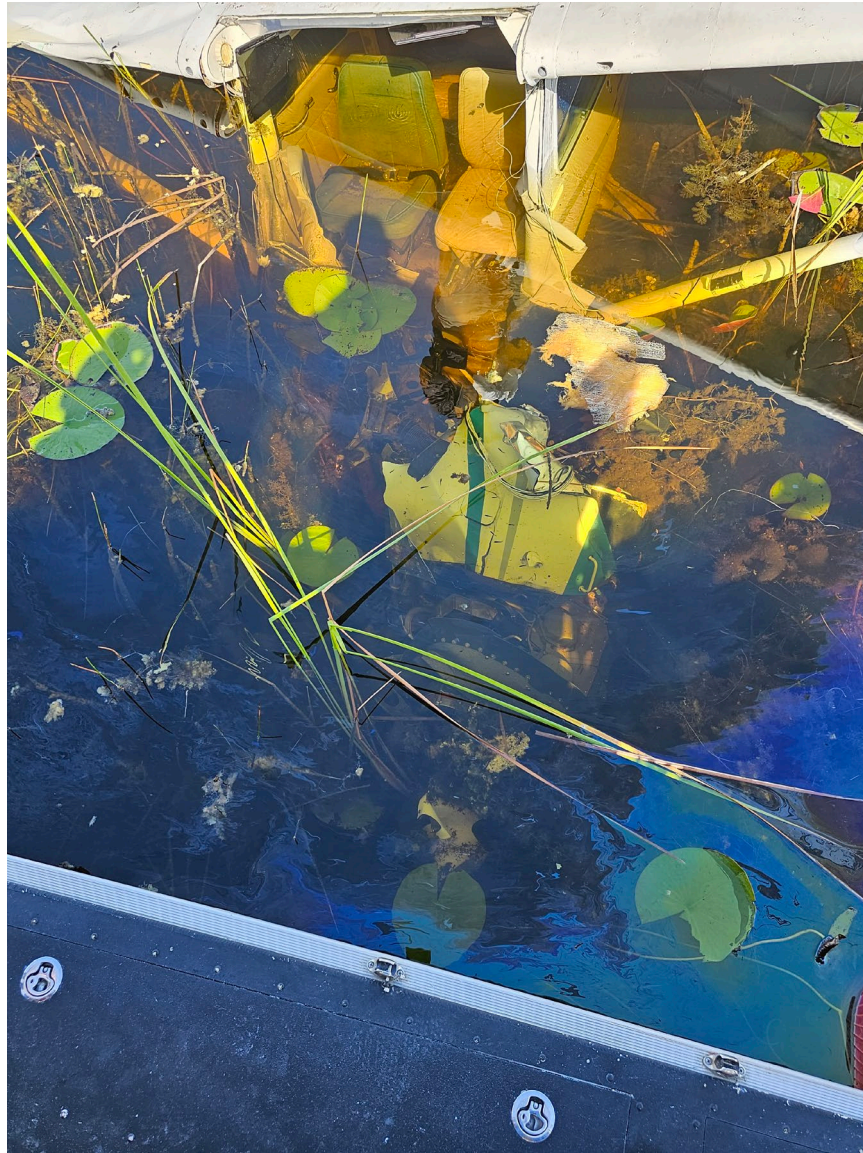
**Photograph 4 - FAA Digital Photograph Frontal View Showing the Damage to the Front Portion of the Airplane**

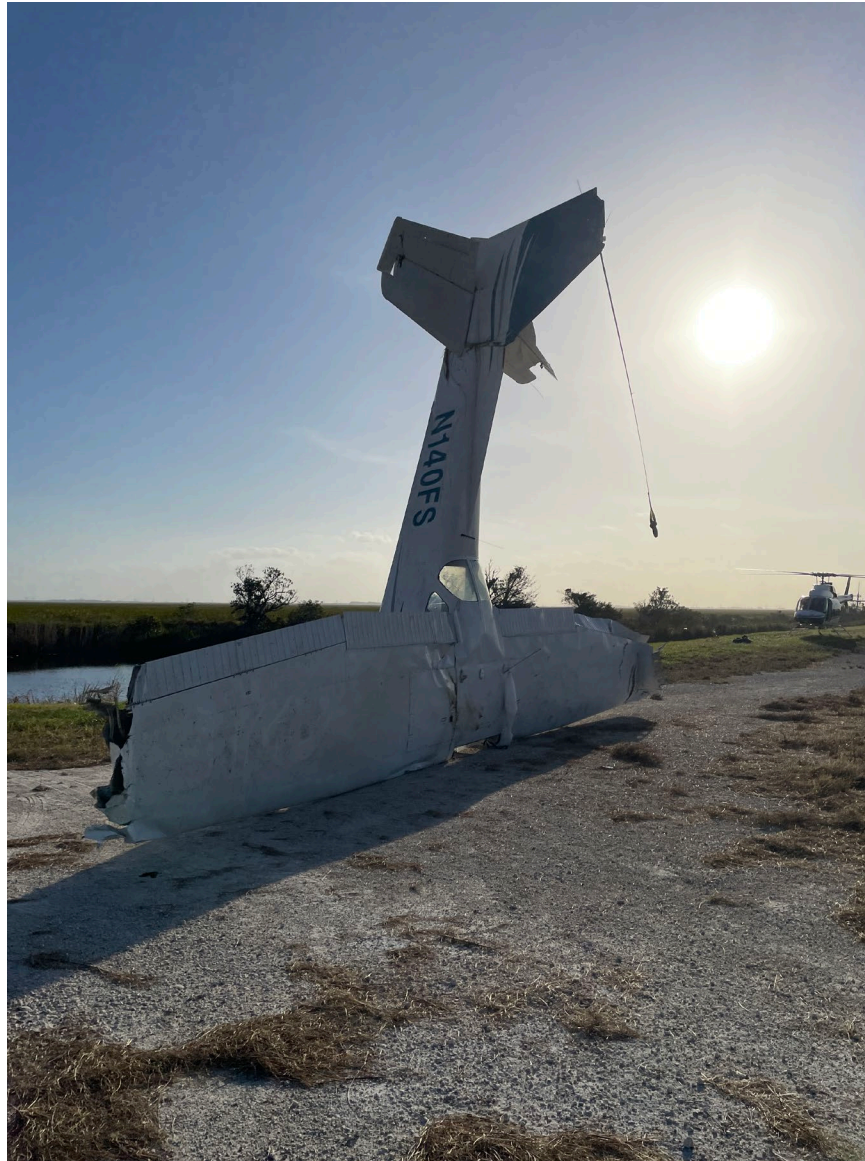
**Photograph 5 - FAA Digital Photograph View of the Top of the Airplane Following Recovery**

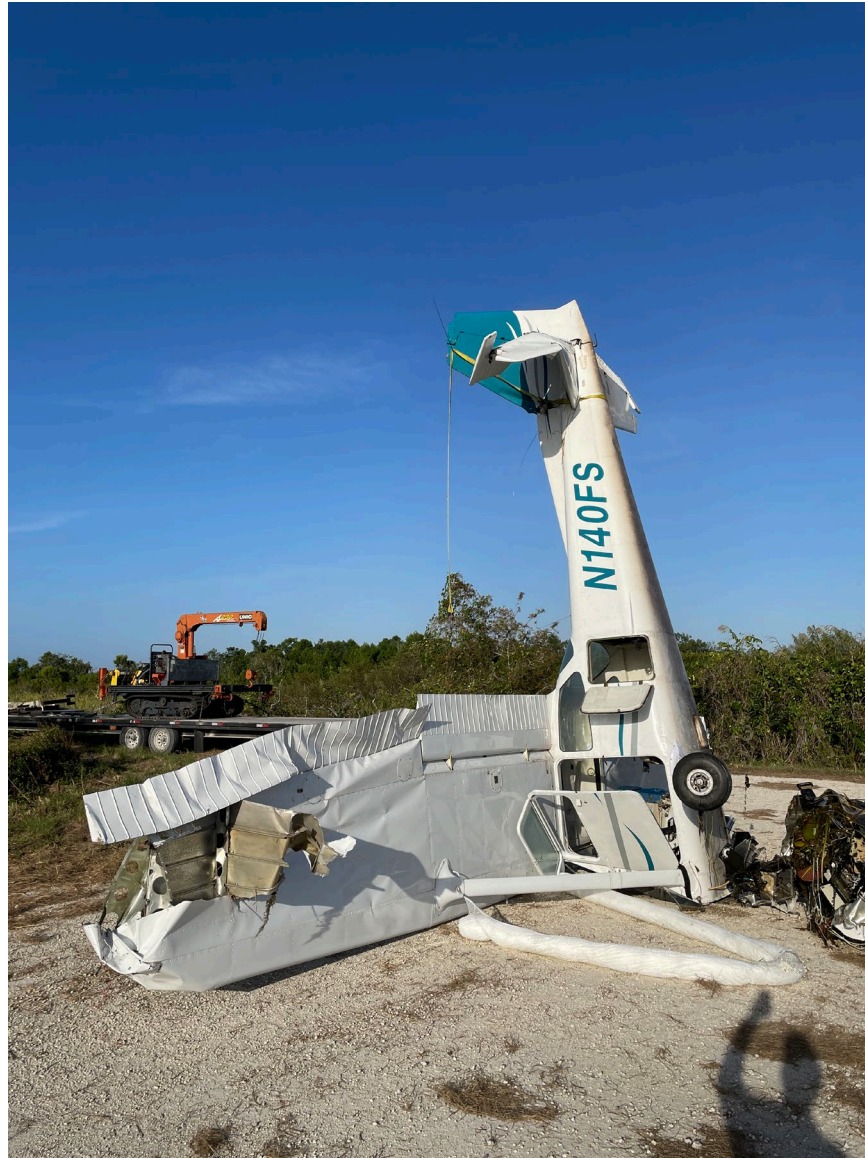
**Photograph 6 - FAA Digital Photograph Left Side View of the Airplane Following Recovery.  
Note the Extensive Damage to the Left Wing**

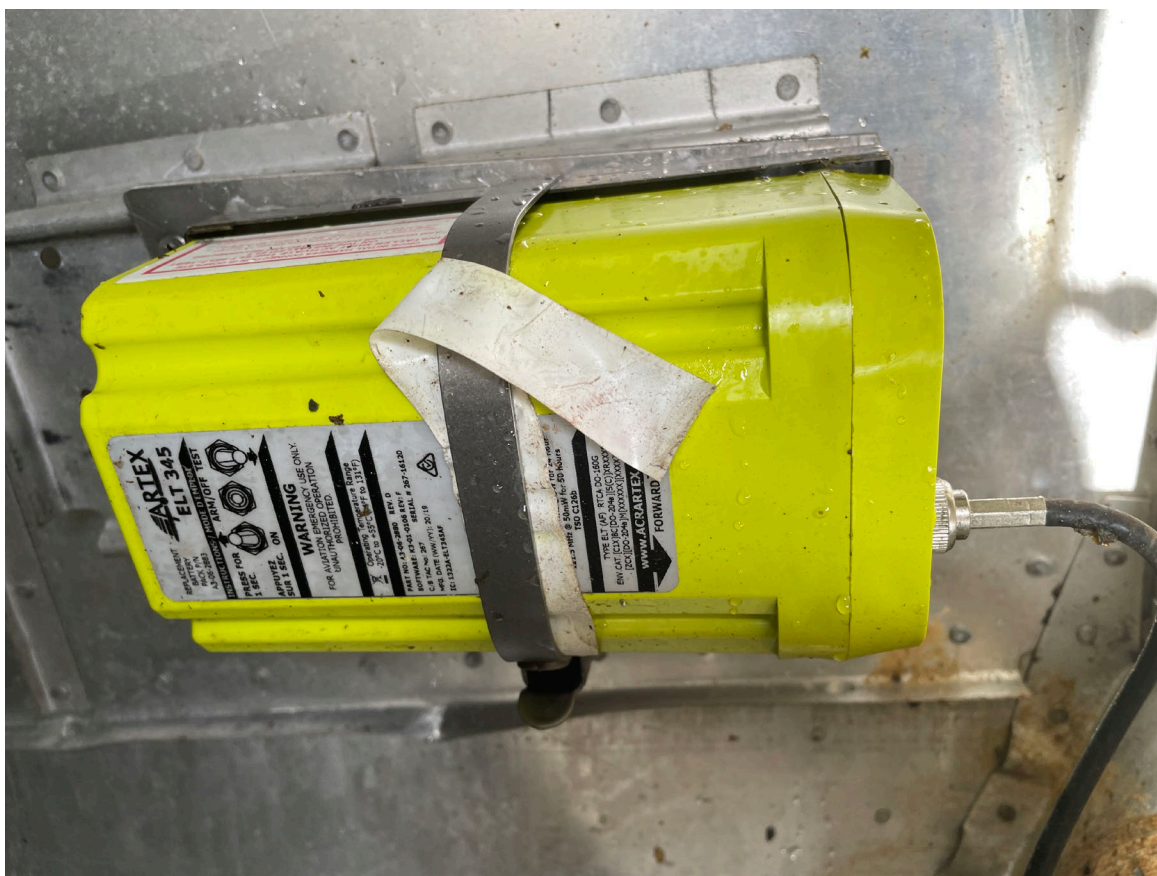
**Photograph 7 - FAA Digital Photograph View of the Installed Emergency Locator Transmitter  
Note the BNC Antenna Connector Still Attached**

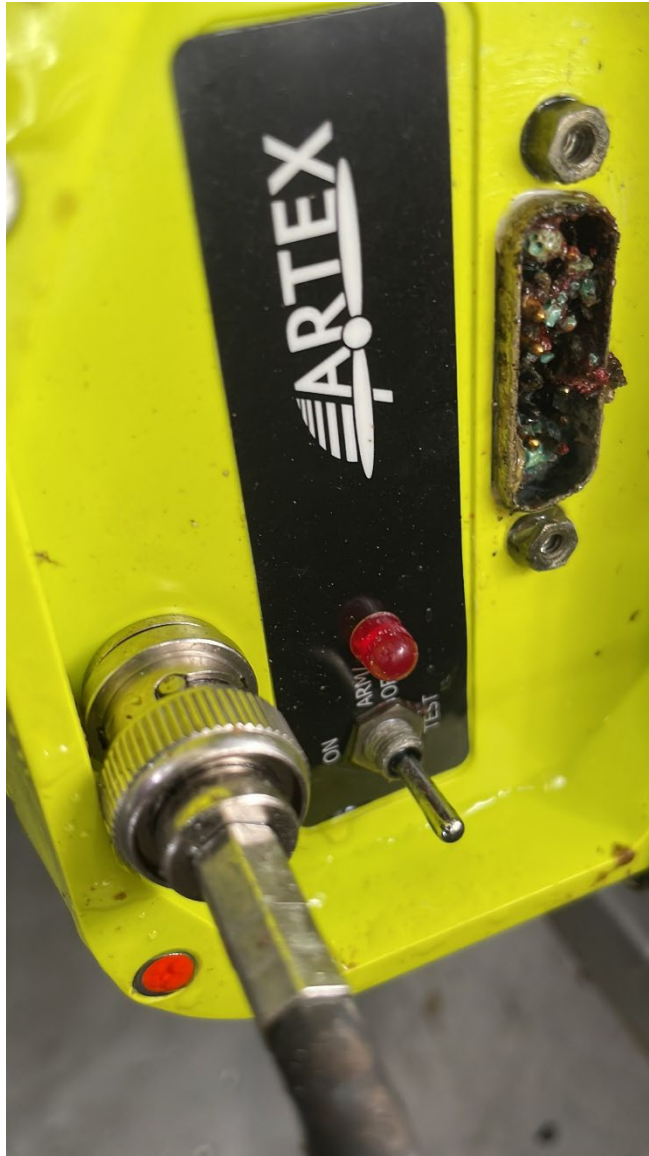
**Photograph 8 - FAA Digital Photograph View Showing the Antenna BNC Connector Installed But the 15-Pin D-SUB Connector Separated**
