ERA24LA031

## INVESTIGATION PHOTOGRAPHS

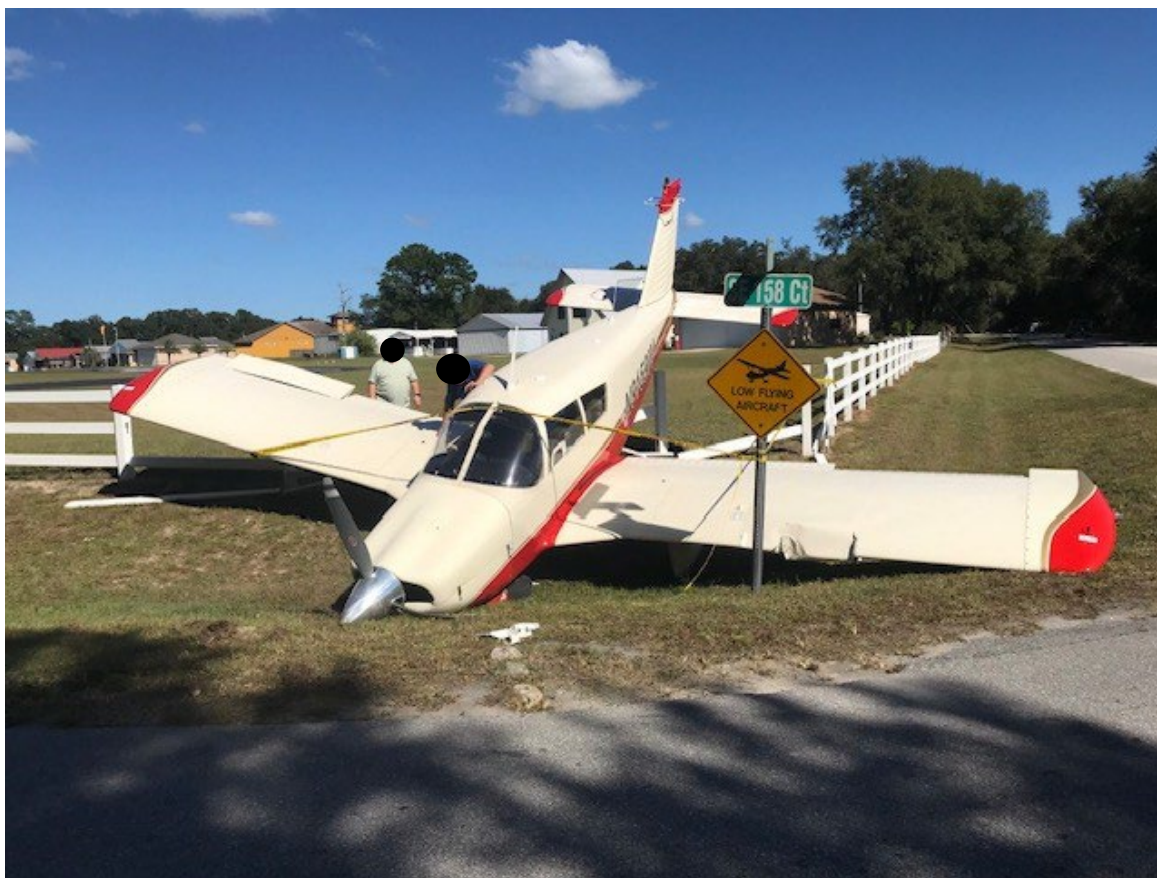
**Photograph 1 - View of the airplane at the accident site. (Courtesy of FAA)**

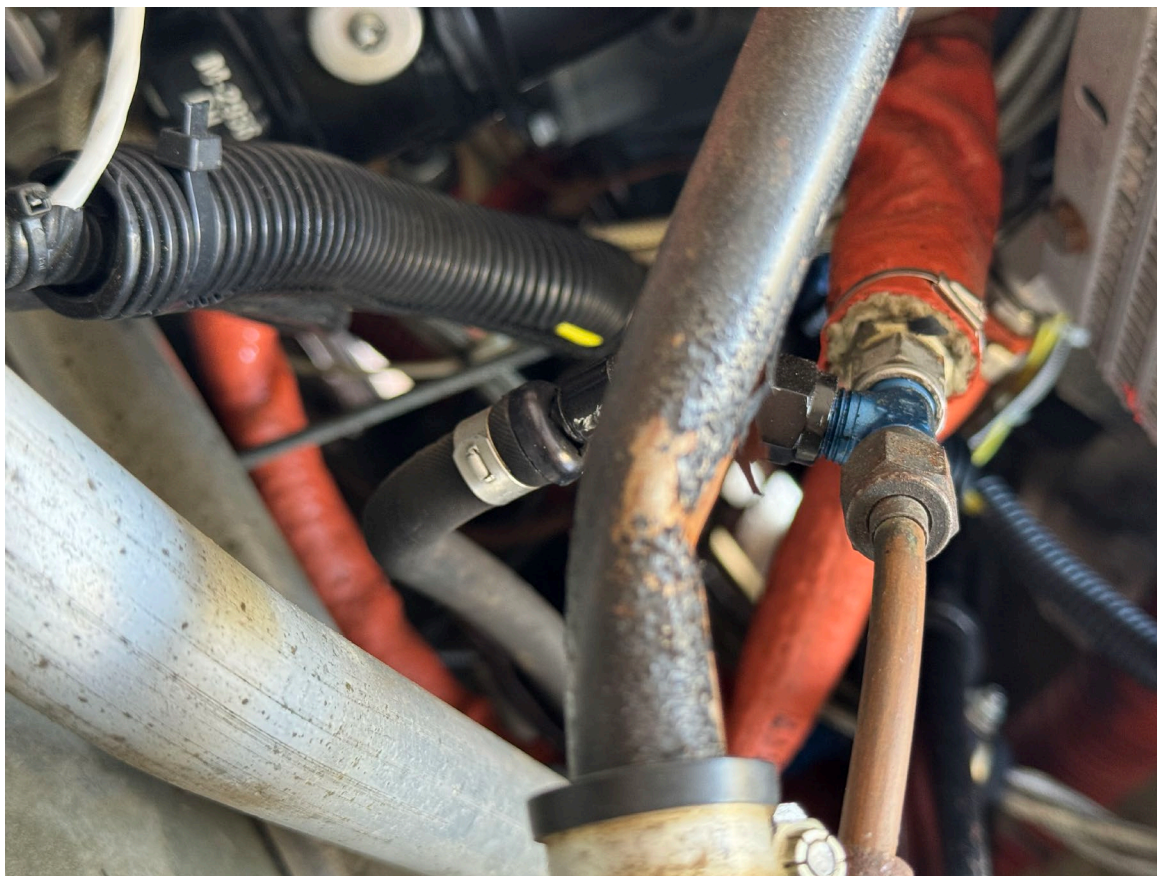
**Photograph 2 - View of damage to the engine mount. (Courtesy of FAA)**
