ERA24LA041

## INVESTIGATION PHOTOGRAPHS

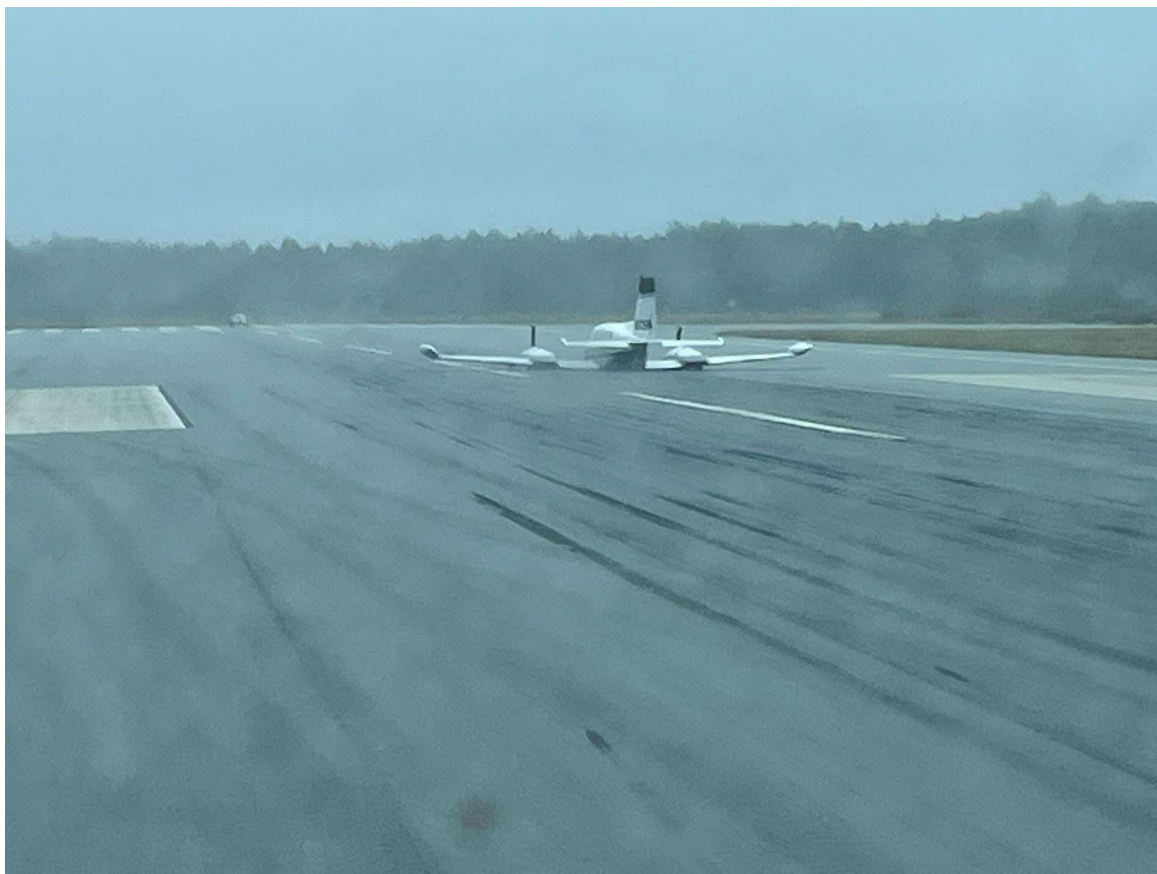
**Photograph 1 - Photograph From Airport Manager. View of the Airplane Before Recovery. Note the Airplane's Location in Proximity to the Aiming Point Marking**

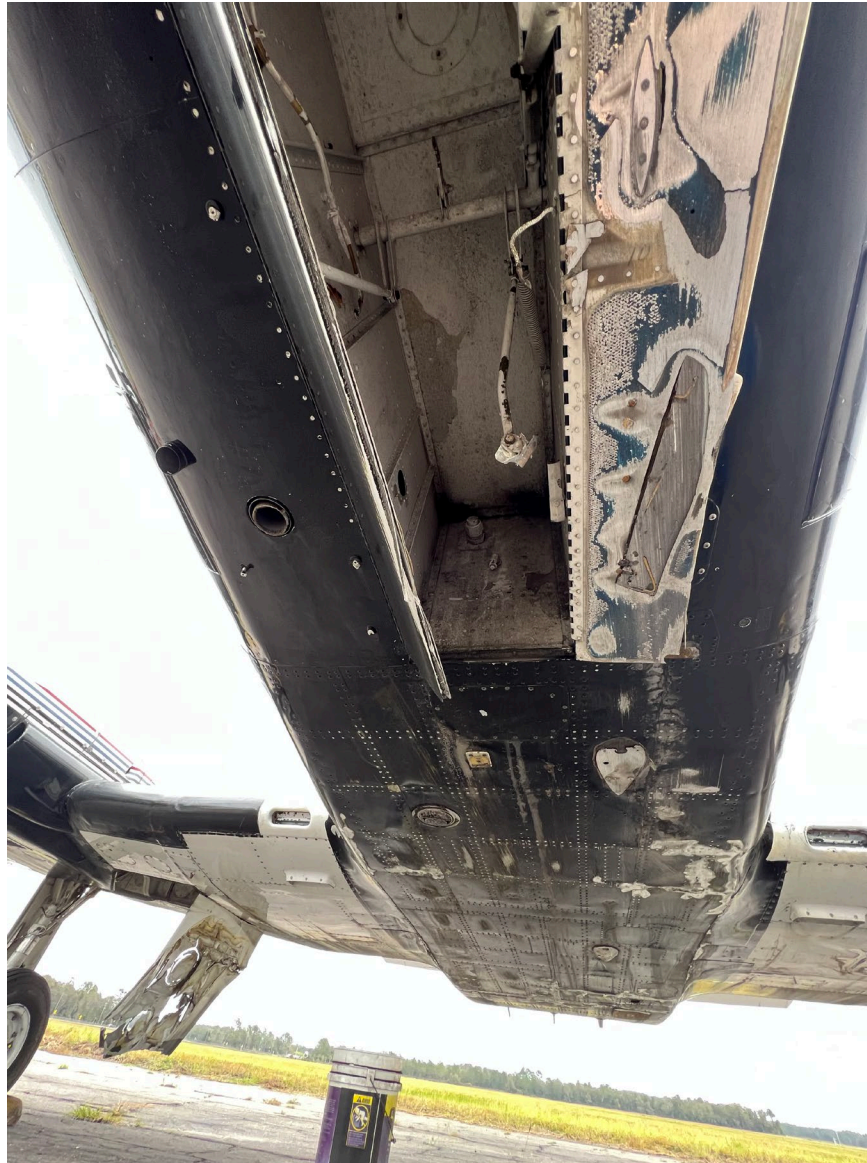
**Photograph 2 - Photograph From Insurance Adjuster. View taken From the Nose Landing Gear Wheel Well Looking aft Showing the Bottom Fuselage Skin Scrape Damage**

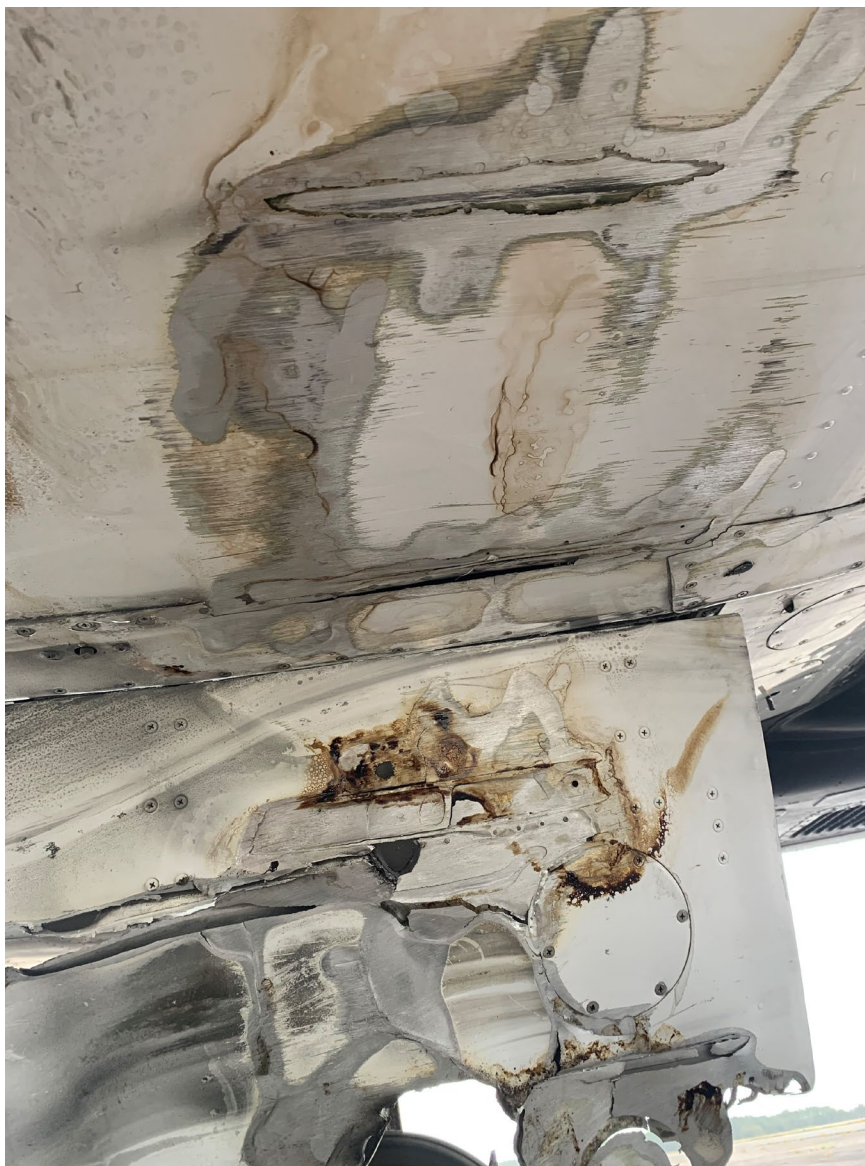
**Photograph 3 - Photograph From Airport Manager. View of the Bottom Wing Skin of the Left Wing. Note the Abrasion Damage in several areas.**

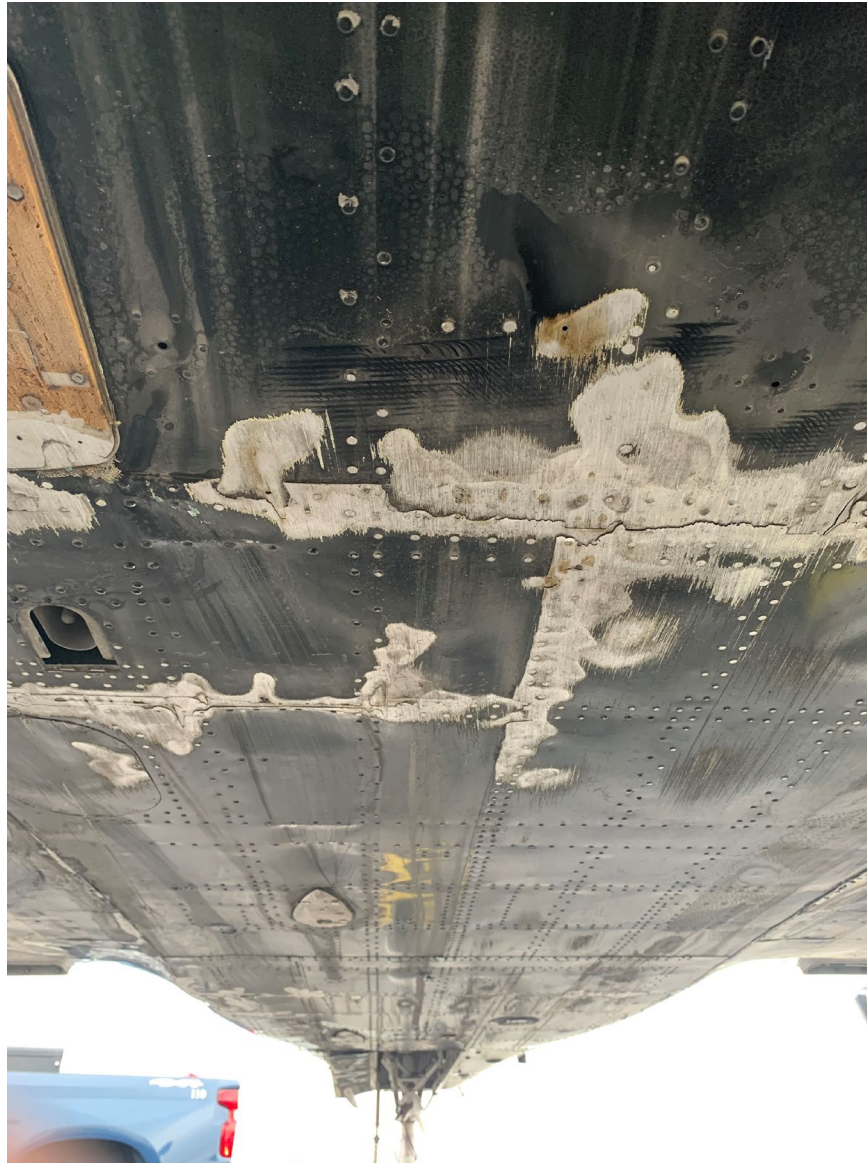
**Photograph 4 - Photograph From Airport Manager. View of the Bottom Fuselage Skin. Note the Abrasion Damage.**
