# National Transportation Safety Board

ERA24LA043

## **ENGINE TEST PREP AND RUN**

Location: Perry, Florida  
Date: November 17, 2023  
Time: 1708 EST  
2208 UTC  
Airplane: N37MB, Lancair IV-P

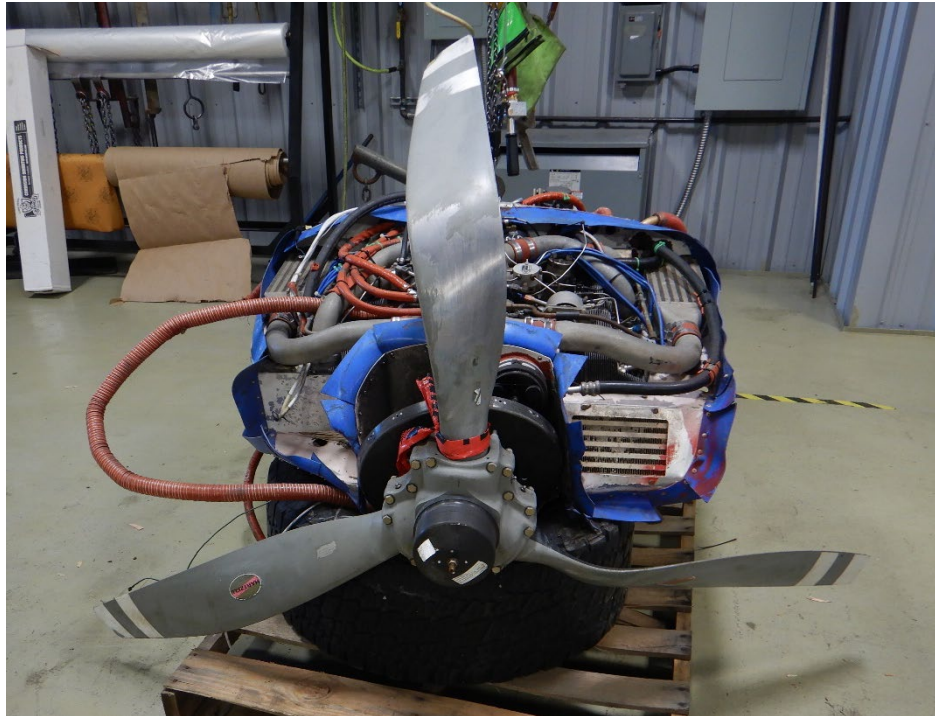
**Photo 1 - Engine as delivered.**

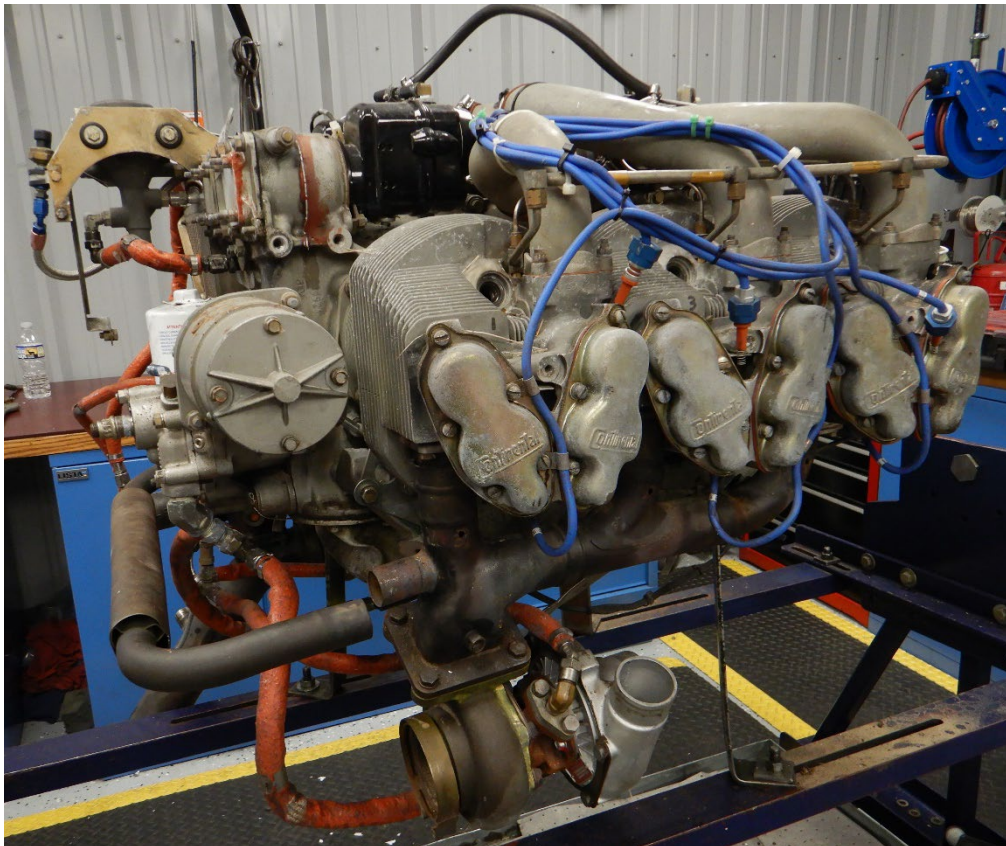
**Photo 2 - Engine prepared to enter test cell.**

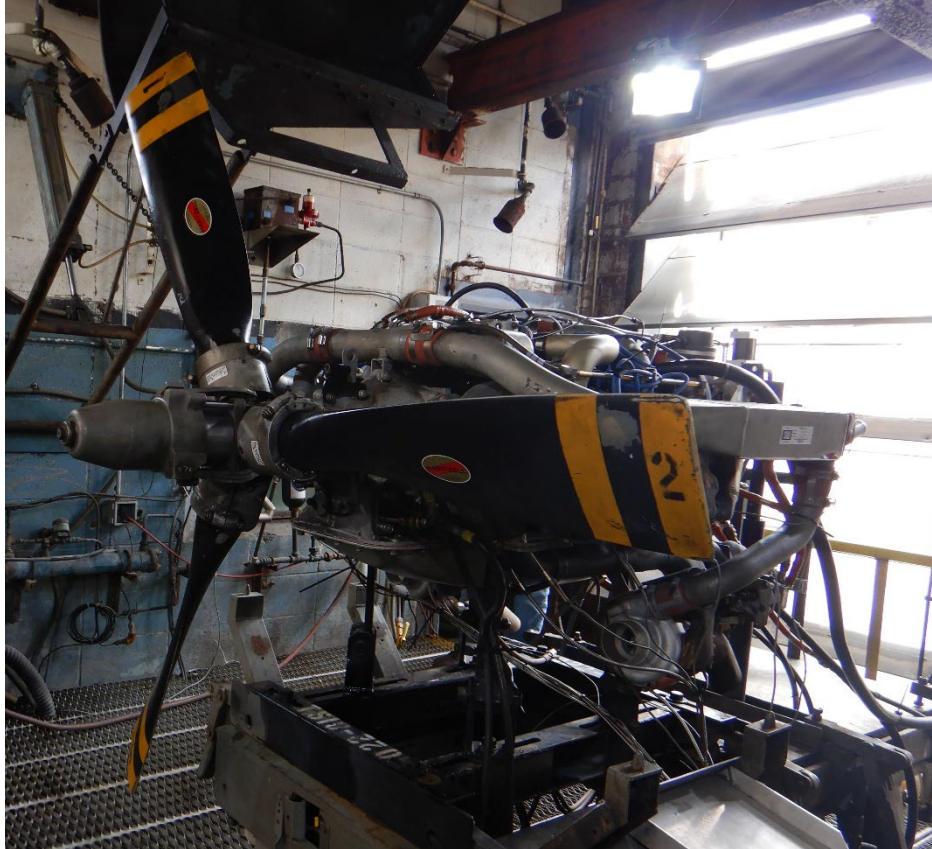
**Photo 3: Engine viewed in test cell from left front before testing.**

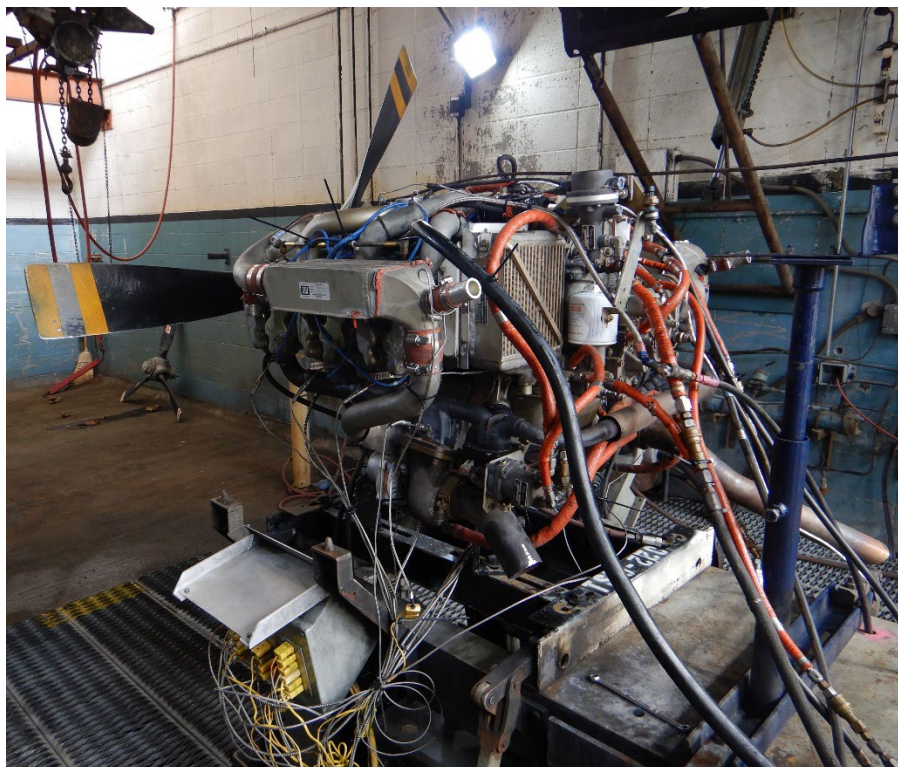
**Photo 4 - Engine viewed in test cell from left rear before testing.**

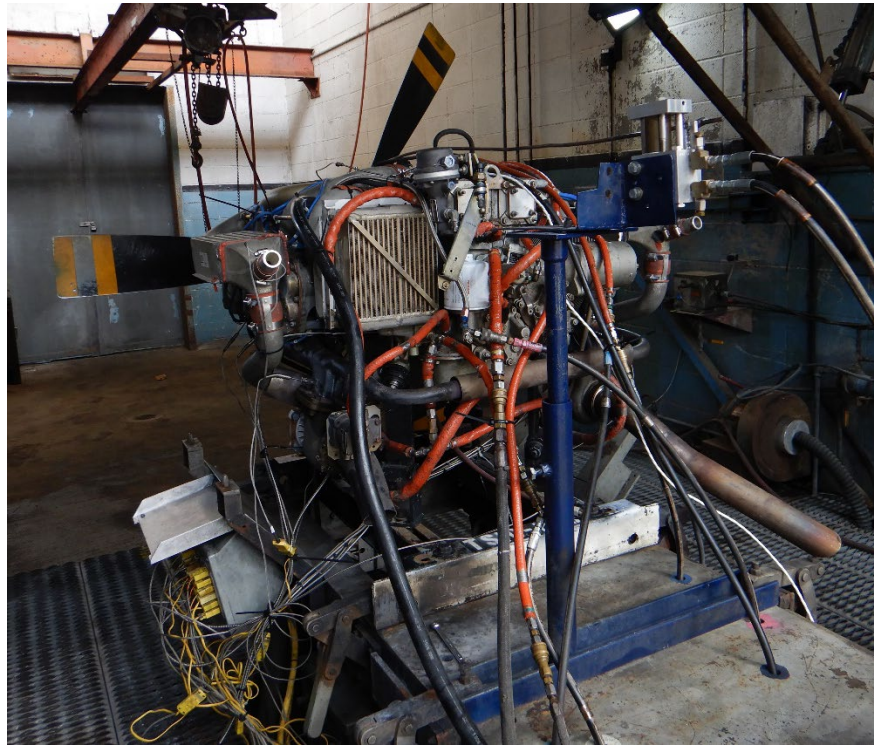
**Photo 5 - Engine viewed in test cell from rear before testing.**

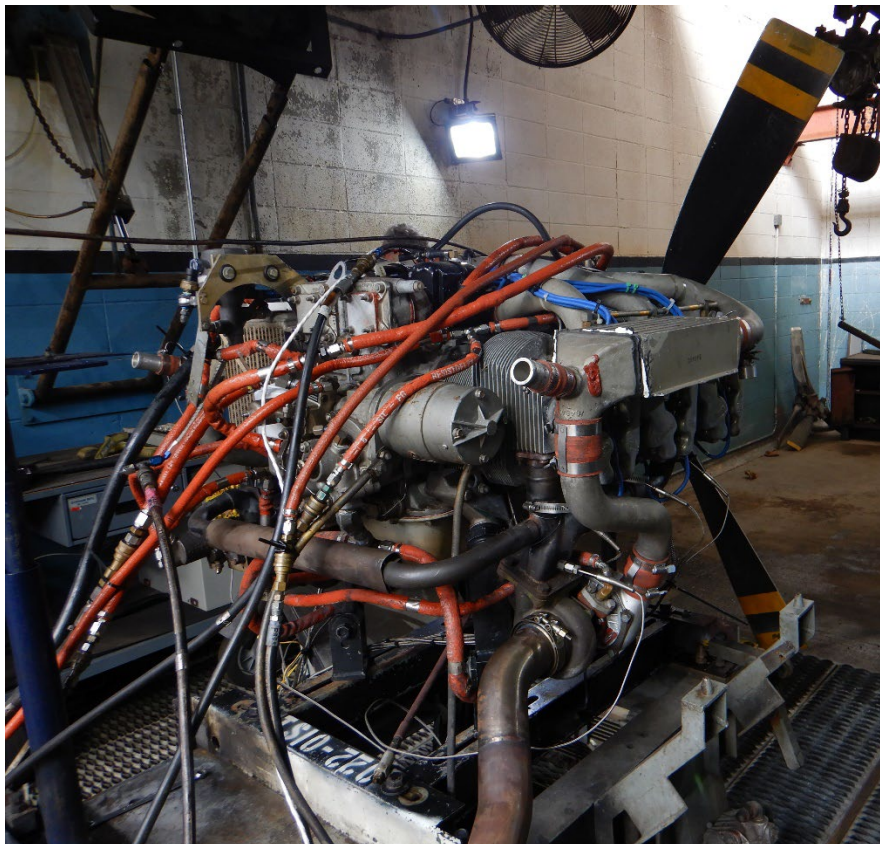
**Photo 6 - Engine viewed in test cell from right rear before testing.**
