# National Transportation Safety Board

ERA24LA054

## **AIRWORTHINESS FACTUAL REPORT**

Location: Millington, TN  
Date: December 3, 2024  
Time: 2104 CST  
Airplane: N7748J, Piper PA-32-260

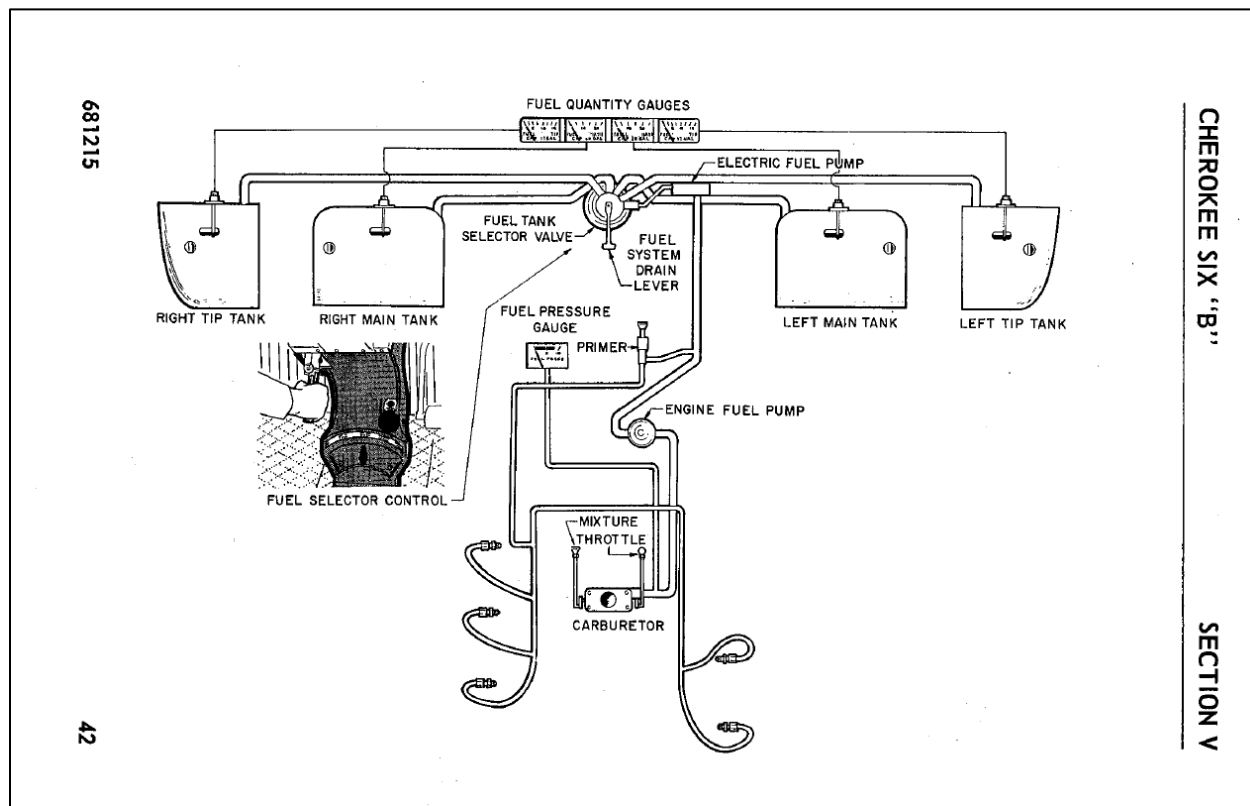
According to the owner's manual, the airplane was equipped with two inboard main wing fuel tanks that each held 25-gallons, and two outboard tip tanks that held 17-gallons of fuel. A fuel selector located on the floor center section of the cockpit enabled a selection of each tank individually, in addition to an OFF position. Fuel is delivered from the tank selected, directly to the engine. Each tank was equipped with a fuel sump. Refer to figure 1 for a drawing of the fuel system.

Figure 1: Drawing of the fuel system.
