# National Transportation Safety Board

ERA24LA059

## **WRECKAGE EXAMINATION SUMMARY**

Location: Zephyrhills, FL  
Date: 12/7/23  
Time: 1248  
<Enter HHMM coordinated universal time (UTC)>  
Airplane: Cessna 172

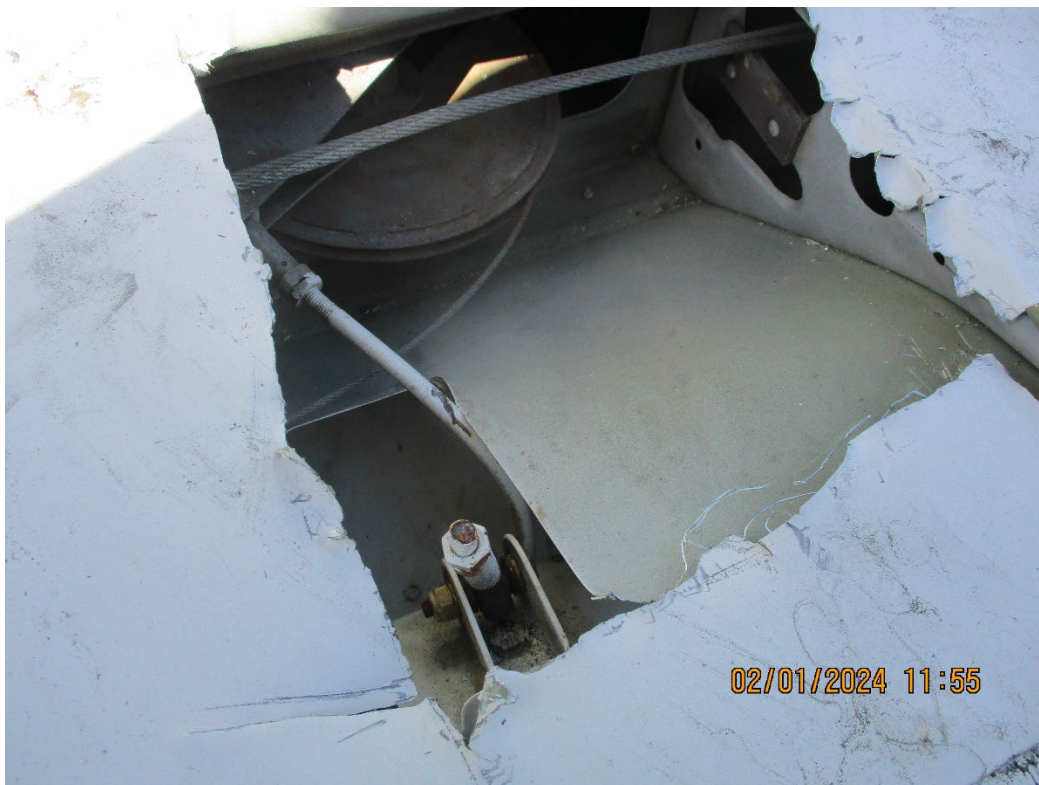
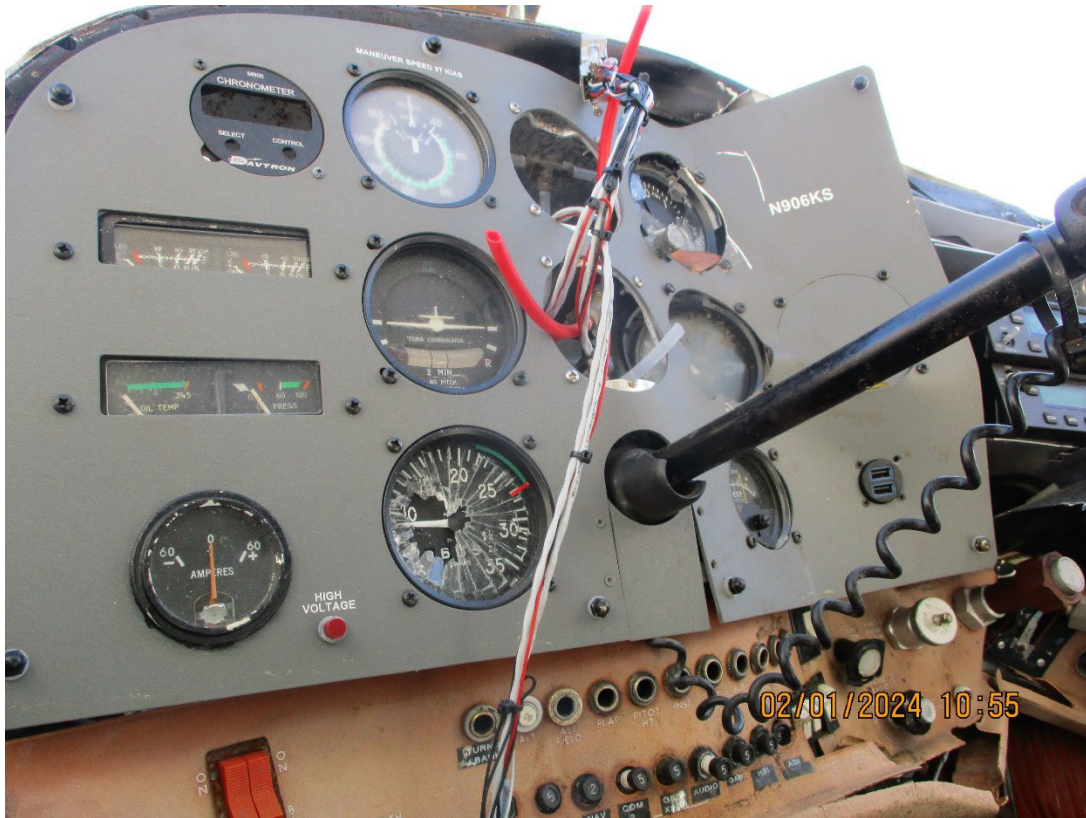
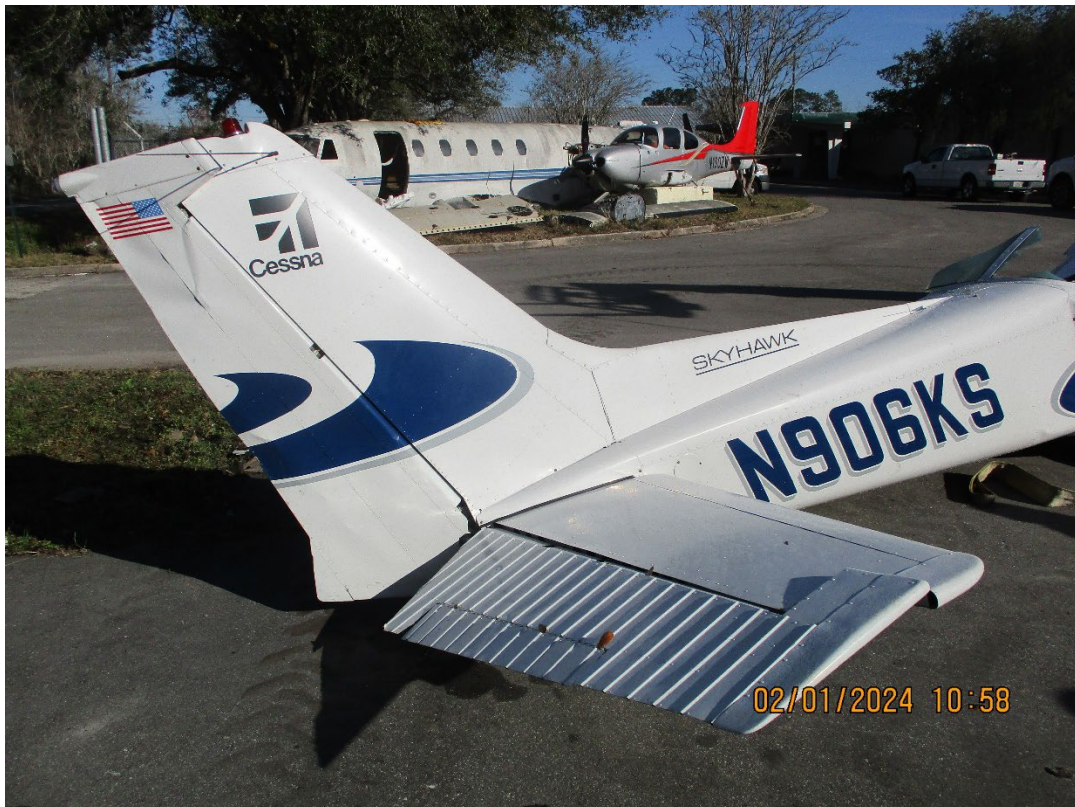
The airplane was first observed at the recovery company salvage yard. The wings were removed and the elevator was cut for transportation. Cable continuity was established by tracing through the separations that were consistent with overload or cuts made by recovery personnel. All primary flight controls moved smoothly by hand. The empennage was fractured by impact forces and connect to the cabin by cables and a couple rivets only. The instrument panel was fractured in several pieces and some instruments were missing from the panel.
