ERA24LA061

## INVESTIGATION PHOTOGRAPHS

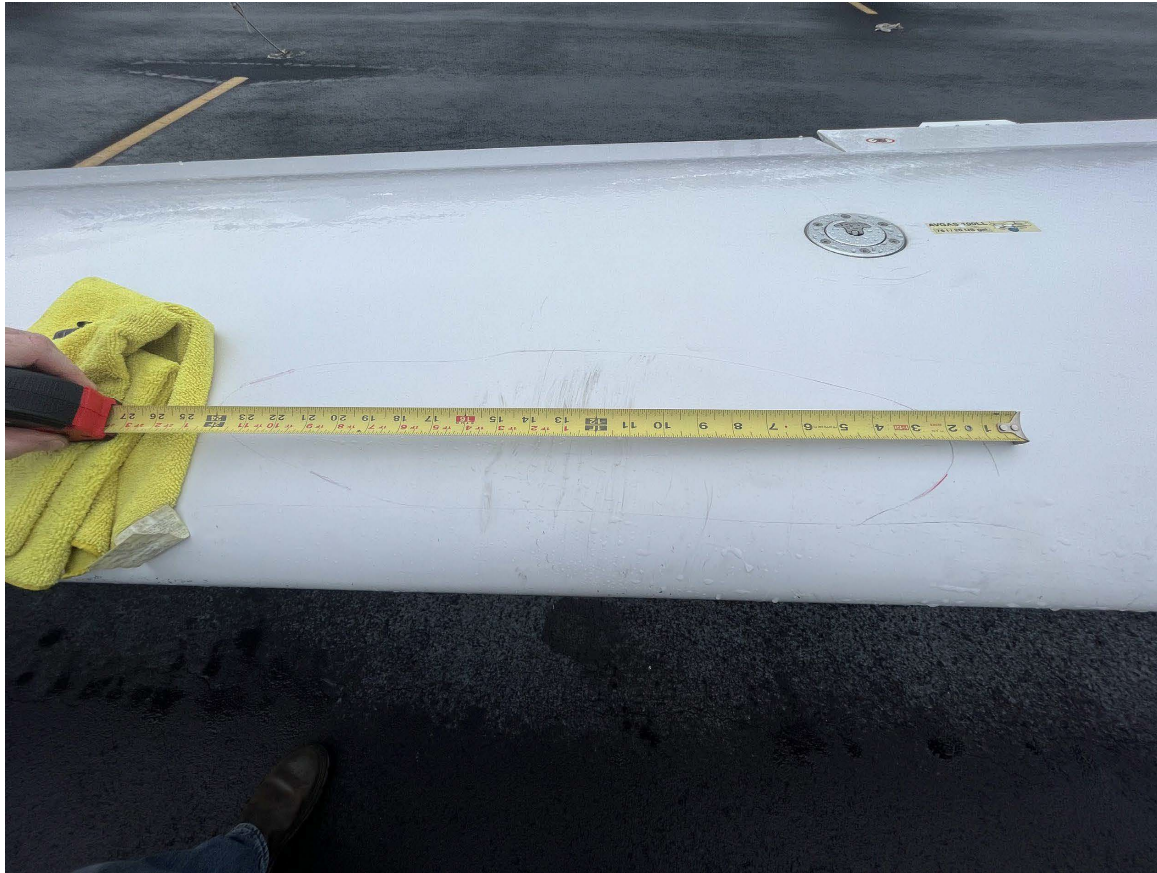
**Photograph 1 - Initial damage overview (Courtesy of FAA)**

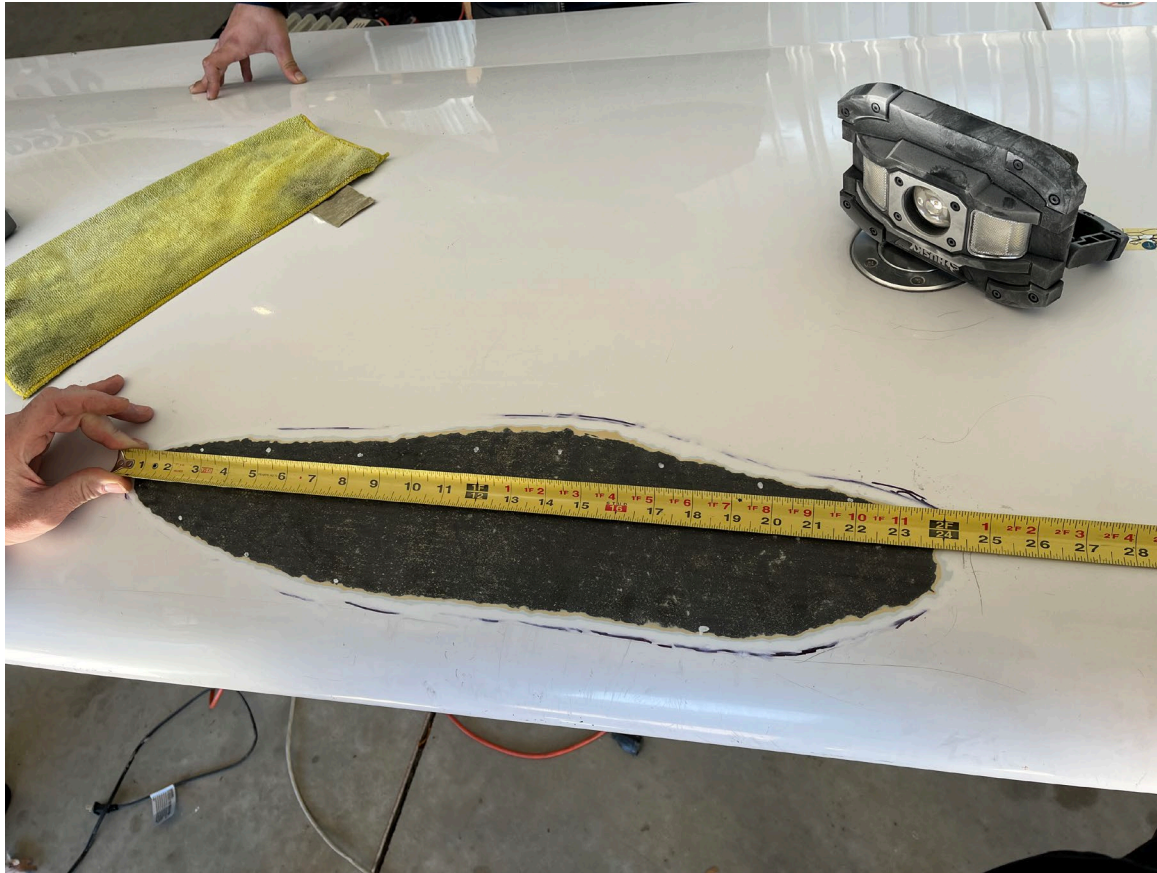
**Photograph 2 - Measurement of delamination/disbonding (Courtesy of FAA)**
