ERA24LA063

## INVESTIGATION PHOTOGRAPHS

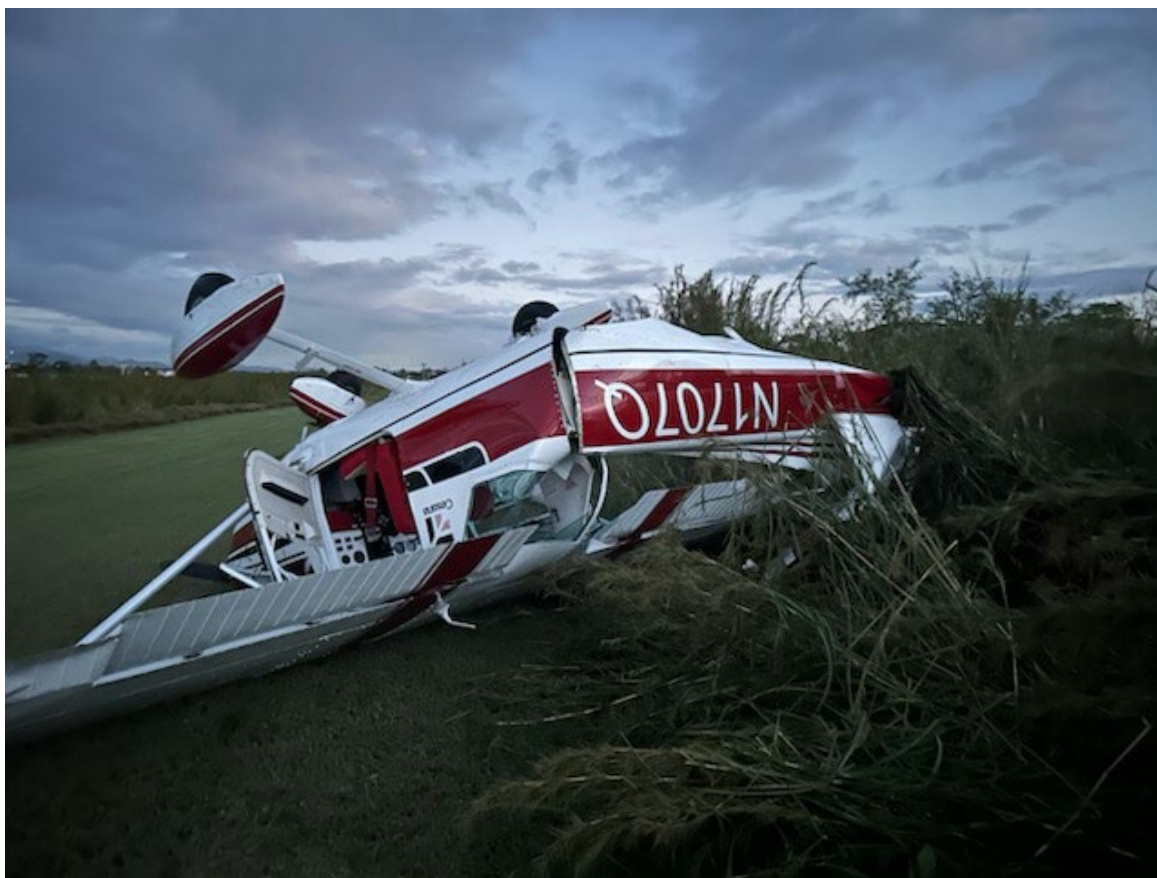
**Photograph 1 -Right Side Tail Structure Damage (Courtesy of FAA)**

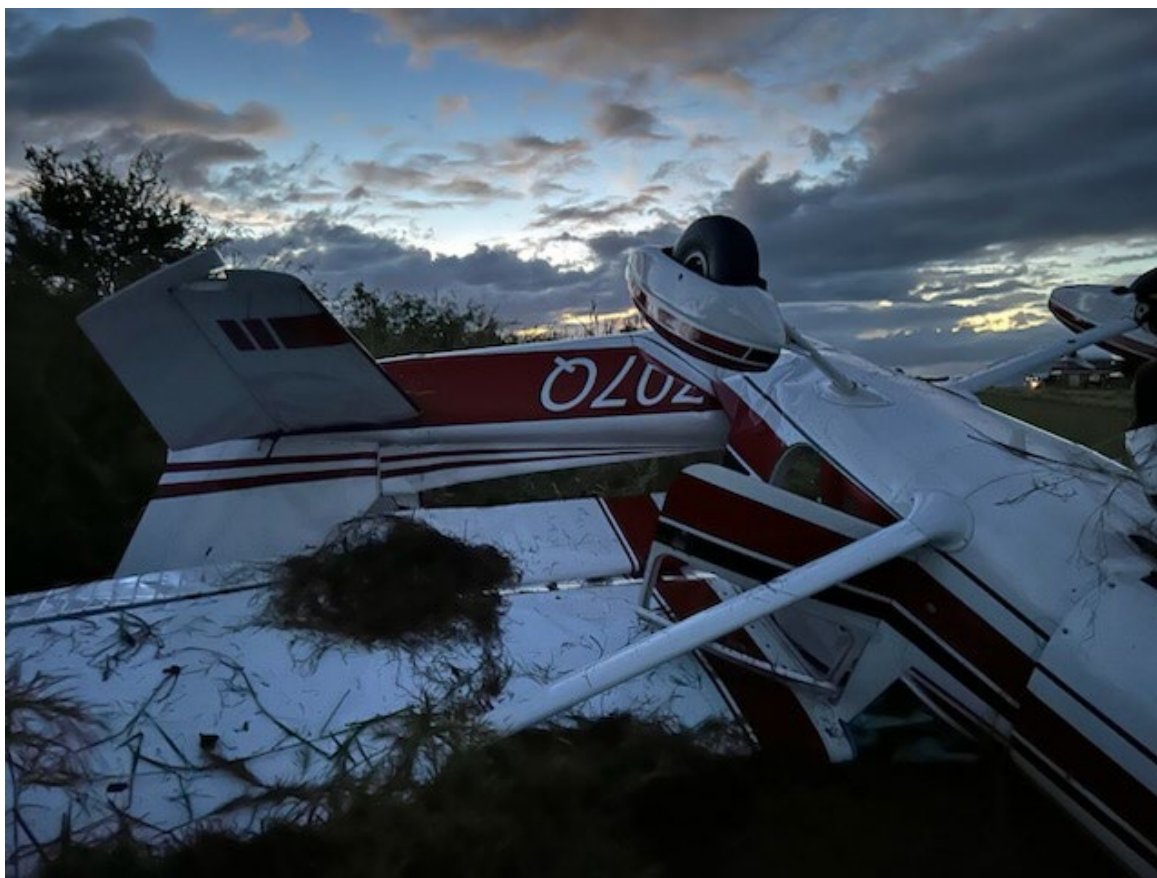
**Photograph 2 - Left Side Tail Structure Damage (Courtesy of FAA)**

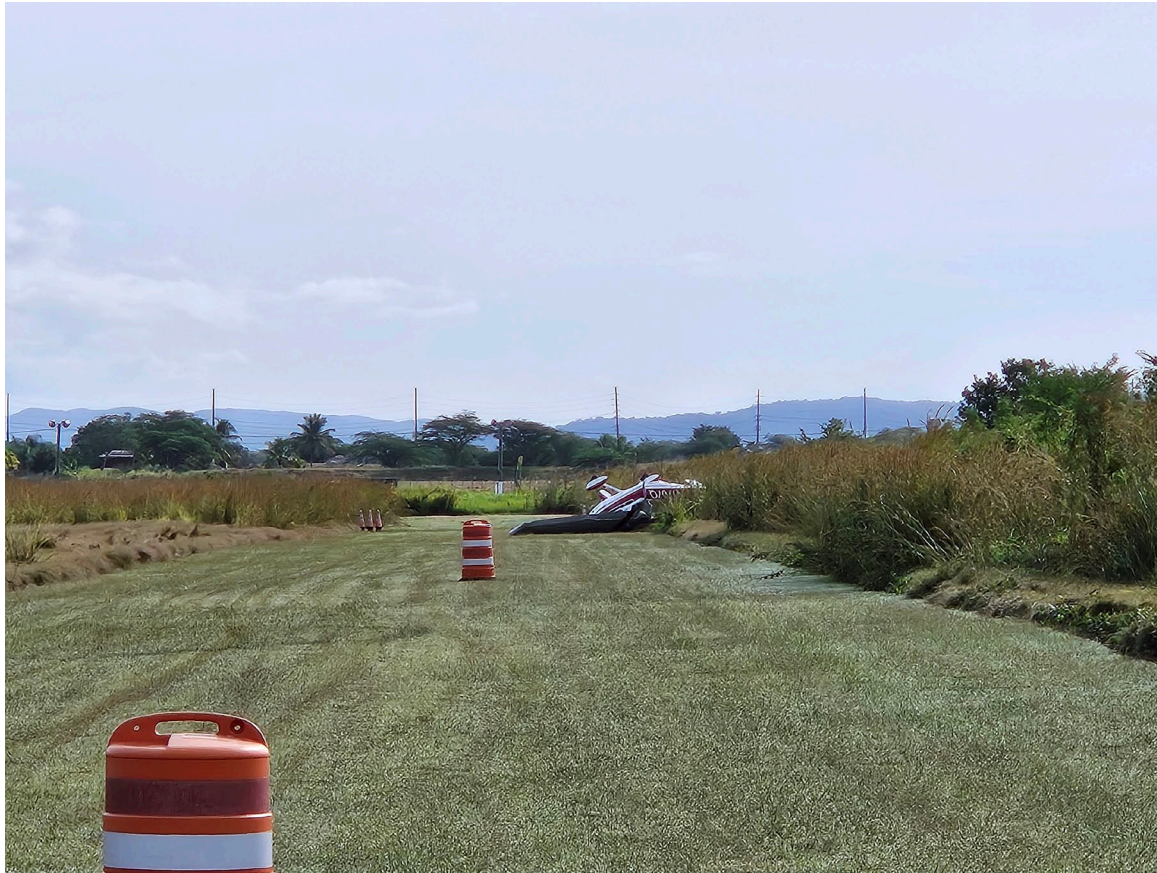
**Photograph 3 - View of Airplane and Runway (Courtesy of FAA)**
