# National Transportation Safety Board

ERA24LA066

## **MATERIALS LABORATORY**

Factual Report 24-072

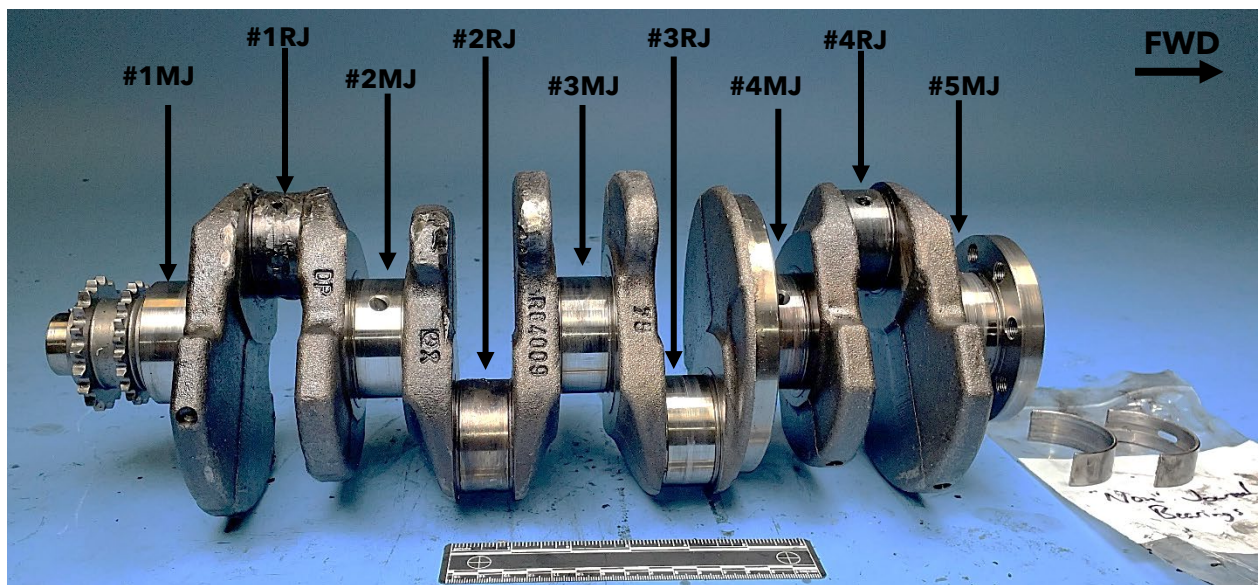
The bearing halves for the #5MJ, as shown in figure 1, showed moderate scoring damage with no evidence tinting (heat damage).

**Figure 1.** As-received crankshaft and bearing halves from the #5MJ. The crankshaft is numbered from aft to front, starting with the #1 main journal (#1MJ) and #1 rod journal (#1RJ) at the aft end, and ending with the #5 main journal (#5MJ) at the front end. The main bearing (two halves) for the #5MJ is shown on the right side of the photograph. Units on the top side of the ruler are inches and at the bottom side are metric (mm).

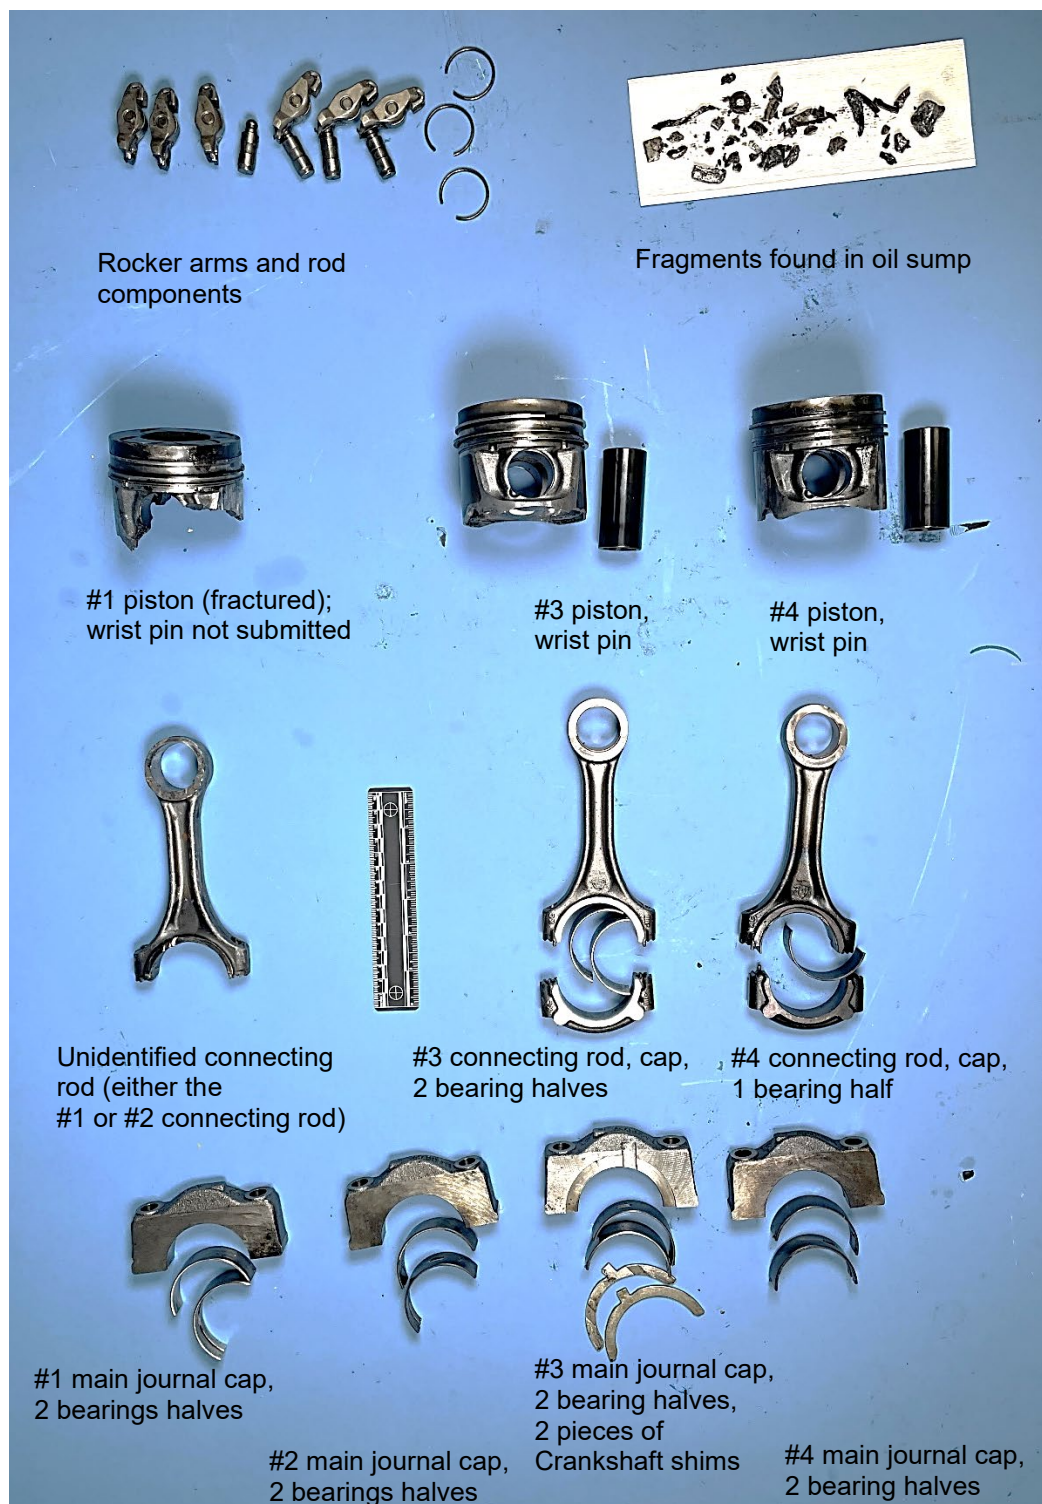
Examination of the #1 piston revealed a major portion of the skirt had fractured and the fractures intersected the bore for the wrist pin (see figure 2). The bore for the wrist pin showed no evidence of scoring. The outer surface of the skirt contained severe scoring damage (orientation of the scoring marks were parallel to the length of the bore for the piston). The piston contained three metallic split rings (two compression rings and one oil control ring) that were attached to the outer diameter of the piston. The three piston rings were intact and free to move within their respective grooves. The surface of the head exhibited evidence of pitting and mechanical damage. The head contained four pockets (round) areas corresponding to the location of the valve heads. The pockets for the inlet valves contained circumferential machine impression marks (in areas between the arrows in figure 11) corresponding to circumferential machine impression marks found on the head of the valve heads.

The #1 through #4 main journal caps and their respective bearings (2 halves each) were submitted for examination, including two pieces of crankshaft shims from the #3 cylinder (see figure 2). The bearings for the main journals exhibited scoring, deformation, and heat damage (heat tinting), the severity of which increased from the #1MJ to the #4MJ; with the #4MJ having the most severe damage. The caps were intact and showed no evidence of damage.

**Figure 2.** As-received pieces from the engine.

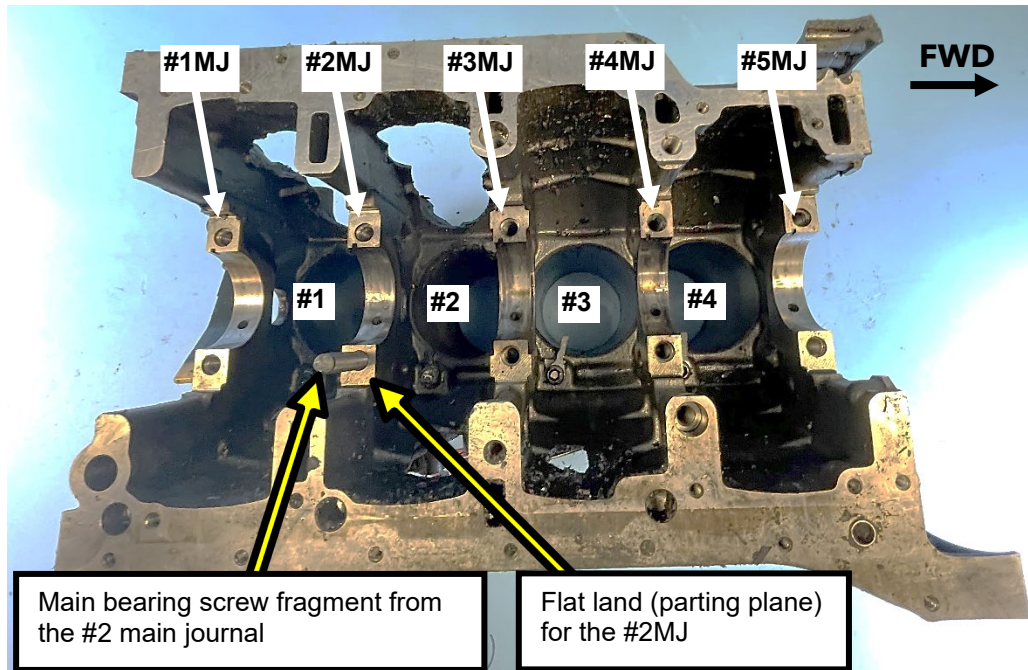
The engine was installed with a total of ten main bearing screws, Austro Engine part number (P/N) E4A-10-100-201. Examination of the as-received engine revealed a main bearing screw fragment from the #2MJ was attached to the engine (see figure 5), but the remaining (nine) main bearing screws were not submitted with the engine. The main bearing screw fragment from the #2MJ fractured in the area below the head, at the transition radius between the screw head and nonthreaded shank portion (see figure 6). The fractured screw head was not recovered. The fracture face of the screw fragment was located approximately 1.6 inch [41 mm] above the flat land (parting plane) for the #2MJ.<sup>2</sup> The screw fragment could not be turned by hand relative to the engine and it was disassembled from the engine block with the aid of pliers. Care was taken not to touch the fracture face during disassembly. The fractured screw was brush cleaned with Alconox, a commercial detergent, followed by ultrasonic cleaning in acetone.

**Figure 5.** As received engine block looking at bottom surface. Cylinders are numbered #1 through #4. A main bearing screw fragment from the #2MJ remained attached to the flat land (parting plane) portion of the engine block.

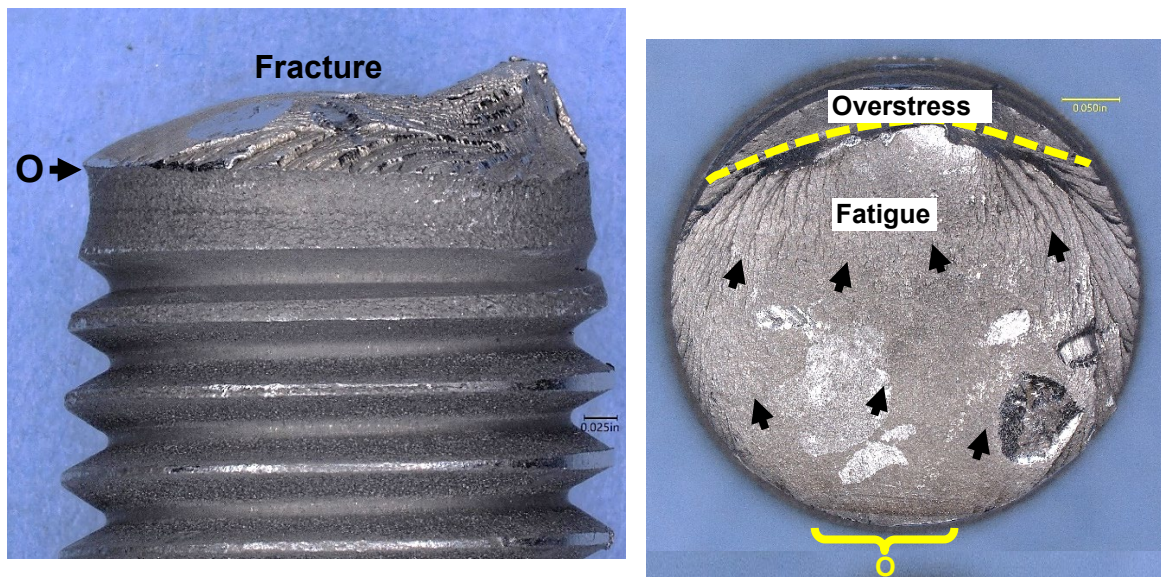
Bench binocular microscope examination of the disassembled main bearing screw fragment revealed the fracture face contained evidence of beach marks, typical of fatigue cracking, that emanated from multiple origins at the transition radius

between the head and non-threaded shank, on one side of the screw, see figure 6. Scanning electron microscope (SEM) examination of the screw fracture face revealed the fatigue crack propagated through approximately 95% of the screw cross section. Typical fatigue striations are shown in figure 7. The origin of the fatigue crack showed no evidence of corrosion damage. The fatigue origin in several areas contained post-accident mechanical damage. The fatigue crack terminated in the area indicated by a dashed line in figure 6. The remaining portion of the fracture face exhibited evidence of microvoid coalescence features typical of overstress separation.

The threads of the screw fragment contained evidence of two minor cracks. The cracks were located on the diametrically opposite side of the fatigue origin and on the root of the first two threads below the head area. The circumferential length of the crack on the first thread root adjacent to the head measured approximately 0.115 inch (2.9 mm) and that of the crack on the second thread root measured approximately 0.171 inch (4.3 mm).

**Figure 6.** Main bearing screw fragment from the #2 main journal showing side view of the fracture where the fatigue origin is indicated by arrow "O" (left image) and head-on view of the entire fracture face where the same fatigue origin is indicated by bracket "O" (right image). The fatigue crack terminated in the area indicated by a dash line. Fracture areas outside of the fatigue region exhibited features typical of overstress separation. The luster (reflective) features on the fracture face are mechanical damage areas.

bearing screws.<sup>5</sup> This AD enforces Austro Engine Mandatory Service Bulletin No. MSB-E4-042, dated 31 January 2024.<sup>6</sup> According to the Austro Engine MSB, “occurrences of E4 series engines have been reported recently. Investigation of the occurrences has shown in some cases the failure of one inner main bearing cap screw. Subsequent investigations have determined that certain batches of inner main bearing cap screws were produced at the lower end of the material strength tolerance for class 8.8 screws having P/N E4A-10-100-201. Depending on the magnitude of the screw’s strength properties, the potential for screw failure, leading to engine failure, exists in cases where abnormal operating conditions are experienced such as fuel quality issues or significant deviations from the fuel system requirements. To address this possible unsafe condition, the MSB requires the replacement of the inner main bearing cap screws, with screws having highest safety factor”.<sup>7</sup> The replacement screw is a class 12.9 screw, having P/N E4A-10-100-202, where the head portion of the replacement screw is identified by the imprint “12.9”. According to ISO 898-1, the ultimate tensile strength of a class 12.9 screw is specified as between 1,200 N/mm<sup>2</sup> and 1,220 N/mm<sup>2</sup>, and the hardness is indicated as in the range between 39 HRC and 44HRC.<sup>8</sup>

According to Austro Engine MSB, instructions for installing the replacement screws are found in Austro Engine Work Instruction WI-MSB-E4-042, titled “Main Bearing Screw Replacement”. Per WI-MSB-E4-042, only the 6 inner screws are replaced, while the outer 4 screws (2 forward and 2 aft) remain in place. The 6 replaced screws are torqued to 55 Nm, followed by tighten them to another 90° turn. The torque for the outer 4 screws remain the same as originally specified.

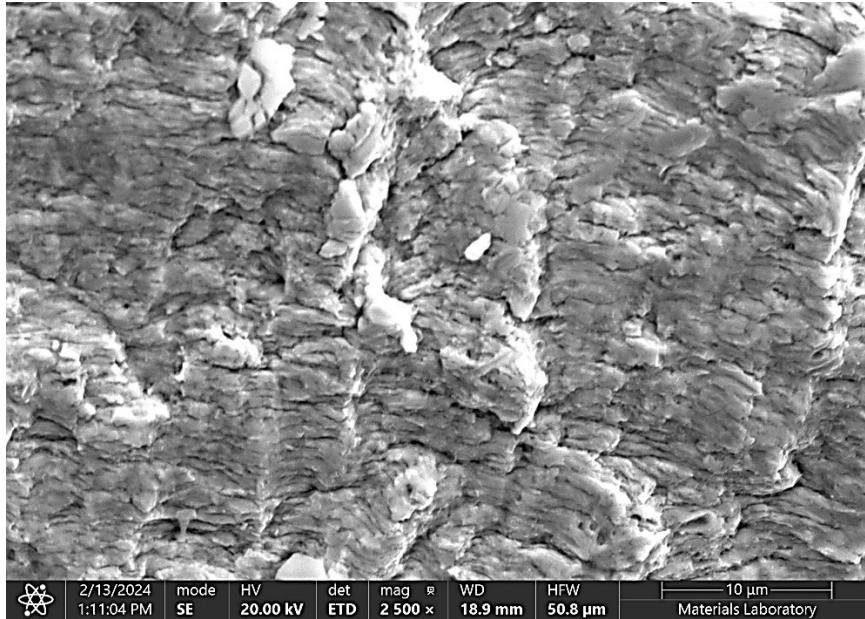
**Figure 7.** SEM image of the fractured main bearing screw from the #2 main journal showing typical fatigue striations in the area near the origin of the fatigue crack.

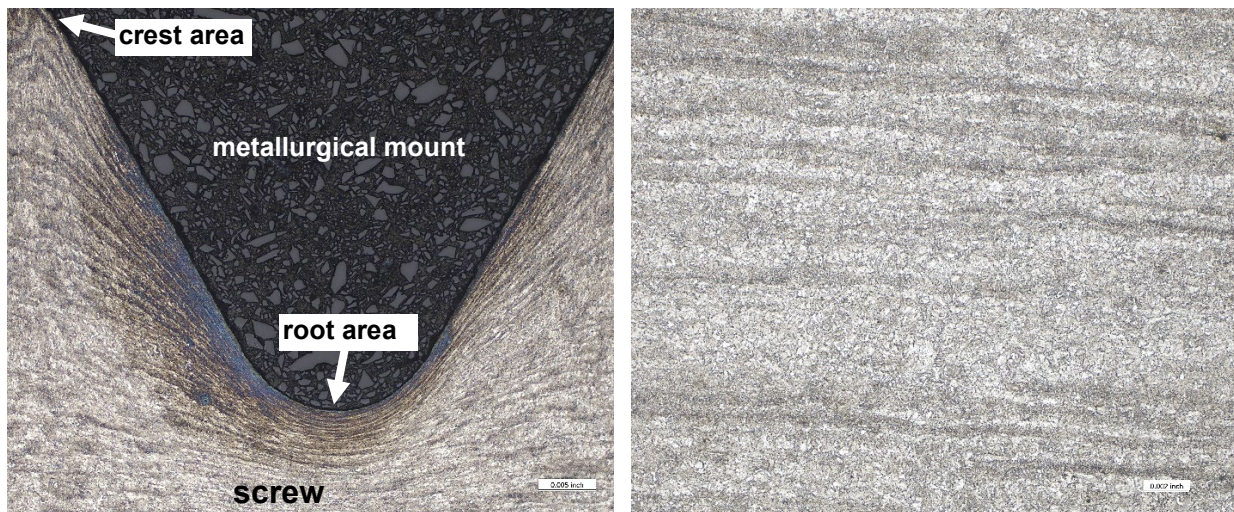
A longitudinal-radial section was made through the origin of the fatigue crack. The section was encased in a metallurgical mount, ground and polished in accordance with standard laboratory procedure, and the prepared section was etched with 2% Nital reagent. The section exhibited a microstructure of tempered martensite. The tempered microstructure grains at the core showed evidence of preferred rolling direction which was parallel to the length of the screw (see figure 8). No evidence of corrosion or material anomalies were noted at the origin of the fatigue crack. The areas adjacent to the threads (root and crest areas) showed evidence of mechanical deformation consistent with rolled threads. The section incorporated the circumferential cracks (described earlier) that were located at the root of the first two threads adjacent to the head. The depth of the two cracks measured approximately 0.425 mm (0.017 inch), each.

**Figure 8.** Longitudinal sections through the #2MJ main bearing screw fragment showing evidence of rolled threads at the root and crest areas (left image); and microstructure at the core of the screw (right image). These sections from the screw showed a microstructure of tempered martensite. Etched with 2% Nital. The brown/blue color at the surface of the thread area is residual staining from the etchant and is not an anomaly in the microstructure.

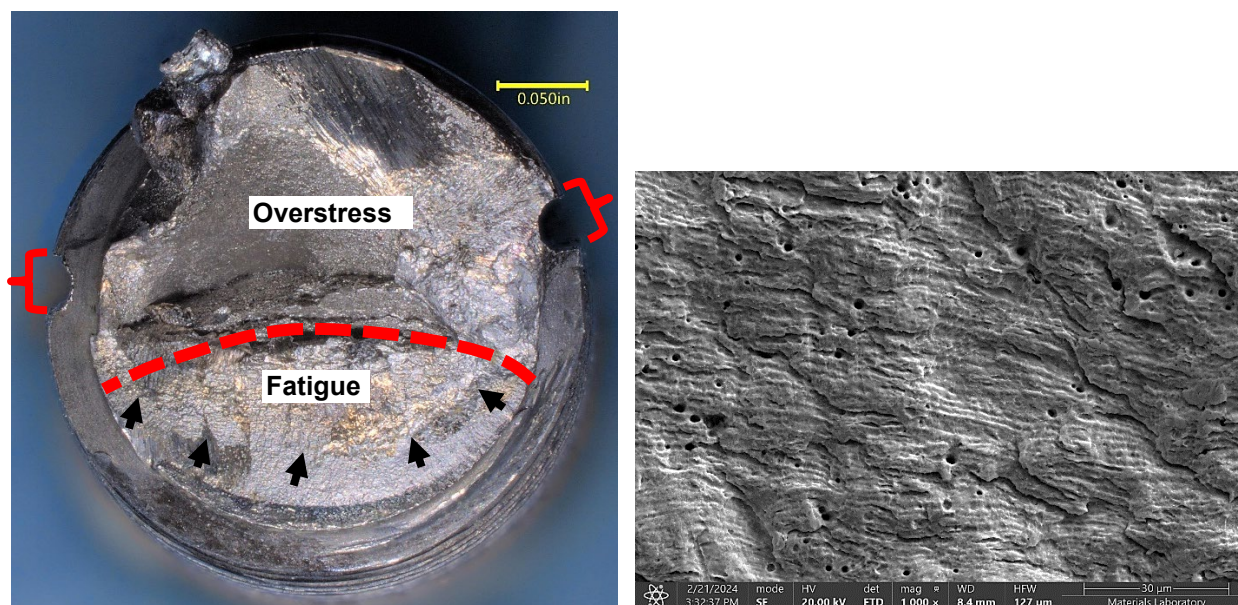
Figure 9 shows the fracture face of connecting rod attachment bolt “A”. SEM examination of bolt “A” revealed the fracture face exhibited beach marks, typical of fatigue cracking, that emanated from multiple origins at the root of the thread, on one side of the bolt. Fatigue crack propagation was through approximately 30% of the bolt cross section. The fracture outside of the fatigue zone contained microvoid coalescence features typical of overstress separation.

**Figure 9.** Fracture face of connecting rod bolt "A" from the unidentified connecting rod arm (either from the #1 or #2 connecting rod). Fatigue crack emanated from multiple origins at the root of the thread, propagated in direction indicated by arrows and terminated in the areas indicated by a dashed line (left image); and SEM photograph of typical fatigue striations (right image). Brackets indicate location of saw cuts that were made to dislodge screw from threaded hole.

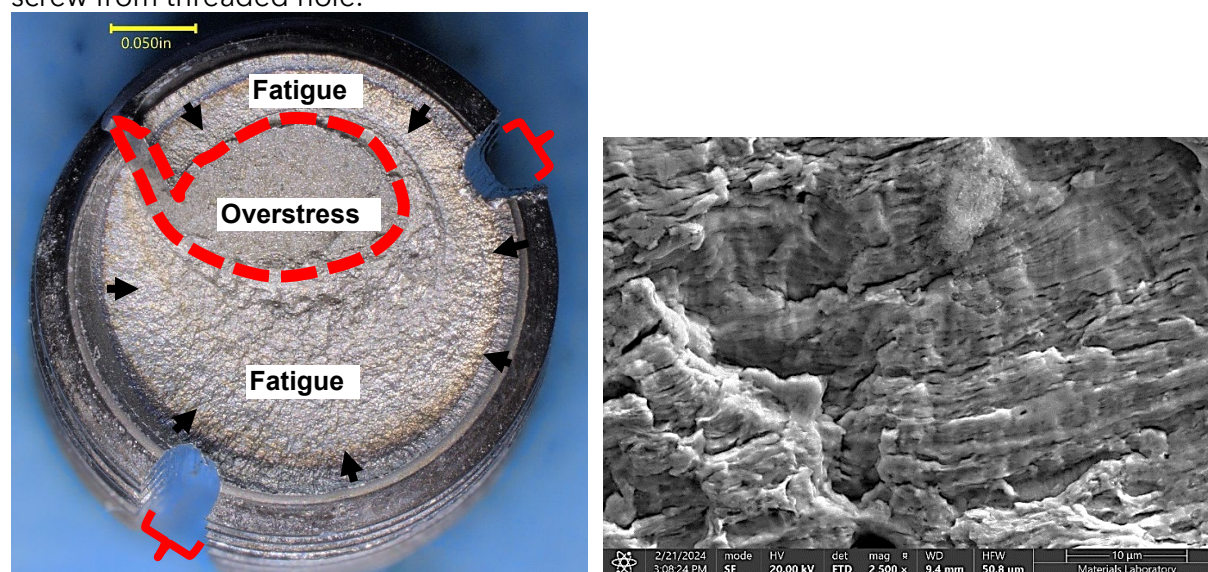
Figure10 shows the fracture face of connecting rod attachment bolt “B”. SEM examination of bolt “B” revealed the fracture face contained beach marks, typical of fatigue cracking, that emanated from multiple origins at the root of the thread all around the bolt. The fatigue crack propagated through approximately 70% of the bolt cross section. The remaining portion of the fracture exhibited microvoid coalescence features typical of overstress separation.

**Figure 10.** Fracture face of connecting rod bolt "B" from the unidentified connecting rod arm (either from the #1 or #2 connecting rod). Fatigue crack emanated from multiple origins at the root of thread in areas all around the screw, propagated in general direction indicated by arrows, and terminated at the core in the area indicated by a dashed line (left image); and SEM photograph of typical fatigue striations (right image). Brackets indicate location of saw cuts that were made to dislodge screw from threaded hole.

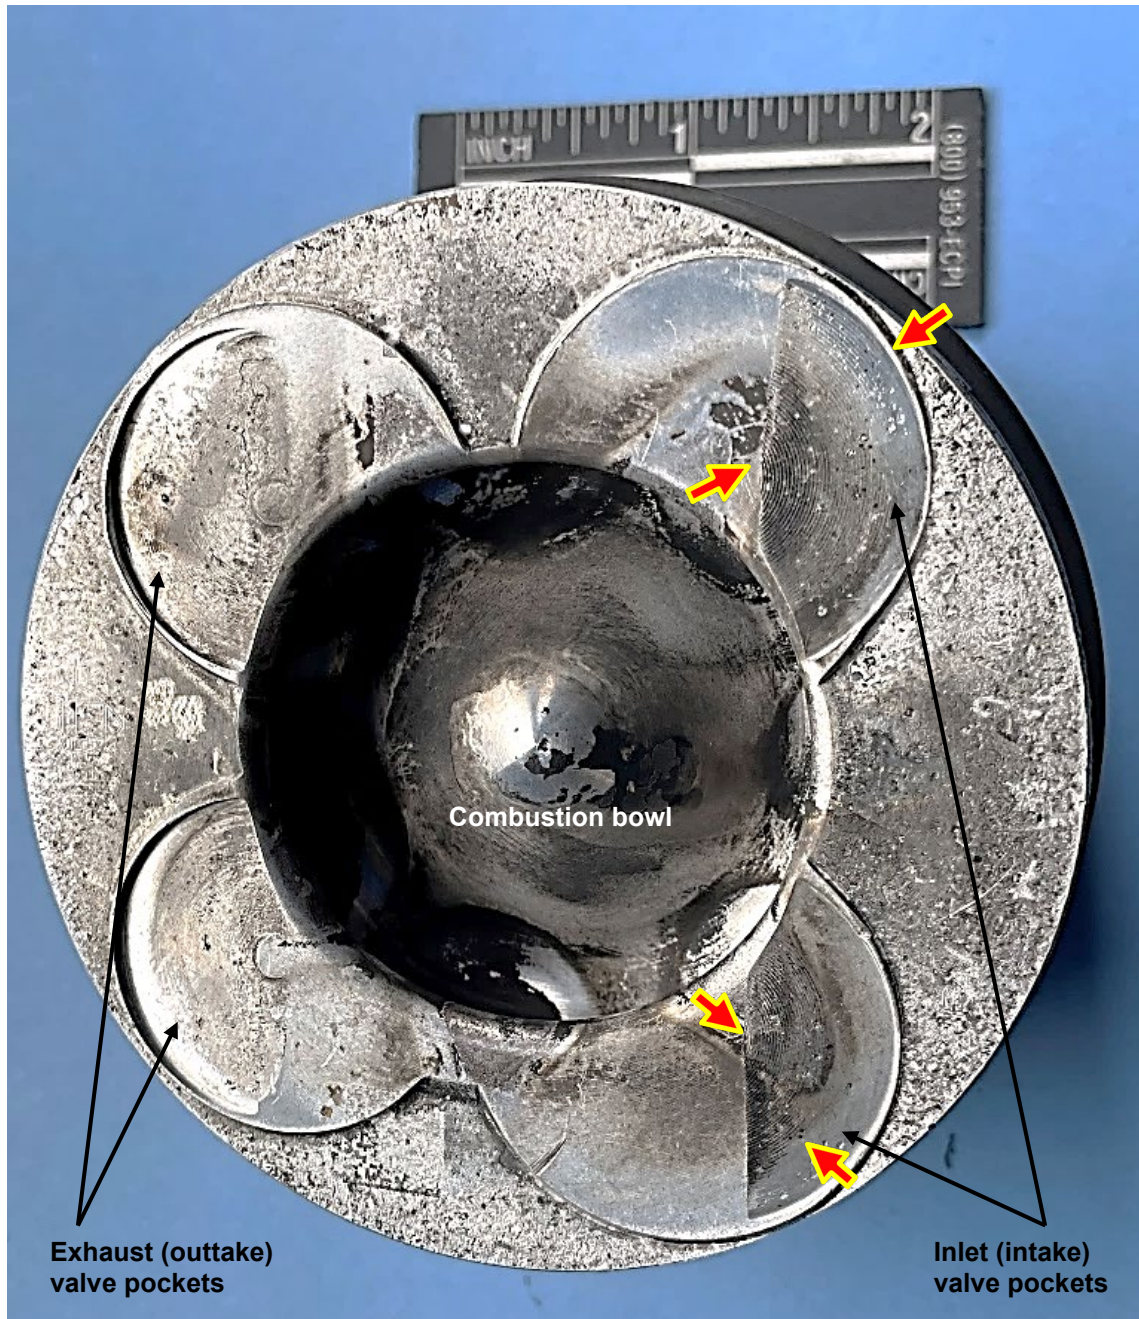
**Figure 11.** Head portion of the #1 piston showing four valve pockets that correspond to the location of the valve heads. The surface of the head also contained pitting and mechanical damage. Circumferential machine impression marks (between arrows) were found in the inlet pocket areas that correspond to those found on the head of the valve heads.

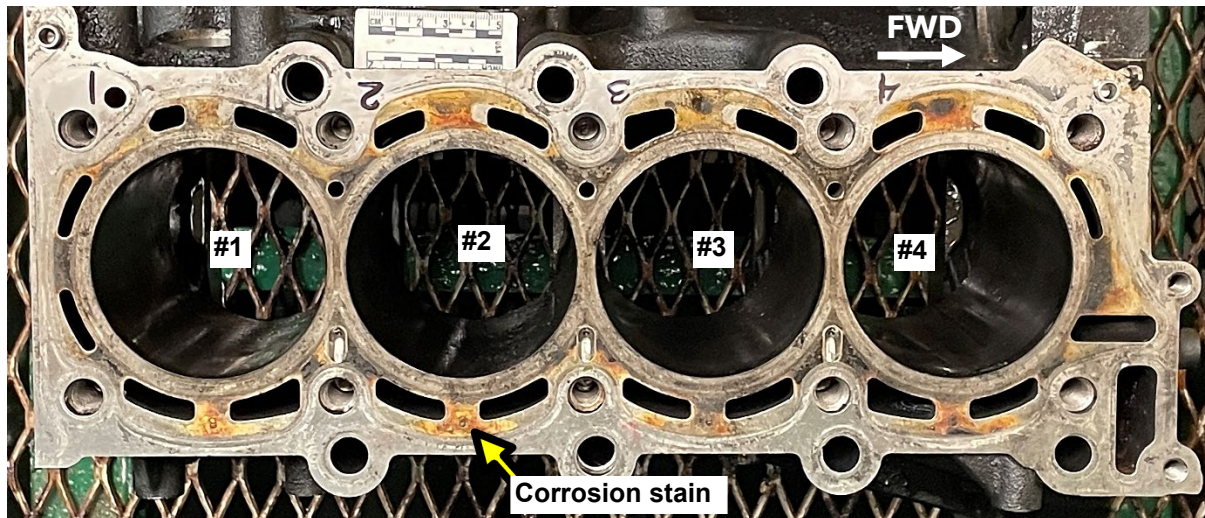
The engine block contained a total of four bores, one for each piston. The top surface of the engine block contained evidence of corrosion stains in several areas around each bore (see figure 12). When looking down into the #2 piston bore, the wall contained four areas of severe scoring damage along its length, in the areas between arrows (see figures 13 and 14). When looking up at the #1 piston bore, the bottom corner edge of the bore on diametrically opposite sides exhibited evidence of mechanical damage (dents) in areas indicated by arrows in figure 15 (these areas correspond to the general location of the respective connecting rod arms.) The #2 piston bore contained a similar dent damage in the same respective area as in the #1 piston bore but only on one side of the bore (see figure 15).

**Figure 12.** Top face of the engine block showing corrosion stains (brown areas) in the areas surrounding the piston bores; shown after cleaning in a degreaser tank. Piston bores are numbered #1 through #4.

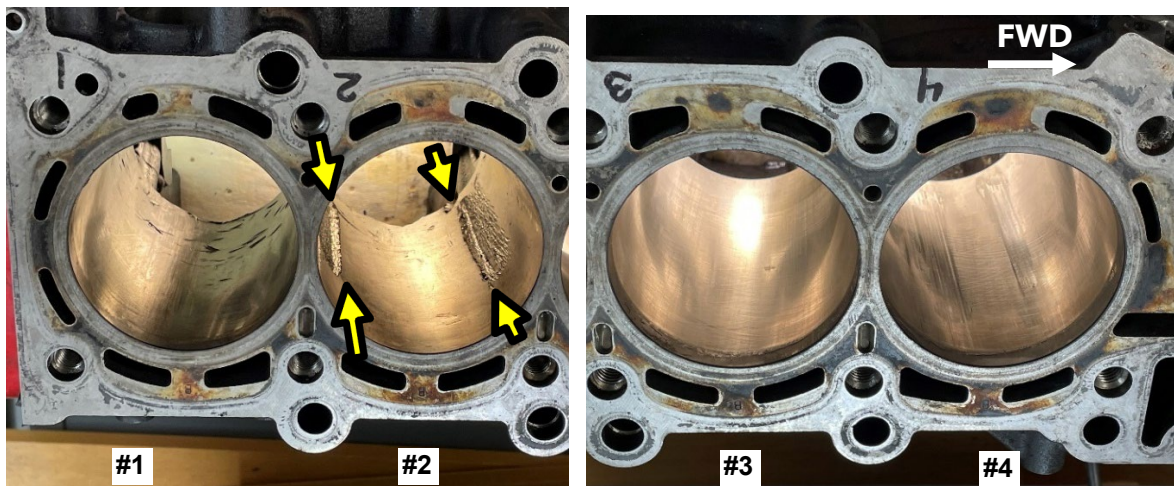
**Figure 13.** View of the top face of engine block with the piston bores exposed to background lighting. In this view, the #2 piston bore shows two of four severe scoring damage areas along the length of the bore in the areas between arrows; shown after cleaning. Piston bores are numbered #1 through #4.

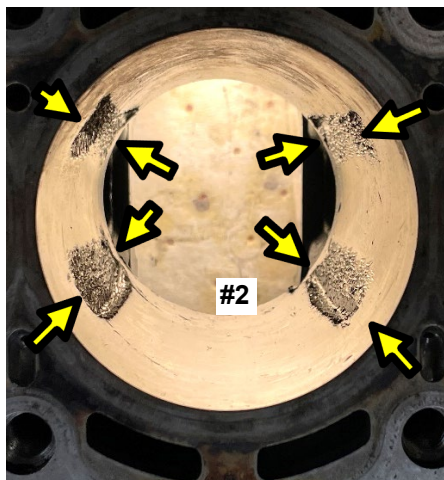
**Figure 14.** View looking down into the #2 bore showing four severe scoring damage areas along the length of the bore in the areas between arrows; after cleaning.

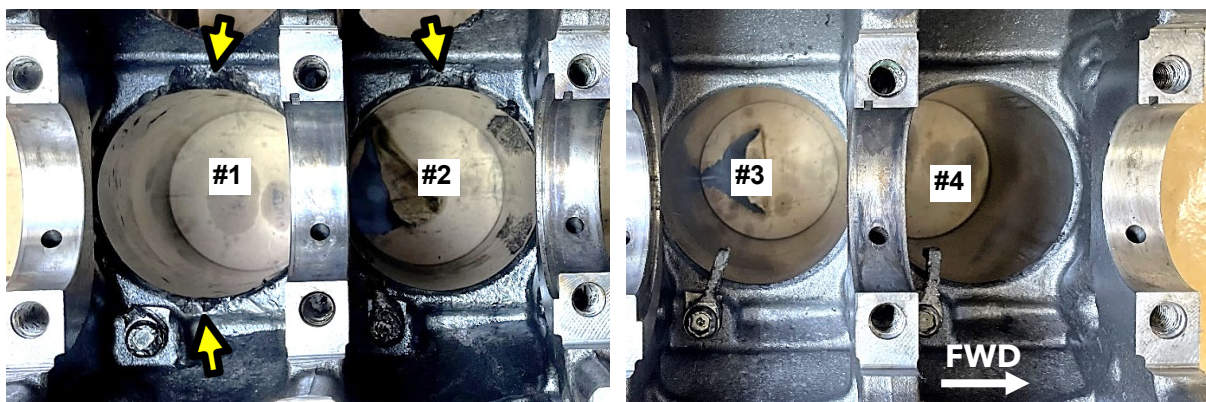
**Figure 15.** View looking up at the piston bores showing mechanical damage (dents) in areas that correspond to the location of the respective connecting rods, in areas indicated by an arrow.

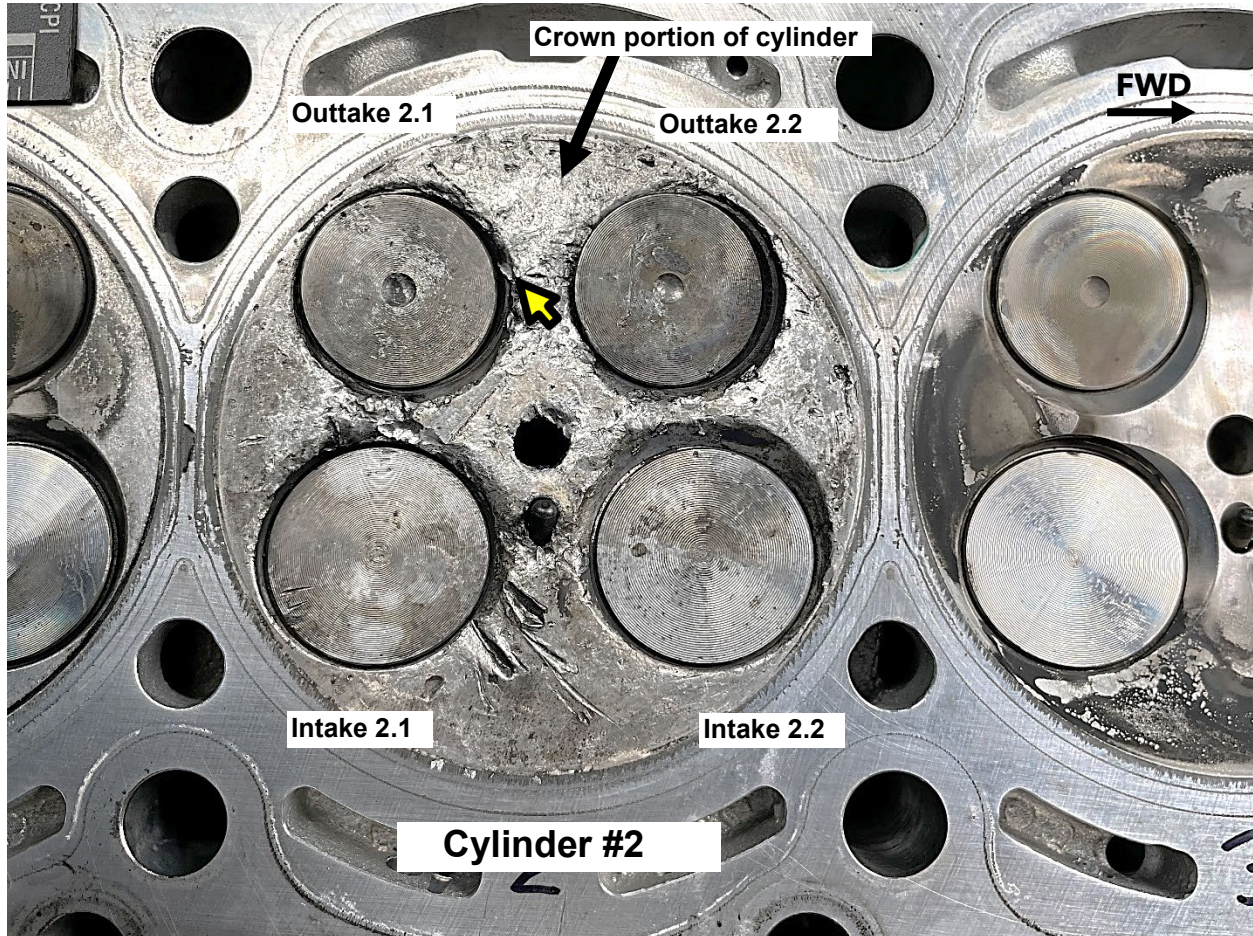
The engine head contained four internal chambers; the crown portion of each chamber incorporated four valves. Out of all the four cylinders, the crown portion of the #2 cylinder, and the four valve heads within this chamber, exhibited the most severe mechanical damage (multiple impact marks), see figure 16. The crown portion of the #1 cylinder showed next to the most severe mechanical damage, see figure 17. The crown portion of the #1 cylinder in the area surrounding outtake valves heads 1.1 and 1.2 contained evidence of minor pitting and mechanical damage, see figure 17. The crown portion of the remaining cylinders, and their corresponding valve heads,

**Figure 16.** View of the intake and outtake valves for the #2 cylinder. A sliver of metal, indicated by an arrow, extended from the chamber into the seat of outtake valve 2.1. The crown portion of the chamber for this #2 cylinder showed severe mechanical damage compared to the crown portion of the chamber for the #1, #3 and #4 cylinders.

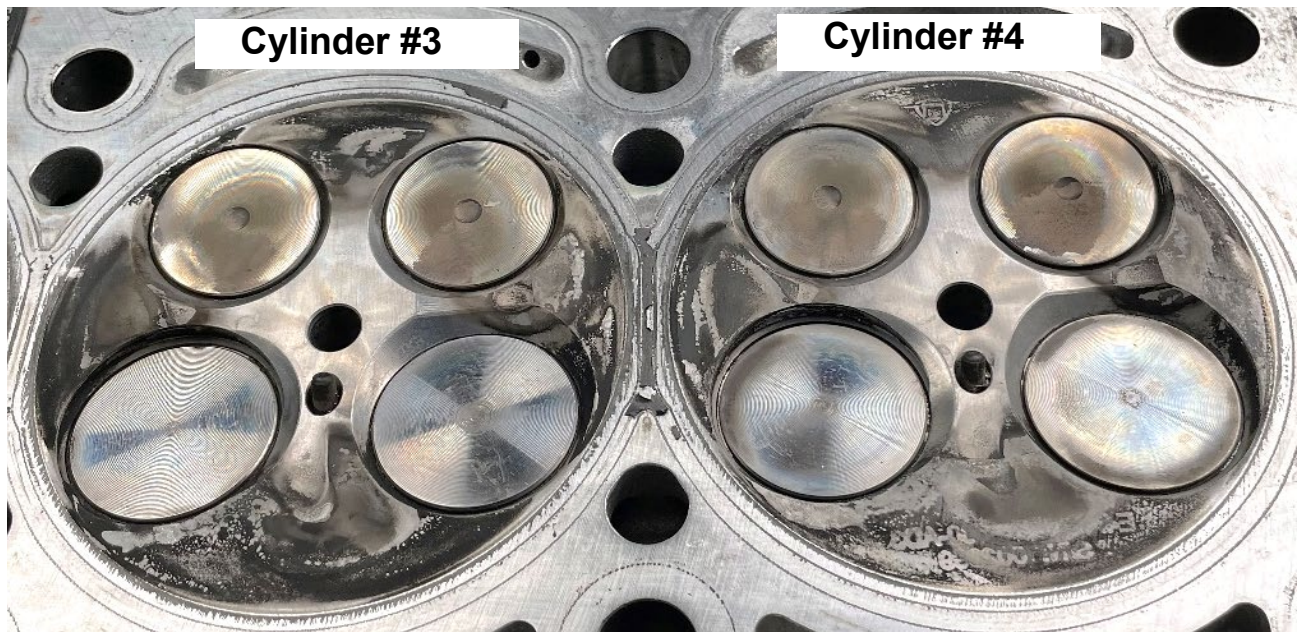
exhibited no evidence of mechanical damage, see figure 18. Examination of the exhaust ports for all the cylinders located at the end of the head revealed no evidence of debris or molten metal.

**Figure 18.** View of the intake and outtake valves for the #3 and #4 cylinders.

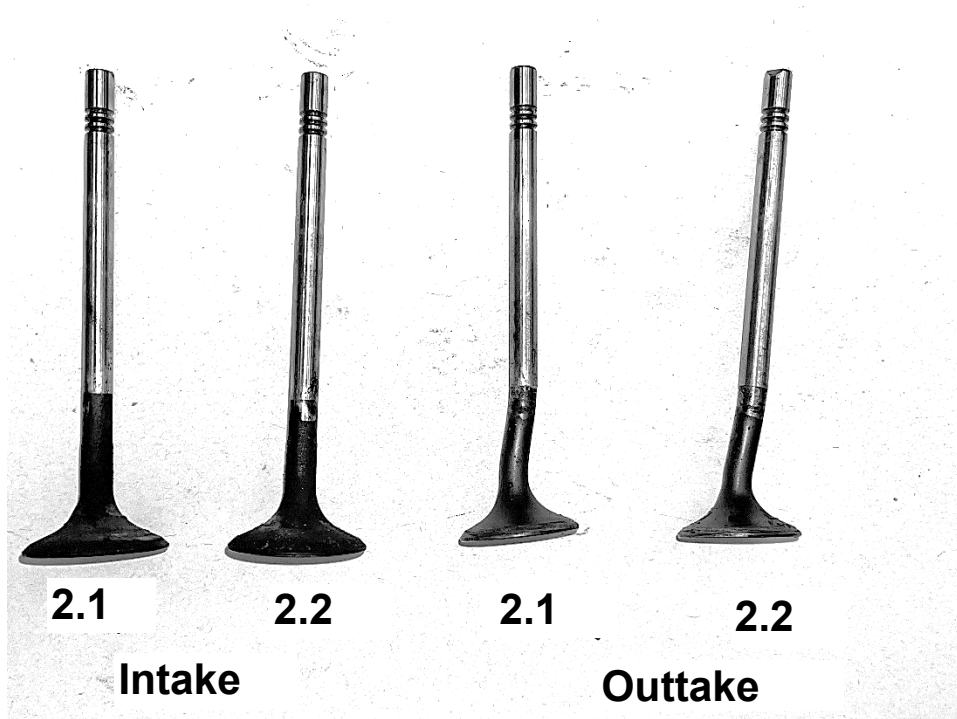
A photograph of the disassembled valves from the #2 cylinder is shown in figure 20. Examination of the disassembled valves revealed they contained no evidence of scoring damage along the length of their respective stem. The stem portion of the outtake 2.1 and 2.2 valves showed evidence of severe bending deformation in the area near the head. The valves from the #1, #3, and #4 cylinders were not disassembled from the engine head.

**Figure 20.** Side view of the disassembled valves from the #2 cylinder. Outtake valves 2.1 and 2.2 show evidence of bending deformation at the stem in the area near the head.

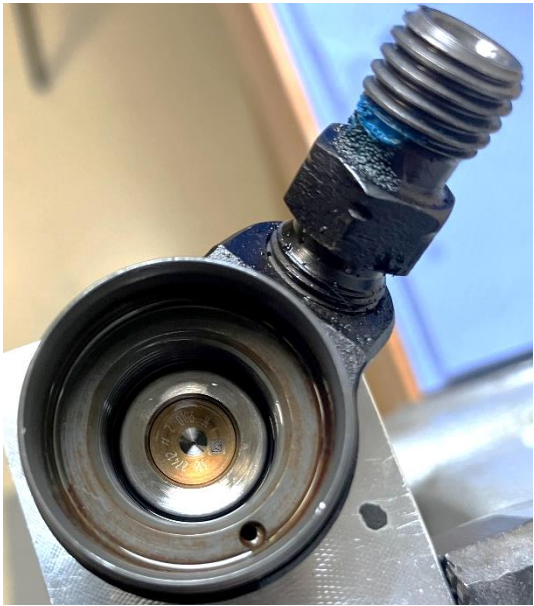
Figure 31 - Injector 1, armature guide removed

Corrosion can be found on armature guide, and inside the injector.

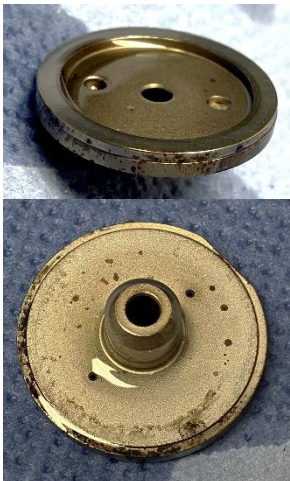
Figure 33 - Armature guide injector 2

During disassembly of injector 2, corrosion was found on armature guide and within the injector as shown in the pictures below.

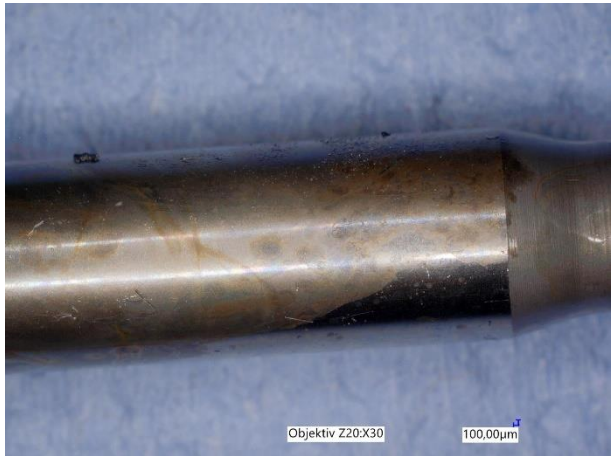
Figure 48 - Injector 1, corrosion on control piston

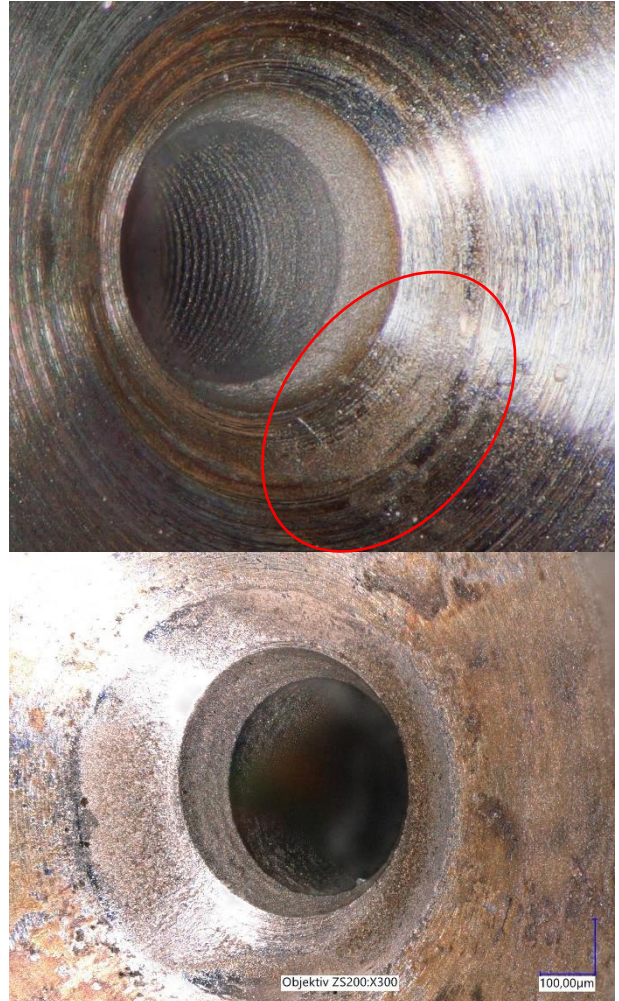
Figure 76 - Comparison roughened surface injector 3 (top) to corroded injector (bottom)
