# National Transportation Safety Board

ERA24LA066

## **ENGINE CONTROL UNIT**

Specialist's Factual Report

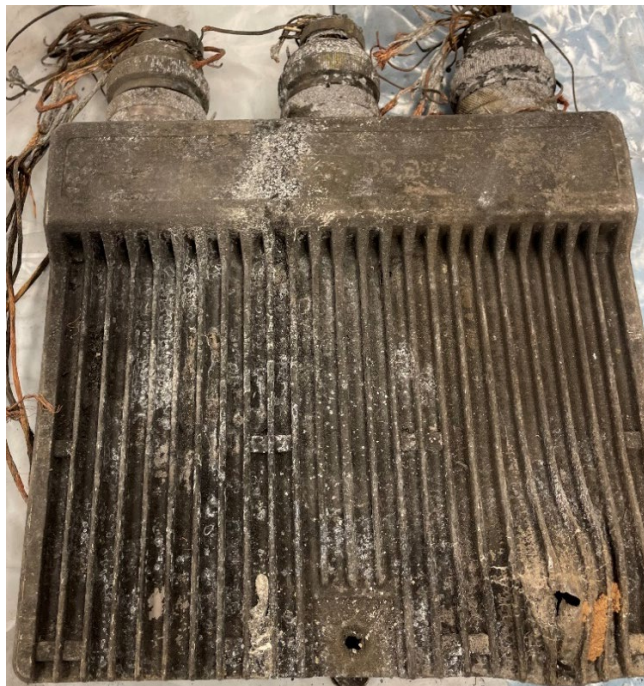
Upon arrival at the NTSB Vehicle Recorder Division, an exterior examination revealed the unit had sustained damage, as shown in figure 1. Figure 2 shows that the main circuit board inside the unit was also severely damaged. The circuit board was sent to the manufacturer in Wiener Neustadt, Austria for data recovery. The manufacturer transferred the memory chips to a surrogate EECU, and the data were downloaded with the witness of an investigator from German Federal Bureau of Aircraft Accident Investigation (BFU).

**Figure 1.** Austro AE300 EECU as received by the NTSB Vehicle Recorder Laboratory.

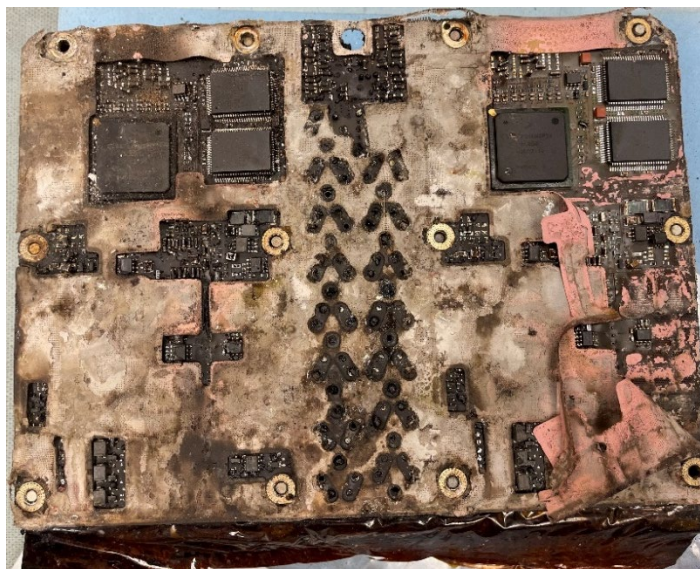
**Figure 2.** Memory module from the Austro AE300 EECU.

Each of the ECU A and ECU B were supposed to store parameter data and event logger data. During the download by the manufacturer, it was noted that the chip on ECU A was significantly damaged. When the data was recovered, the parametric data was corrupt, but not the event loggers. Therefore, for this report, the parametric data is from ECU B solely. However, the manufacturer informed the NTSB that the ECU A and ECU B event loggers were not corrupt. Also observed in the parametric and event logger data was a 6-minute lapse in recorded data towards the end of the recording. The manufacturer informed the NTSB that it is possible that the engine was off or there was a data logging error. For the EECU to record, the engine must be on. The manufacturer informed the NTSB that the data logging feature is not certified and therefore is subject to recording issues.

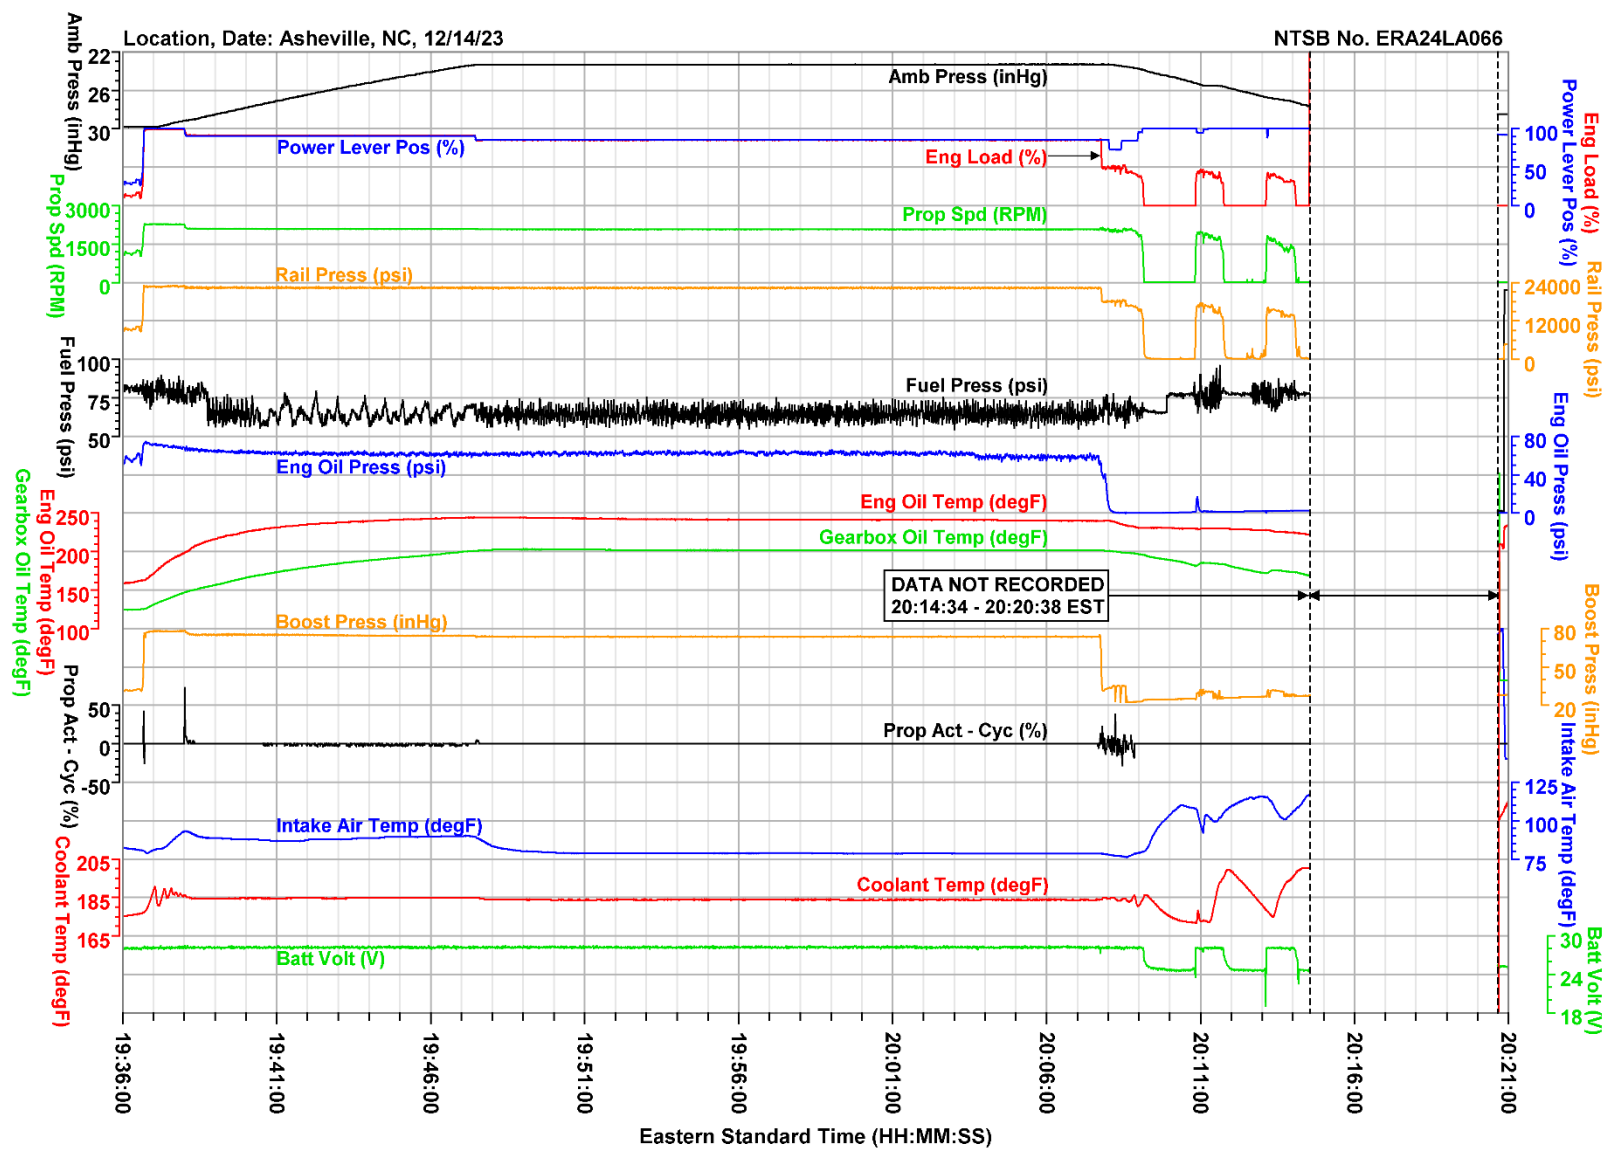
Figures 3 and 4 are time history plots that present the same parameters from the ECU B channel. Figure 3 presents data from the entire flight, which encompasses the 6-minute window where data was not recorded. Figure 4 presents a time history plot of data prior to the 6-minute loss in data recording.

- **20:14:33 EST:** The last recorded ECU B data point before a 6 minute and 5 second stop in data recording.
- **20:20:39 EST:** Data recording resumed. The ECU B event logger recorded the following: "Indicator: set if ECU is active." The ambient pressure at this time was 28.50 inHg and remained constant through the remainder of the recording.

**Figure 3.** Time history plot of the entire accident flight.

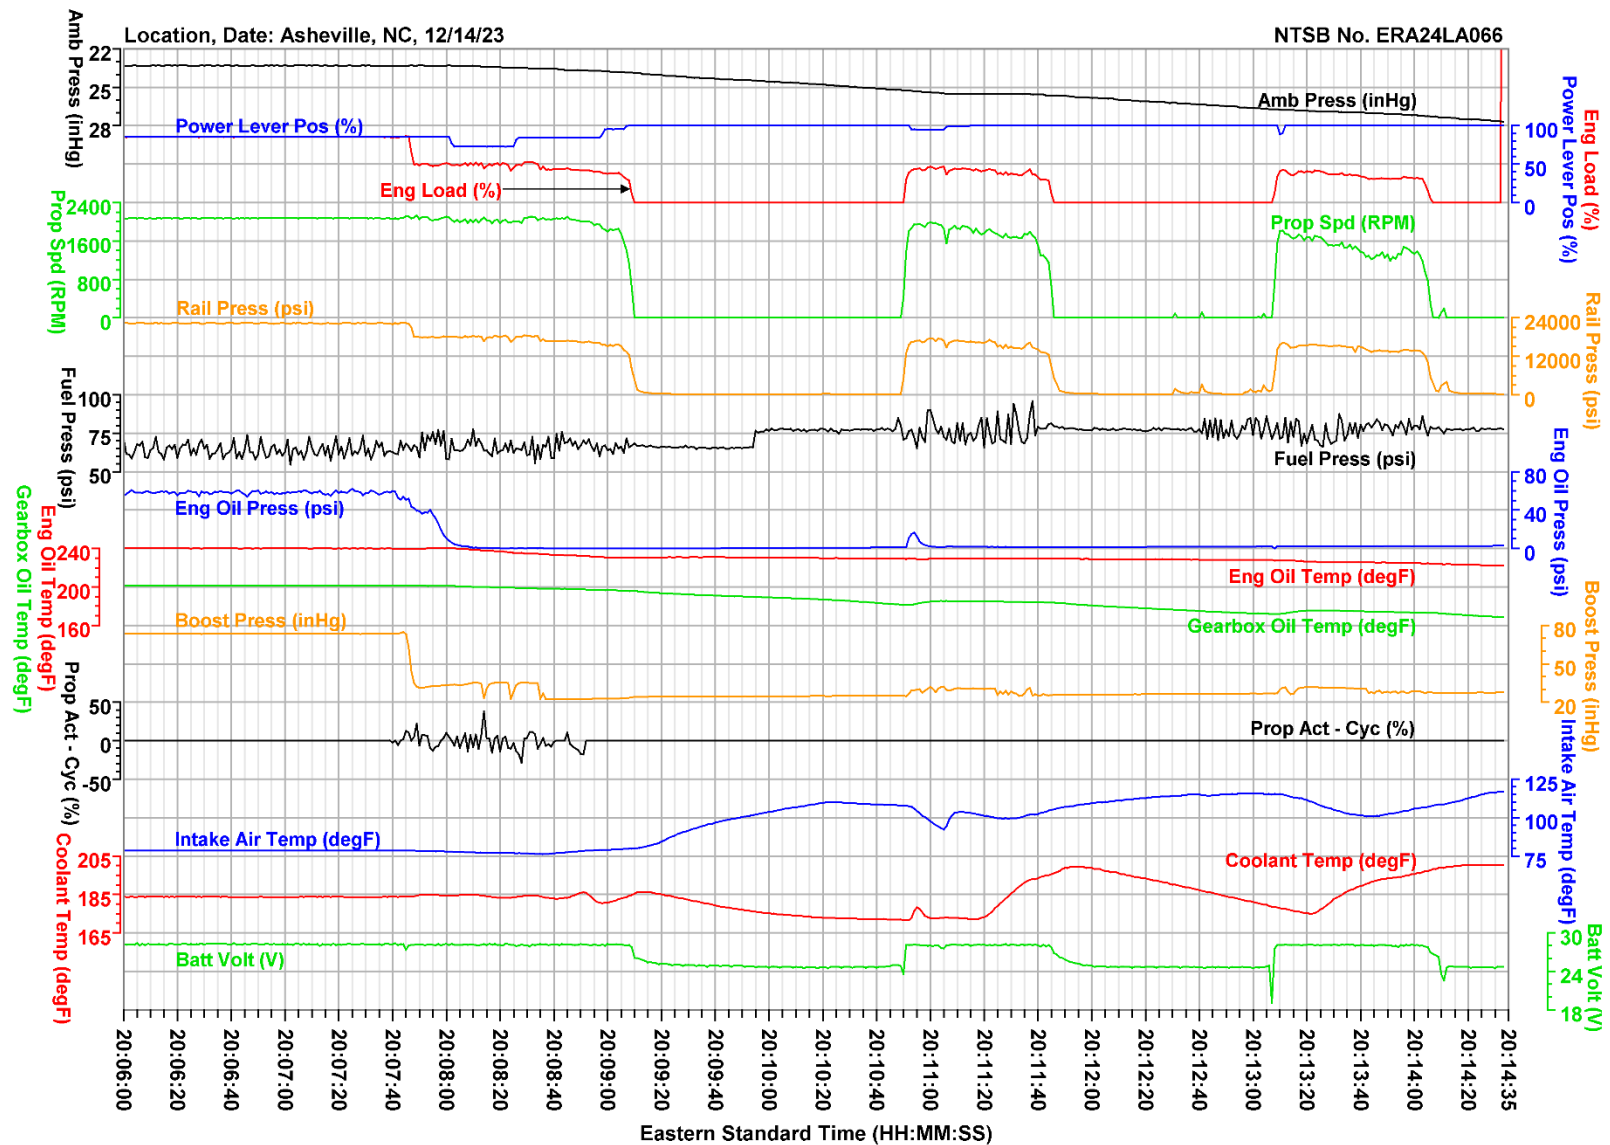
- **19:47:30 EST - 20:07:19 EST:** The aircraft flew uneventfully at an altitude with an ambient pressure of approximately 23.27 inHg.
- **19:07:20 EST:** The ECU A event logger recorded the following log: "Boost pressure governor failure (MAX: Positive governor deviation limit exceeded)." The power lever position, propeller speed, engine load, oil pressure, and boost pressure were 85.46%, 2072 RPM, 85.10%, 57.84 psi, and 73.35 inHg, respectively.

- **19:07:21 EST:** The ECU A event logger recorded the following: "Engine oil pressure failure (MIN: Engine oil pressure too low)."

- **20:08:09 EST:** Oil pressure was 1.00 psi.
- **20:09:10 EST:** The power lever position, propeller speed, engine load, oil pressure, and boost pressure were 99.99%, 0 RPM, 0.00%, 0.00 psi, and 24.10 inHg, respectively. The ambient pressure was 23.89 inHg.

**Figure 4.** Time history plot of the time leading up to the 6-minute loss in data.
