# Bundesstelle für Flugunfalluntersuchung

BFU23-1167

**Subject: Diamond DA-40 NG Aircraft Accident in Asheville, NC, Dec 14 2023 – Request for Readout of Engine Data from damaged Austro Engine Electronic Engine Control Unit (EECU)**

## Laboratory Report

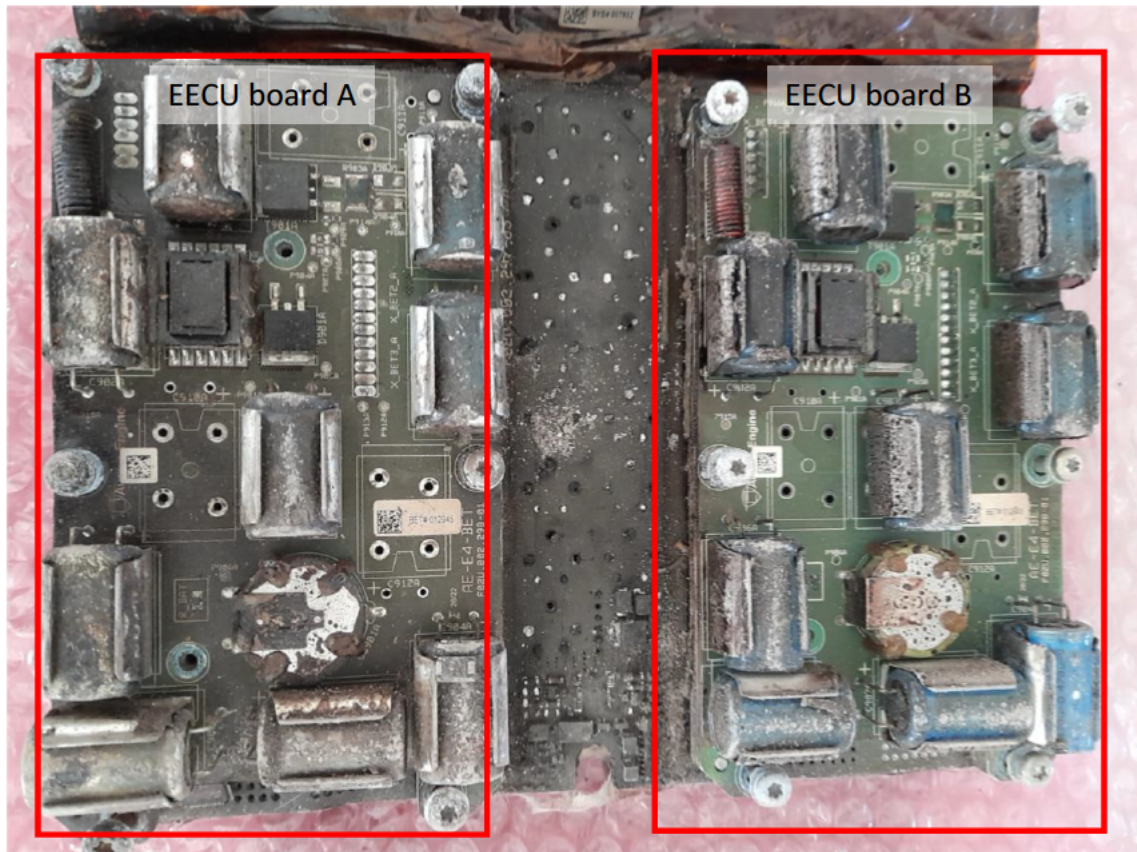
Figure 1: External Inspection – Top View

| Condition | <p>The EECU printed circuit boards (PCB) were severely damaged at arrival in the BFU lab. Only the PCB's (without housing) was provided to the BFU. The PCB showed heavy thermal damage resulting in loose and burned electronic components on the PCB. The PCB itself was bent, burned and with partially delaminated layers.</p> |

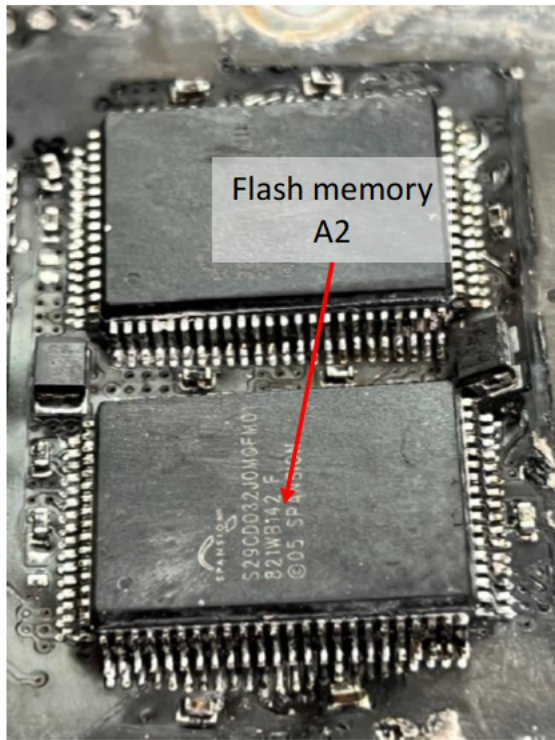
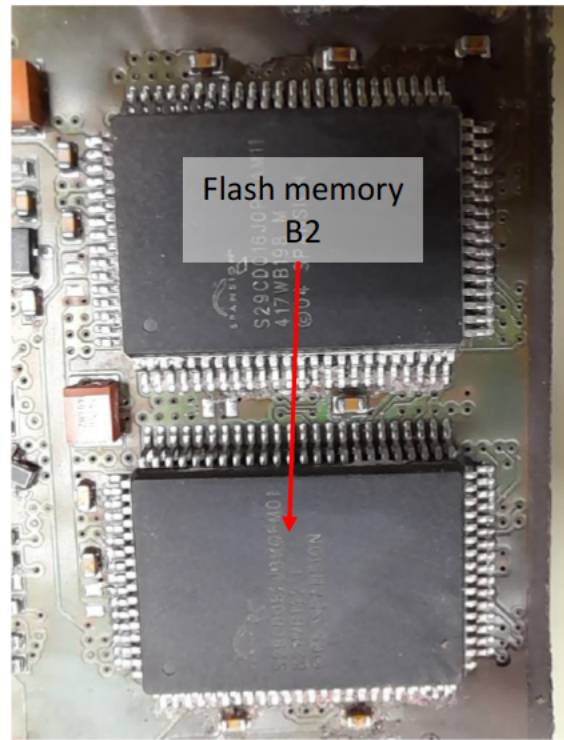
Figure 3: Detailed view flash memory A2 and B2

The EECU was heavily damaged by heat (mainly). Several small components were already completely desoldered from the PCB. Flash memory A2 had signs of blisters and was partially lifted from the PCB. Flash memory B2 was still completely soldered to the PCB. The PCB around the flash memory B2 was less damaged by the heat than at flash memory A2's position.

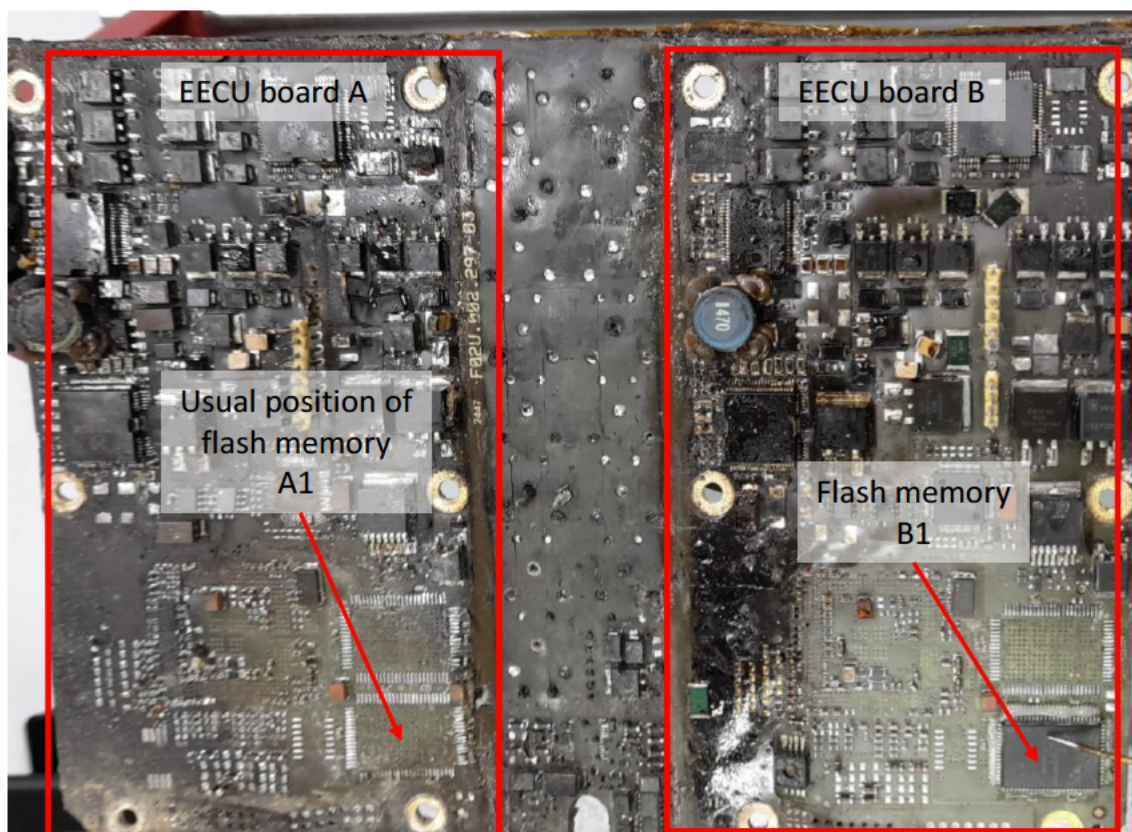
Figure 4: Main PCB after removal of the upper capacitor PCB's

The flash memory A1 was discovered desoldered and loose on the main PCB. Flash memory B1 was still soldered to the PCB with all connections intact. The flash memories A2, B1 and B2 were desoldered from the main PCB using hot air and flux.

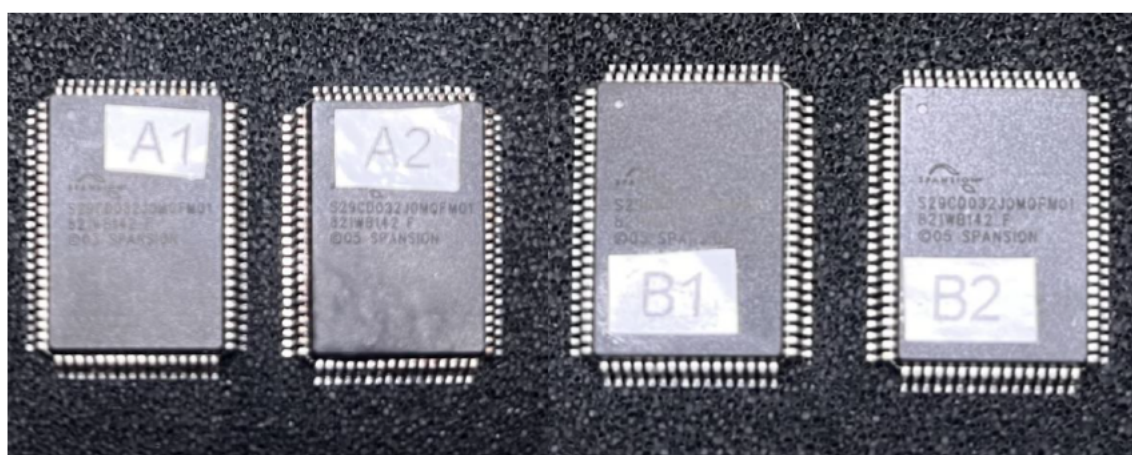
Figure 5: Flash memories after desoldering and cleaning

No damage was detected on flash memory A1, B1 and B2. On flash memory A2 several blisters on the upper surface and a crack on the lower surface were detected. Microscopic images of those findings are included in the appendix 2 to this report.

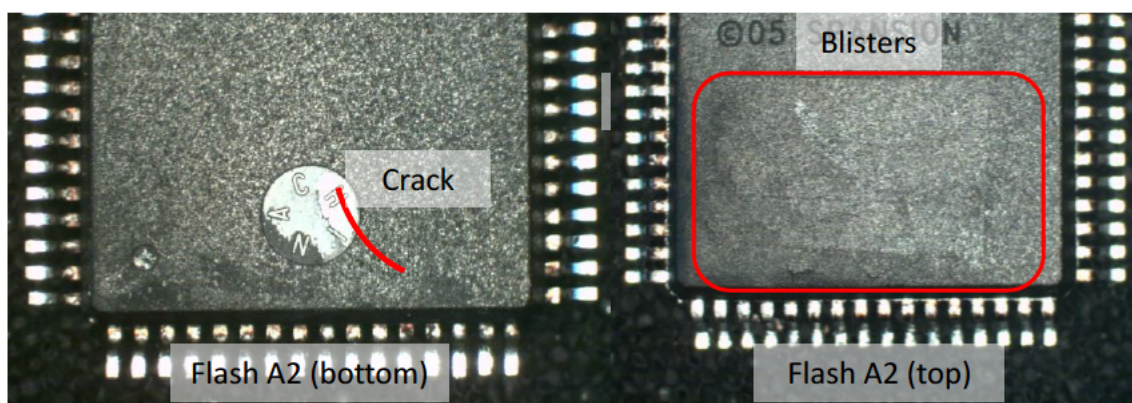
Figure 6: Microscopic findings on flash memory A2

The internal verification check for the data from memory A2 was not successful, even though retrieval of data was possible. Nevertheless, the retrieved and partially corrupt data was further analysed. More detailed analyses showed, that several parts of the data did not correspond to the expected and usual binary pattern for the EECU data storage.
