ERA24LA070

## INVESTIGATION PHOTOGRAPHS

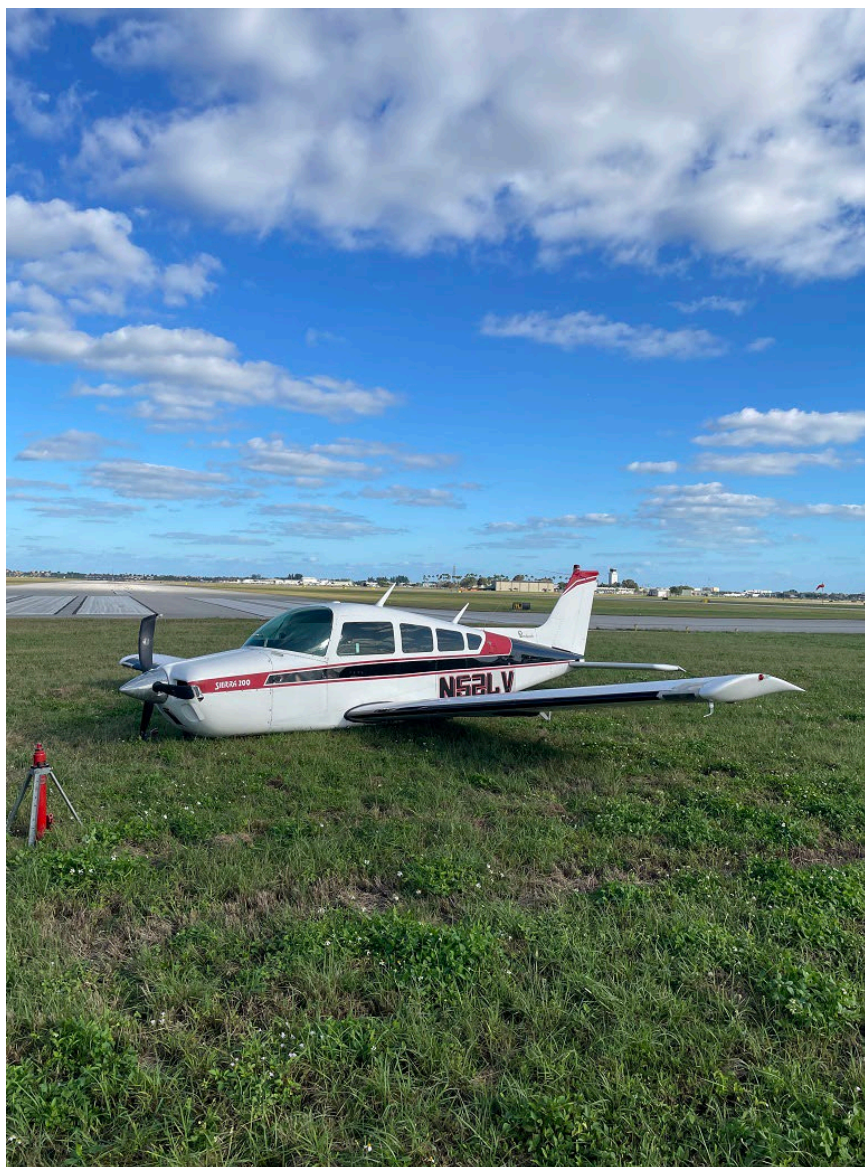
**Photograph 1 - Main Wreckage (Courtesy of FAA)**

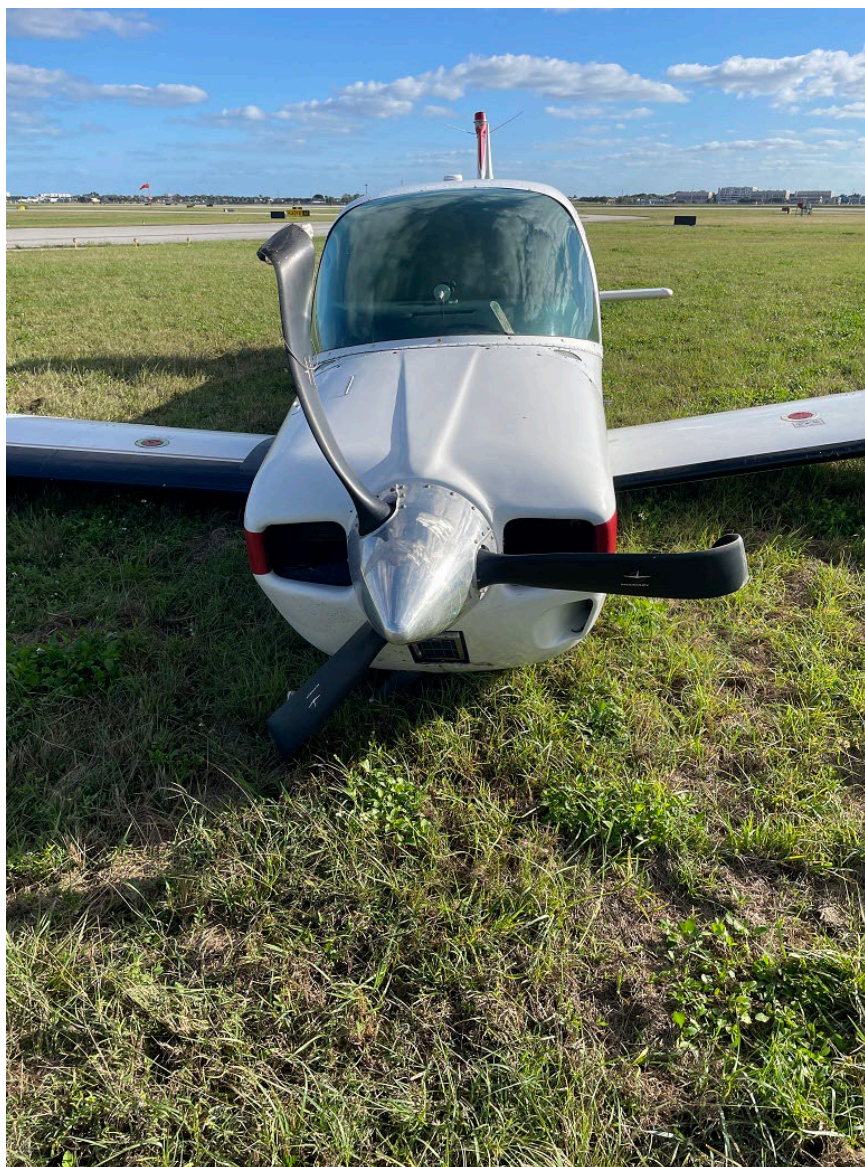
**Photograph 2 - Propeller (Courtesy of FAA)**

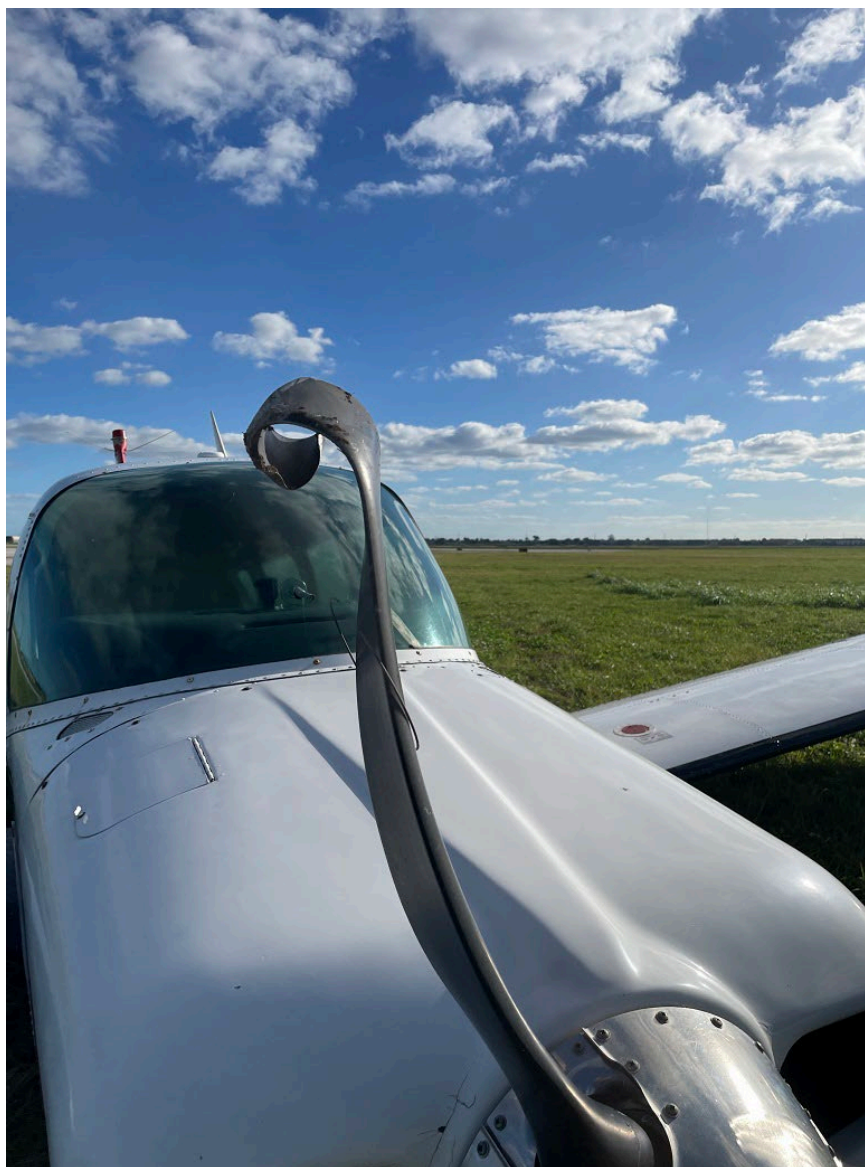
**Photograph 3 - Propeller Tip Curling (Courtesy of FAA)**

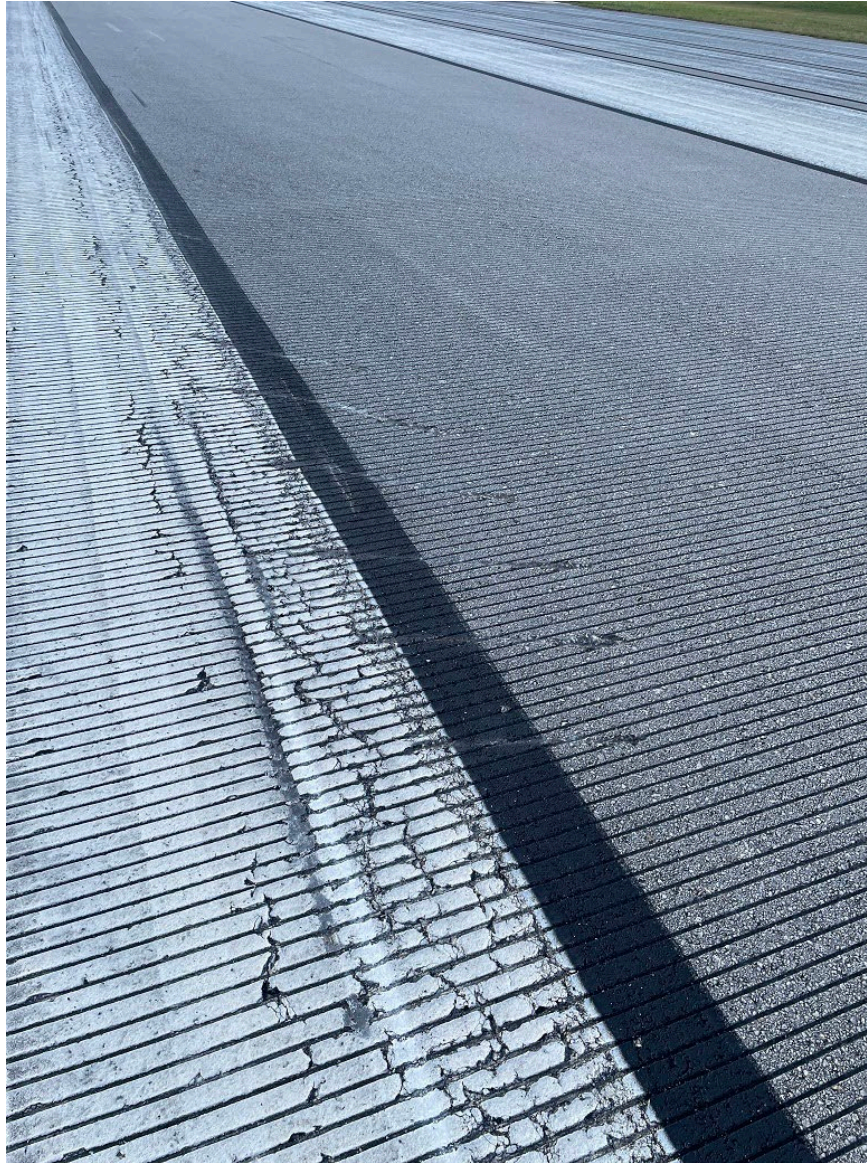
**Photograph 4 - Propeller Gouge Marks in Runway (Courtesy of FAA)**

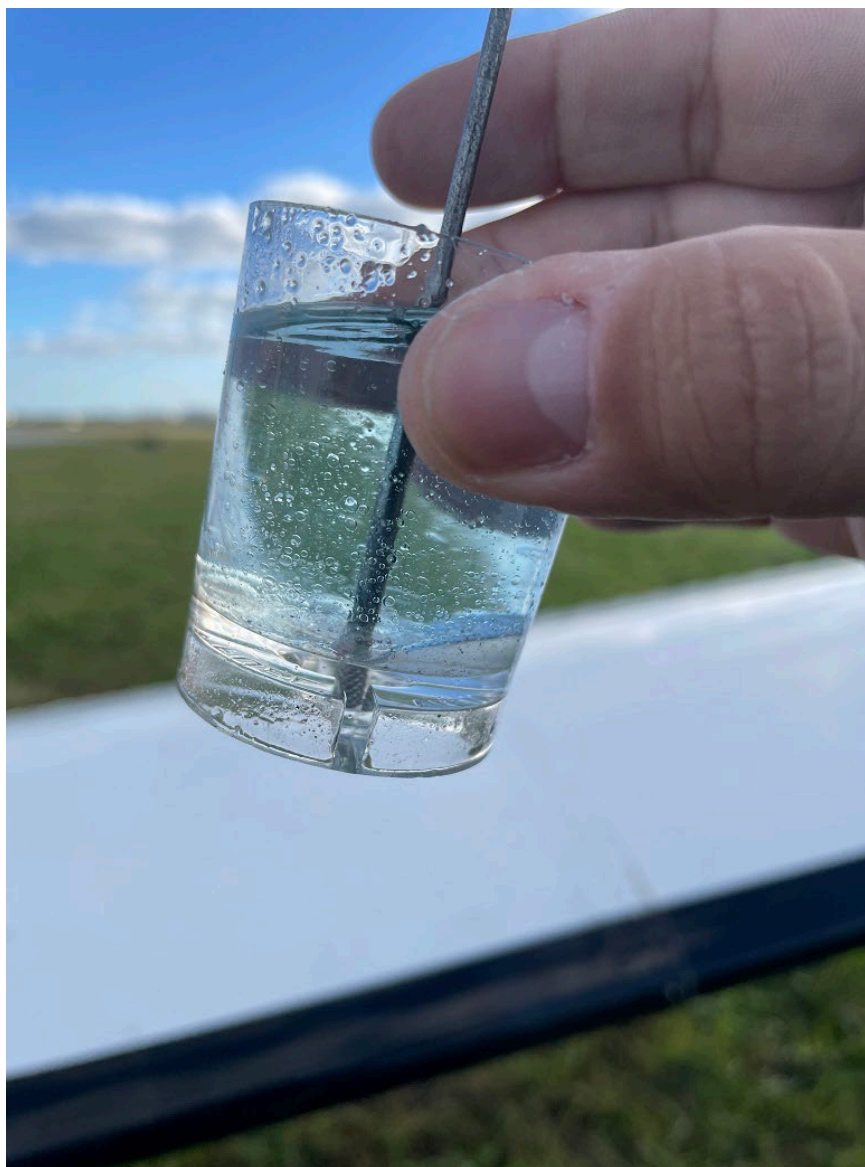
**Photograph 5 - Fuel Sample (Courtesy of FAA)**

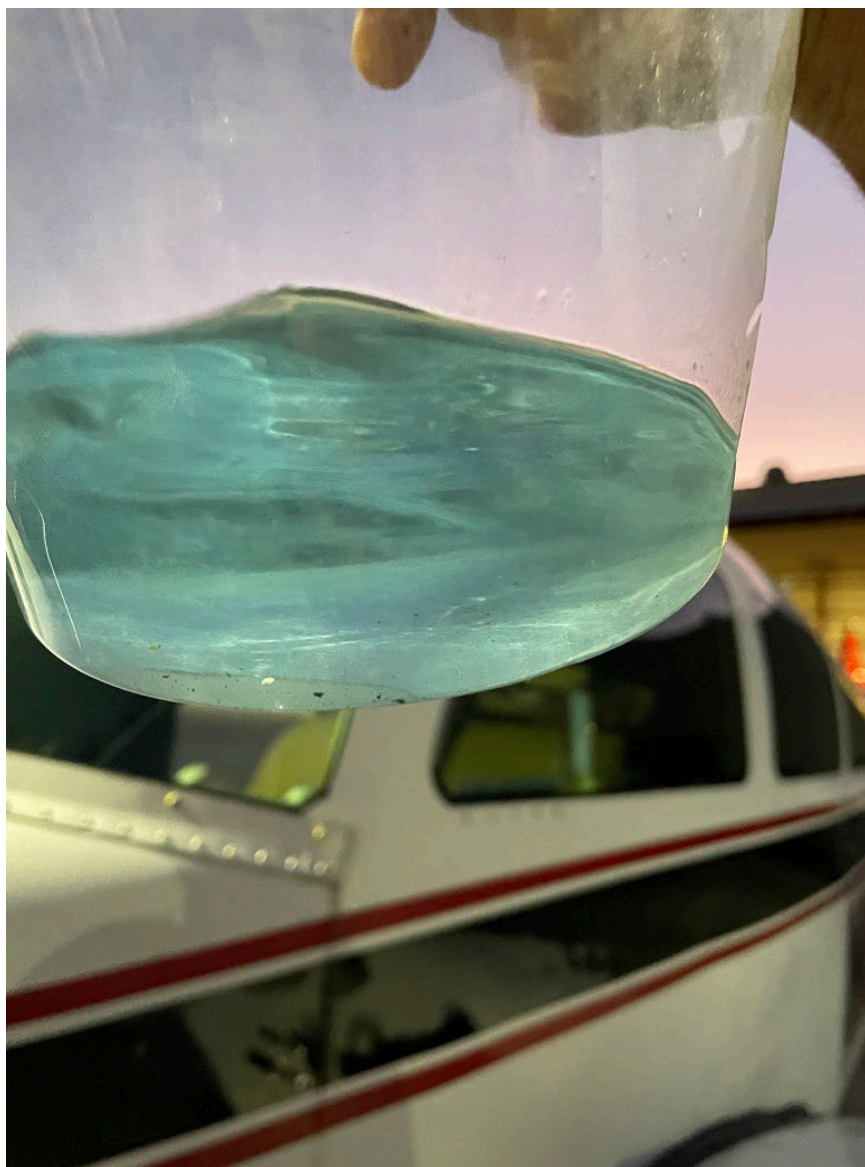
**Photograph 6 - Second Fuel Sample (Courtesy of FAA)**
