# National Transportation Safety Board

ERA24LA076

## **POWERPLANT FACTUAL REPORT**

Location: Walland, Tennessee  
Date: December 28, 2023  
Time: 1340 eastern standard time  
Helicopter: Bell B206L-1, Registration Number N571CJ

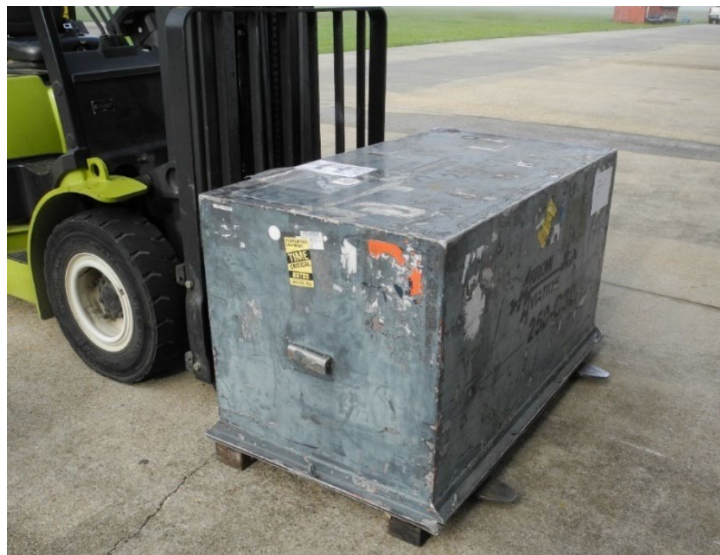
**Photo 1** - Rolls-Royce M250-C28B S/N CAE-860608 - As Received

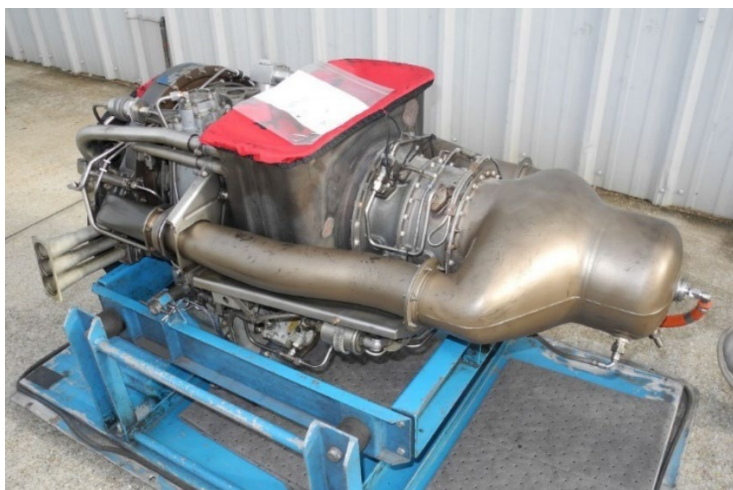
The engine was in a metal engine container which was opened in the presence of the NTSB ([Photo 1](#)). It was externally clean and intact ([Photo 2](#)). There was no evidence of an un-containment, external impact or fire.

**Photo 2** - Externally Clean and Intact

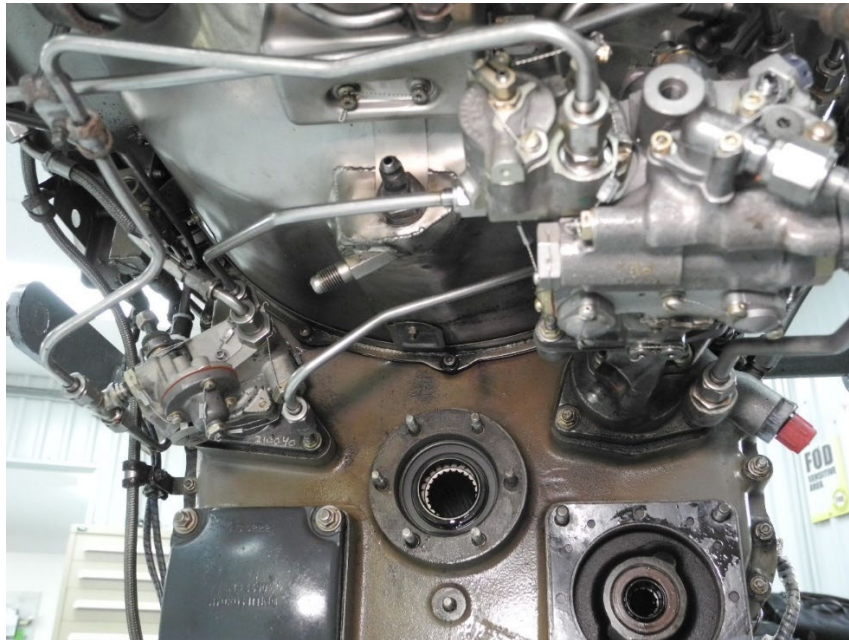
The accessory gearbox (AGB) power takeoff (PTO) inner spline and starter/generator inner spline were intact and undamaged ([Photo 3](#)). The fuel pump/fuel control unit (FCU) and power turbine governor (PTG) were intact and undamaged ([Photo 3](#)). The AGB did not contain any oil; however, it was reported that 16 ounces of oil was drained from the AGB in the field, which is a normal oil quantity in the cavity. It was reported during the field exam that there was a coating of black paste and metallic debris found on the upper chip detector. The lower chip detector was clean of magnetic debris

**Photo 3** - Accessory Gearbox Splines, FCU and PTG - Undamaged

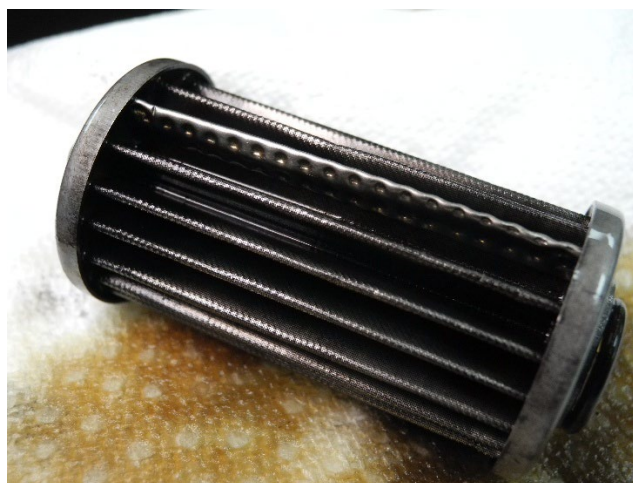
The engine oil filter ([Photo 4](#)) was removed and found to be clean and oil wetted.

**Photo 4** - Engine Oil Filter - Clean

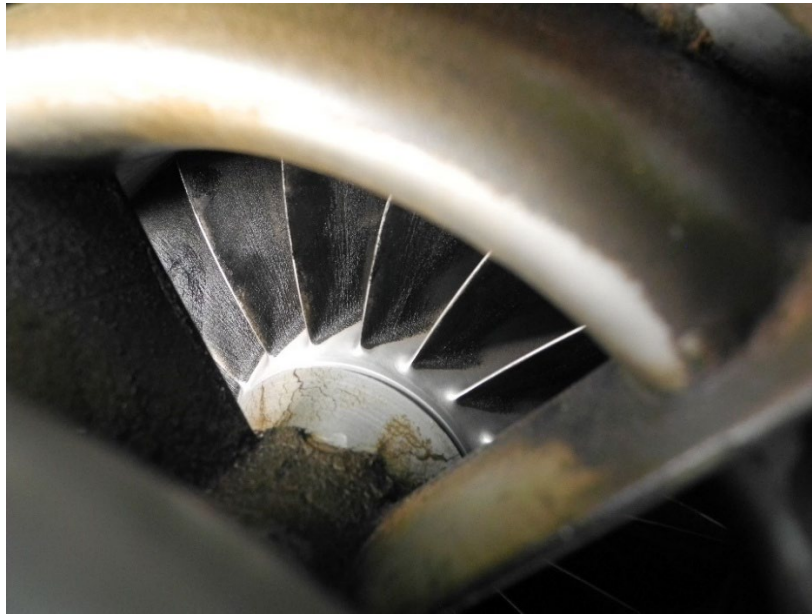
The leading edges of the impeller vanes ([Photo 5](#)) were intact and undamaged; however, they were coated with a black oily substance.

**Photo 5** - Impeller Vanes Leading Edges - Undamaged

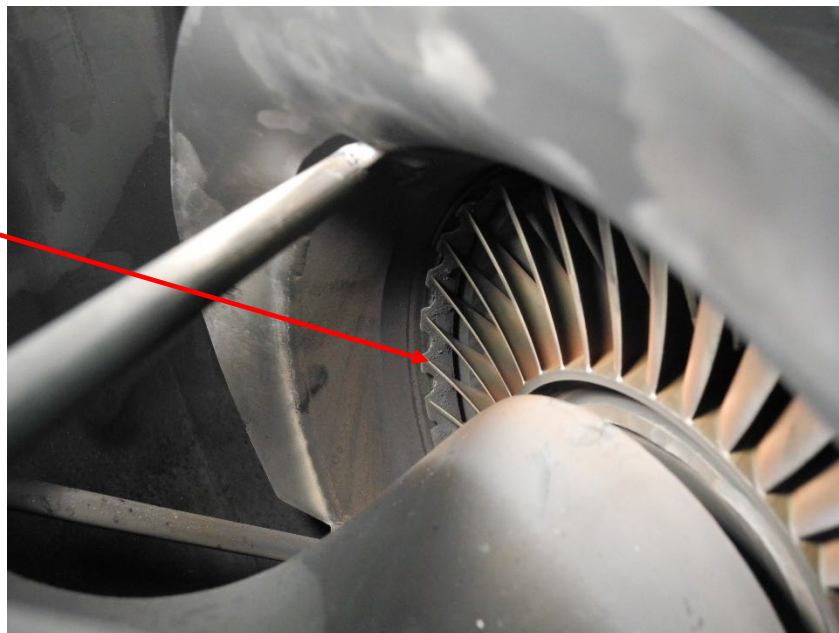
**Photo 6** - 4<sup>th</sup> Stage Turbine Wheel

The exhaust collector was intact; however, the inner surfaces were sooty. All the blades of the 4<sup>th</sup> stage turbine wheel (2<sup>nd</sup> stage power turbine) were intact; however, most of the blade shrouds were rotationally abraded away, consistent with contact against 4<sup>th</sup> stage wheel tracks ([Photo 6](#)).

Shrouds  
Abraded

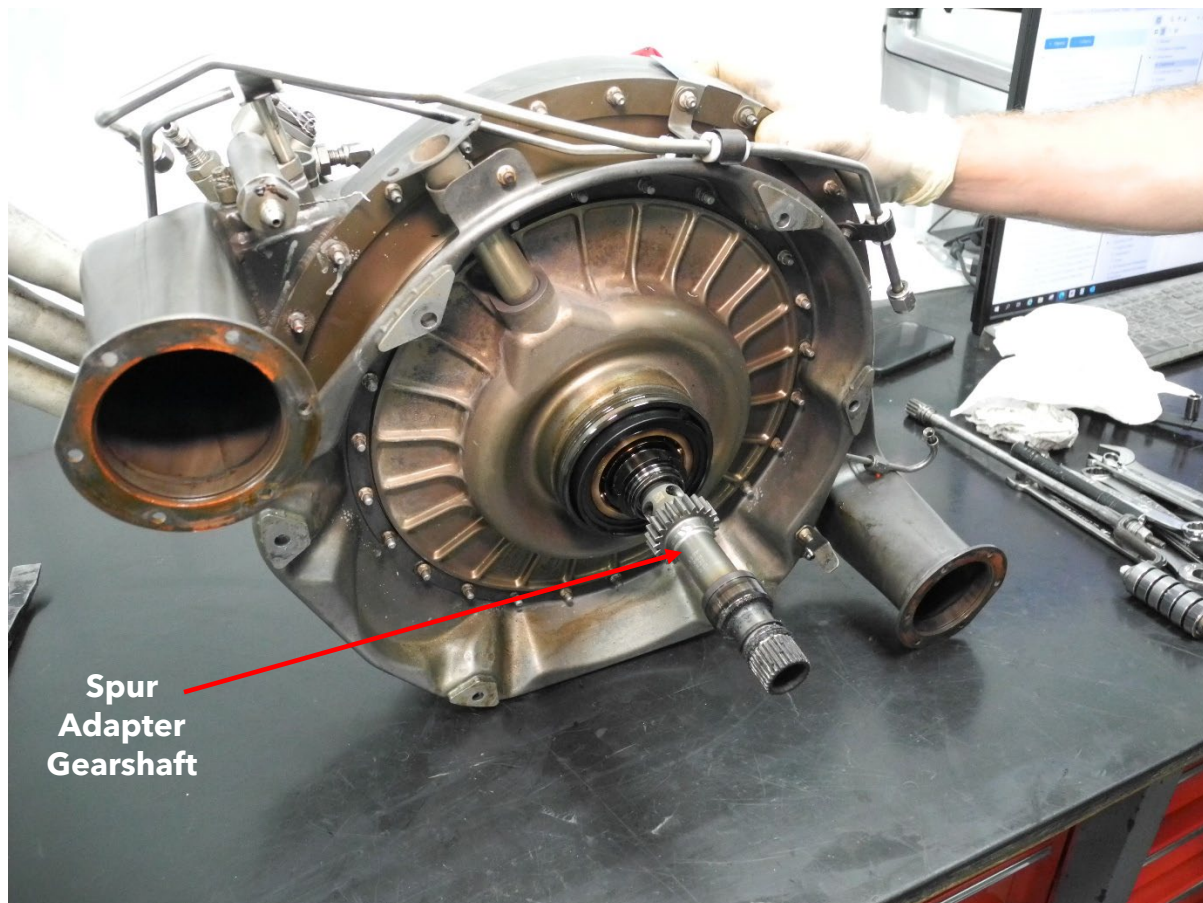
The compressor module ([Photo 7](#)) was intact and undamaged and the compressor impeller turned freely and smoothly, consistent with the No.1 and No.2 bearings being undamaged. It was not disassembled further.

**Photo 7** - Compressor Module - Undamaged

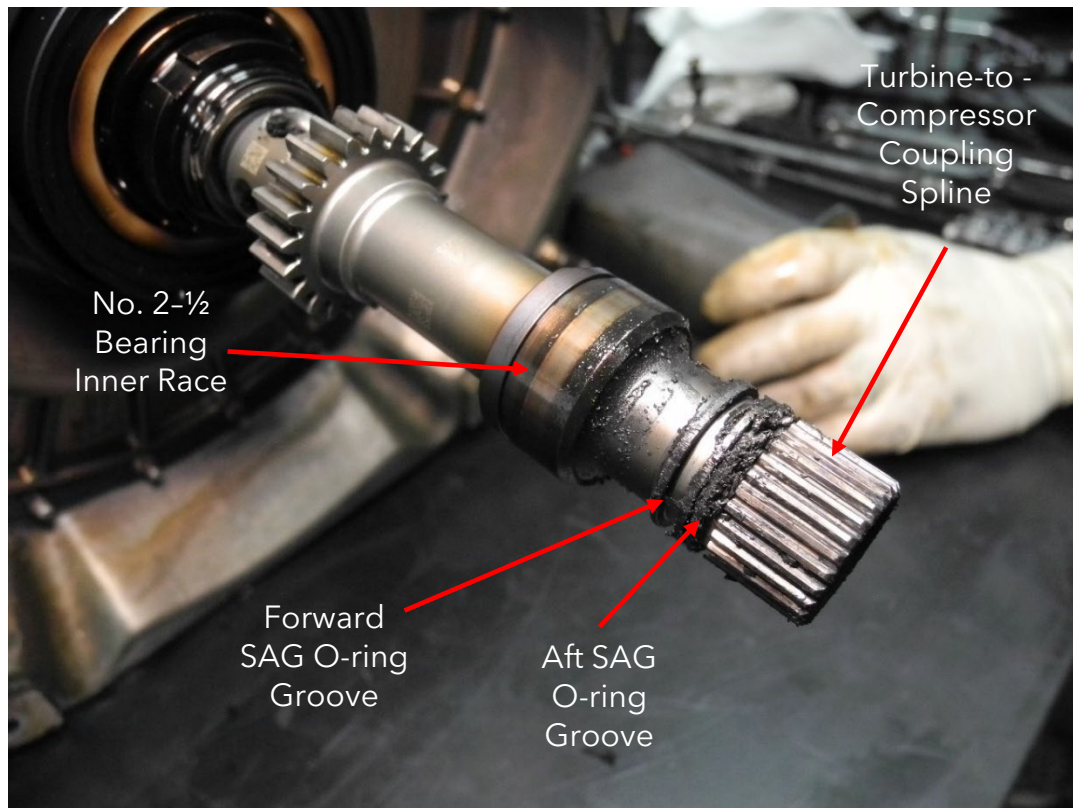
**Photo 8** - Spur Adapter Gearshaft

The spur adapter gearshaft (SAG) (Ref. [Photo 7](#) & [Photo 8](#)) was intact and undamaged. The No. 2-½ bearing inner race section of the SAG was intact and displayed minor wear, consistent with normal operation. The turbine-to-compressor coupling spline was intact. The aft SAG O-ring was present; however, it had disintegrated into coarse black paste. There was no evidence of an O-ring in the forward SAG O-ring groove. The RR Operation and Maintenance Manual 72-30-00

states that O-rings must be installed on both O-ring grooves to prevent carbon build-up in the engine.

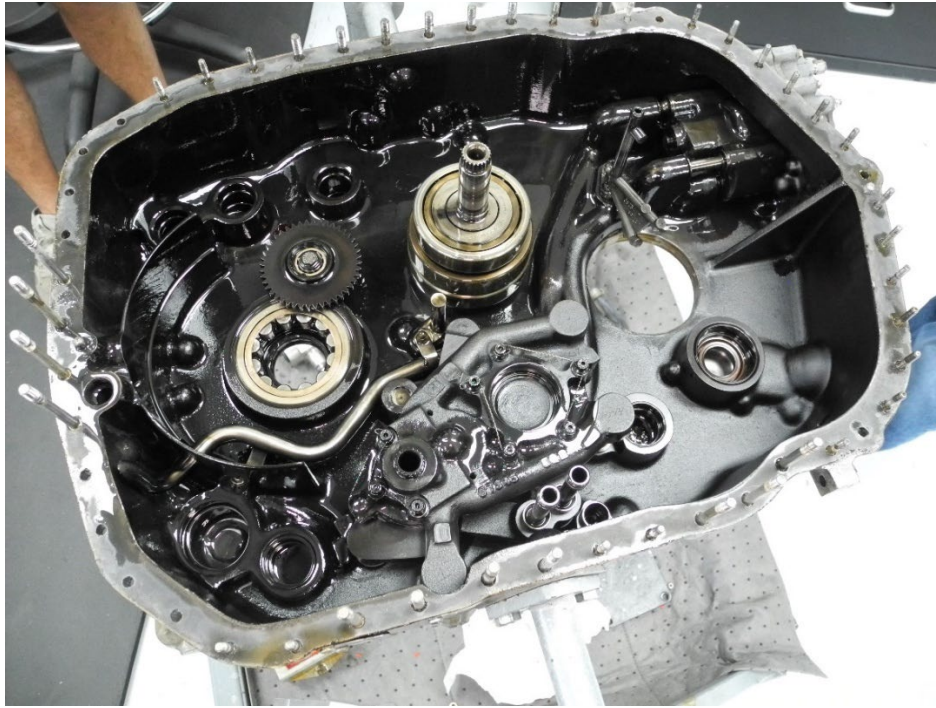
The AGB was disassembled, revealing undamaged, oil wetted internal components ([Photo 9](#) & [Photo 10](#)).

**Photo 9** - AGB Housing - Undamaged Internal Components

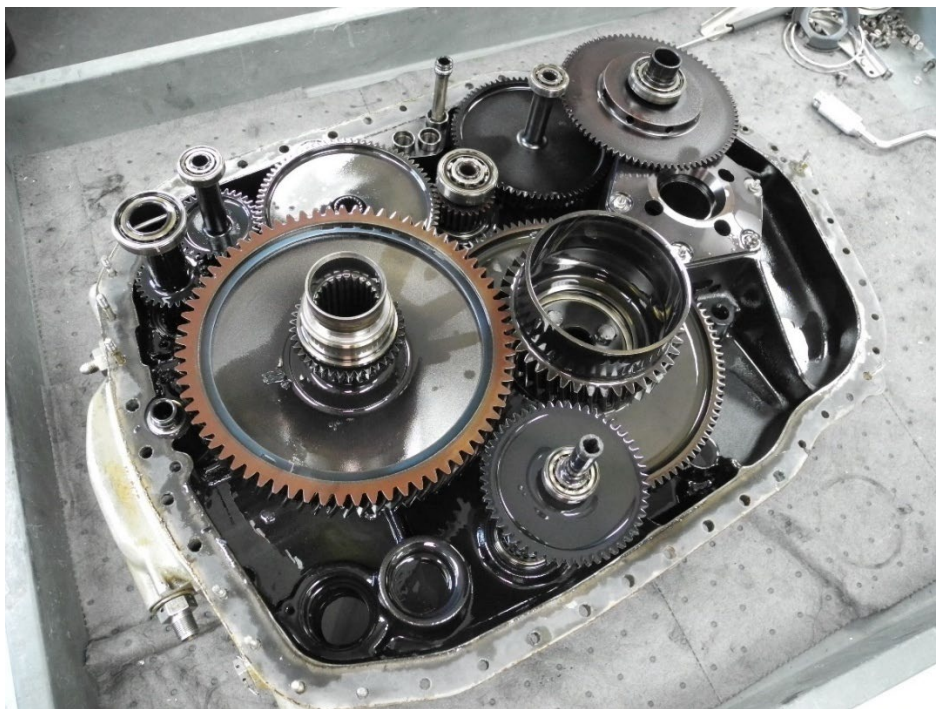
**Photo 10** - AGB Cover - Undamaged Internal Components

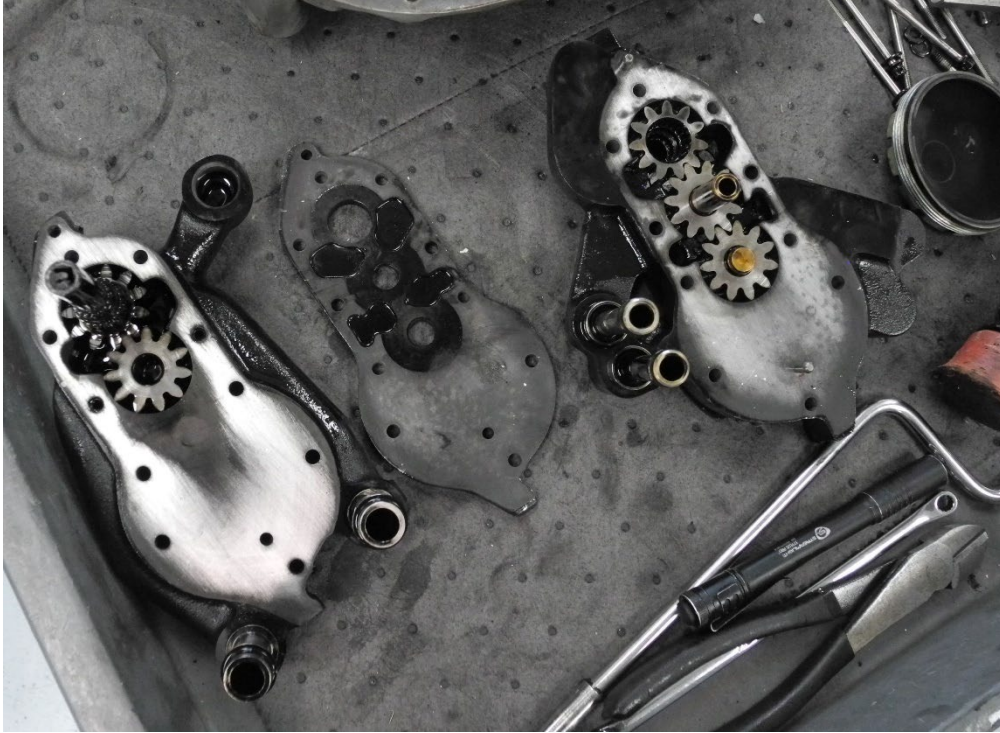
The oil scavenge and pressure pumps were disassembled, revealing undamaged, oil wetted components ([Photo 11](#)).

**Photo 11** - Oil Pumps - Undamaged

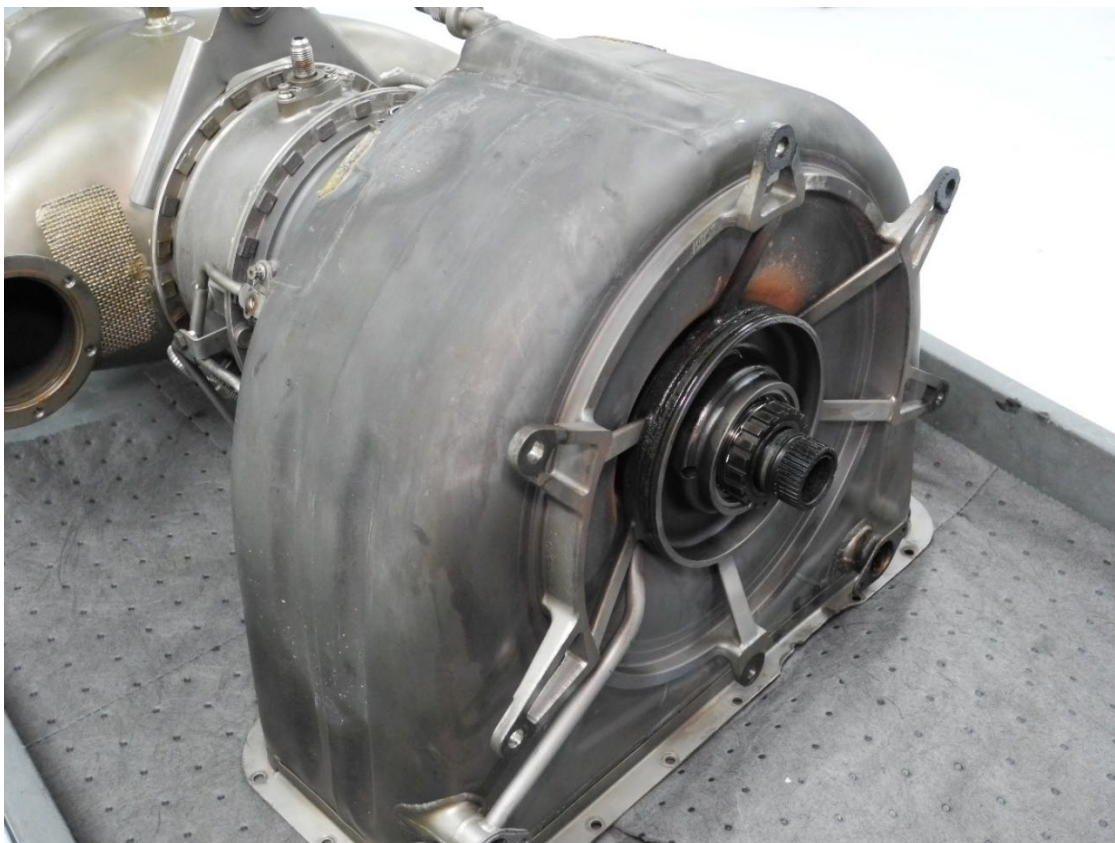
**Photo 12** - Exhaust Collector Support Housing - AGB Side

The exhaust collector support housing was intact and undamaged; however, when it was separated from the AGB module ([Photo 12](#)) the power turbine-to-pinion gear coupling and the power turbine-to-pinion gear couplings could not be removed ([Photo 13](#)). The shafts could still be turned; however, they were restricted from being axially removed.

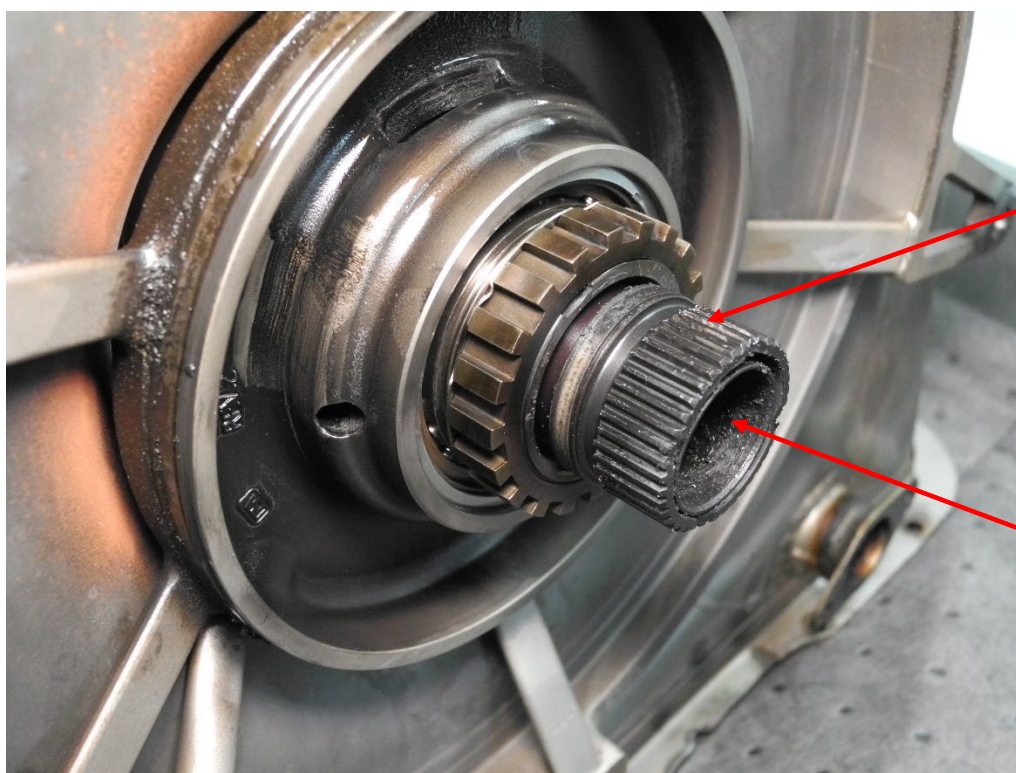
**Photo 13** - Exhaust Collector Support Housing - Shaft Details

Power  
Turbine-to  
Pinion Gear  
Coupling -  
Seized

Turbine-to-  
Compressor  
Coupling -  
Seized

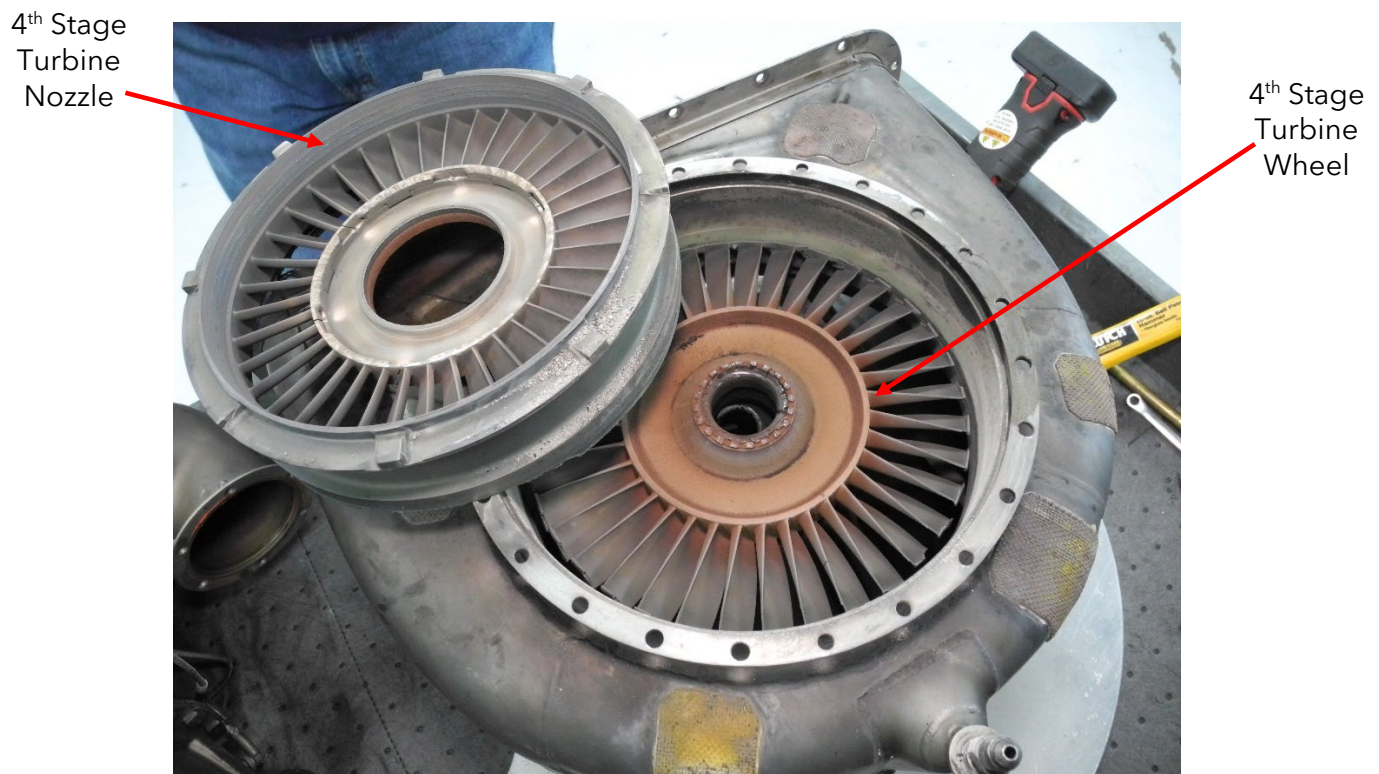
**Photo 14** – 4<sup>th</sup> Stage Nozzle and Turbine in Exhaust Collector Support Housing

When the exhaust collector support housing was separated from the turbine module, the 4<sup>th</sup> stage turbine wheel could not be withdrawn ([Photo 14](#)) because the power turbine inner shaft was fractured and deformed ([Photo 15](#)) in an outward, petalled manner, locking the 4<sup>th</sup> stage turbine wheel in position. Additionally, a segment of the fractured and deformed turbine-to-compressor coupling was observed in the hollow power turbine inner shaft, and it could not be removed.

The 4<sup>th</sup> stage turbine wheel was intact; however, the curvic coupling mating it with the 3<sup>rd</sup> stage turbine wheel was rotationally smeared. Additionally, most of the blade shrouds were rotationally abraded away, consistent with contact against 4<sup>th</sup> stage wheel tracks (Ref. [Photo 5](#)). The shafts could still be rotated in the exhaust collector support housing; however, the No. 5 bearing was rough when rotated.

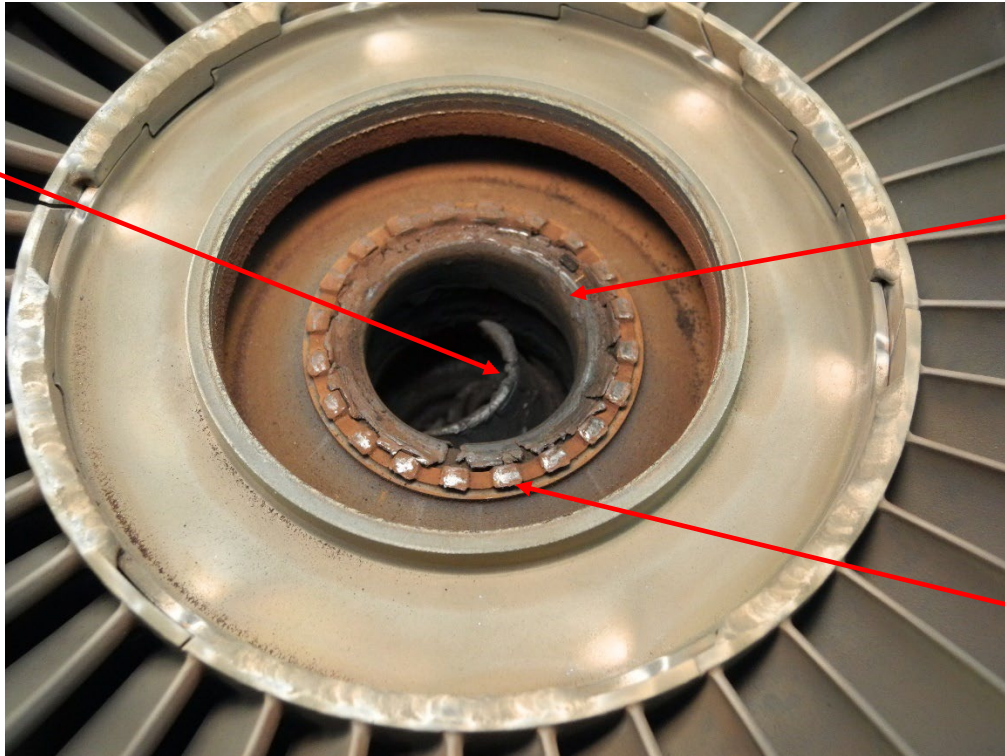
**Photo 15** - 4<sup>th</sup> Stage Turbine Wheel and Shaft Details

Turbine to  
Compressor  
Coupling -  
Fractured

Power  
Turbine  
Inner Shaft -  
Fractured  
and  
Deformed

4<sup>th</sup> Stage  
Wheel Curvic  
Coupling -  
Deformed

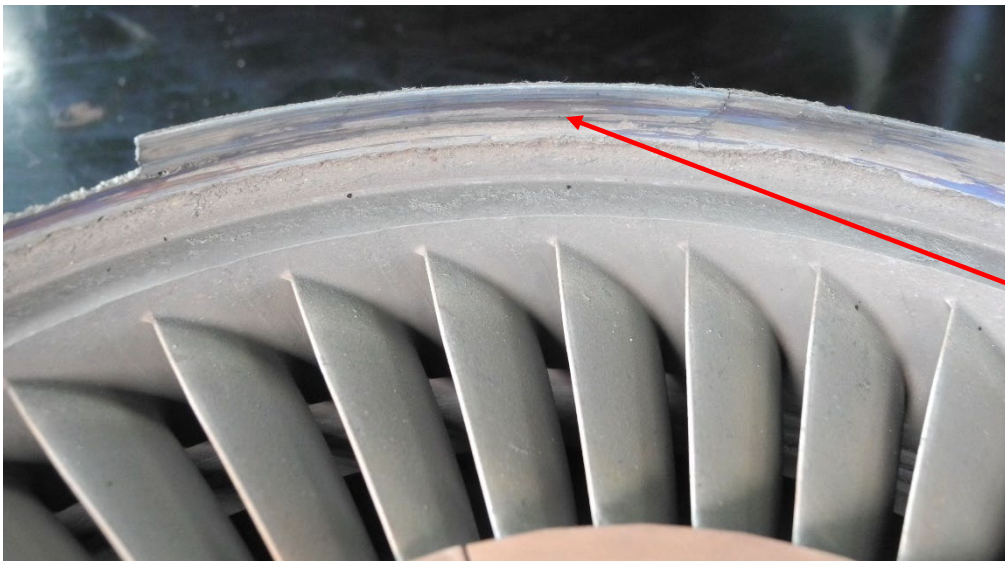
The 4<sup>th</sup> stage turbine nozzle was intact; however, it was rotationally scored on the 3<sup>rd</sup> and 4<sup>th</sup> stage turbine wheel tracks ([Photo 16](#)).

4<sup>th</sup> Stage  
Turbine  
Wheel Track -  
Rotationally  
Scored

**Photo 16** - 4<sup>th</sup> Stage Turbine Nozzle - 4<sup>th</sup> Stage Turbine Wheel Track Rotationally Scored

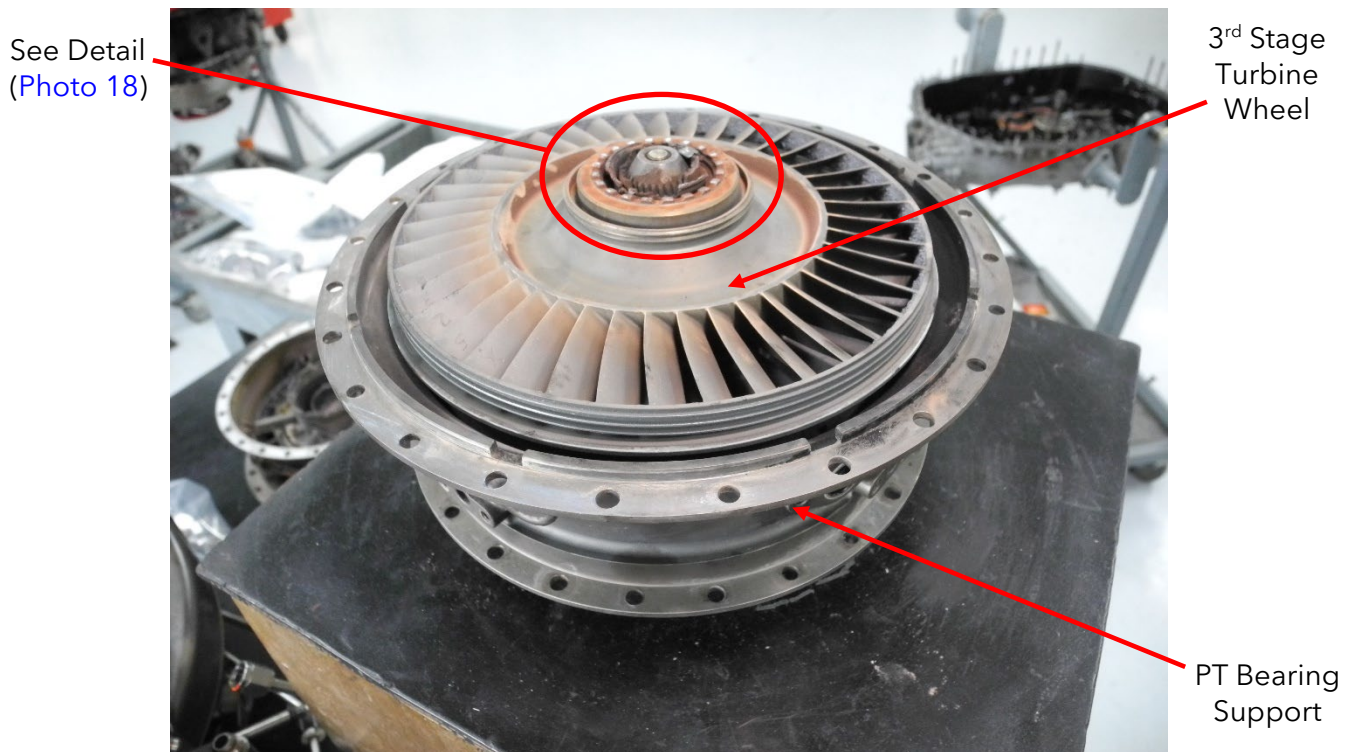
**Photo 17** - PT Bearing Support - Forward Side

The PT bearing support (Photo 17) was intact; however, the 3<sup>rd</sup> and 1<sup>st</sup> stage turbine wheels could not be withdrawn because the turbine-to-compressor coupling and the power turbine inner shaft were fractured and deformed in an outward, petalled manner, locking the 3<sup>rd</sup> stage turbine wheel in position (Photo 18). The 3<sup>rd</sup> stage turbine wheel was intact; however, the curvic coupling mating with the 4<sup>th</sup> stage turbine wheel was smeared in a rotational manner (Photo 18). All the blades of the 3<sup>rd</sup> stage turbine wheel were intact.

The 2<sup>nd</sup> stage nozzle and wheel and 3<sup>rd</sup> stage nozzle were confined within this assembly and could not be examined. The No. 6 and No. 7 bearings could not be examined; however, they still could be rotated with moderate hand effort.

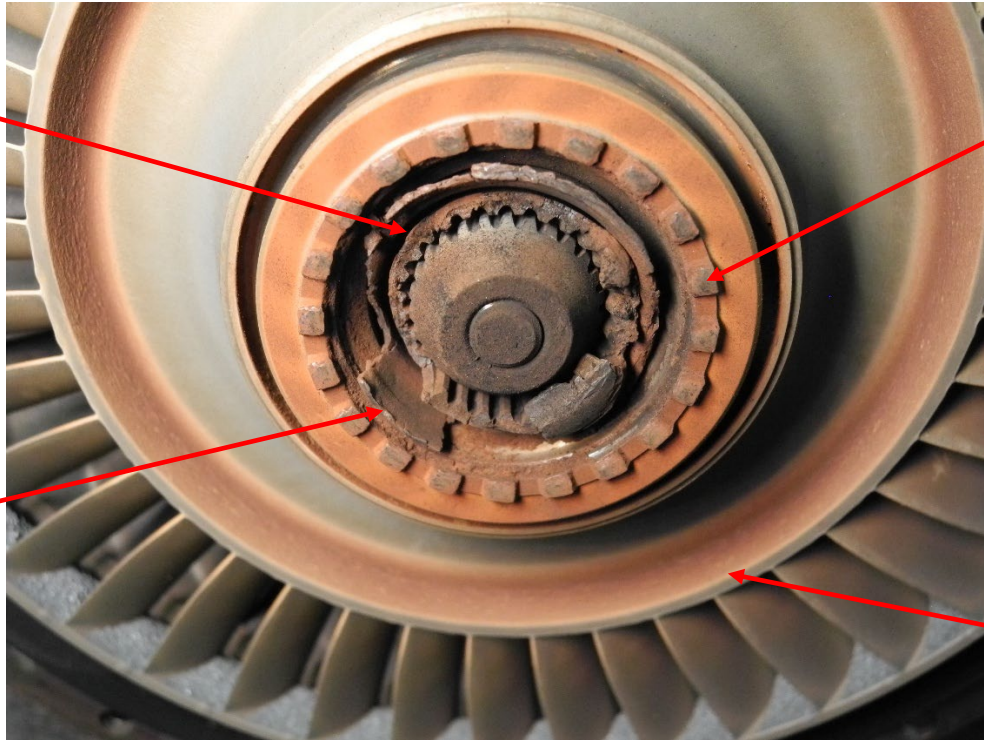
**Photo 18** - 3<sup>rd</sup> Stage Turbine Wheel - Details

Turbine to  
Compressor  
Coupling -  
Fractured

Curvic  
Coupling -  
Smeared

Power  
Turbine Inner  
Shaft -  
Fractured and  
Deformed

3<sup>rd</sup> Stage  
Turbine  
Wheel

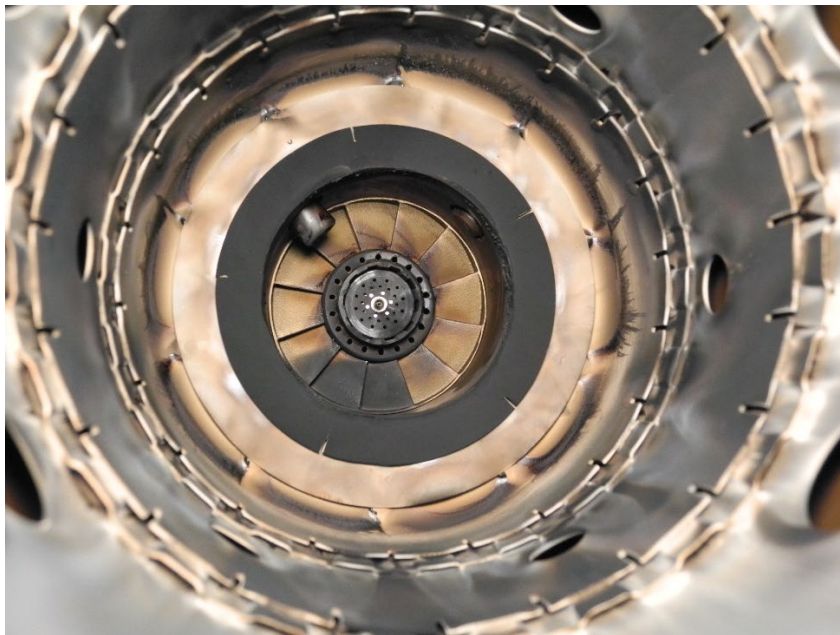
The combustor outer case and the combustor liner ([Photo 19](#)) were intact and undamaged. The fuel nozzle was intact, undamaged and clean.

**Photo 19** - Combustor Liner and Fuel Nozzle - Intact and Undamaged

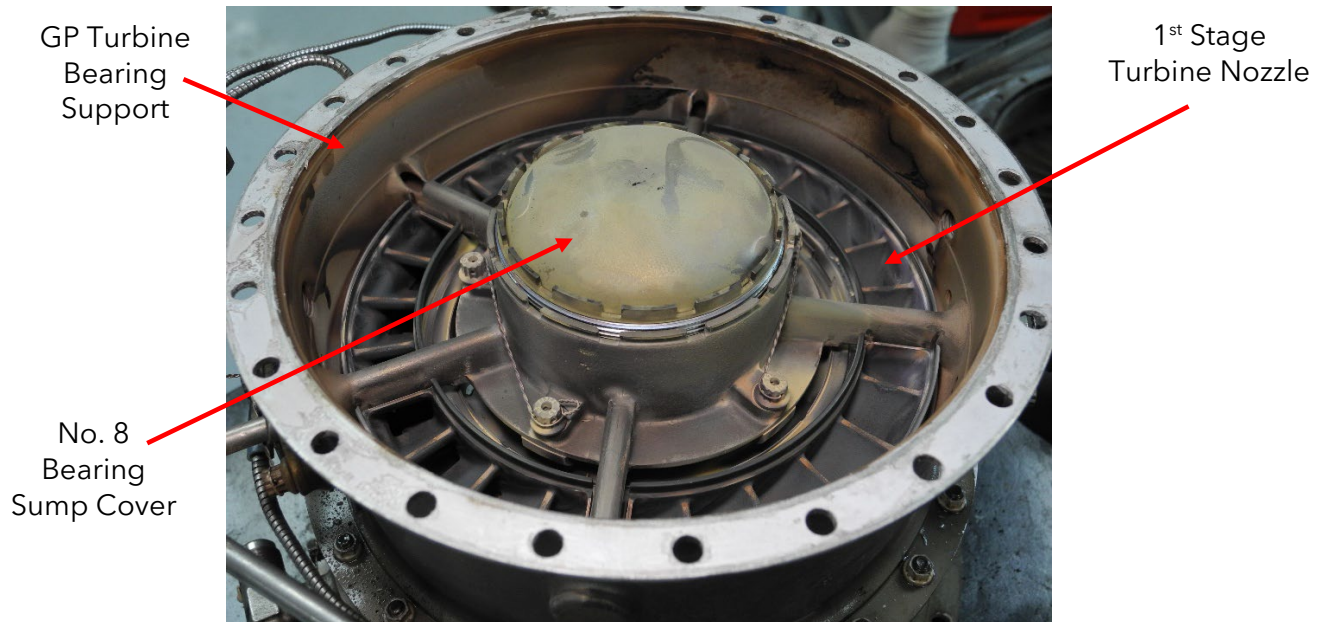
**Photo 20** - GP Turbine Bearing Support and No. 8 Bearing Cover

With the combustor removed, the GP turbine bearing support and the No. 8 bearing cavity could be examined ([Photo 20](#)). The No. 8 bearing cover was dry and coated with a layer of black sooty deposit.

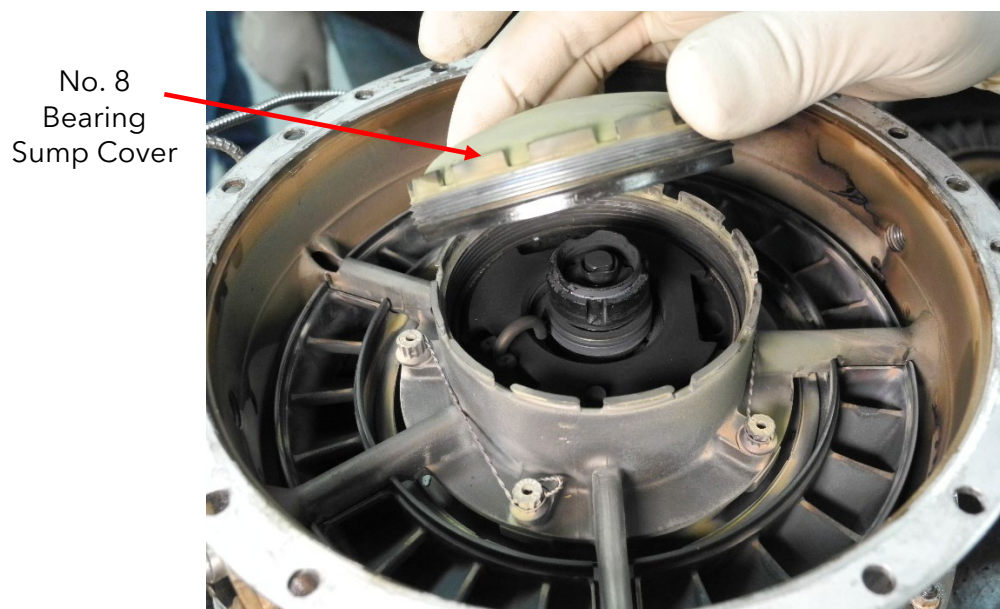
**Photo 21** - No 8 Bearing Sump Cavity

The No. 8 bearing sump cover was removed revealing a dry cavity coated with a black residue ([Photo 21](#)).

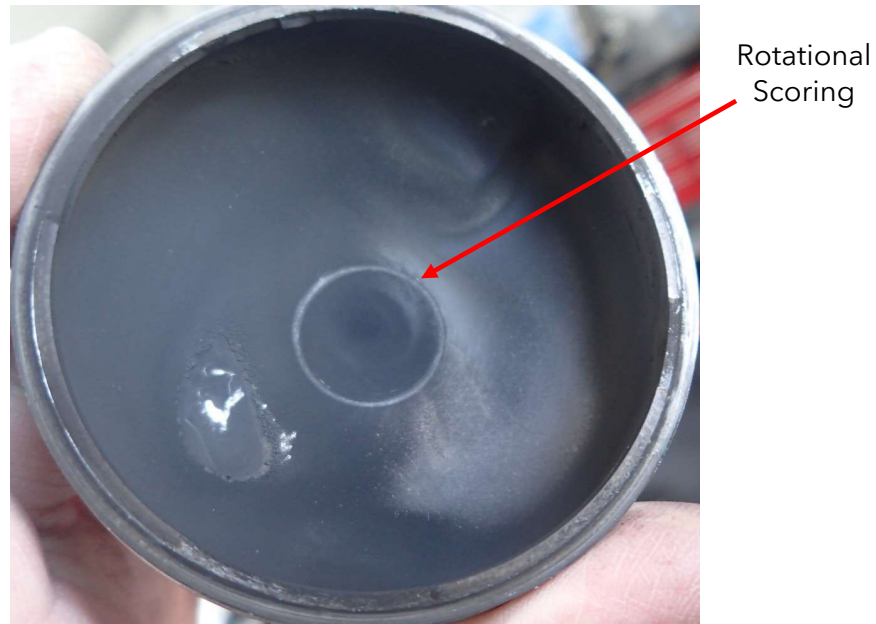
**Photo 22** - No 8 Bearing Sump Cover - Inside View

An examination of the No. 8 bearing sump cover revealed a rotational score on the inside, consistent with contact against the No. 8 bearing spanner nut ([Photo 22](#)).

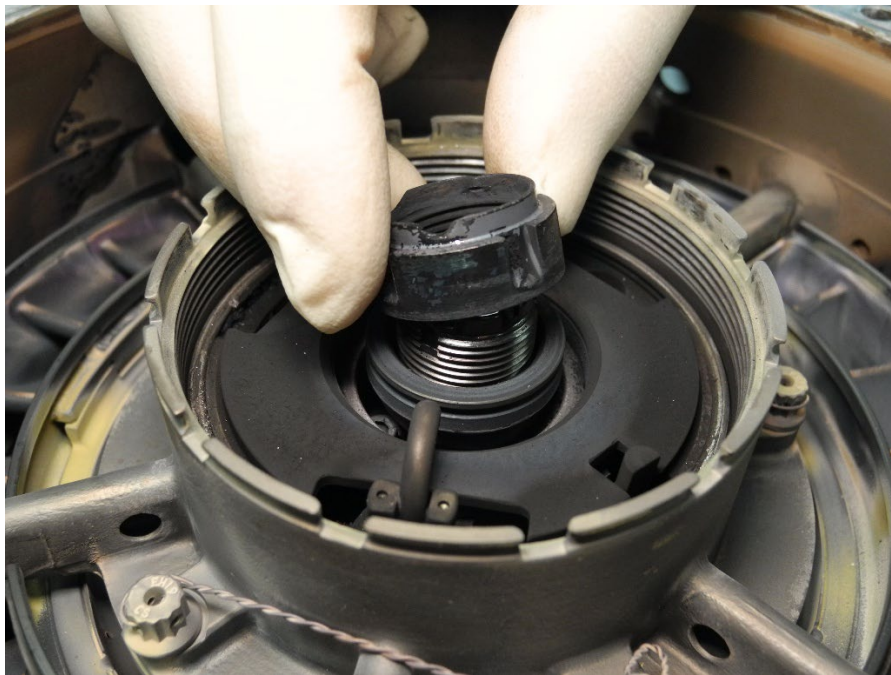
The engine disassembly and examination revealed an un-torqued and loose No. 8 spanner nut. The nut locking crimp exhibited a witness mark consistent with a pry mark on the inner diameter surface consistent with a nut that was staked at a previous locking position. Rotational scoring was observed on the inside of the sump cover consistent with contact with the No. 8 spanner nut during engine operation.

The No. 8 bearing spanner nut was un-torqued and had backed out until the last approximately one thread ([Photo 23](#)).

**Photo 23** - No. 8 Bearing Spanner Nut - Loose

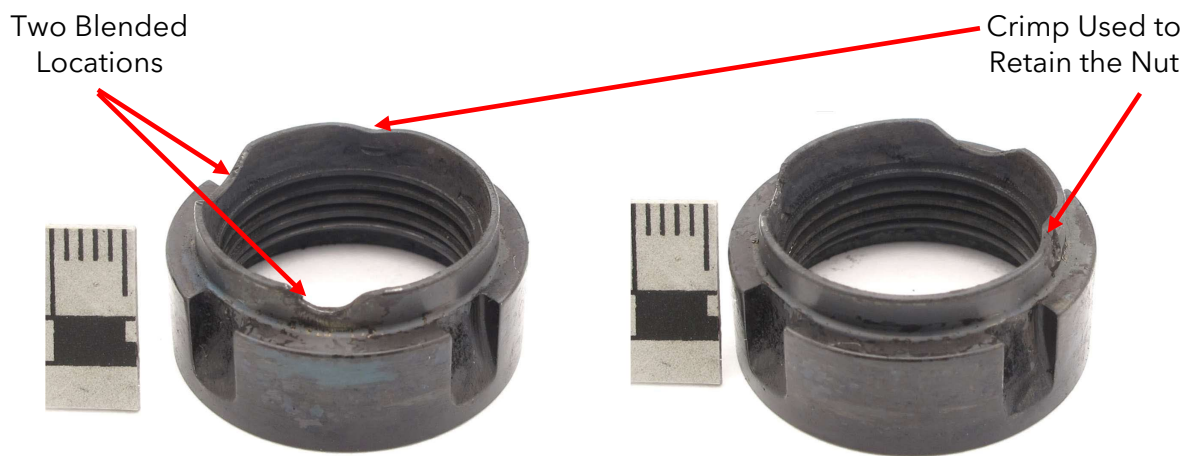
**Photo 24** - Two Images of Spanner Nut (Rotated by 90°) (from RR Materials Lab)

The No. 8 bearing spanner nut was submitted to the Rolls Royce materials laboratory for examination ([Photo 24](#) & [Photo 25](#)) which revealed:

- a) The spanner nut exhibited two blended locations consistent with acceptable removal of prior crimps and one crimp.
- b) The crimp exhibited a pry mark on the inner diameter surface consistent with a nut that was staked at a previous locking position.
- c) The mark was oxidized consistent with exposure to engine operation.

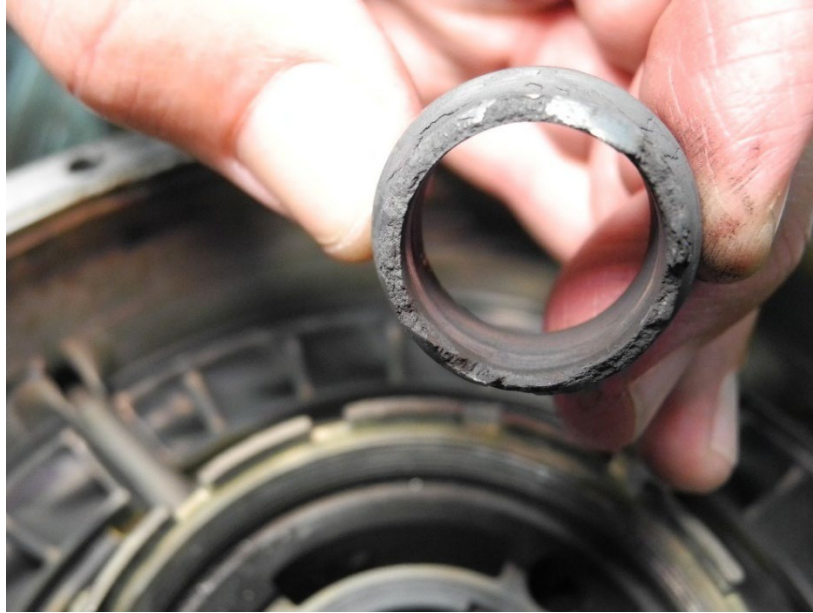
**Photo 26** - No. 8 Bearing Inner Race

Only a portion of the thermally distressed inner race remained ([Photo 26](#)). The inner ring exhibited rub damage resulting in the loss of the forward shoulder of the raceway and material transfer from the balls was observed on the bearing raceway.

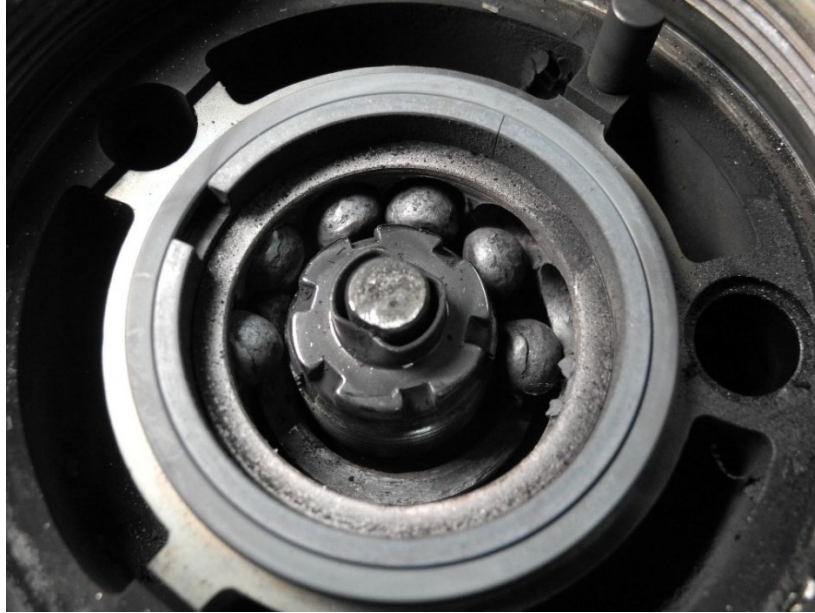
The No. 8 bearing was thermally distressed, dry and coated with a black residue, consistent with coked oil and had disintegrated ([Photo 27](#)). The balls exhibited varying degrees of deformation, spalling, and skidding wear resulting in varying shapes and diameters. The outer ring raceway exhibited material deposits.

**Photo 27** - No. 8 Bearing - Disintegrated

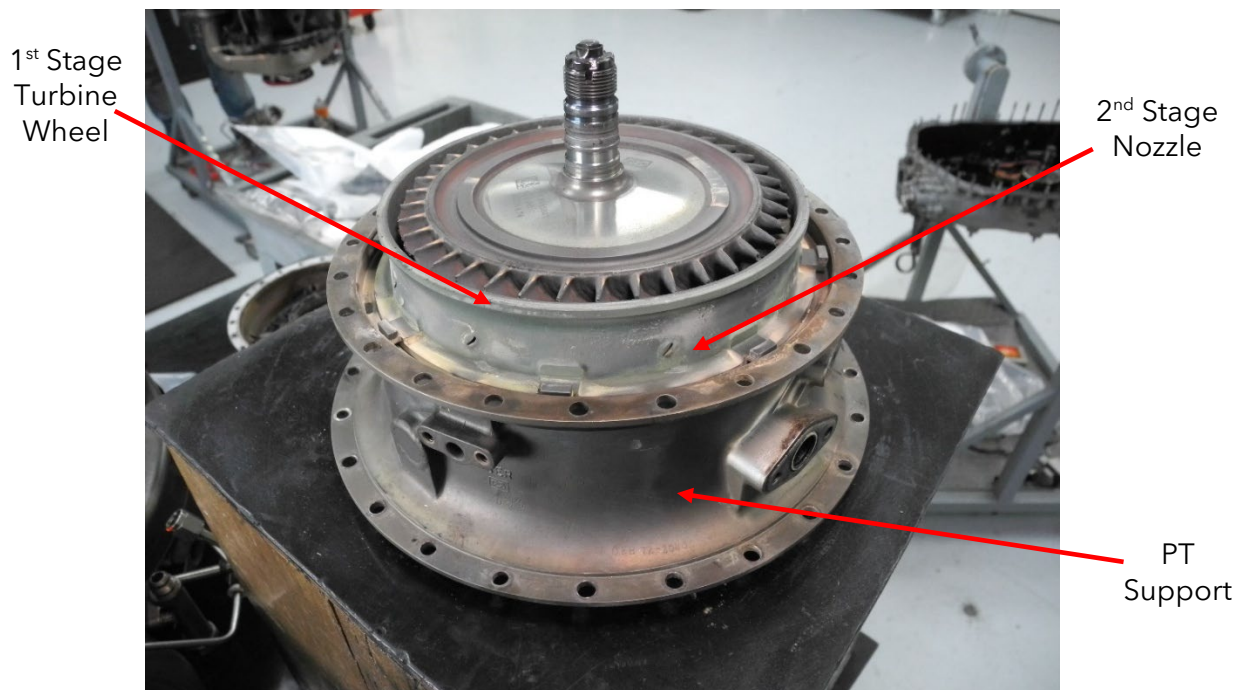
**Photo 28** - PT Support - Intact

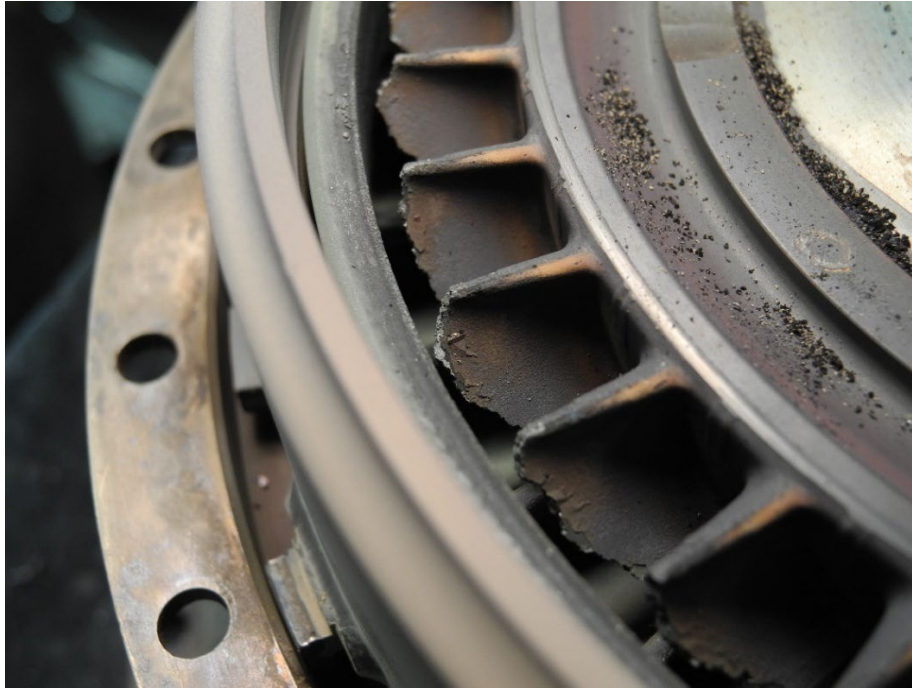
The gas producer turbine bearing support was removed, revealing the 1<sup>st</sup> stage turbine wheel (Photo 28) which was intact with all blades were present; however, the blade tips had been fractured from contact against the blade shroud, consistent with having lost axial and radial retention (Photo 29).

**Photo 29** - 1<sup>st</sup> Stage Turbine Blades - Fractured Tips
