# National Transportation Safety Board

ERA24LA076

## ENGINE EXAMINATION

N571CJ, B206L-1

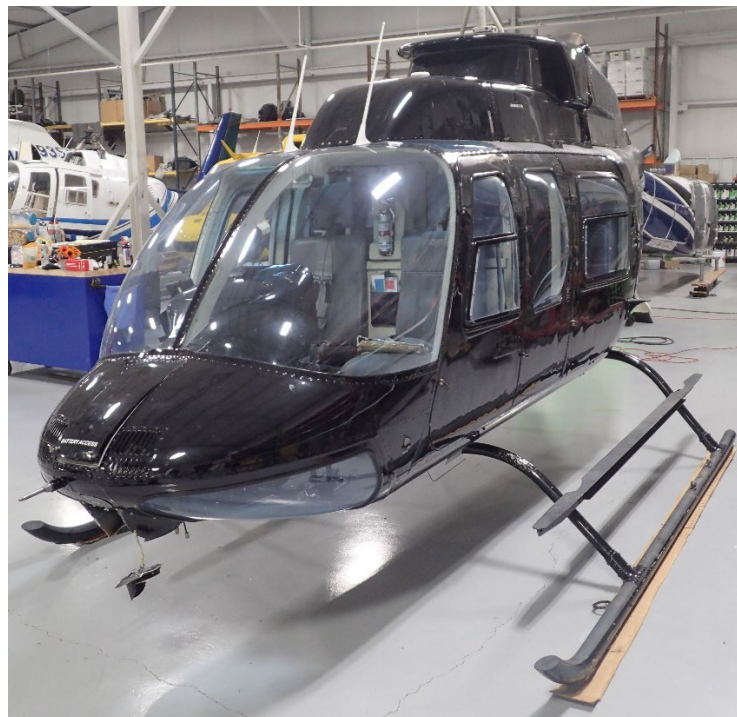
**Photo 1 - Front view of helicopter before examination.**

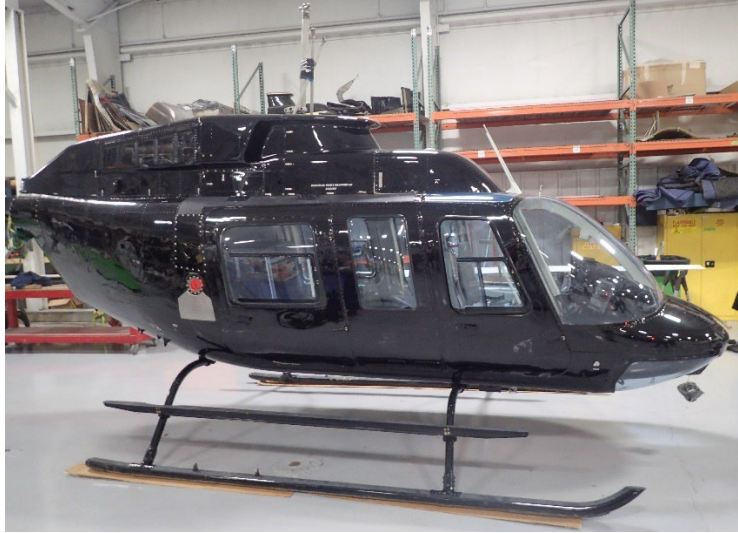
The helicopter was positioned upright in its normal position on its skids. The fuselage exhibited no visible damage however the aft portion of the fuselage displayed oil streaking on both the right and left sides extending from below the engine bay area aft. The tail boom and main rotor had been removed for transport.

**Photo 2 - Side view of helicopter before examination.**

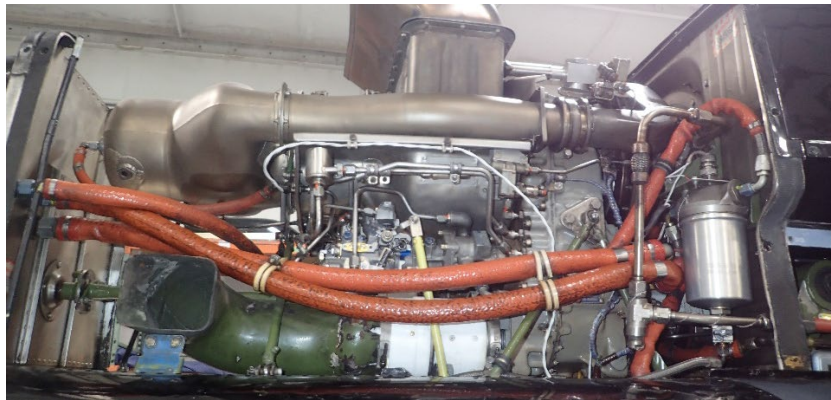
The engine to airframe oil tank lines were found secure with no evidence of leakage. During the engine removal, residual oil was observed in the supply line from the oil tank to the engine. The return line was void of oil. The engine oil tank contained less than half a tank of oil. 16 ounces of oil was drained from the accessory gear box.

**Photo 3 - View of engine and oil supply lines from engine to airframe oil tank.**

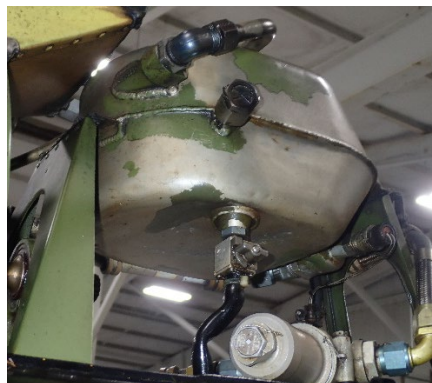
**Photo 4 - View of engine oil tank.**

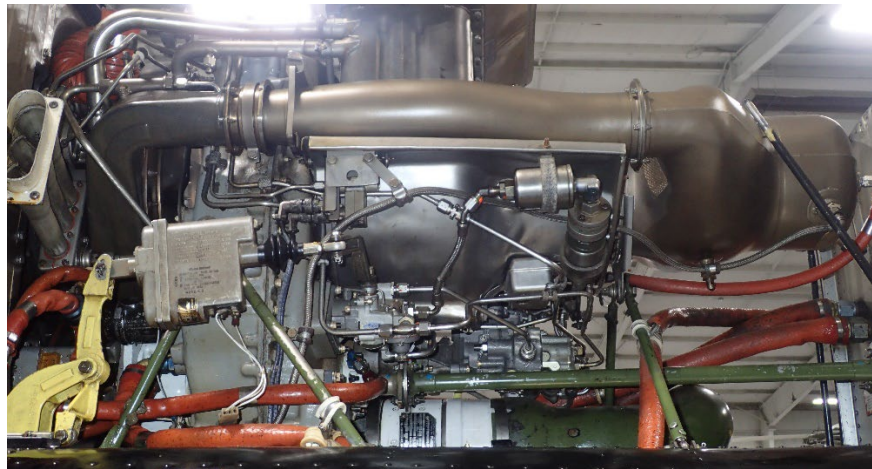
An exterior examination of the engine revealed the engine to have remained in position within the engine bay with all three mounts appearing intact. All engine oil, fuel and pneumatic lines were found secure with all "B" nuts at least hand tight and with no evidence of leakage. Engine control continuity was confirmed from the throttle to the fuel control unit. The power turbine governor remained in position and the governor arm was free from stop to stop.

**Photo 5 - Engine before examination.**

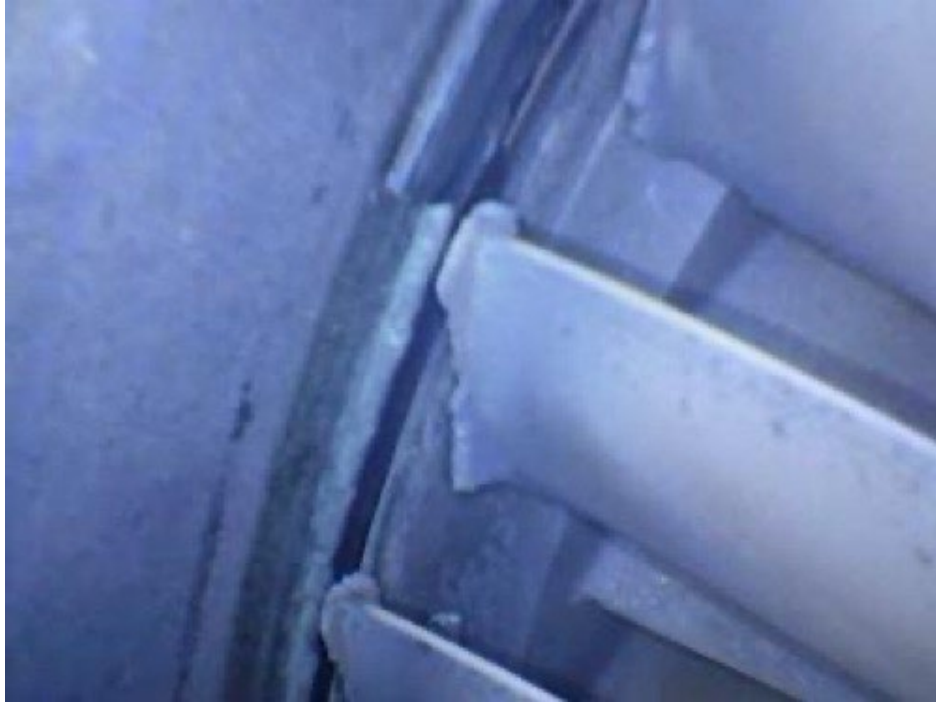
The examination took place at Thoroughbred Aviation in Lexington, Kentucky, on January 30, 2024, under the oversight of the Investigator-In-Charge. Borescope examination of the stage four turbine wheel through the exhaust collector support revealed the absence of much of the wheel shroud. Additionally, rotation of the N1 drivetrain resulted in N2 drivetrain rotation.

Examination of the N1 and N2 drive trains revealed that during manual rotation of either the N1 or N2 drive trains at their respective pads would result in movement and rotation of the opposite drive train as well. Both the N1 and N2 drive trains exhibited light to moderate drag during rotation. The turbine module remained in position and displayed no visible exterior damaged. Borescope examination of the stage four turbine wheel through the exhaust collector support revealed the absence of much of the wheel shroud.

**Photo 6 - Missing wheel shroud on stage four turbine wheel as viewed through the exhaust collector support via borescope.**

The determination was made to ship the engine to an appropriate facility for further disassembly and examination.

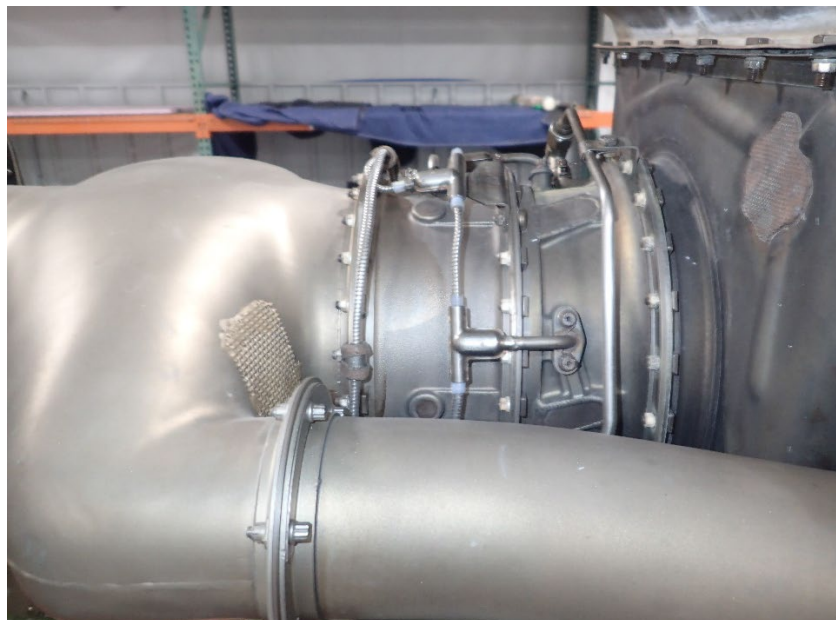
The outer combustion case was in position and displayed no damage. Both left and right compressor air discharge tubes were in position and properly seated at both ends.

**Photo 7 - View of the outer combustion case.**

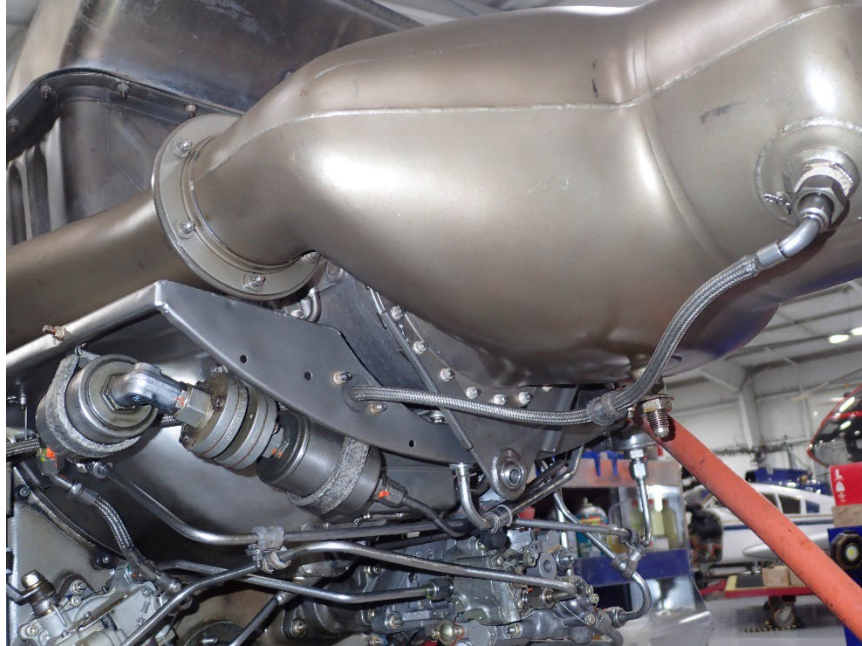
**Photo 8 - Outer combustion case with air discharge tube.**

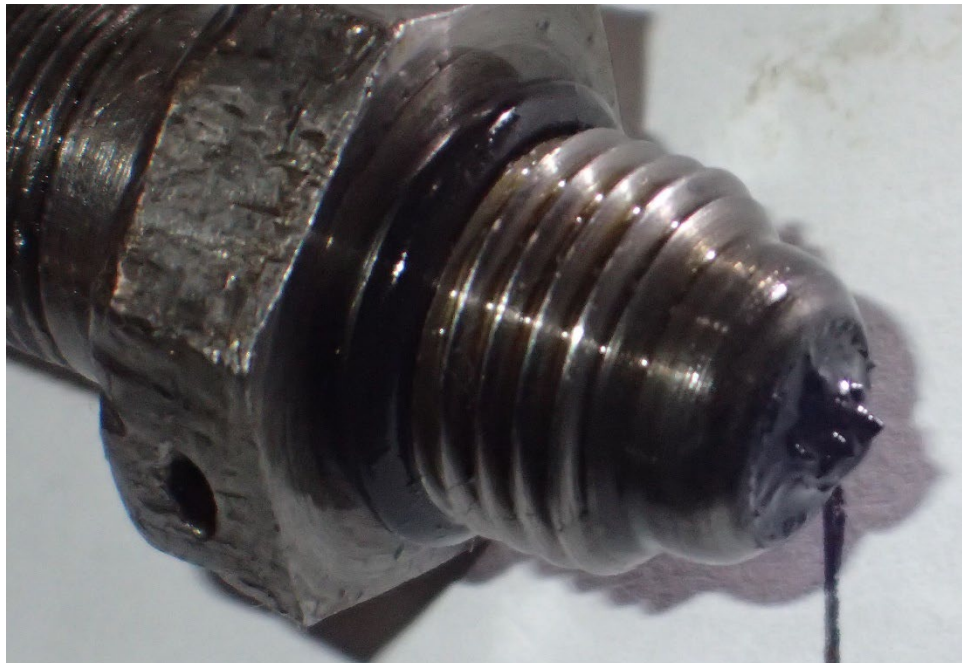
Both the upper and lower chip detectors were removed and inspected. The upper chip detector exhibited paste and several small chips. The lower chip detector was void of material.

**Photo 9 - View of the upper chip detector.**

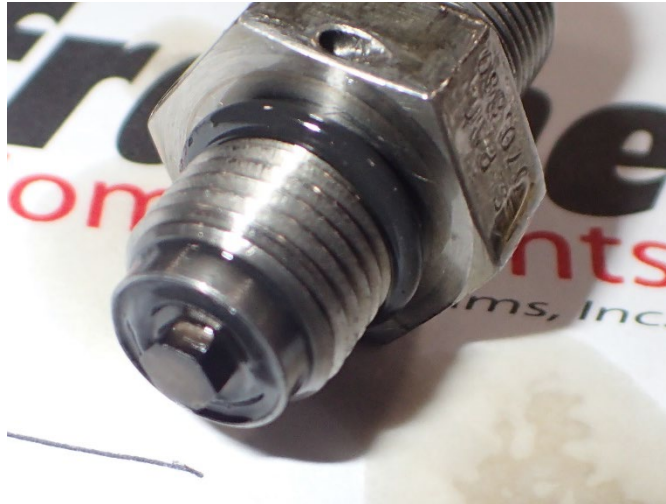
**Photo 10 - View of lower chip detector.**
