ERA24LA076

## INVESTIGATION PHOTOGRAPHS

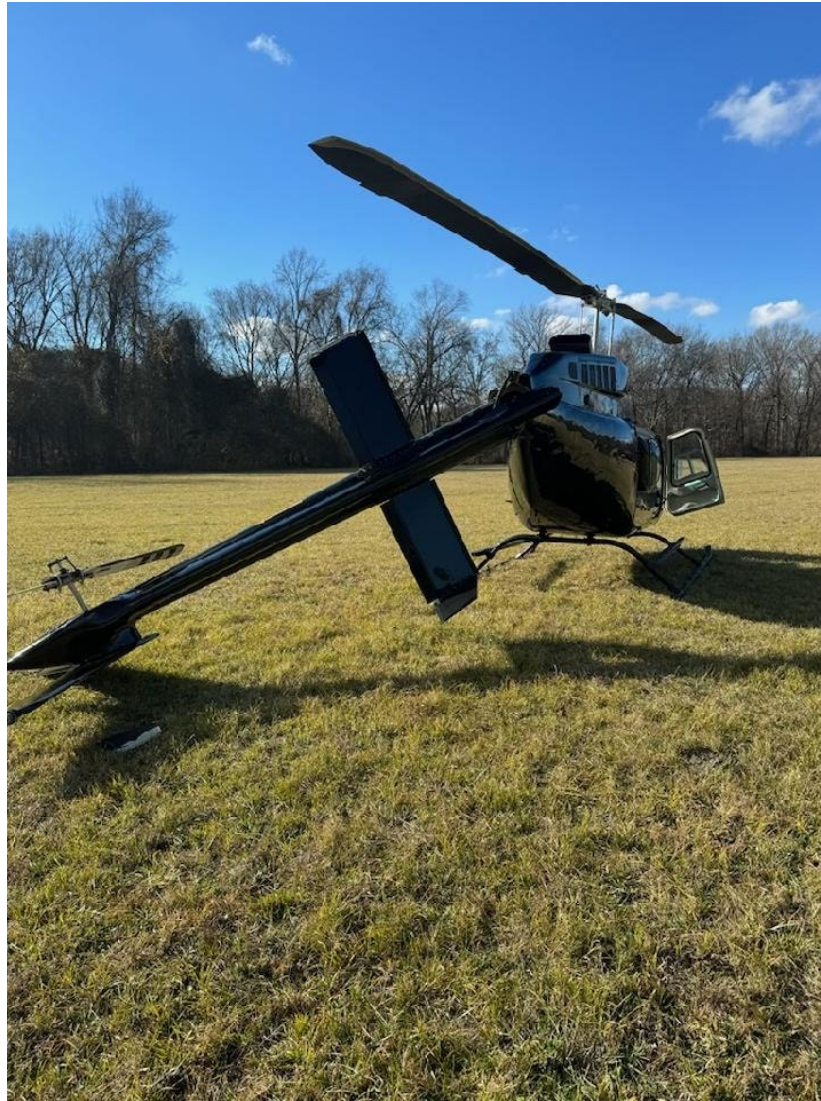
**Photograph 1 - Helicopter damage at the accident site. (Courtesy of FAA)**

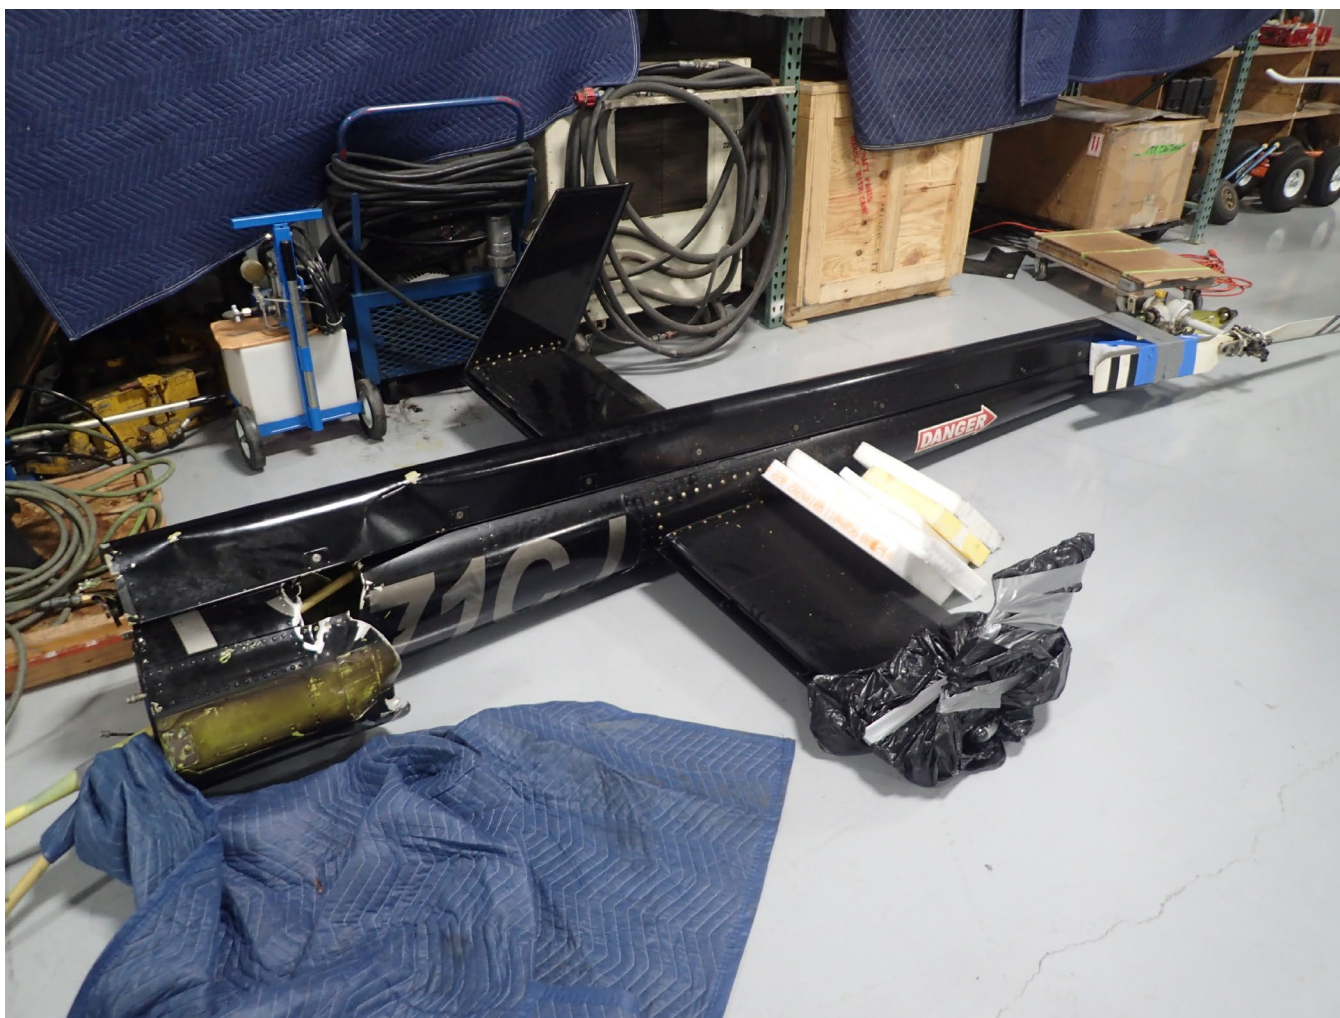
**Photograph 2 - Damaged tail boom after recovery. (Courtesy of FAA)**
