ERA24LA079

## INVESTIGATION PHOTOGRAPHS

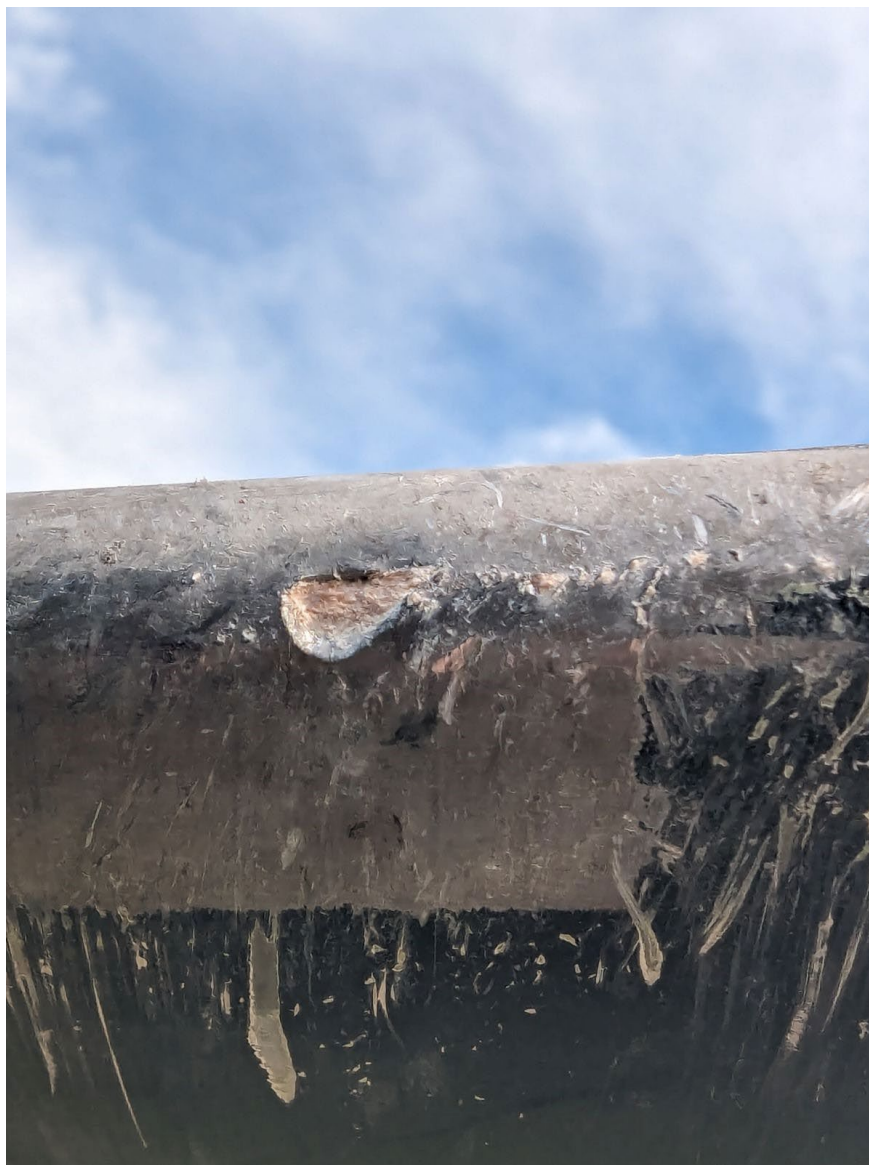
**Photograph 1 - View of damage to the main rotor blade (Courtesy of FAA)**

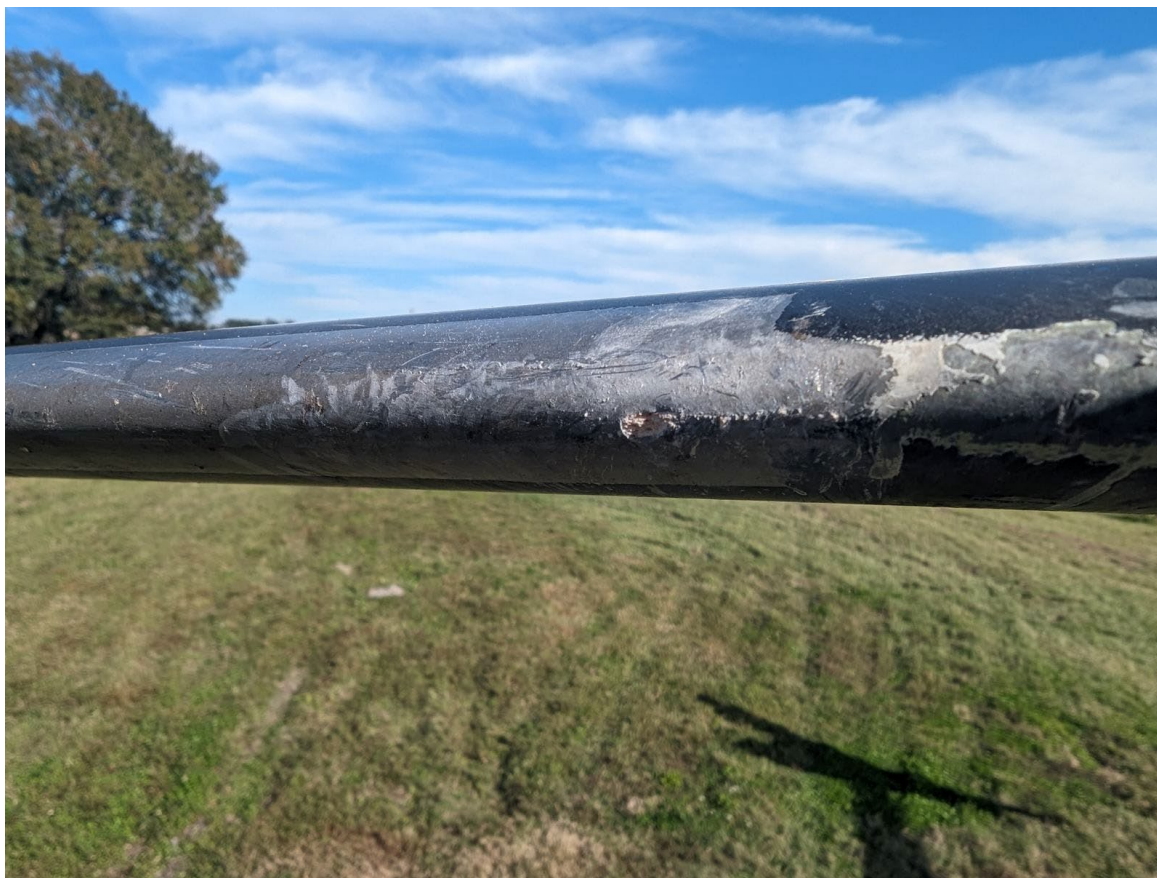
**Photograph 2 - View of damage to the main rotor blade (Courtesy of FAA)**
