Timothy W. Monville  
Sr. Air Safety Investigator  
OAS-Eastern Region Aviation

**Subject:** ERA24LA081, Record of Conversation/Interview

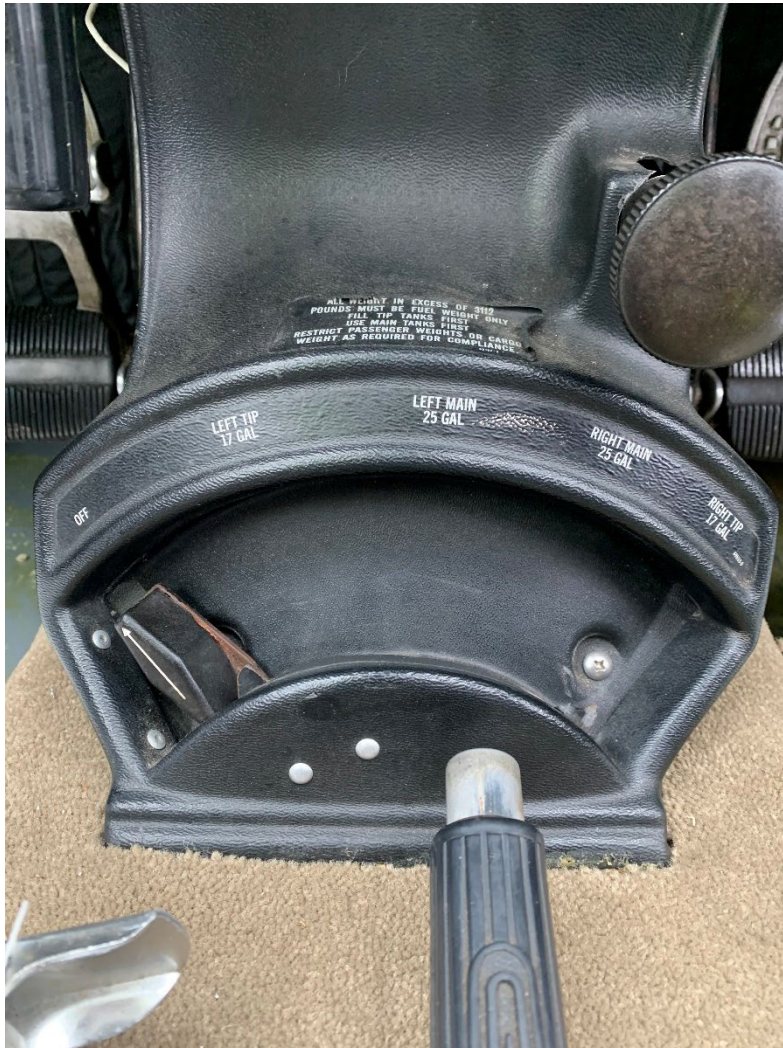
He departed TGI with the fuel selector on the left main fuel tank which indicated 8 gallons of fuel remaining. About 15 minutes later, he moved the fuel selector to the right tip tank and flew about 20 minutes. At that time, or about 35 minutes into the flight he moved the fuel selector to the left tip tank and flew about 15 minutes. He then intended to move the fuel selector to the right main fuel tank<sup>4</sup>, but he only moved the selector 1 place to the right to the left main fuel tank, which only had about 2 gallons remaining. After the engine lost power he did move the fuel selector to the right main fuel tank, but could not get the engine restarted. He added that it happened so quick. At touchdown the fuel selector was on the right main tank position, and after coming to rest he moved the fuel selector to the off position<sup>5</sup>.

<sup>5</sup> The on-scene investigation by the FAA found the fuel selector in the off position.

Figure 1: Digital Photograph From Anglin Air personnel. View of the Fuel Selector.

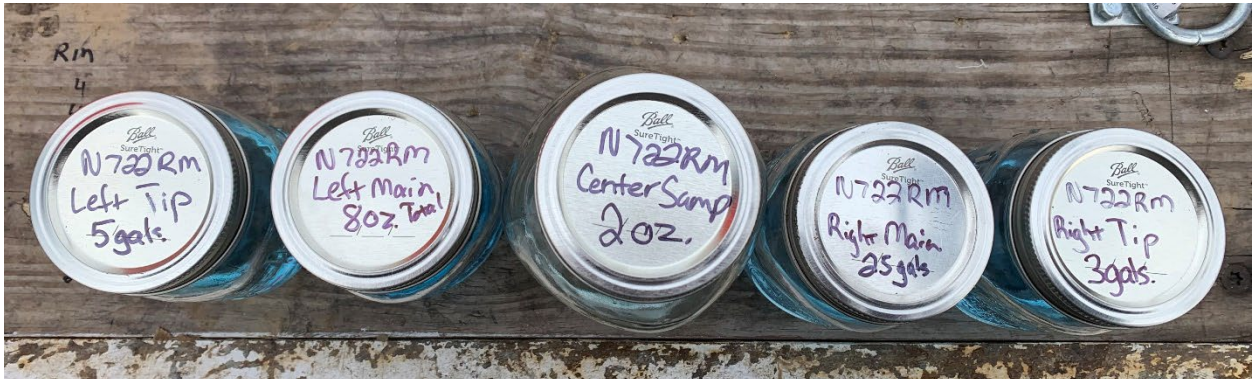
He indicated that he was in the process of recovering the airplane and as requested by NTSB, he had drained each fuel tank segregating the fuel. He drained 8 ounces from the left main fuel tank, 5 gallons from the left tip tank, was in the process of draining the right main fuel tank, and 3 gallons from the right tip tank. He was asked if he could, as an airframe and powerplant mechanic, check the fuel selector to make sure it moves freely. He indicated that he would text me the final value from the right main fuel tank and the fuel selector test.

He texted at 1041 EST the following, "Selector valve is functional in all positions, indicator aligns properly in detents. Selecting right tip is slightly tighter and more difficult than other positions." At 1107 EST, he texted 2 pictures with glass jars and hand writing on each lid with the tank (Figure 1), and quantity. For the right tank it depicted, "25 [gallons]. He also drained the airframe fuel strainer or "center sump" and drained 2 ounces. No contaminants were noted in any fuel samples taken from the tanks.

Figure 1: Digital Photograph From Anglin Air. Documents an Initial Sample of Fuel and/or the Complete Amount Drained From each Tank, and the Quantity Drained From Each Fuel Tank.
