ERA24LA081

## INVESTIGATION PHOTOGRAPHS

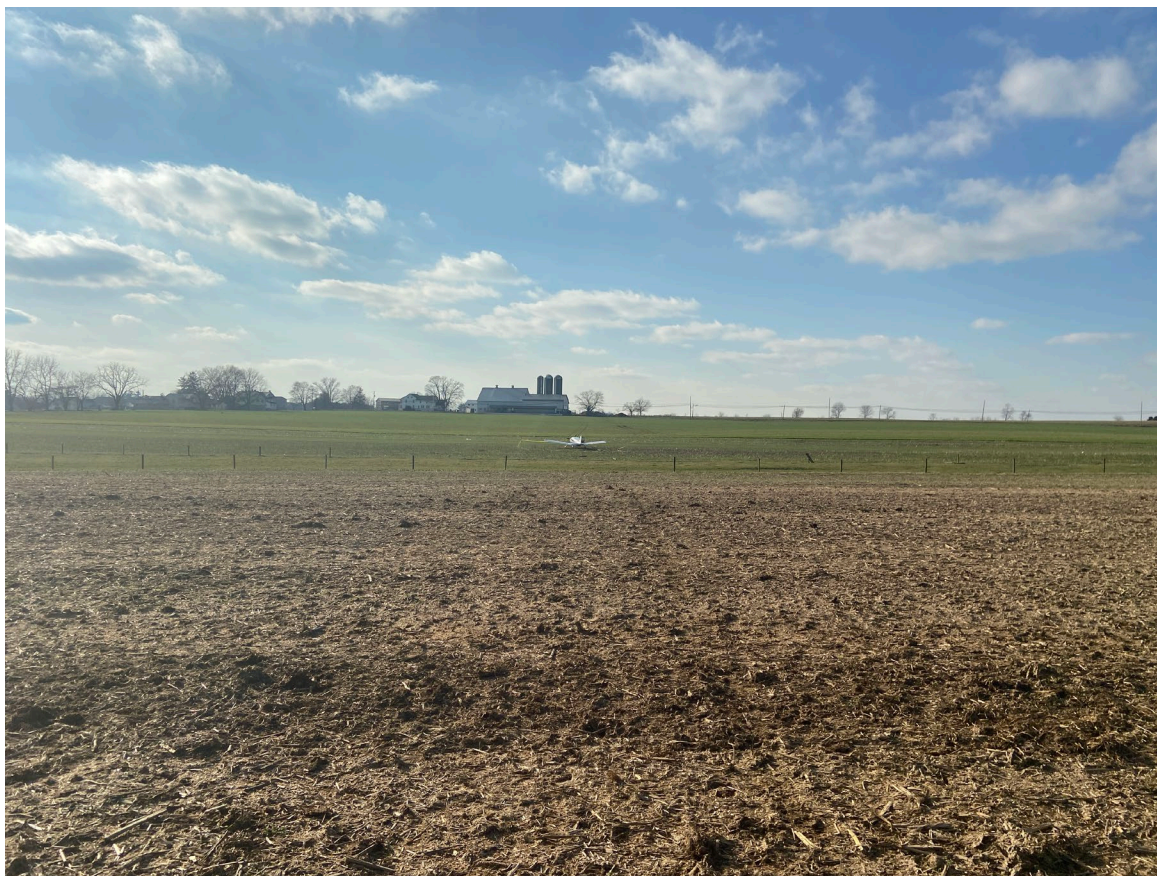
**Photograph 1 - FAA Digital Photograph. View Taken near Initial Touchdown Point Showing the Ground Track During the Forced Landing. Airplane is in the Background.**

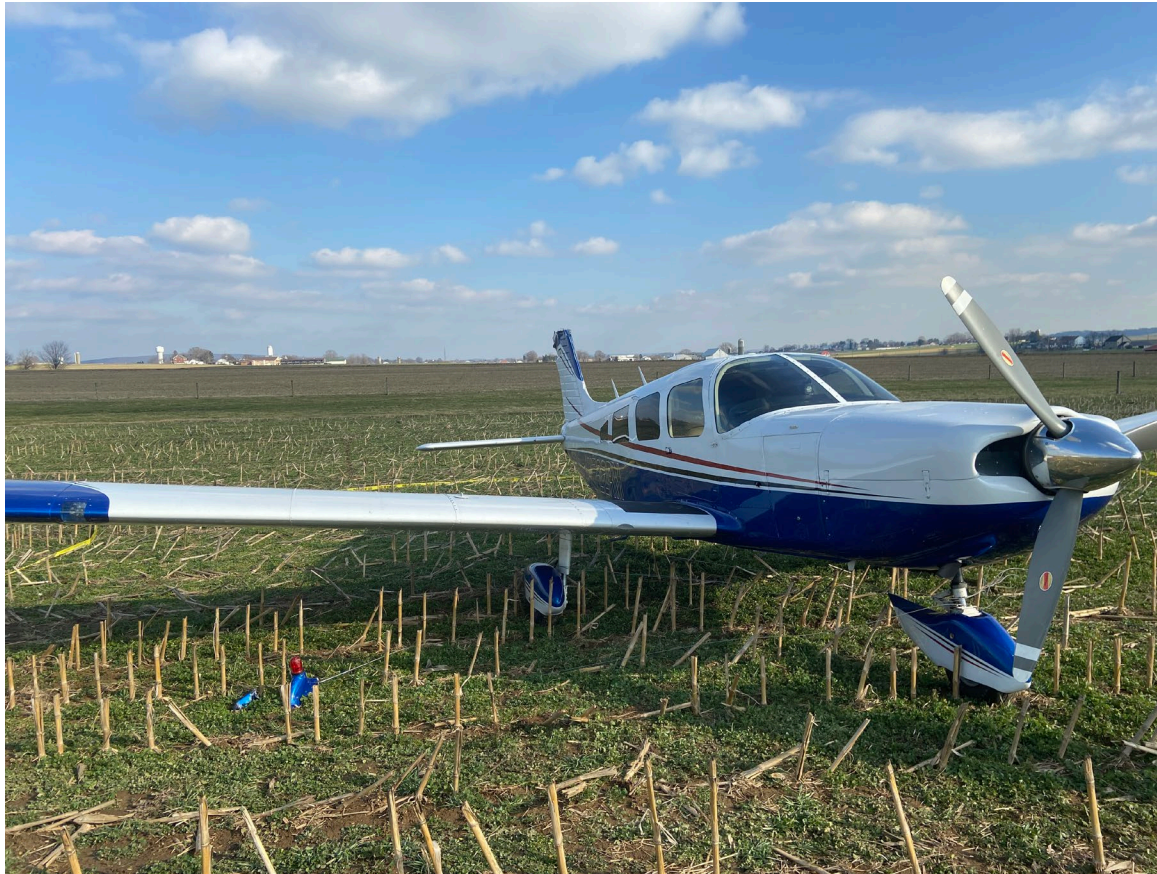
**Photograph 2 - FAA Digital Photograph. Right Forward Quartering View of the Airplane at the Accident Site. Note the Lack of Damage to 2 Visible Propeller Blades.**

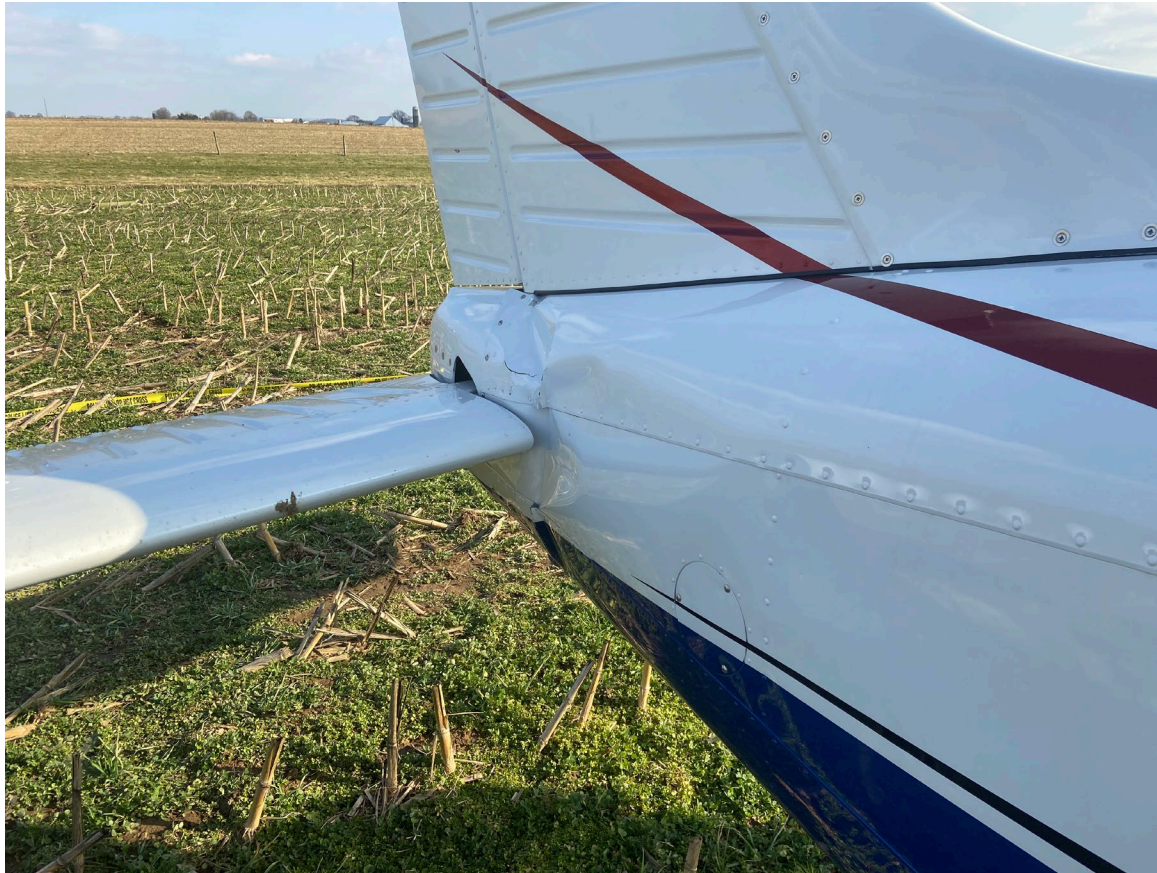
**Photograph 3 - FAA Digital Photograph. Right View of Aft Empennage Showing Structural Damage Near Right Horizontal Stabilator.**

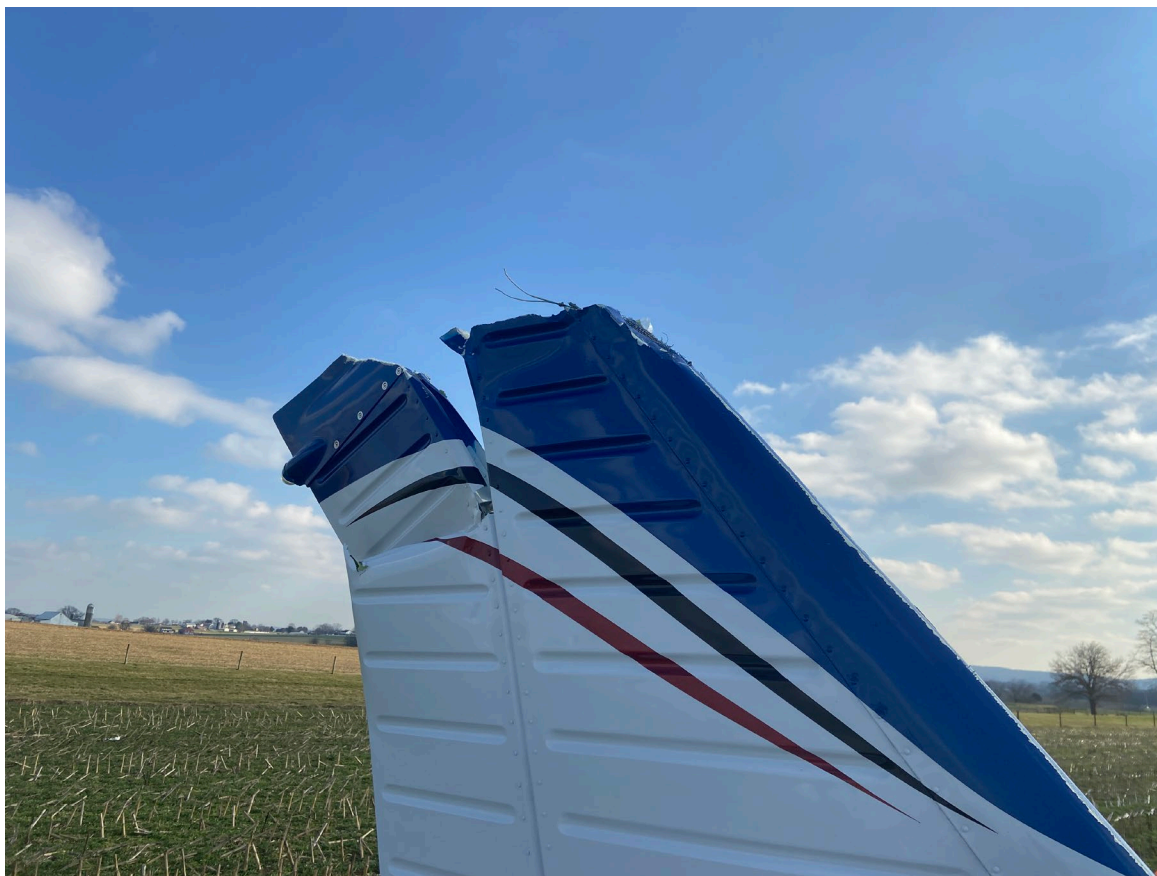
**Photograph 4 - FAA Digital Photograph. Right Side View of the Upper Portion of the Vertical Stabilizer and Rudder. Note the Damage to the Spar of the Rudder.**

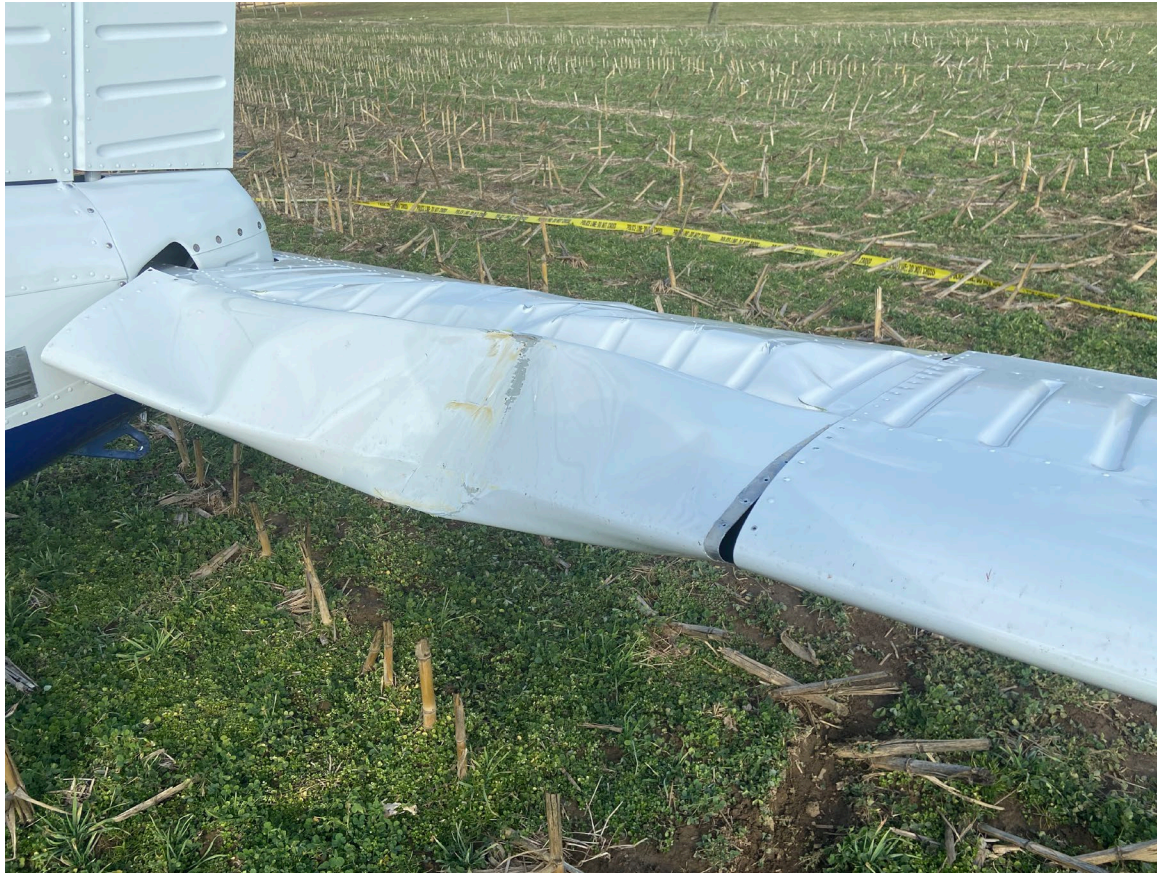
**Photograph 5 - FAA Digital Photograph. View of a Portion of the Left Horizontal Stabilator.  
Note the Extensive Structural Damage**

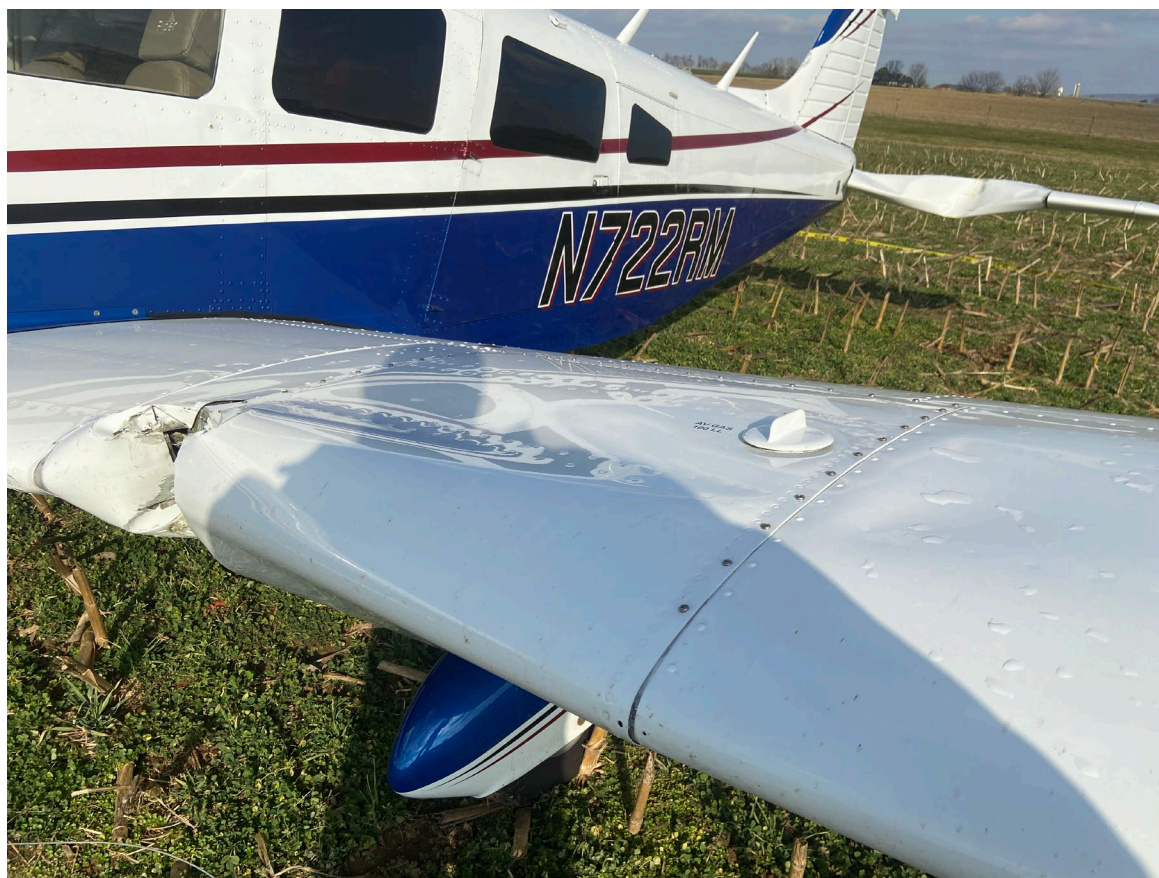
**Photograph 6 - FAA Digital Photograph. View of the Inboard Portion of the Left Wing, and Left Side of the Fuselage. Note the Impact Damage on the Inboard Portion of the Main Fuel Tank.**

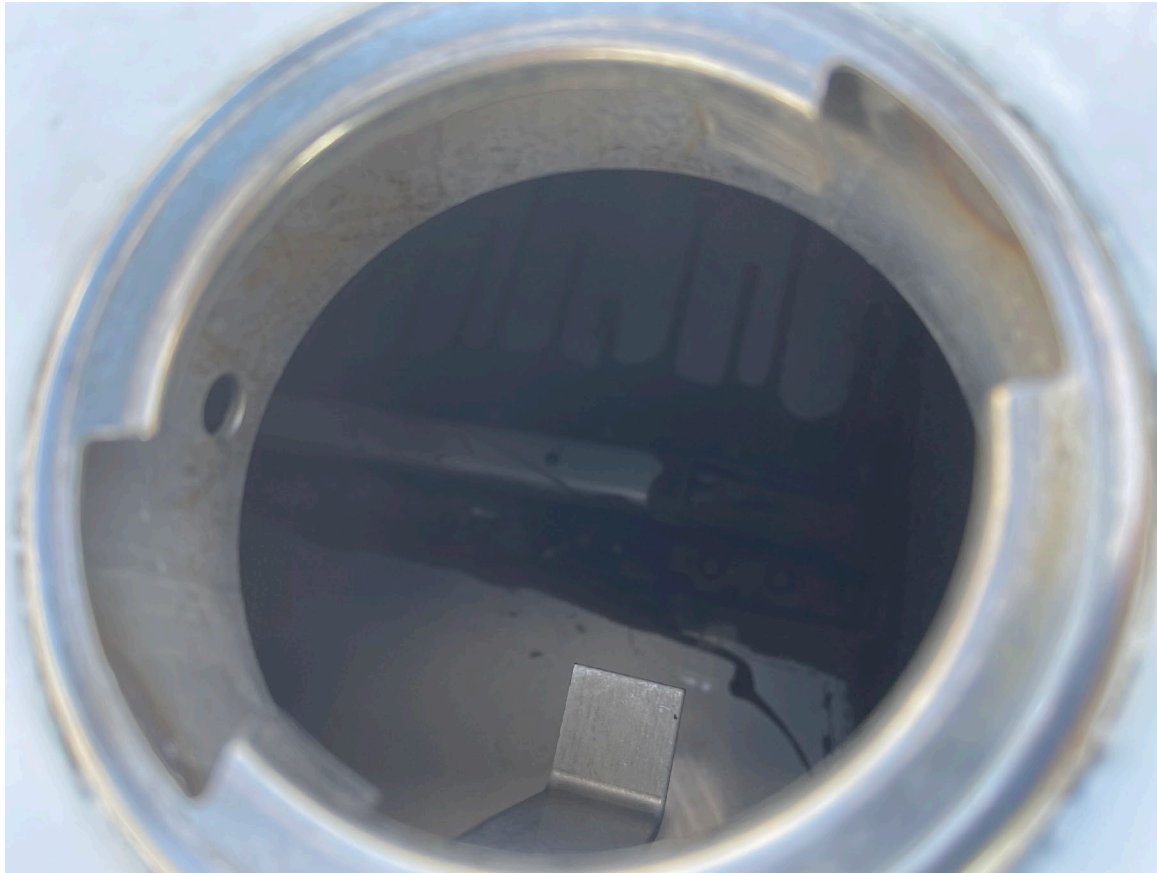
**Photograph 7 - FAA Digital Photograph. View of the Left Main Fuel Tank Which was Nearly Empty of Fuel.**

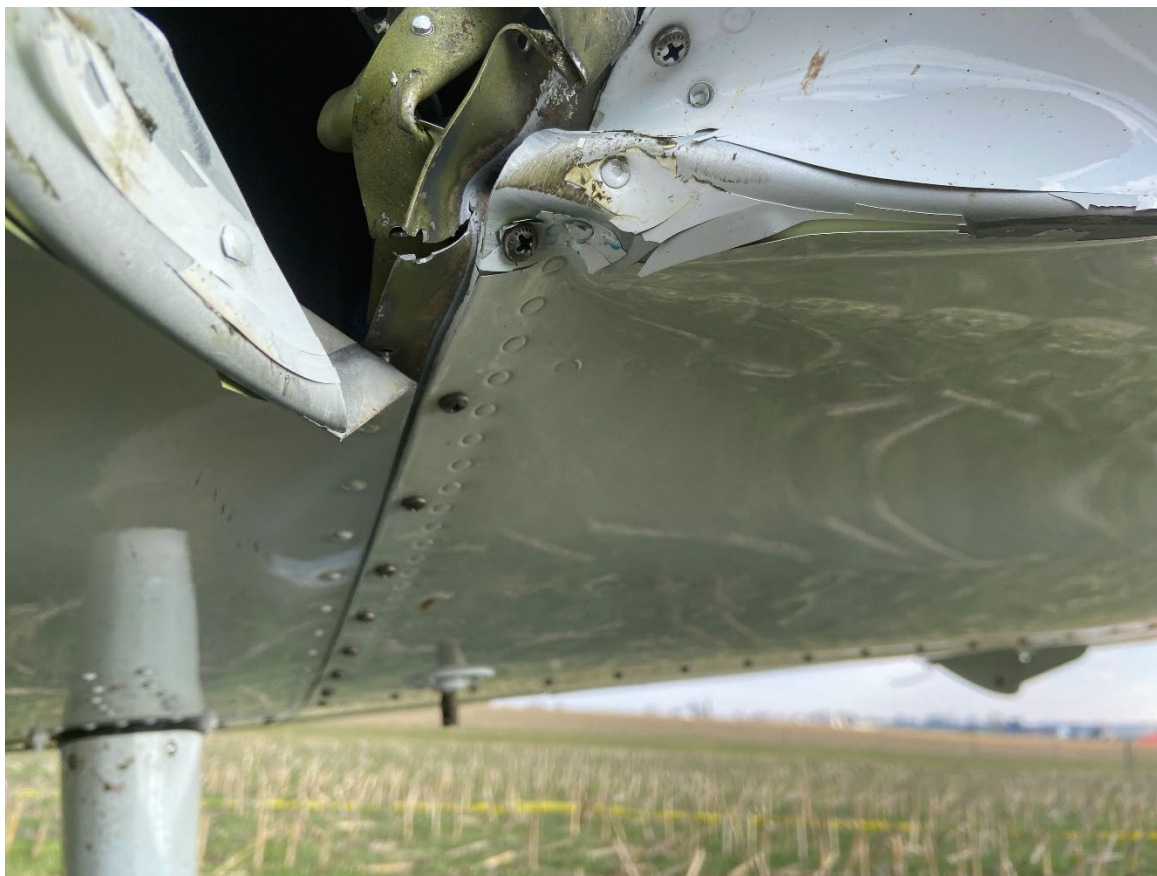
**Photograph 8 - FAA Digital Photograph. View of the Lower Wing Skin of the Left Wing Adjacent to the Impact Damage to the Fuel Tank. Note the Absence of Fuel Stains.**

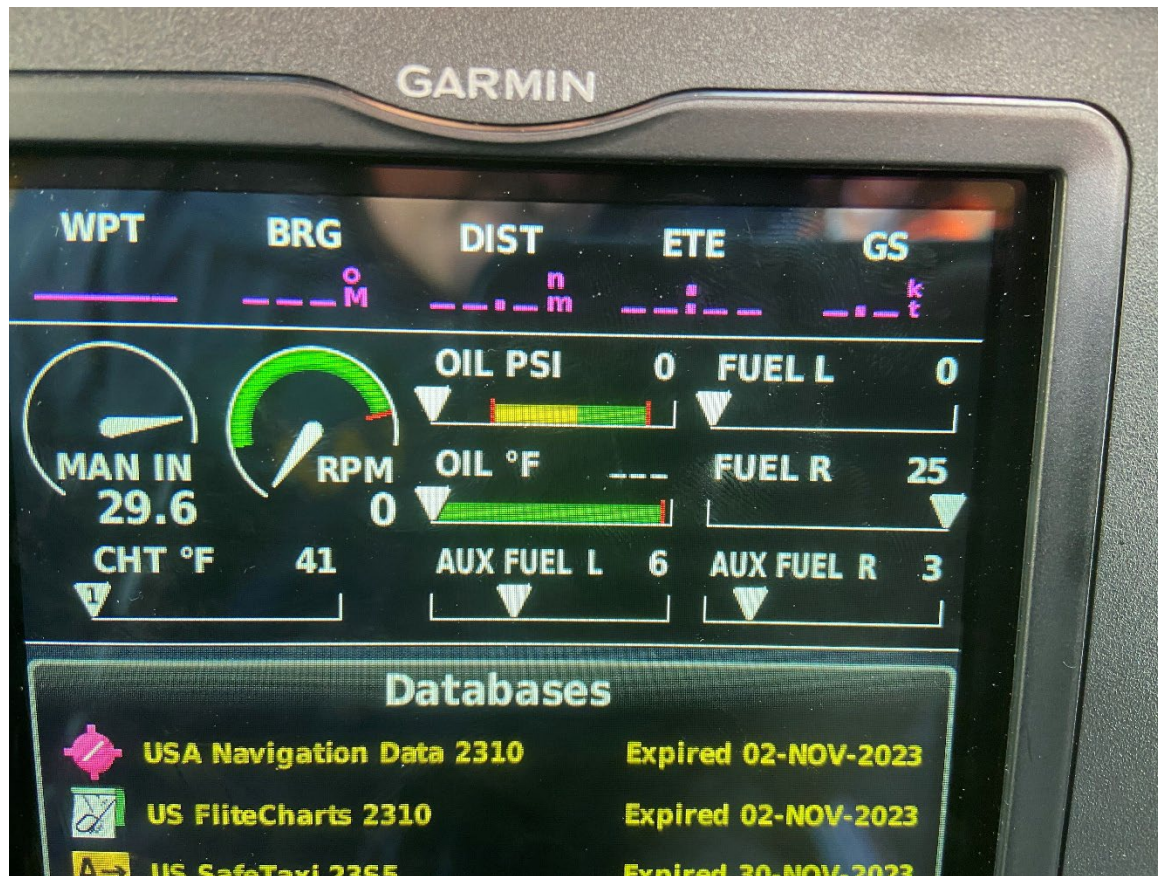
**Photograph 9 - FAA Digital Photograph. View Showing the Main and Auxiliary Fuel Tank Readings.**
