ERA24LA086

## INVESTIGATION PHOTOGRAPHS

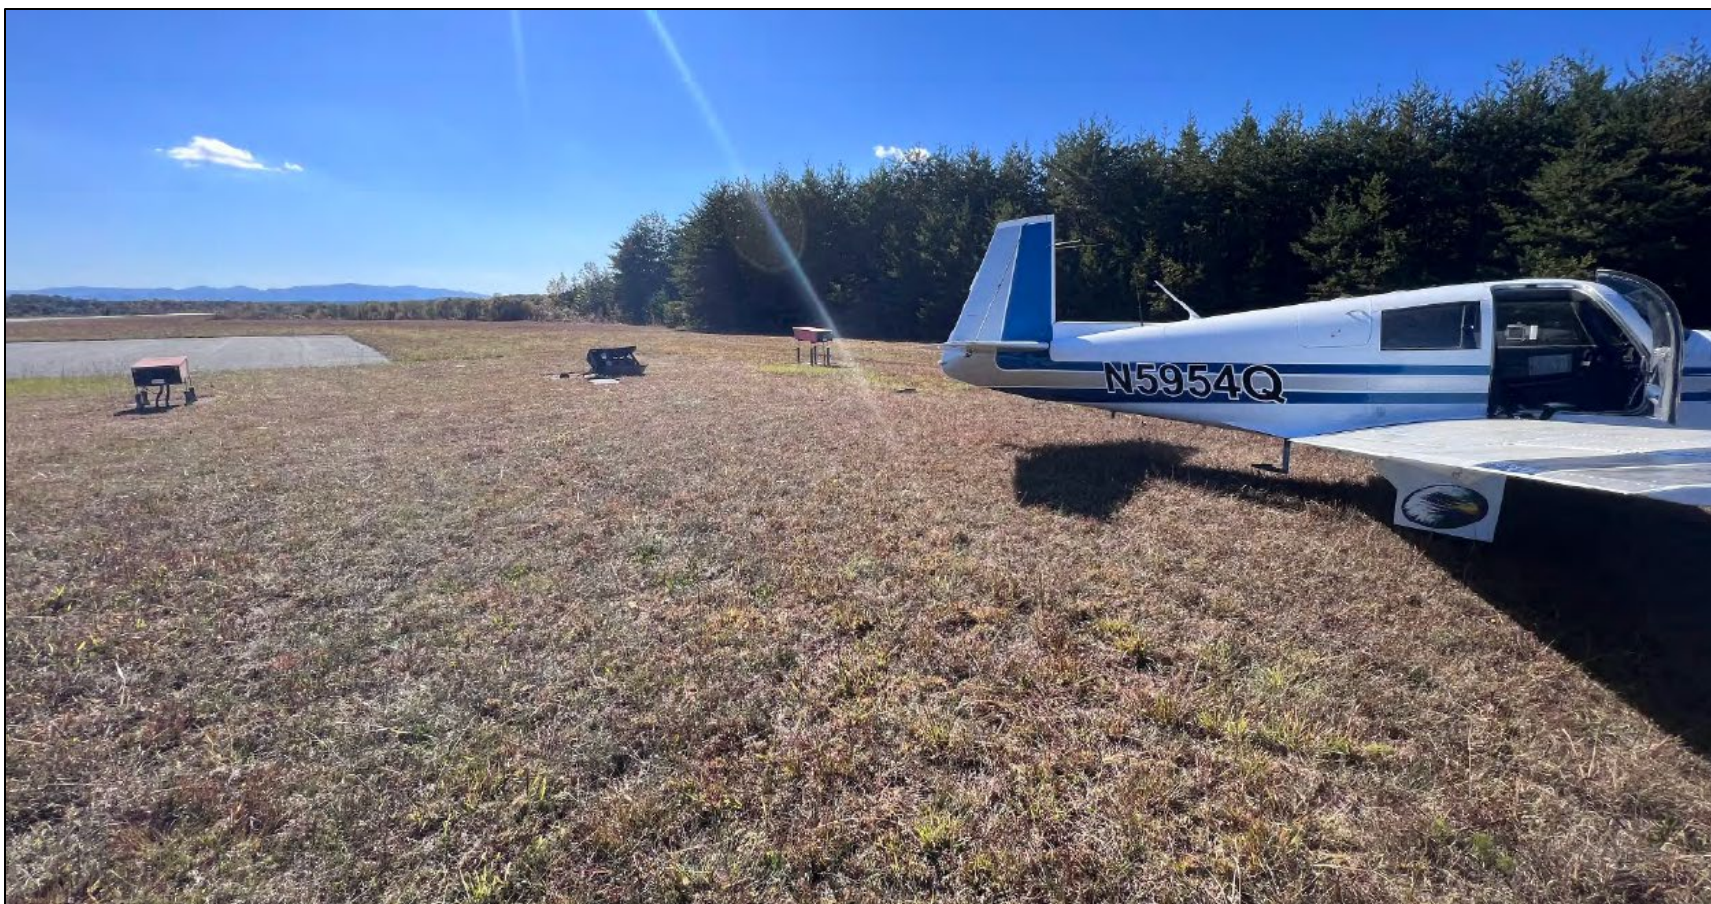
**Photo 1: View of the airplane at the accident site, with the lighting equipment struck, located in the background (Photo Courtesy of FAA)**

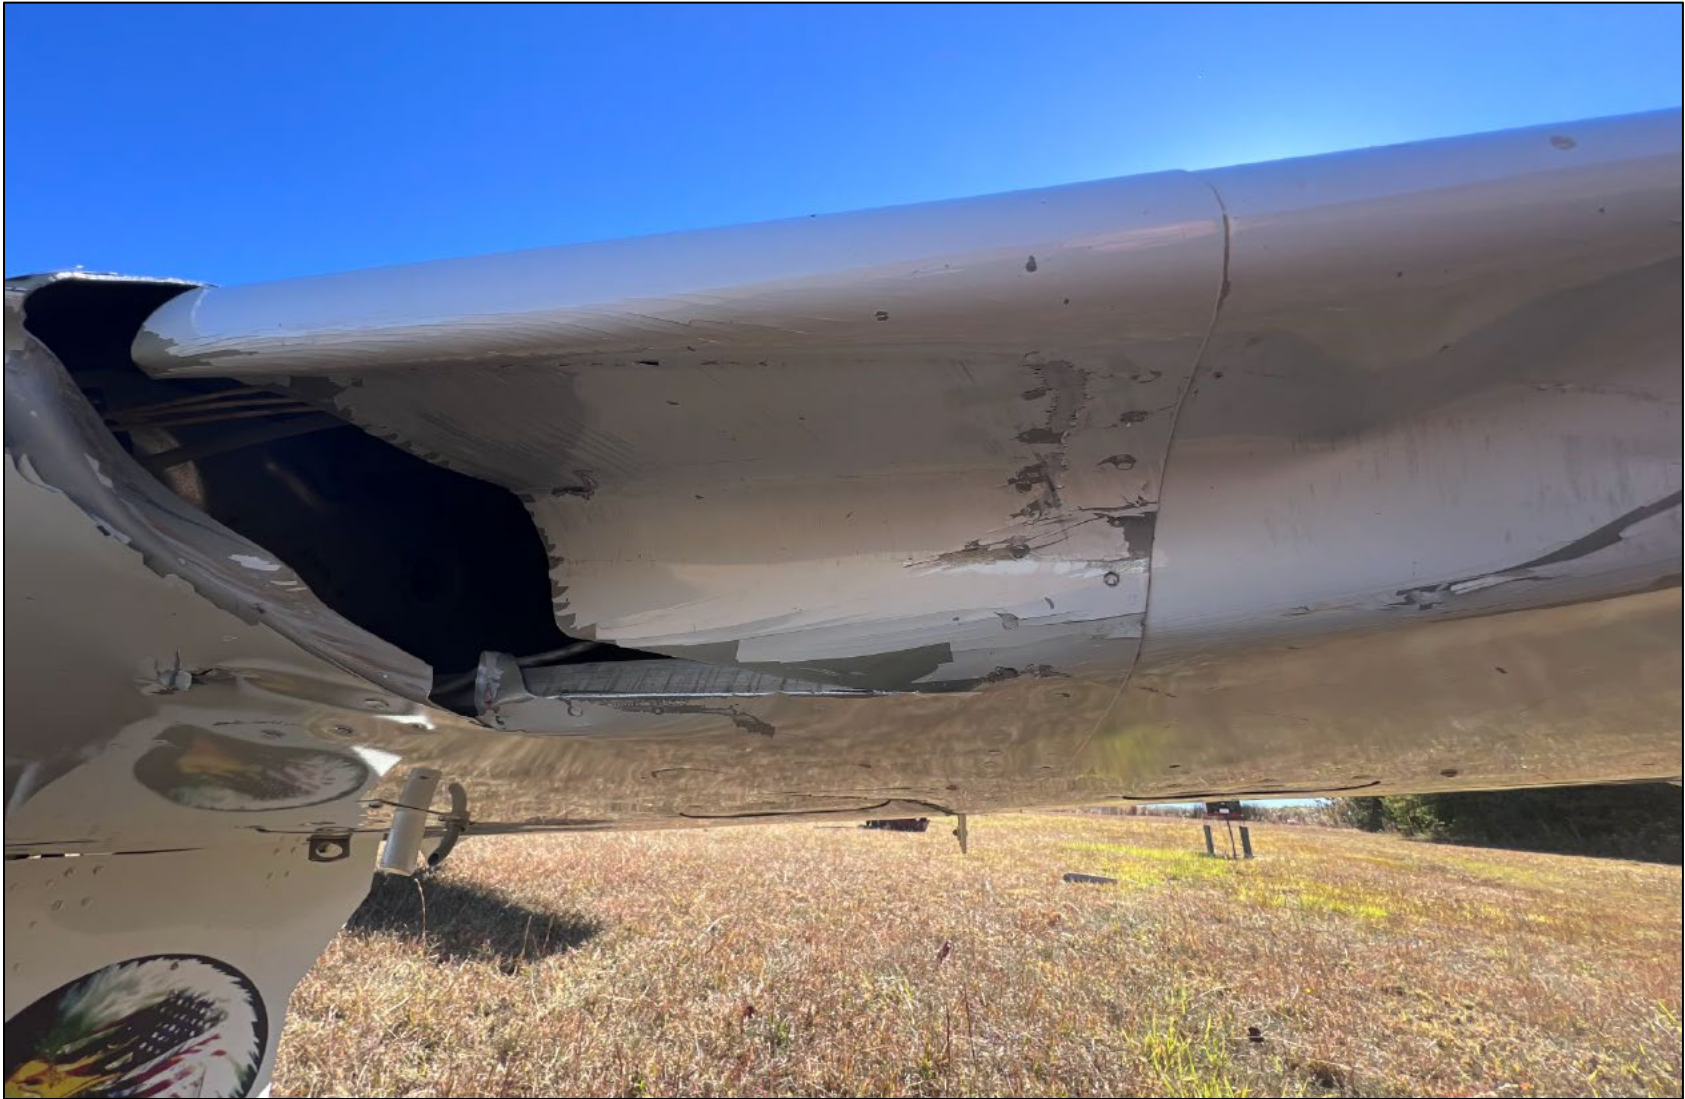
**Photo 2: View of the damaged left wing (Photo Courtesy of FAA)**

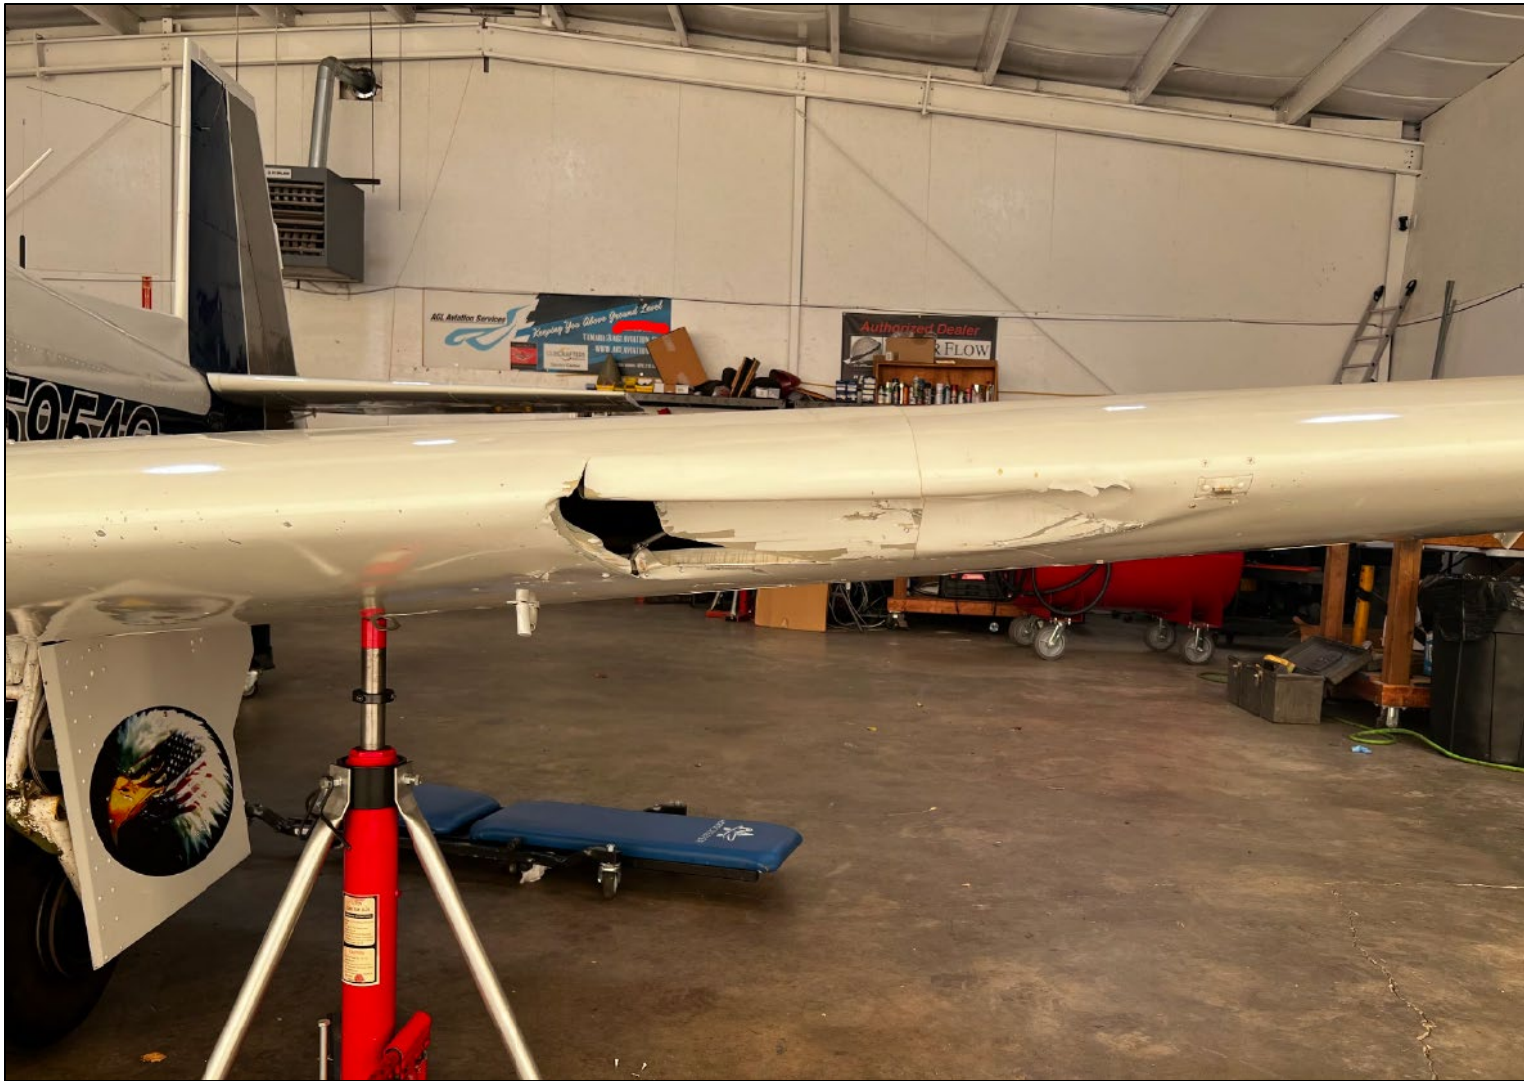
**Photo 3: View of the damaged left wing (Photo Courtesy of FAA)**

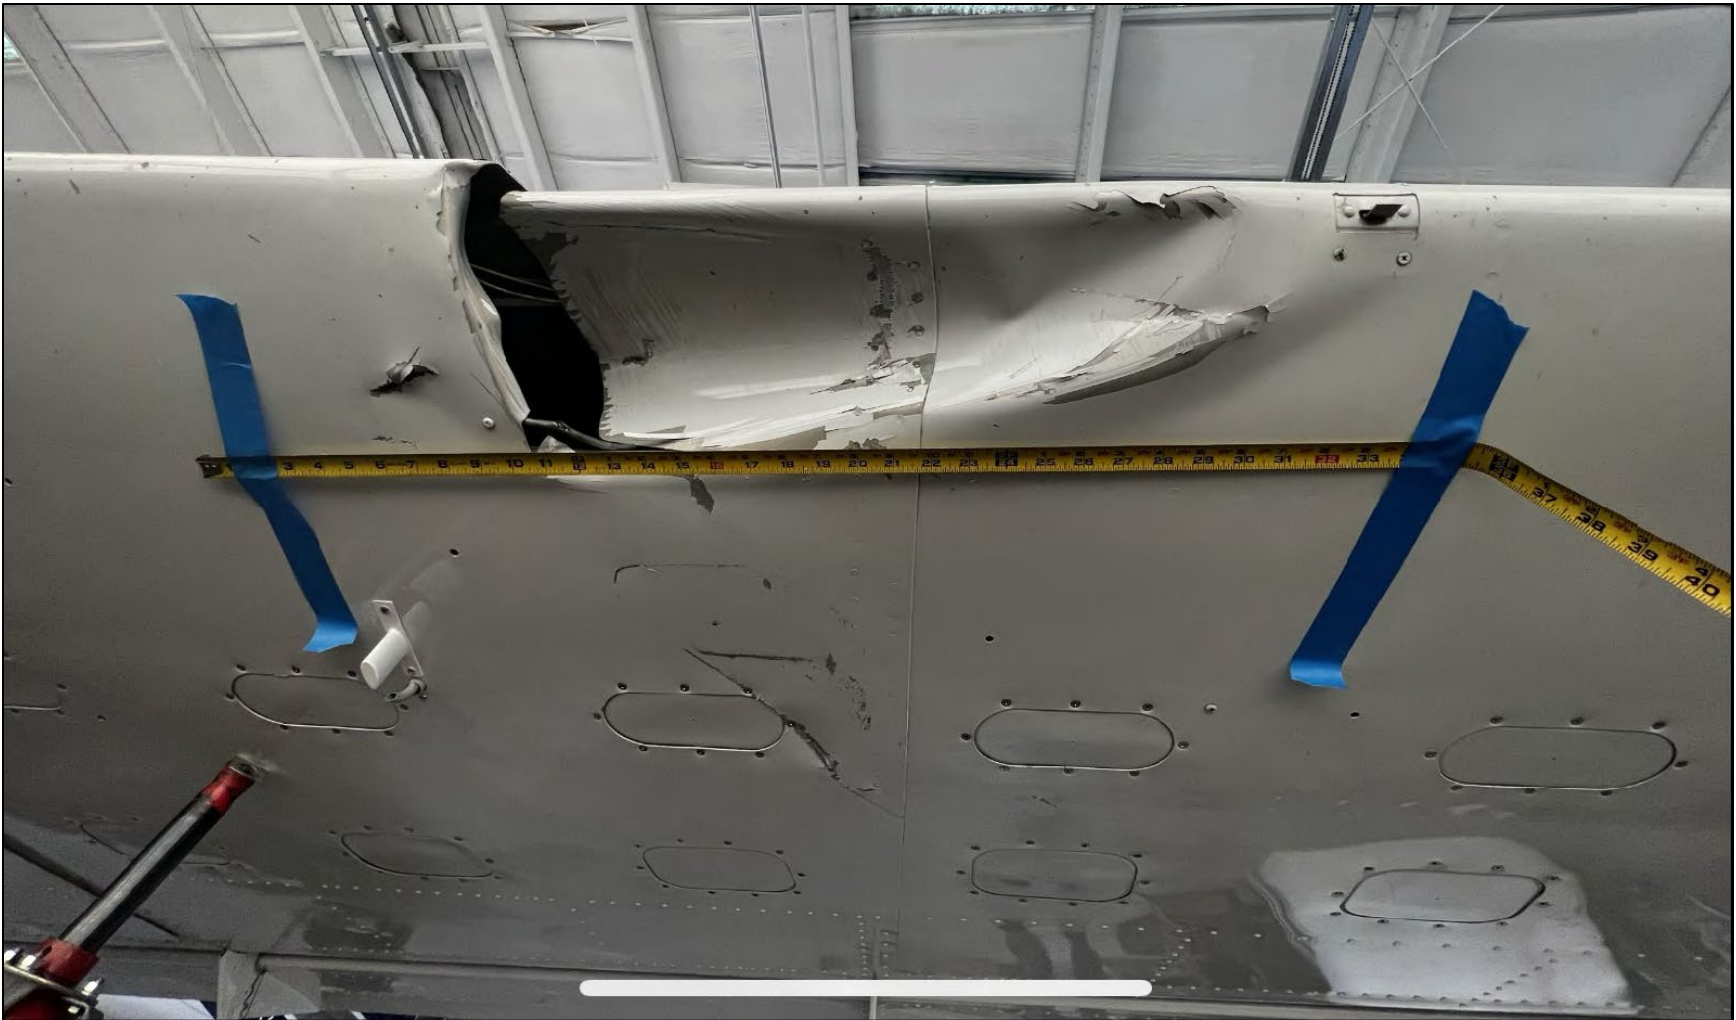
**Photo 4: View of the damaged left wing (Photo Courtesy of FAA)**

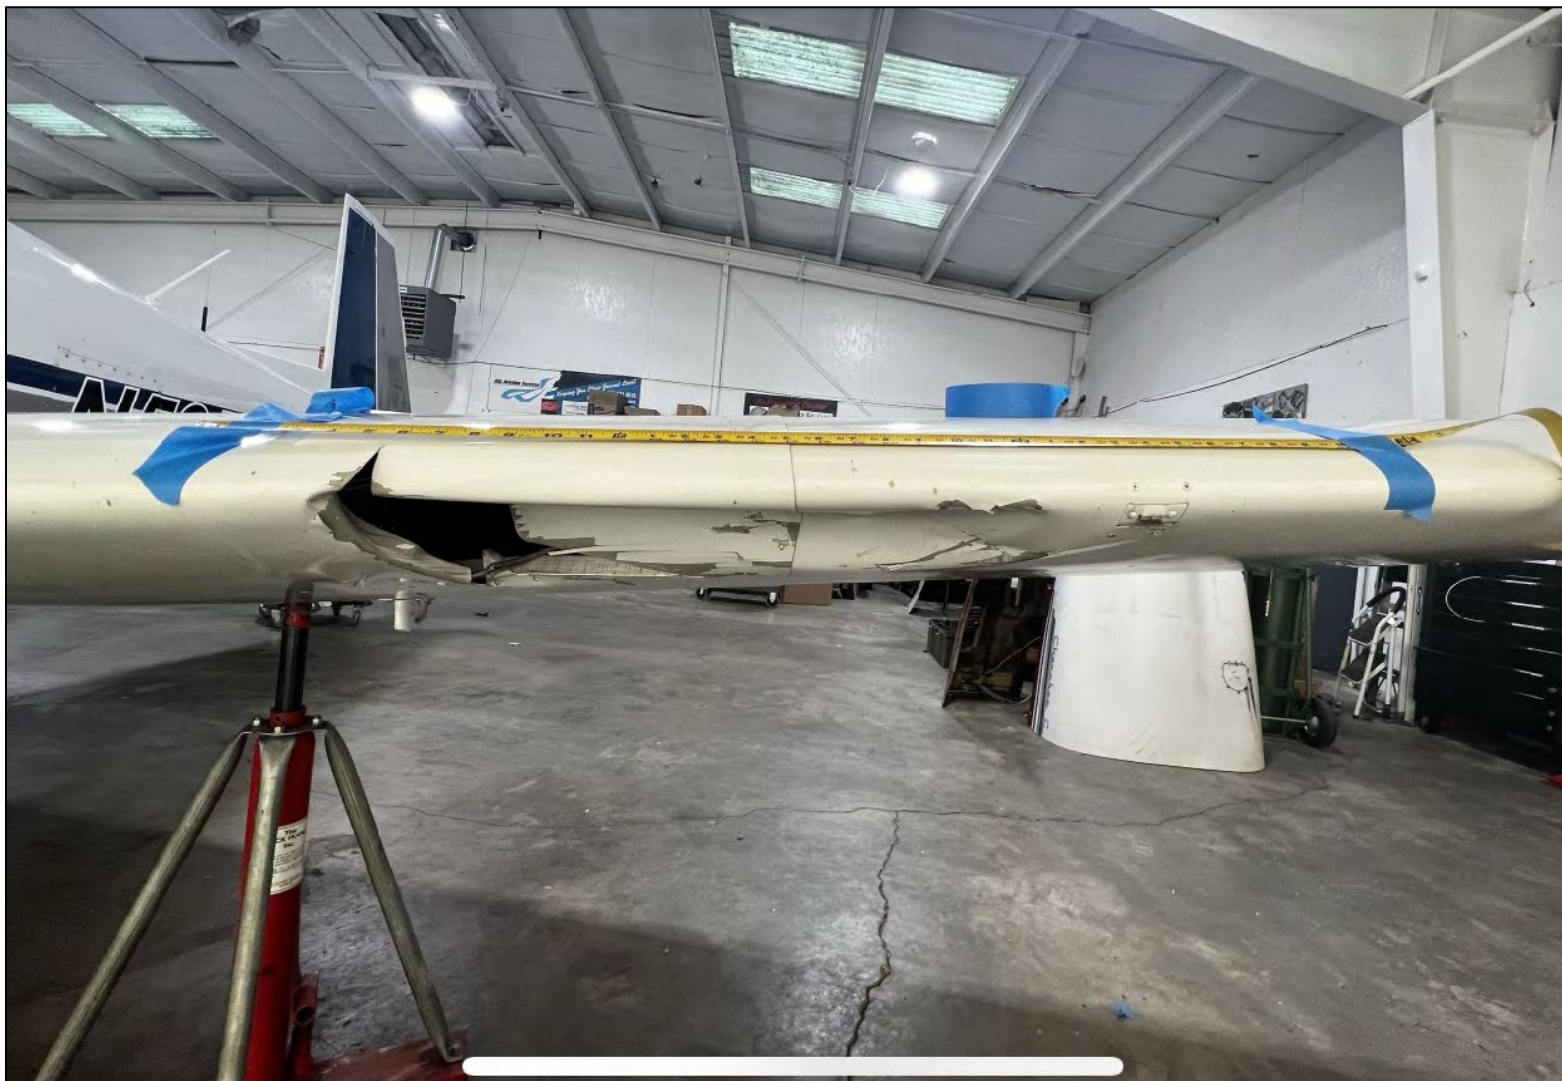
**Photo 5: View of the damaged left wing (Photo Courtesy of FAA)**

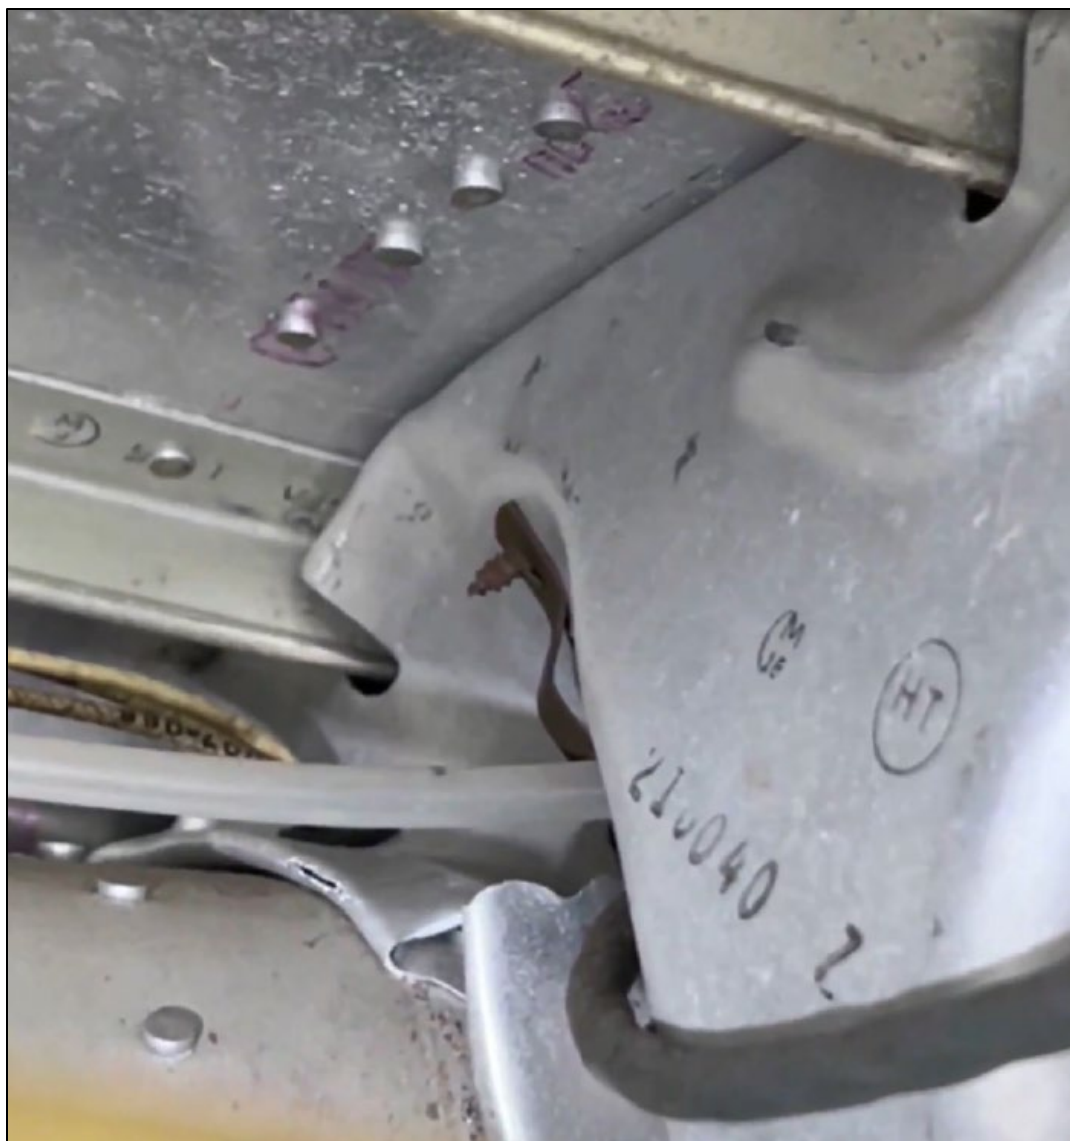
**Photo 6: View of the damaged left wing, internal view. (Photo Courtesy of FAA)**
