ERA24LA087

## INVESTIGATION PHOTOGRAPHS

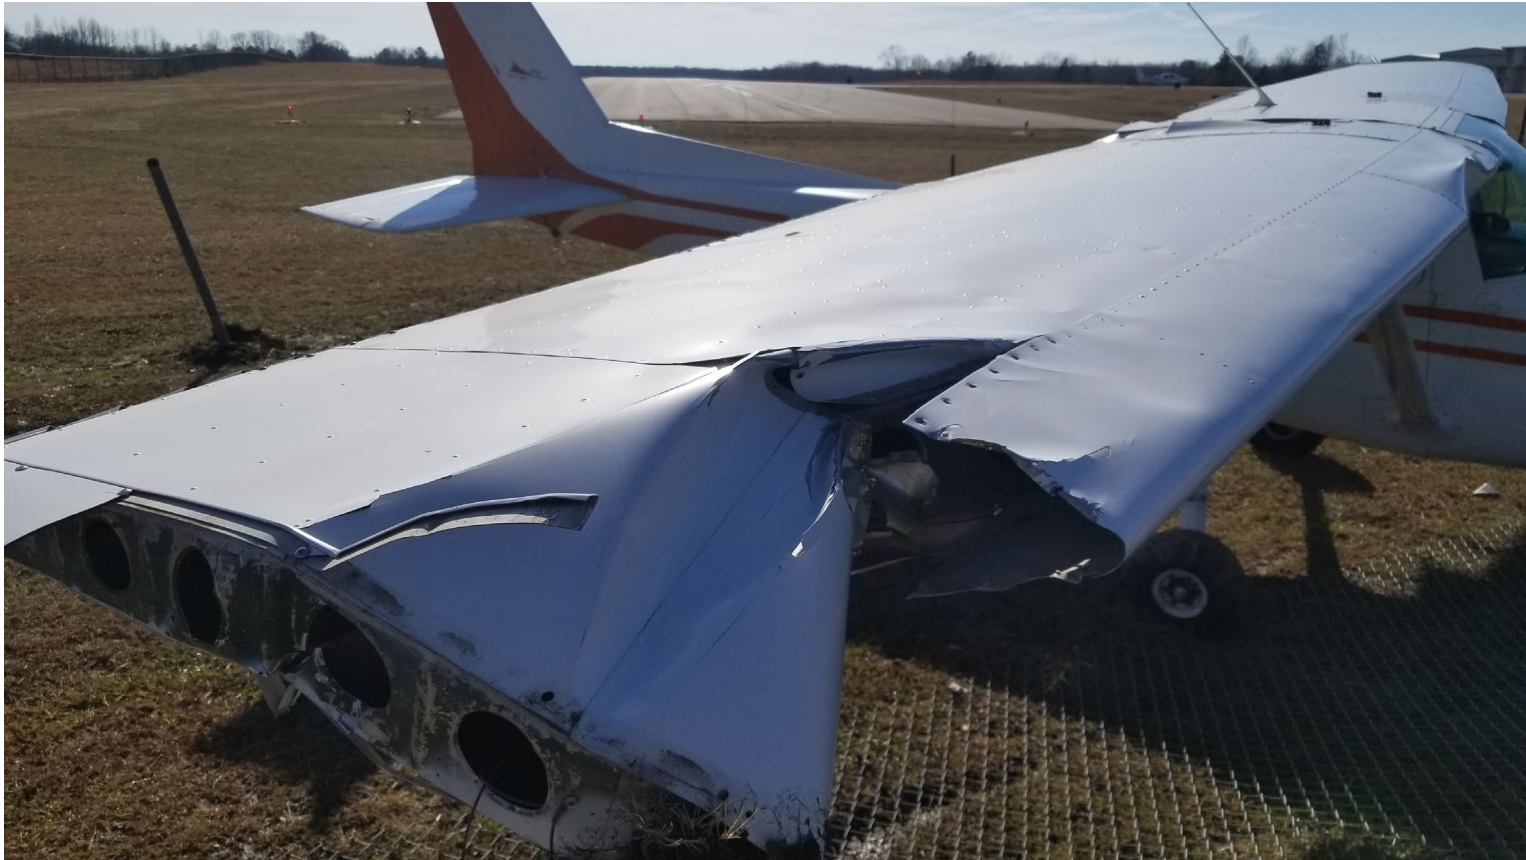
**Photograph 1 - View of right damaged wing and spar. (Courtesy of FAA)**

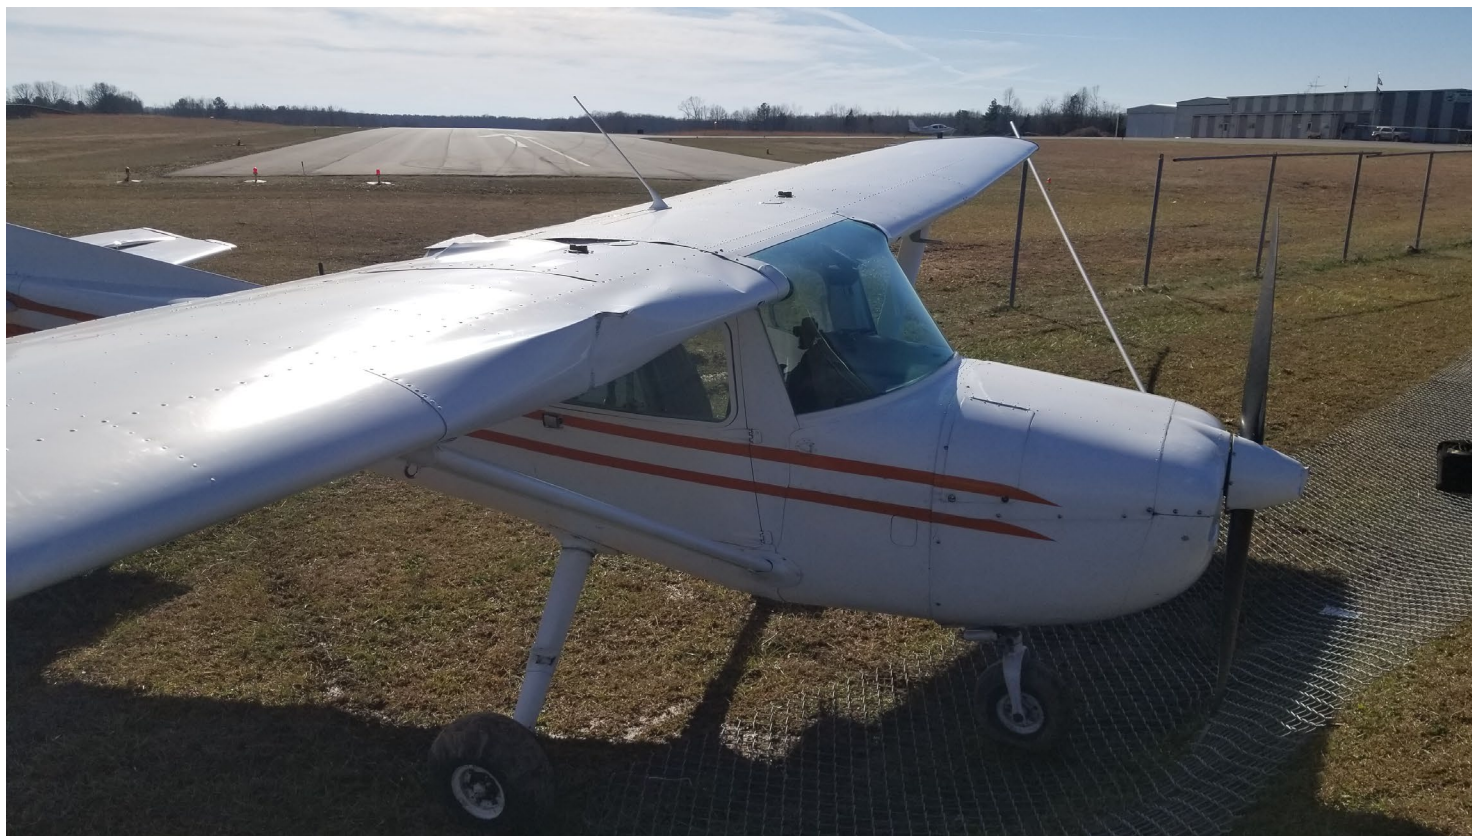
**Photograph 2 - View of airplane in the security fence. (Courtesy of FAA)**

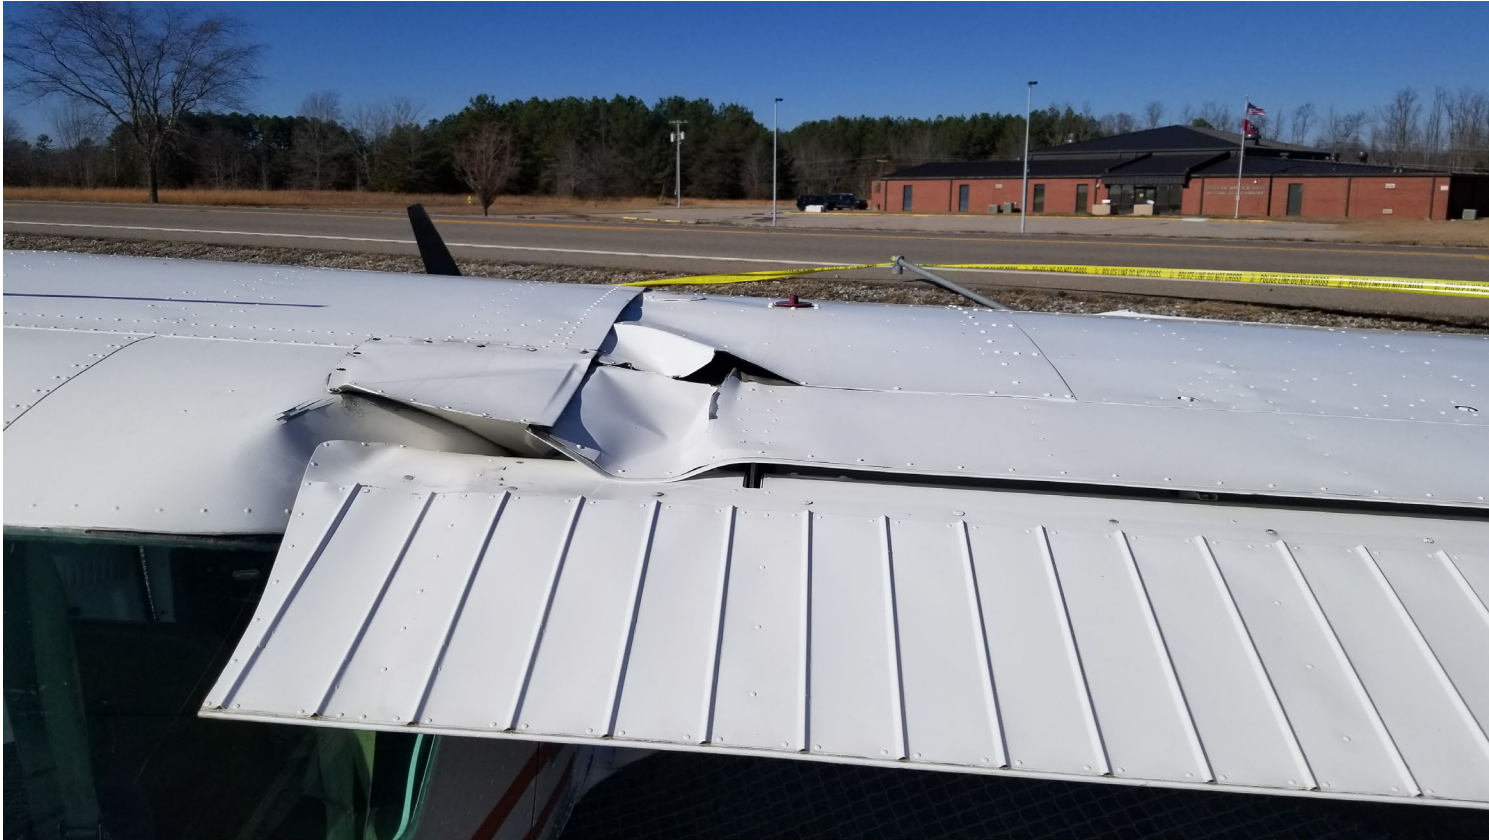
**Photograph 3 - View of damaged right wing aft. (Courtesy of FAA)**

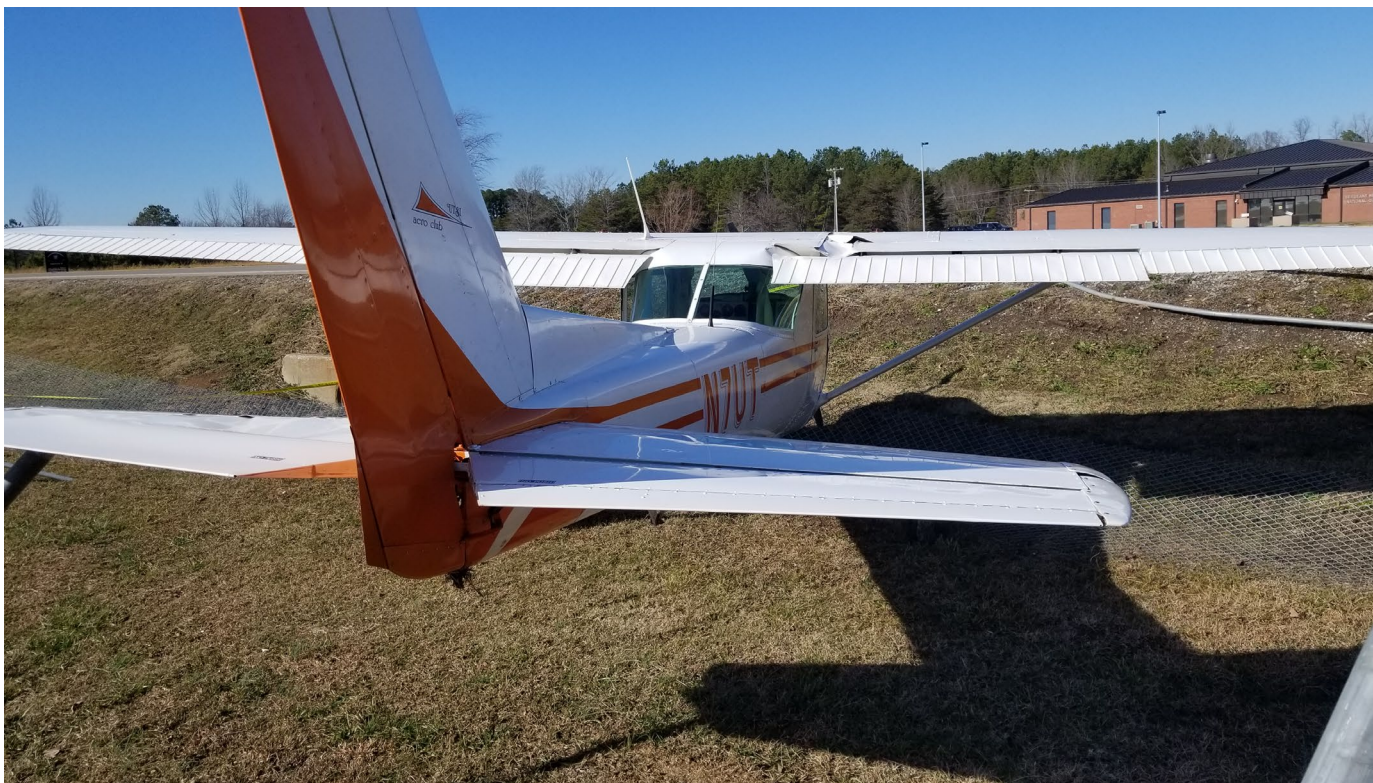
**Photograph 4 - Aft view of airplane in security fence. (Courtesy of FAA)**
