ERA24LA089

## INVESTIGATION PHOTOGRAPHS

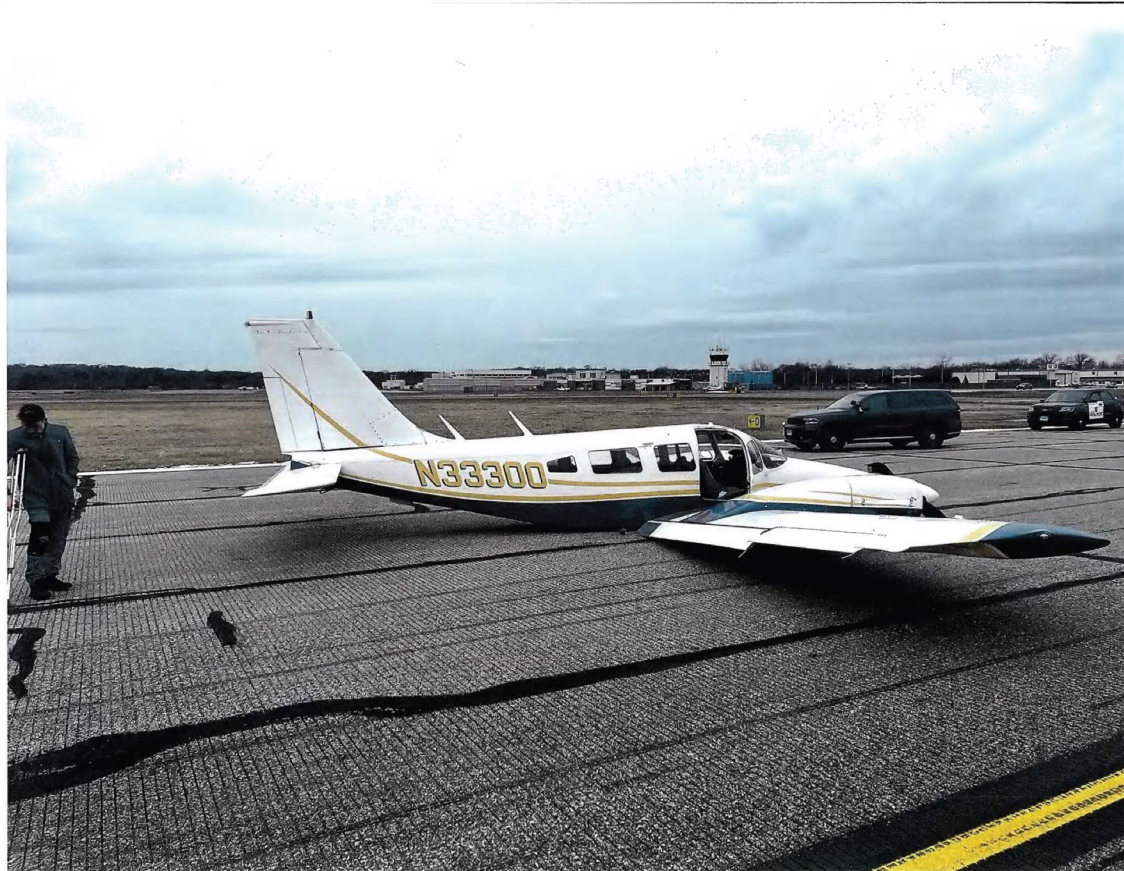
**Photograph 1 - Aircraft on runway (Courtesy of FAA)**

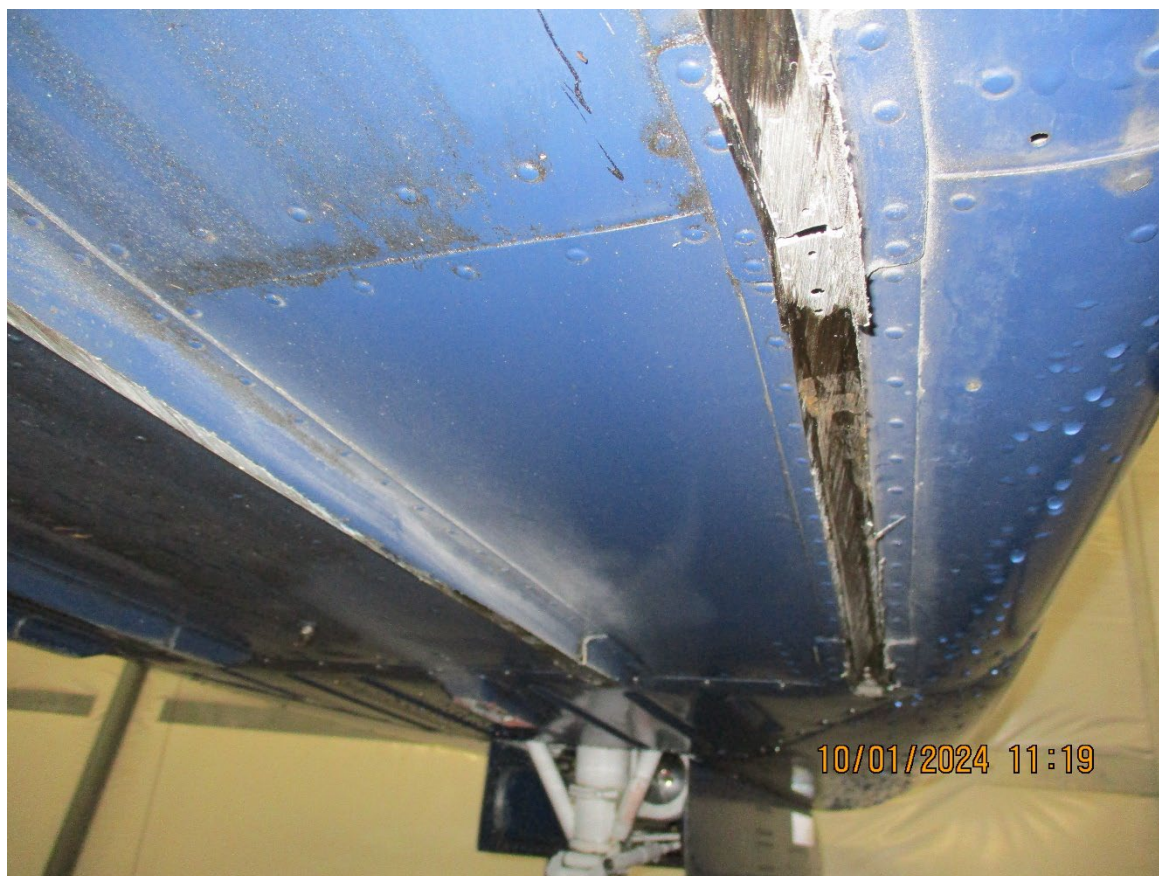
**Photograph 2 - Damage to external longerons (Courtesy of FAA)**

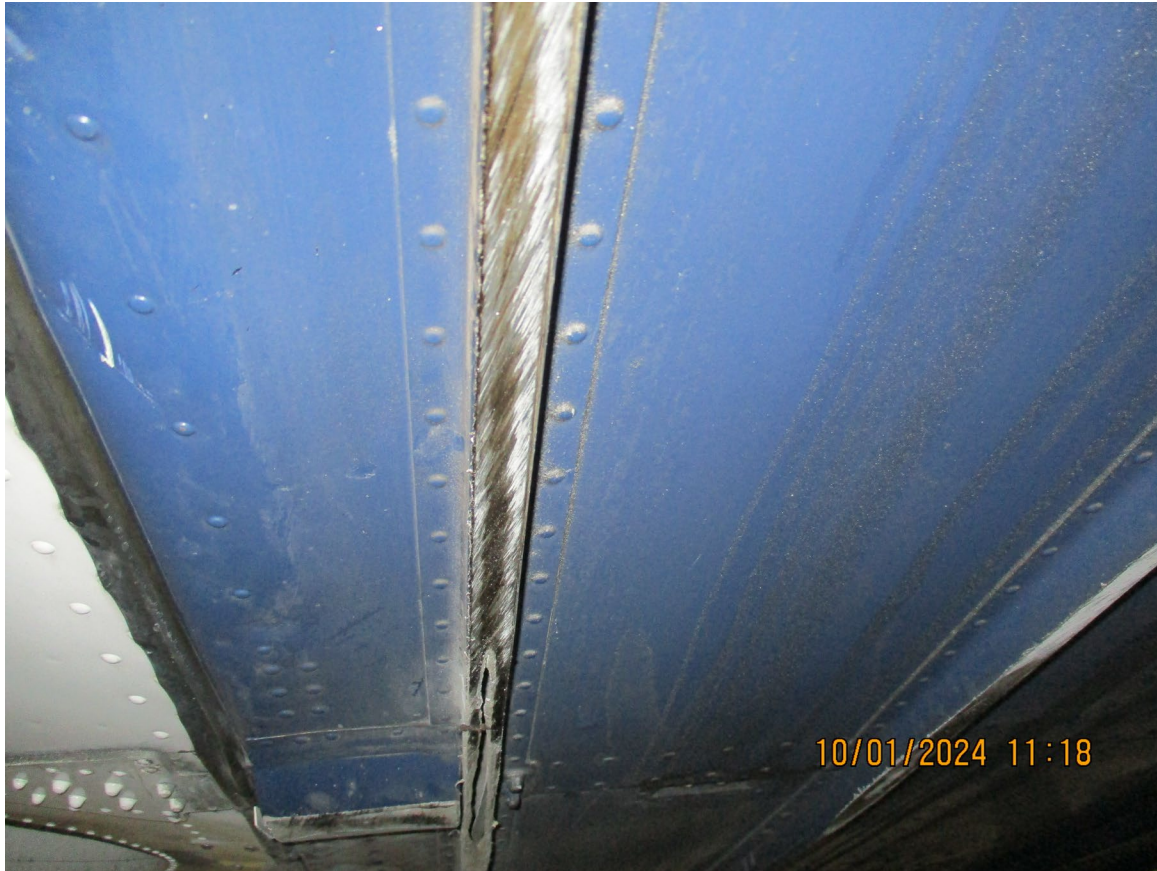
**Photograph 3 - Damage to external longerons (Courtesy of FAA)**

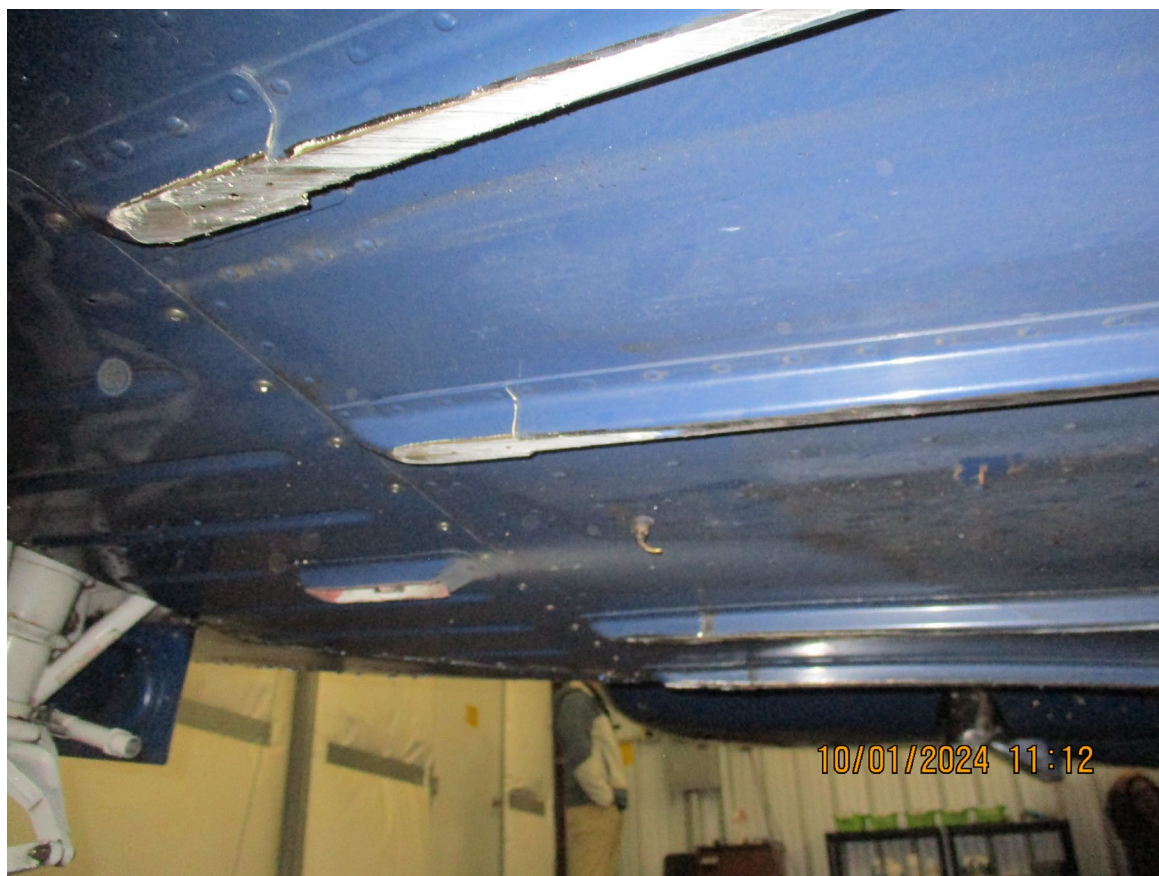
**Photograph 4 - Damage to external longerons (Courtesy of FAA)**
