ERA24LA092

## INVESTIGATION PHOTOGRAPHS

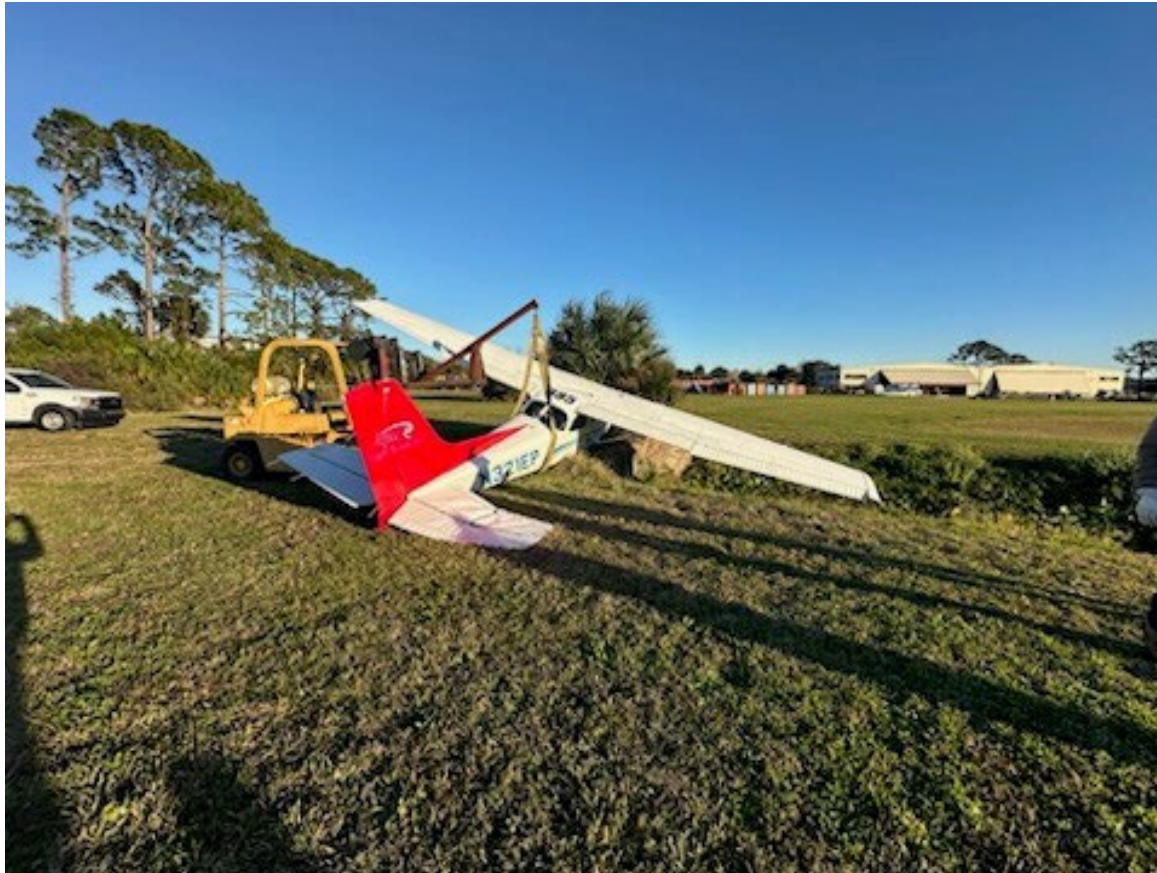
**Photograph 1 - Airplane Resting Position Overview (Courtesy of FAA)**

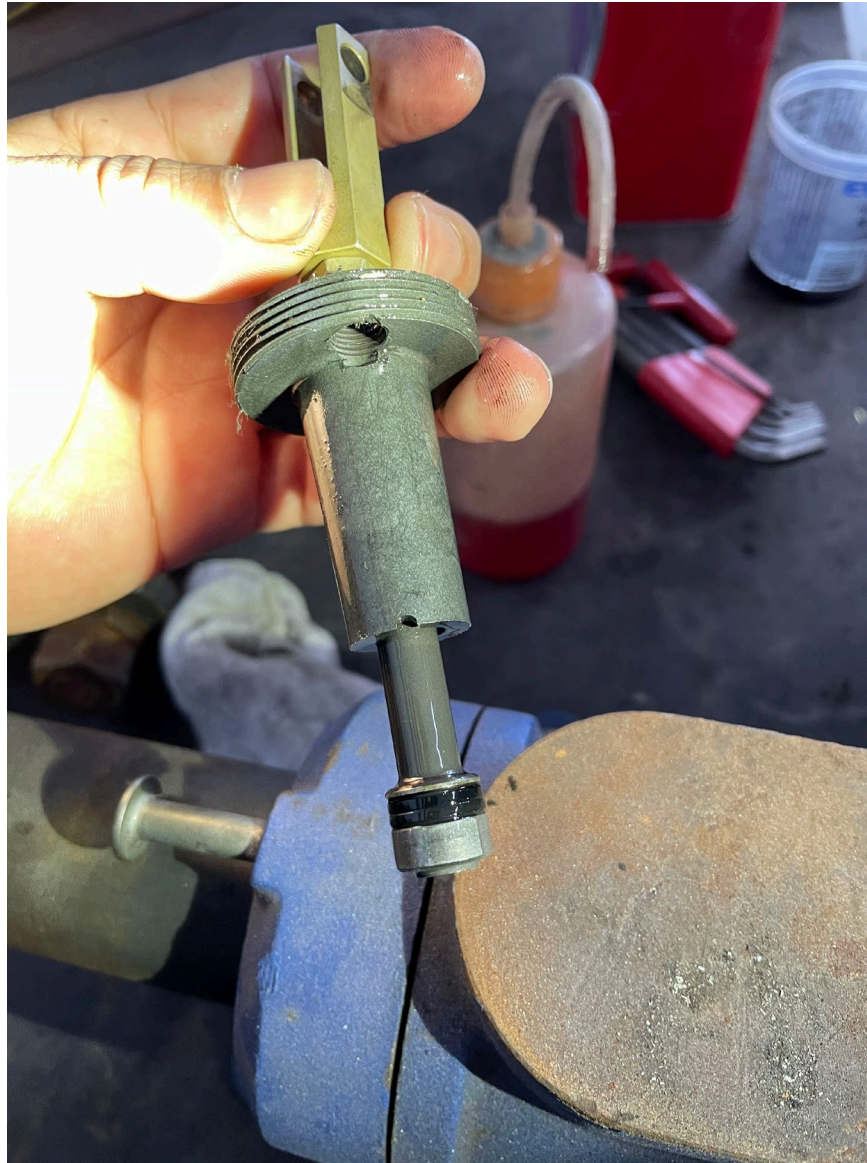
**Photograph 2 - Master Cylinder Piston as Removed (Courtesy of FAA)**

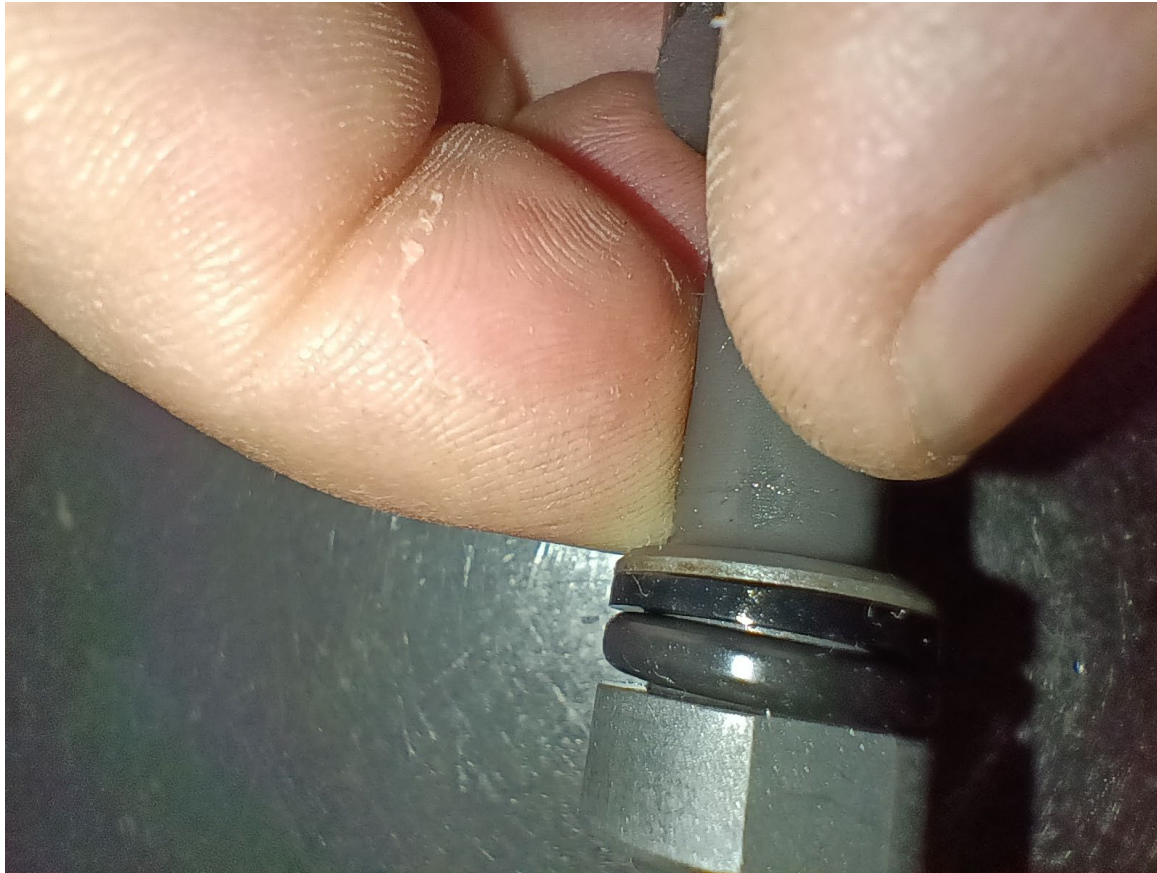
**Photograph 3 - O-ring and Backup Ring (Courtesy of FAA)**
