Ryan Enders  
Aviation Accident Investigator  
Eastern Region

**Subject:** ERA24LA092 Master Cylinder Photo Examination

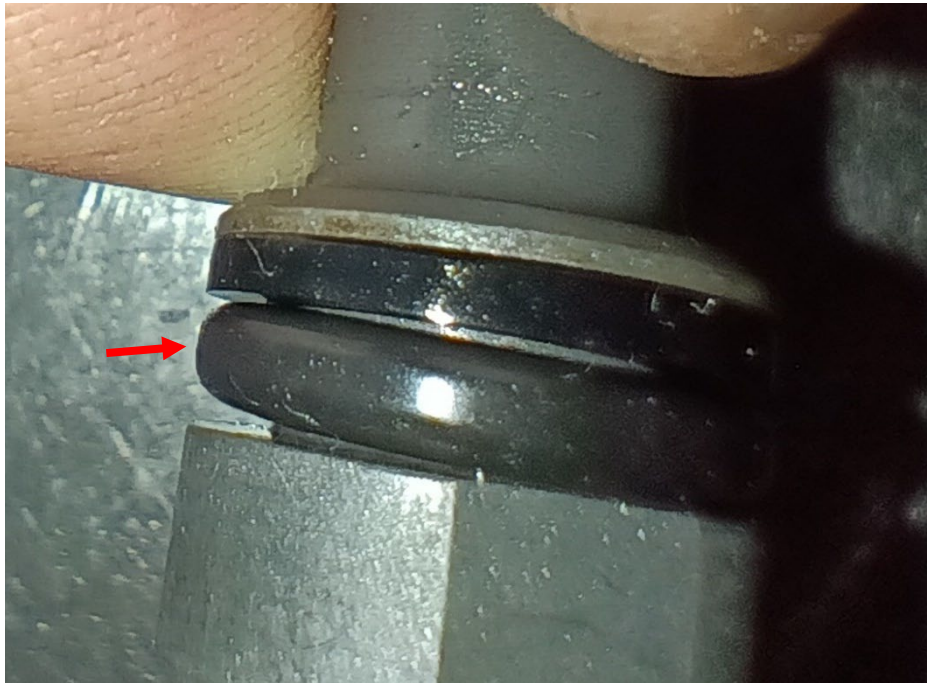
Review of the photographs appear to show that the o-ring took set and received flat spots. Photograph 1 shows flat spots on the outer edge of the o-ring. The maintenance mechanic was asked to remove the o-ring and backup ring for additional photographs. Photograph 2 shows the backup ring on the left and o-ring on the right as removed. The backup ring was damaged during the removal process. After review of the photographs provided by the FAA inspector, the maintenance mechanic was asked to photograph the removed o-ring beside a new o-ring of the same part number (MS28775-110) on January 31, 2024. Photograph 3 shows the new o-ring on the left and the removed o-ring on the right. The removed o-ring appears to have set and taken flat spots, as indicated with arrows, when compared to the

**Photograph 1 – Flat spot/setting of o-ring (Courtesy of FAA)**

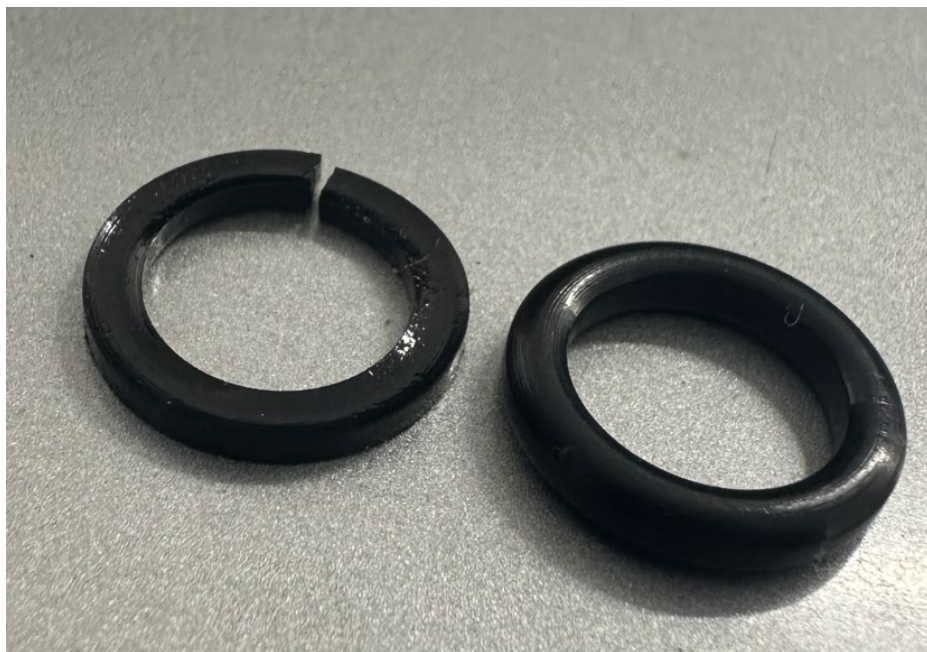
**Photograph 2 – O-ring and backup removed (Courtesy of FAA)**

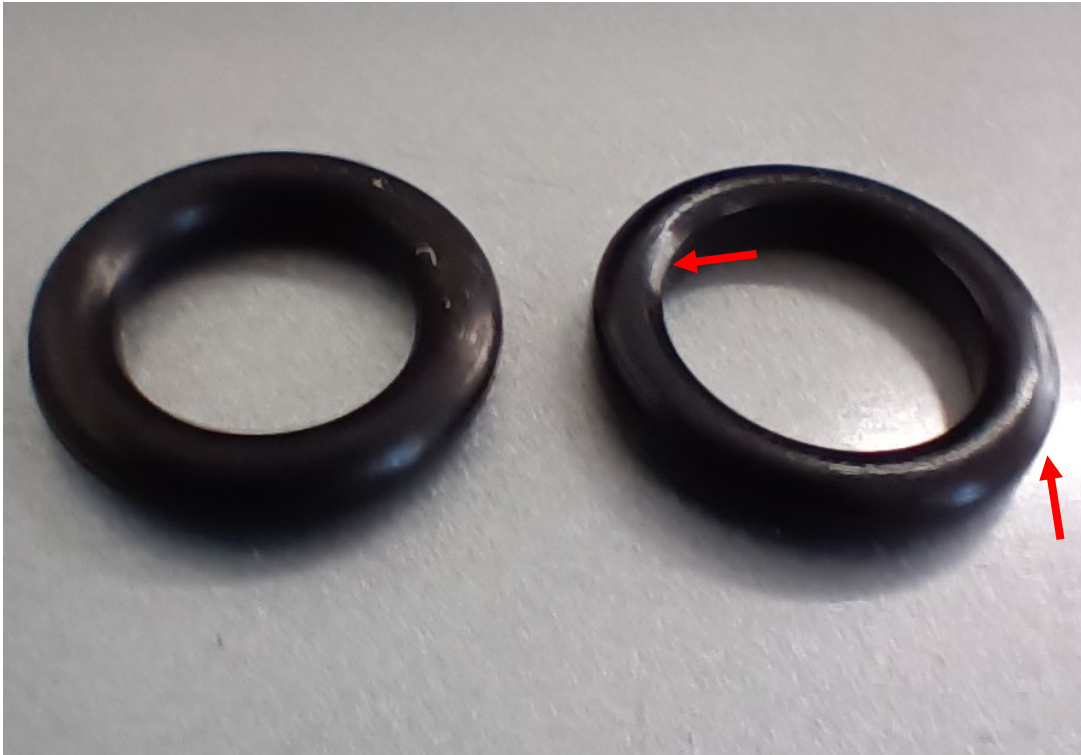
**Photograph 3 – Removed o-ring and new o-ring (Courtesy of Epic Flight Academy)**
