# National Transportation Safety Board

ERA24LA094

## **POWERPLANTS**

Group Chair's Factual Report

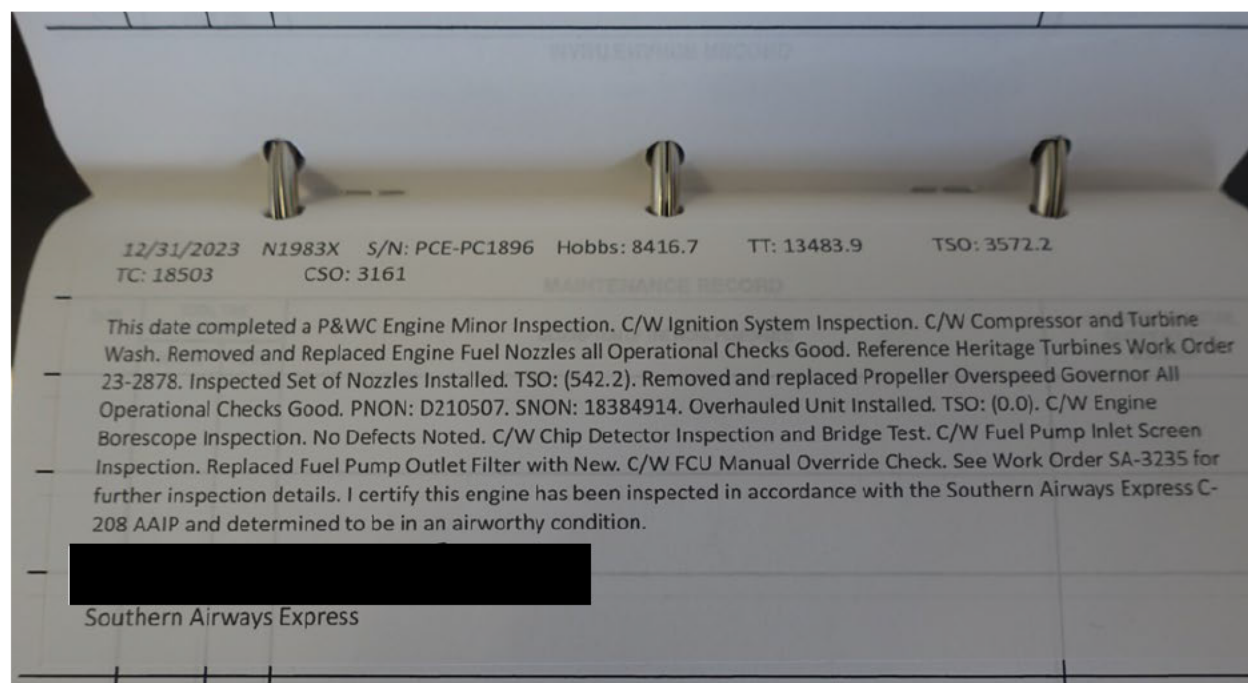
**Photo 1- Engine Logbook Entry- December 31, 2023**

PC1896 was installed on the incident airplane on September 14, 2020. The last engine related maintenance was completed by Southern Airways Express on December 31, 2023, and included a P&WC engine minor inspection, ignition system inspection, compressor/turbine wash, fuel nozzle inspection, and propeller overspeed governor removal and replacement (**Photo 1**). The engine was operated on condition and had not undergone a hot section inspection or other heavy maintenance since major overhaul.

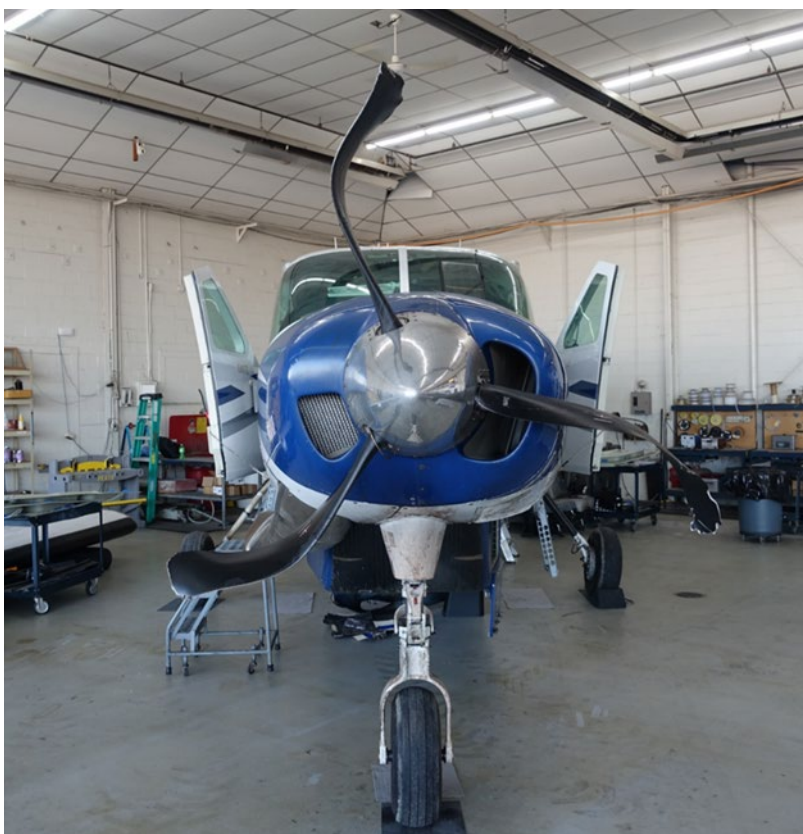
**Photo 3- Propeller, as Received**

The three propeller blades all exhibited impact damage including gouging and blade tip material loss. The blade tips were all bent opposite the direction of rotation. Blades 1 and 2<sup>2</sup> were in the feathered position and Blade 3 was rotated 180 degrees relative to the other two blades. Two blade tip fragments were recovered from the highway and shipped in a box (**Photo 4**).

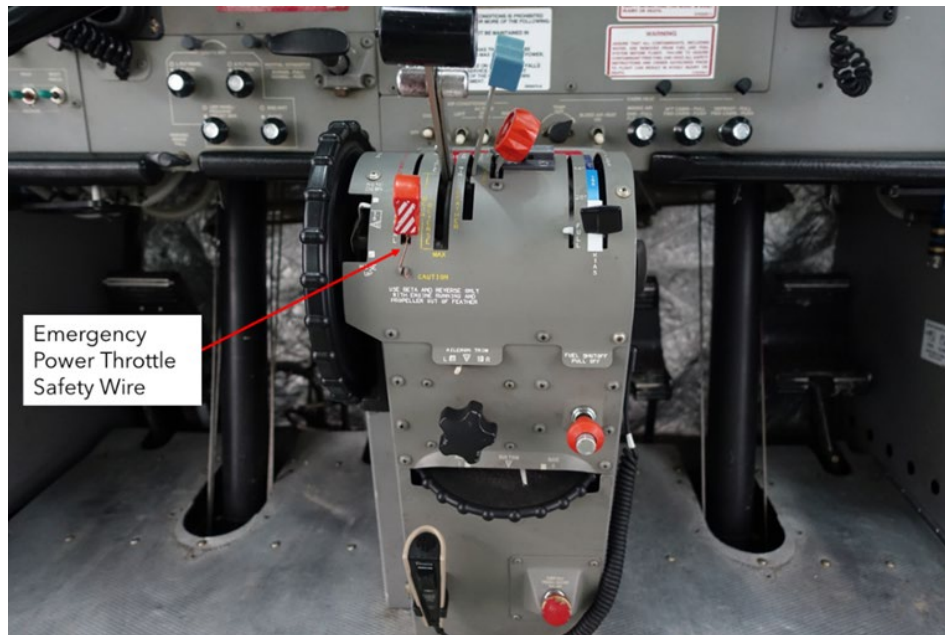
**Photo 5- Cockpit Throttle Quadrant**

The safety wire securing the emergency power throttle in the cockpit was intact (**Photo 5**).

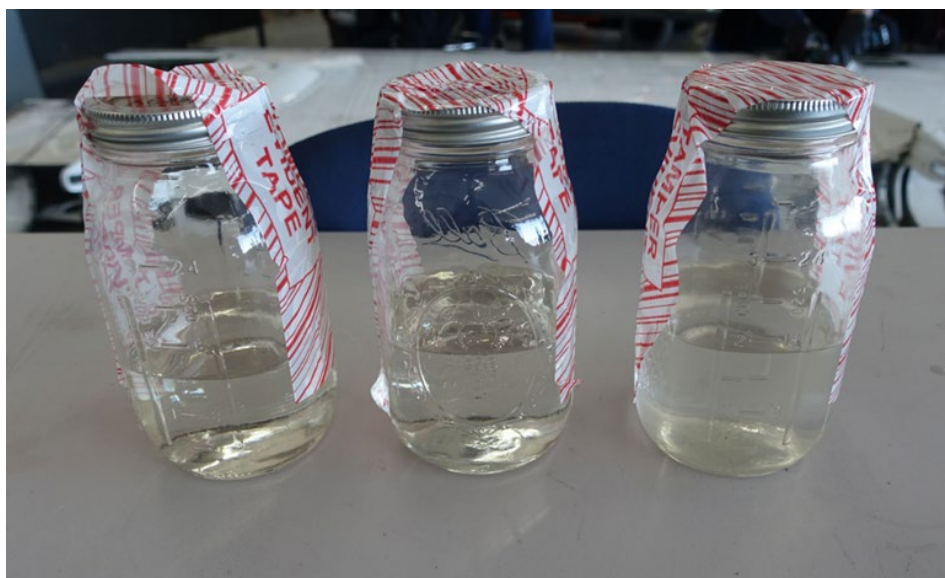
**Photo 6- Fuel Tank Samples**

Three fuel samples collected on scene from the left wing tank, right wing tank, and reservoir tank were shipped with the airplane. All samples were clear with no evidence of water or other contamination (**Photo 6**). The investigation team opted not to perform fuel sample testing due to a lack of evidence that fuel contamination was a contributing factor in the incident.

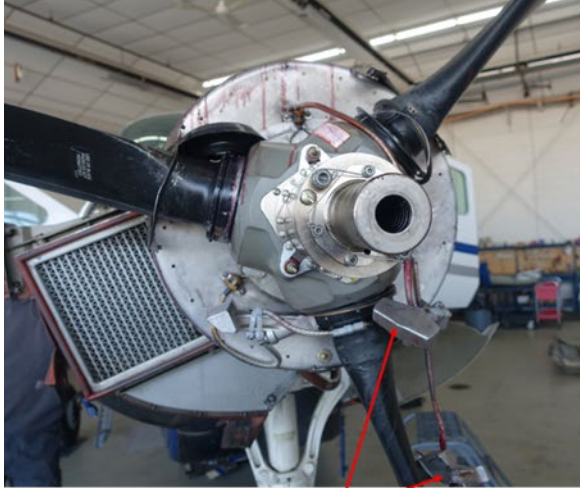
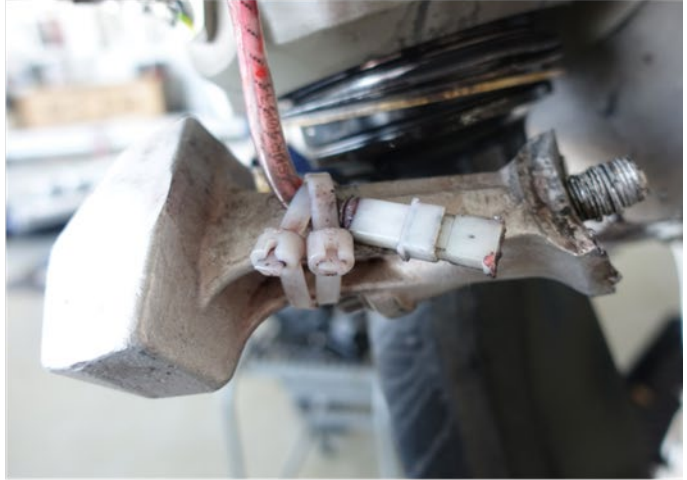
**Photo 7- Propeller Blade Counterweights, Separated**

The propeller nose cone was removed to examine the propeller hub. The counterweight attaching studs on Blades 1 and 3 were pulled out of the hub and the threads exhibited deformation (**Photo 7**). The counterweight attaching stud on Blade 2 was below torque specification and when removed, the threads also exhibited deformation. The pitch of all three blades could be rotated by hand with minimal resistance.

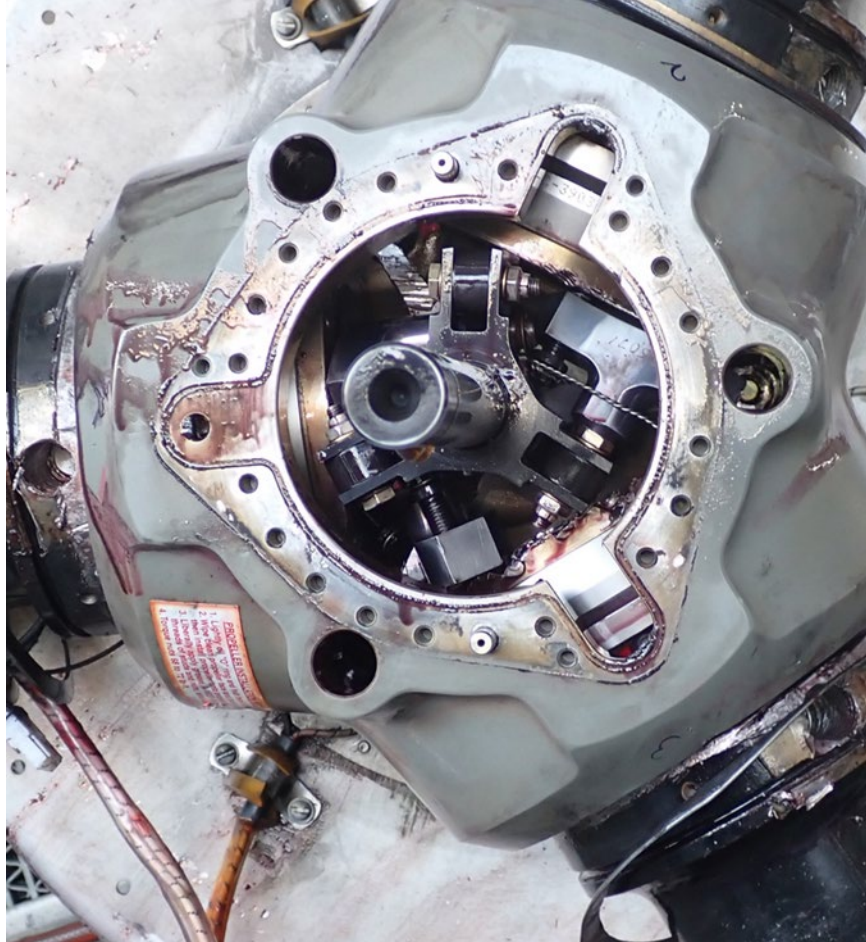
**Photo 8- Propeller Blade Pitch Change Attaching Linkage Damage**

The propeller piston assembly was removed, and all pitch change attaching linkages inside the hub were fractured (**Photo 8**). The blade shanks had impact damage and gouging. The propeller was removed as an assembly and packaged for shipment to McCauley Propeller in Wichita, Kansas. The counterweight, nose cone, and propeller logbook were included in the shipping crate (**Photo 9**).

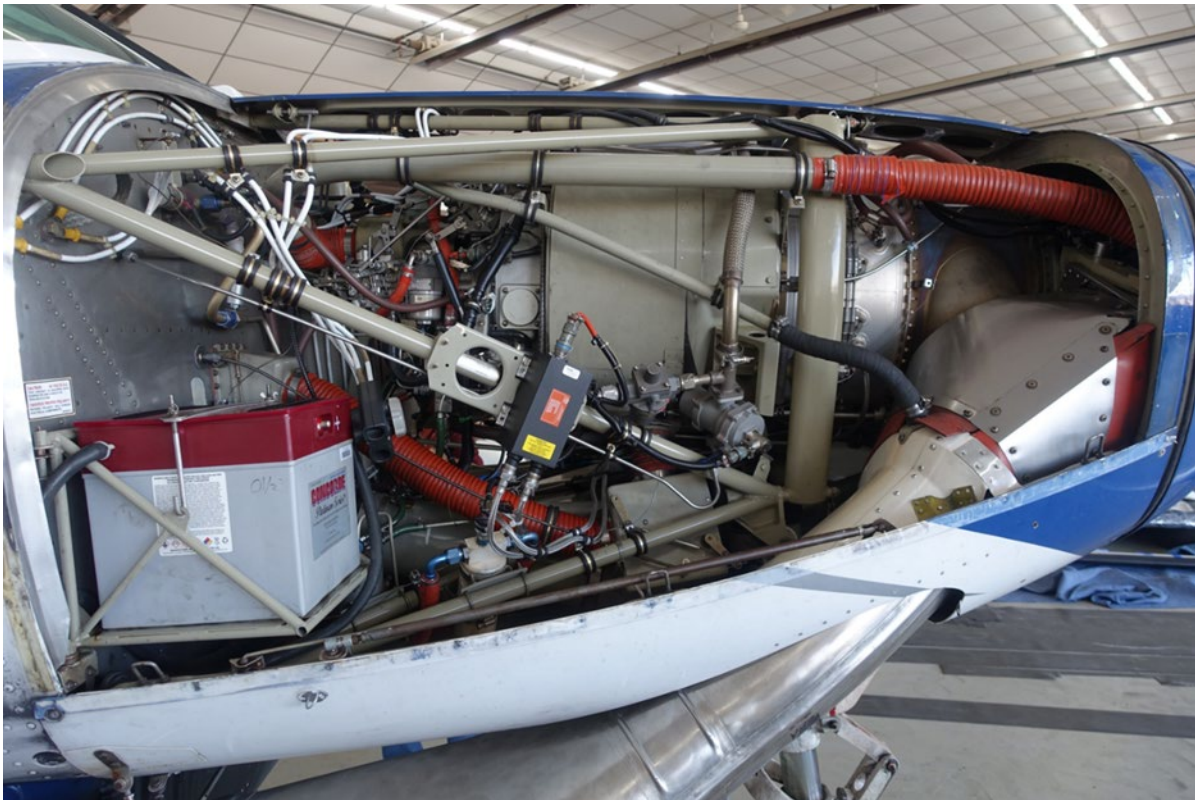
**Photo 10- N1983X Engine Bay**

External engine surfaces appeared unremarkable with no evidence of uncontainment or undercowl fire (**Photos 10 and 11**). The gas generator (Ng) spool was manually rotated by turning the alternator/alternator pad in the accessory gearbox (AGB). The Ng spool rotated smoothly with no audible grinding. The reduction gearbox (RGB) and AGB magnetic chip detector plugs had no significant debris accumulation (**Photo 12**). The fuel, oil, and P3<sup>3</sup> filters were in good condition and free of debris (**Photos 13**). The P3 and Py<sup>4</sup> b-nut connections on the propeller governor, FCU, and bulkhead were torqued, and safety wired. A safety wire could be not inserted through the forward or aft clevis inspection holes that function as check points for proper thread engagement during engine rigging. The beta arm was installed on the correct side of the beta arm retaining pin and the beta block was intact and secure (**Photo 14**).

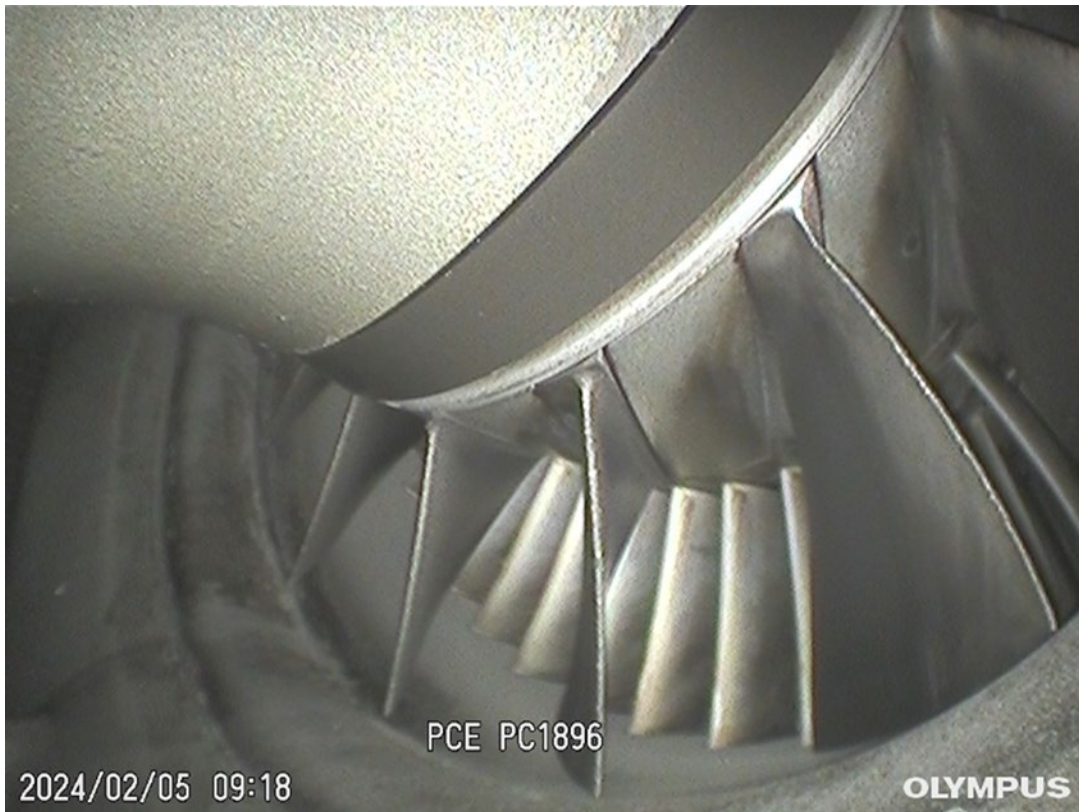
**Photo 15- Borescope Photo of 1<sup>st</sup> Stage Axial Compressor and 1<sup>st</sup> Stage Stator Vanes**

A borescope was inserted into the engine inlet to inspect the axial compressor blades. Minor 1<sup>st</sup> stage compressor leading edge erosion was observed but there was no evidence of impact/foreign object damage (FOD) on visible rotor blades or stator vanes (**Photo 15**). A fuel nozzle was removed to inspect the combustion liner, fuel nozzles, and compressor turbine. The combustion liner had minor discoloration but there was no evidence of burn through or excessive coking (**Photo 16**). According to PWC, the combustor condition was typical of similar service run engines. The power turbine blades visible through the exhaust were all complete and unremarkable. The PT rotor spun smoothly with no audible grinding (**Photo 17**).

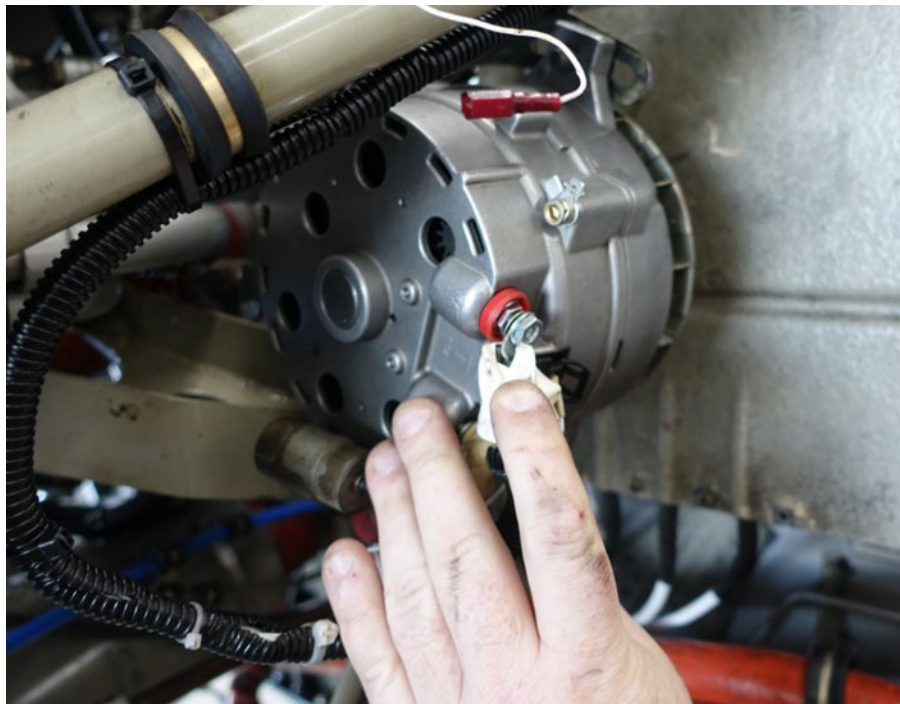
**Photo 18- Engine Alternator Power Cable Attaching Lug**

An engine alternator positive power cable attaching lug nut was partially backed off (**Photo 18**). The engine was removed from the airframe and placed in an engine container for shipment to PWC in Bridgeport, West Virginia for additional examination and testing (**Photo 19**).
