## Air Safety Investigations Aircraft Incident/Accident Technical Report

| <b>Aircraft Incident/<br/>Accident Information</b> | Year: 2003 | Make: Cessna | Model: 208B |
| Senior Air Safety Investigator: Casey J. Love | | Report #: ASI-24-AJ-T | Report date: 06-26-24 |

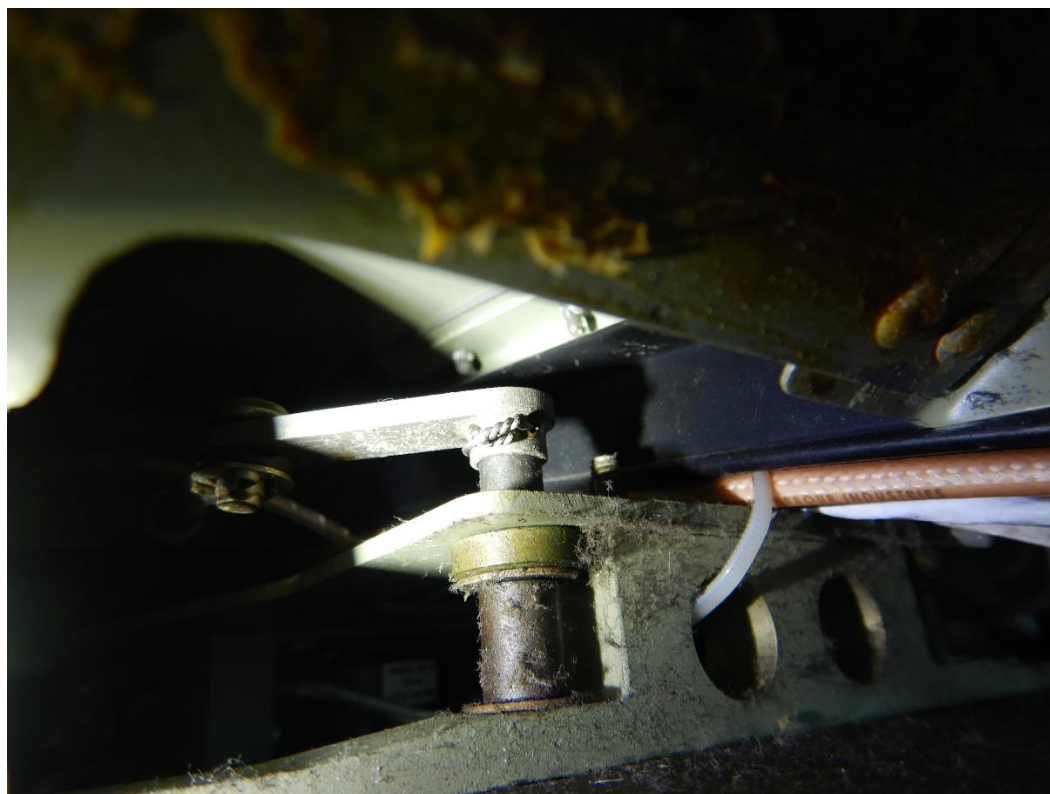
The wings were removed from the aircraft for transportation prior to the examination. The pilots reportedly turned the fuel off before exiting the aircraft. The fuel system was examined and found to be free of restrictions. Electrical power was applied, and the auxiliary fuel pump was tested satisfactorily. The fuel selector warning horn circuit breaker (CB) was collared to prevent intentional deactivation, as required, and the horn sounded satisfactorily. The reservoir fuel tank fuel level warning activated when approximately three gallons of fuel was drained from it. When the fuel shutoff valves were actuated by hand, the associated warning switch contacts were heard actuating. The fuel shutoff handles in the cockpit overhead were examined and found to be intact and operational. The fuel firewall shutoff valve cable was observed to be securely attached and operated normally when the handle was actuated.

ASI-24-AJ-087 (Fuel Shutoff Handle Cable Attachment)

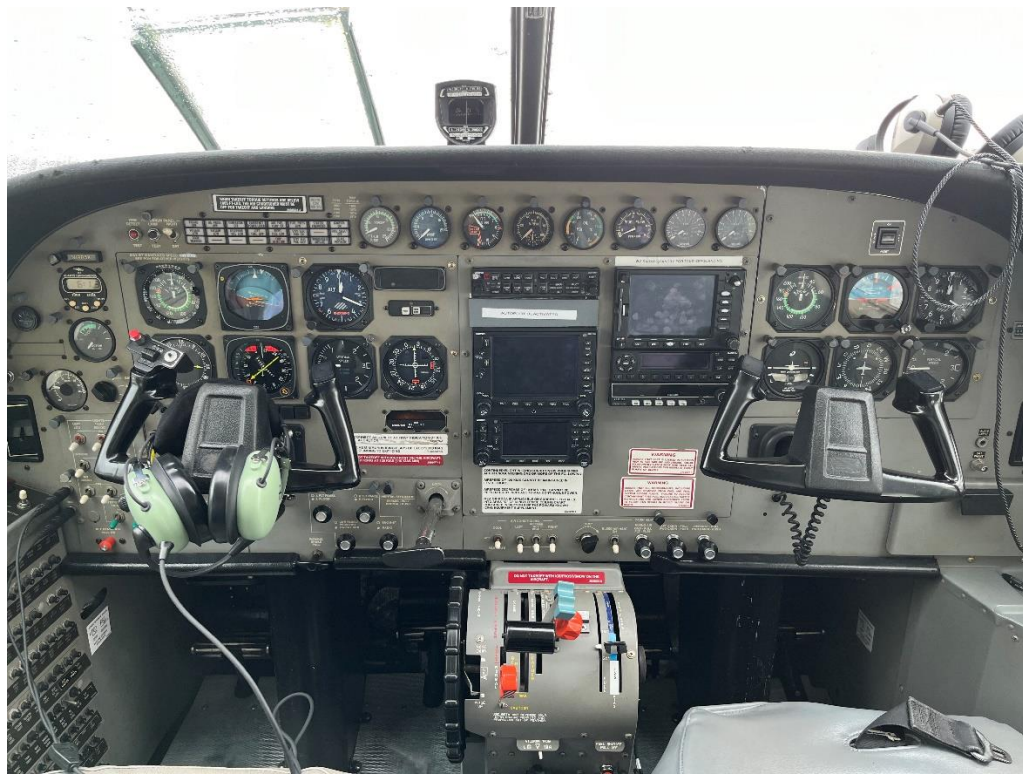
FAA On Scene Engine Controls and Inertial Separator Handle Photo

The Engine Instrument and Engine Control Position sections were derived from FAA on scene photographs. The engine cowling was removed from the aircraft prior to examination. The inertial separator was examined off the aircraft and functioned normally when actuated by hand.

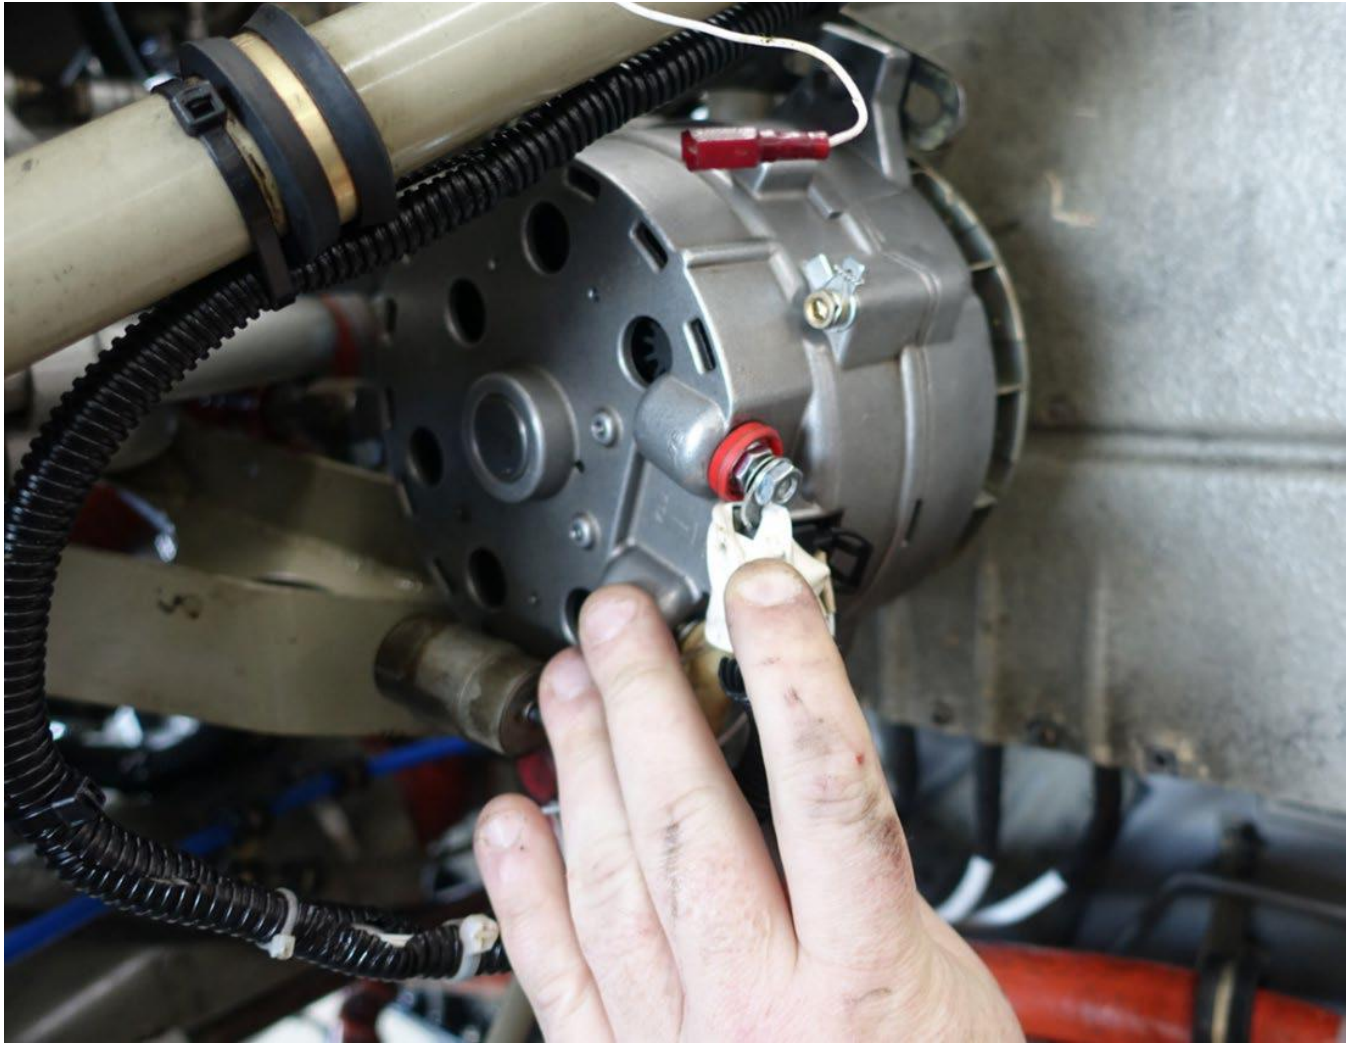
The positive power cable attaching lug nut was observed loose and backed off on the stand-by alternator.

NTSB Photo of Loose Power Cable

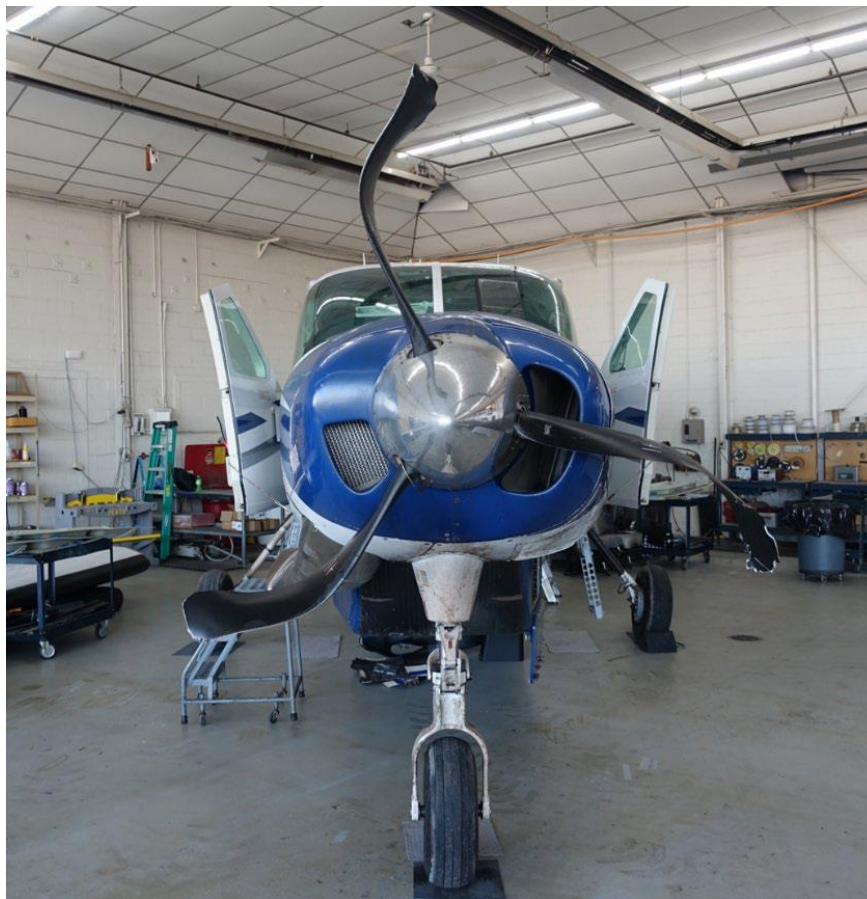
The three propeller blades all exhibited impact damage including gouging and blade tip material loss. The blade tips were all bent opposite the direction of rotation. Blades 1 and 2 were feathered and blade 3 was rotated 180 degrees relative to the other two blades. Two blade tip fragments were recovered from the highway and shipped in a box with the airplane.

*The propeller had sudden-failure type damage and gross part deflections typically associated with impact forces. The investigation found no evidence of any type of fatigue failure. There were no indications of any type of propeller failure or malfunction prior to the impact sequence.*

NTSB Photo (Propeller)
