# National Transportation Safety Board

ERA24LA094

## **OPERATIONAL FACTORS**

Specialist's Factual Report

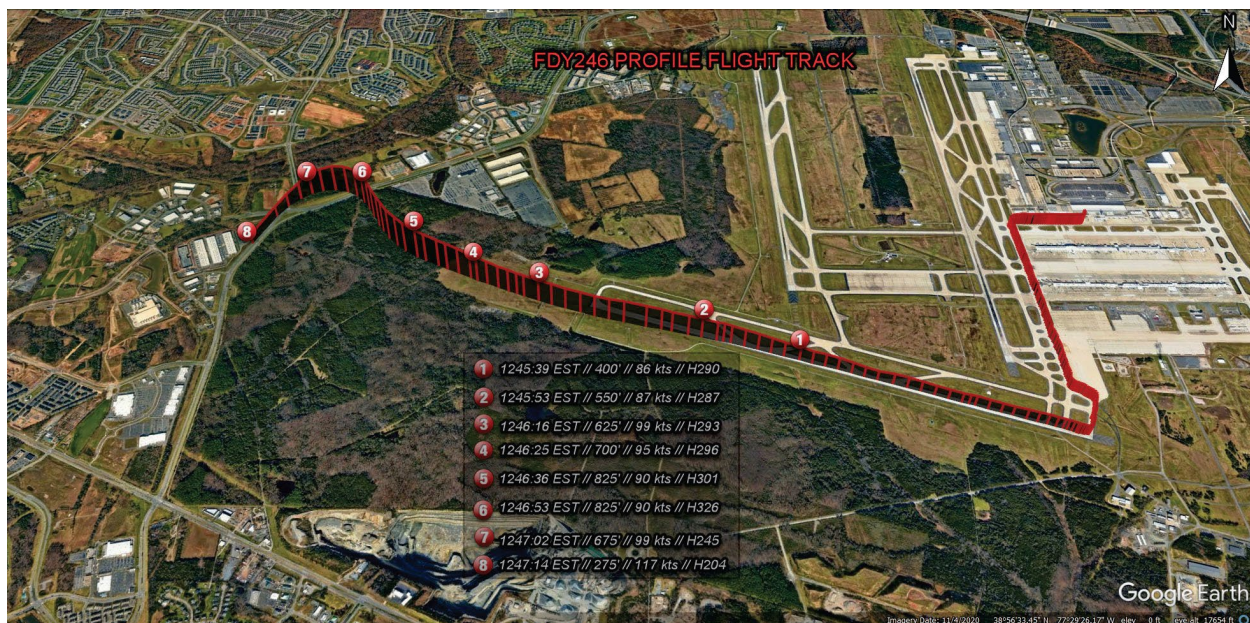
The data in this section was from ADS-B data obtained from ADS-B Exchange, which included groundspeed and uncorrected pressure altitude. Airspeed data was unavailable as the airplane was not equipped, nor required to be, with a flight data recorder. All altitudes are uncorrected pressure altitude and speeds are ground speed from ADS-B data. The incident aircraft began taxiing on the terminal ramp for takeoff about 1239. Takeoff roll commenced at 1244:30. The aircraft became airborne at 1245:06. At 1246:09 the aircraft reached barometric altitude of 900 ft and a speed of 94 kts. At 1246:38 the aircraft continued to climb to 1,100 ft but decelerated to a speed of 72 kts. About 12 seconds later the aircraft indicated at 1,100 ft but had decelerated to 40 kts. Eight seconds later the aircraft had descended to 900 ft and indicated 91 kts. At 1247:14, about 30 seconds after the initial vibration, the aircraft landed on a roadway and subsequently came to a stop on the shoulder. See attachment 2 for complete ADS-B data.

**Figure 1:** Profile view of the accident ground track: (Source: adsbexchange.com)
