ERA24LA095

## INVESTIGATION PHOTOGRAPHS

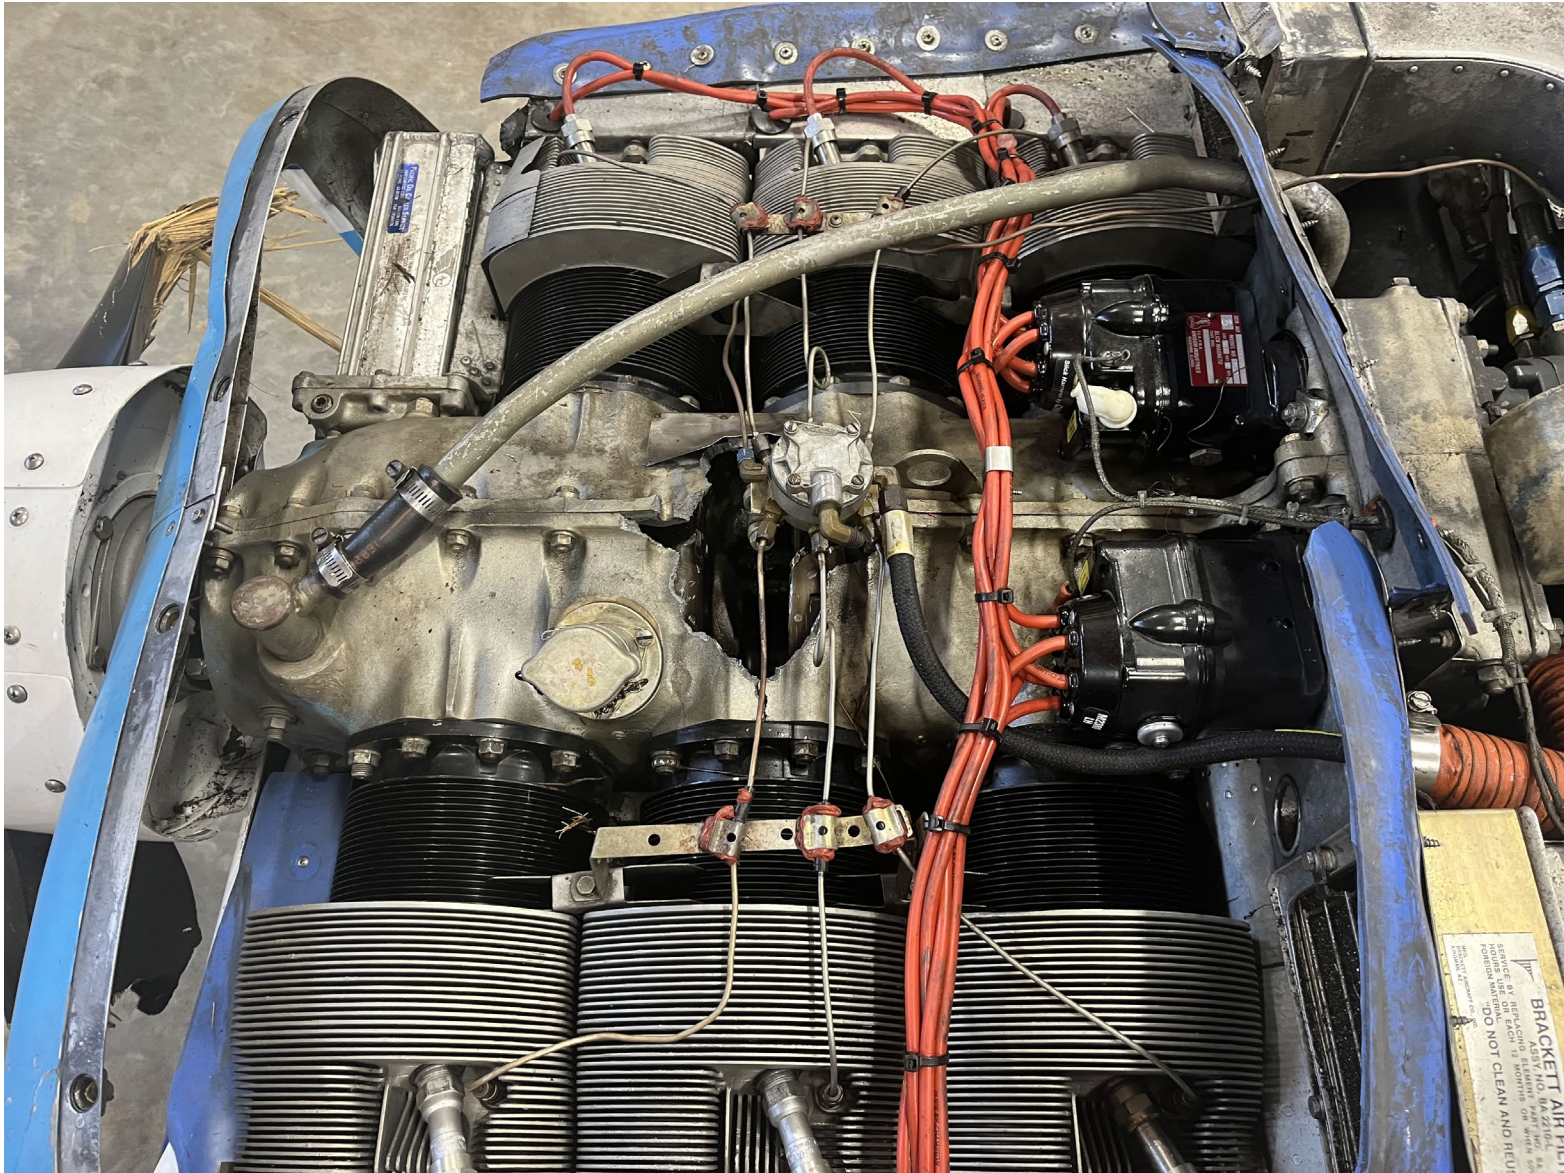
**Photograph 1 - Top of engine**

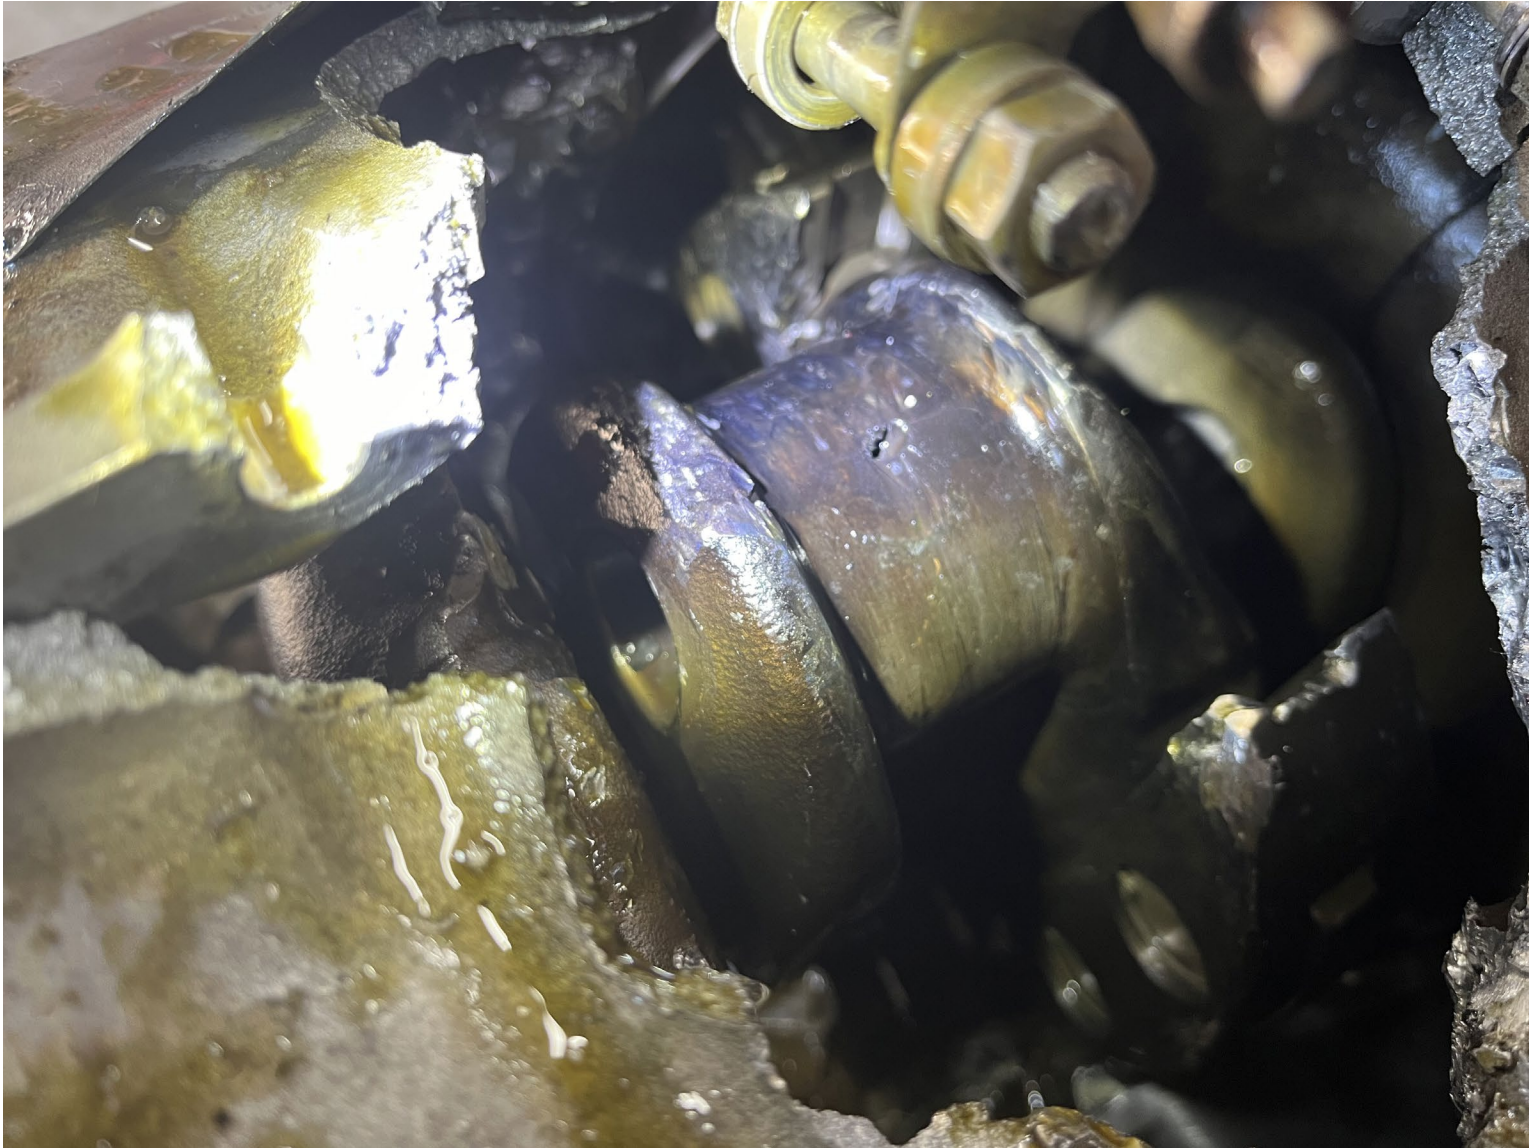
**Photograph 2 - No. 4 Main journal, note: blocked oil port**

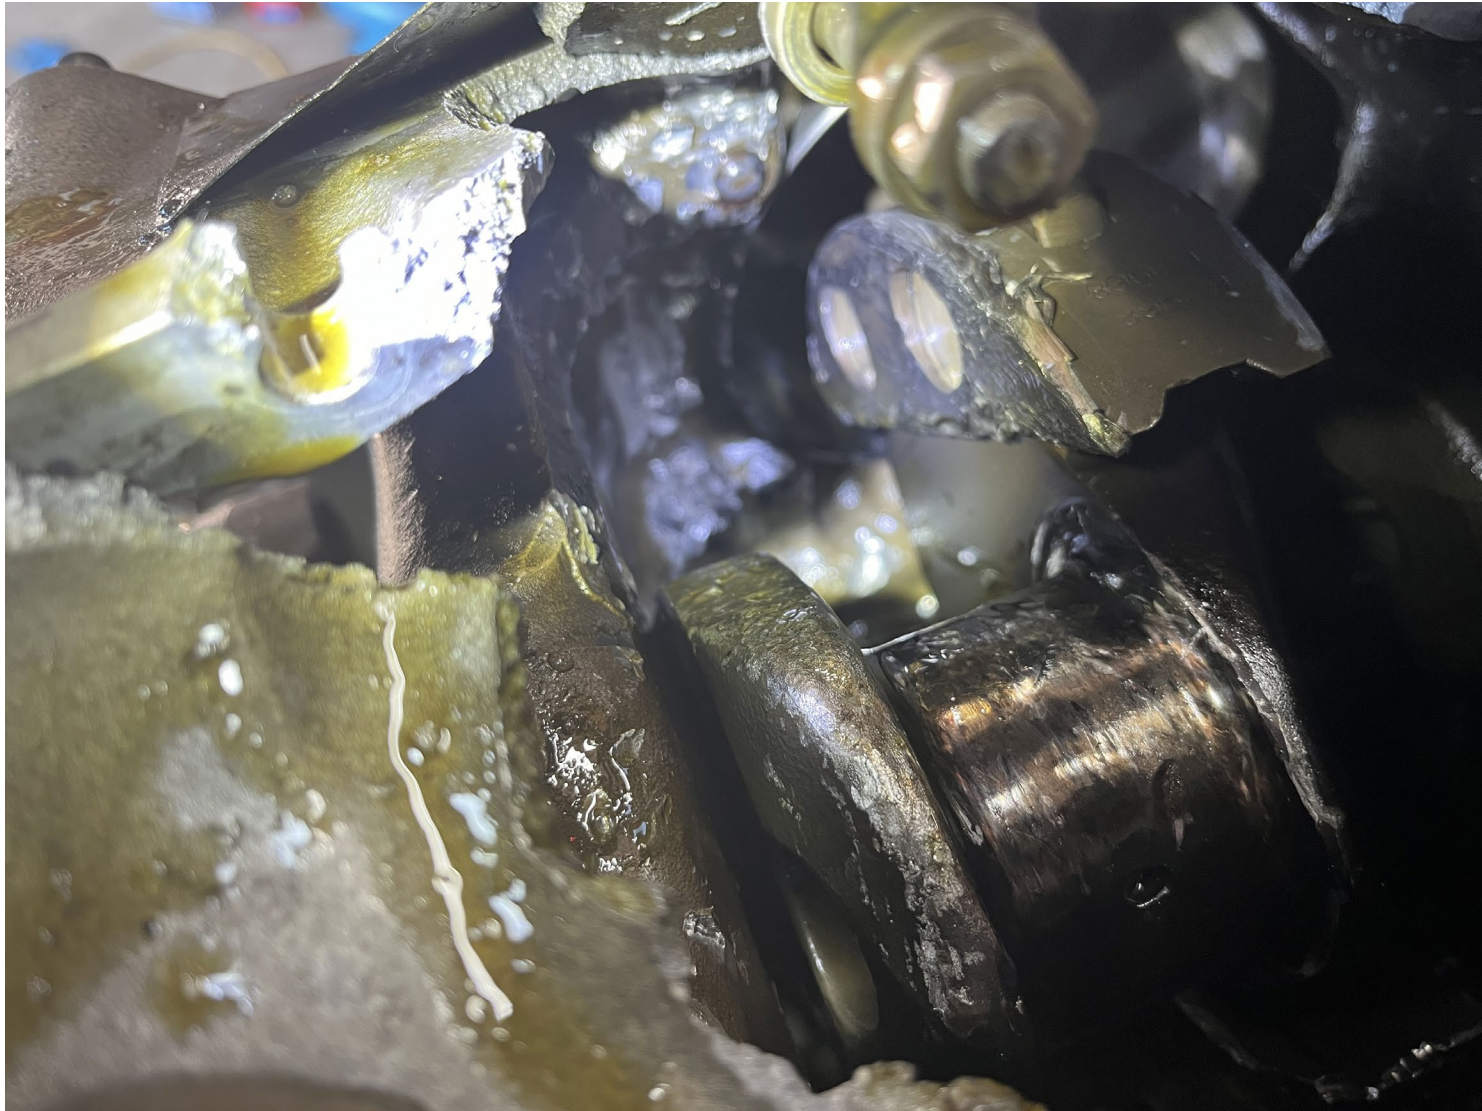
**Photograph 3 - No. 4 main journal**

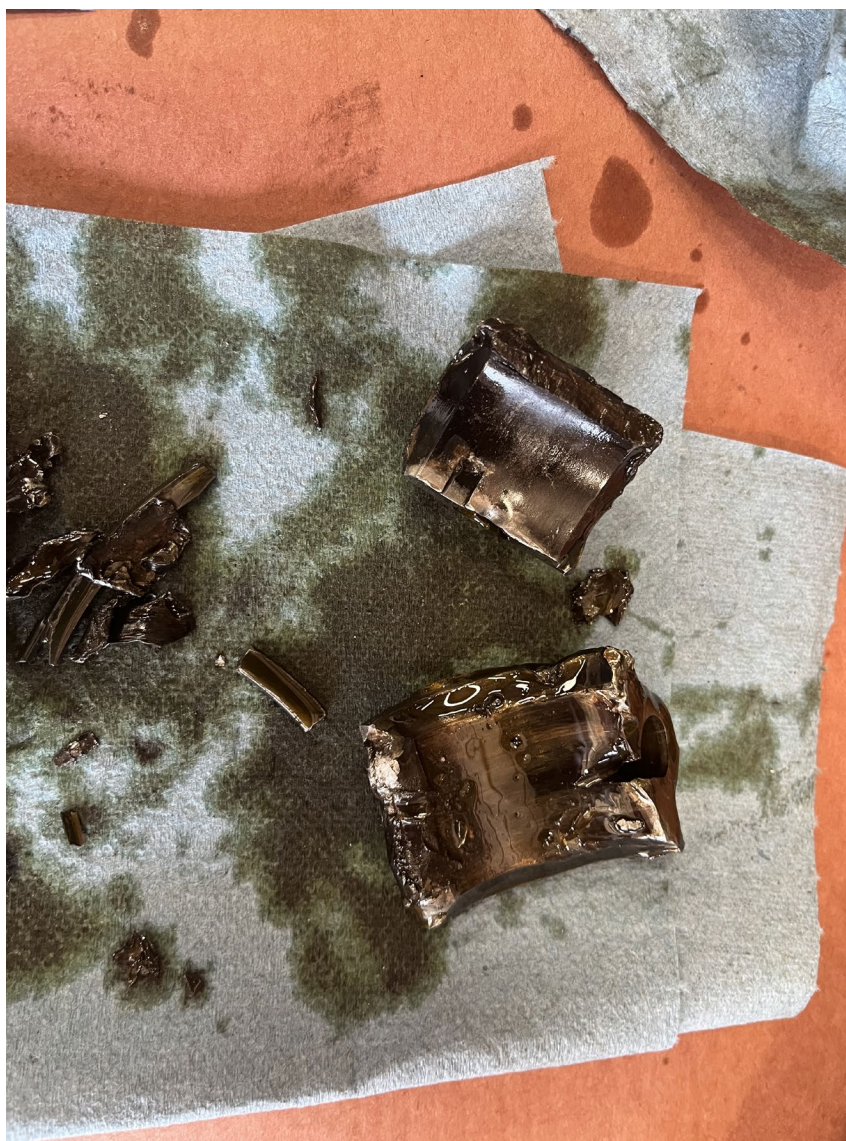
**Photograph 4 - Parts of No. 4 Rod cap found in sump**

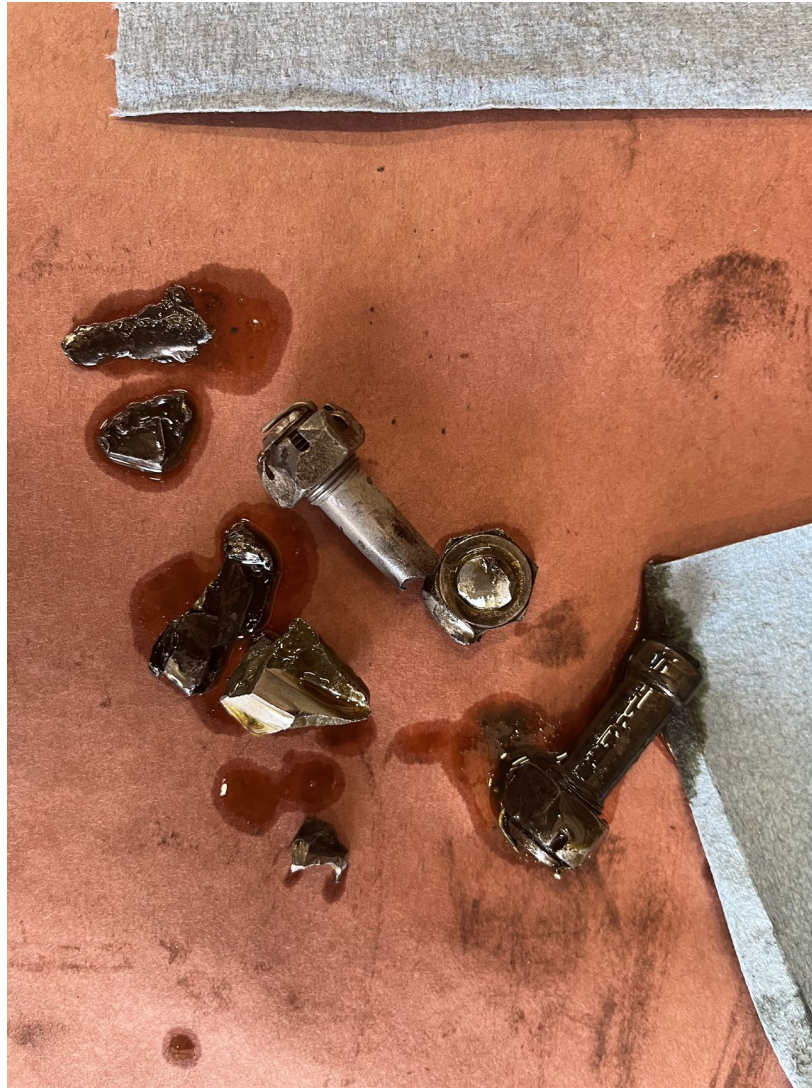
**Photograph 5 - Hardware from the No. 4 connecting rod**
