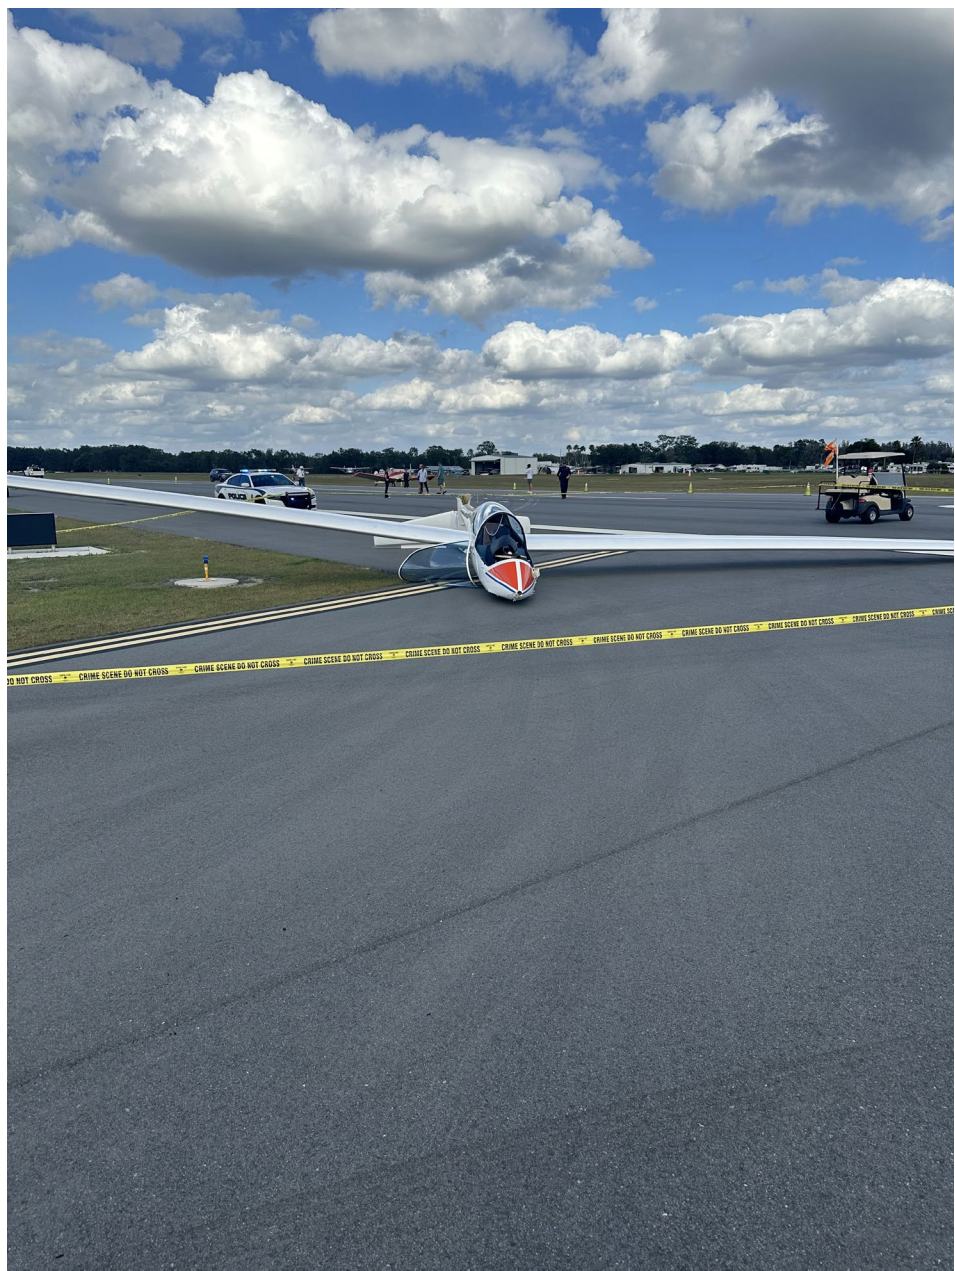
**Photo 1 – View of Glider as Found. Note Tow Plane in Background (FAA)**

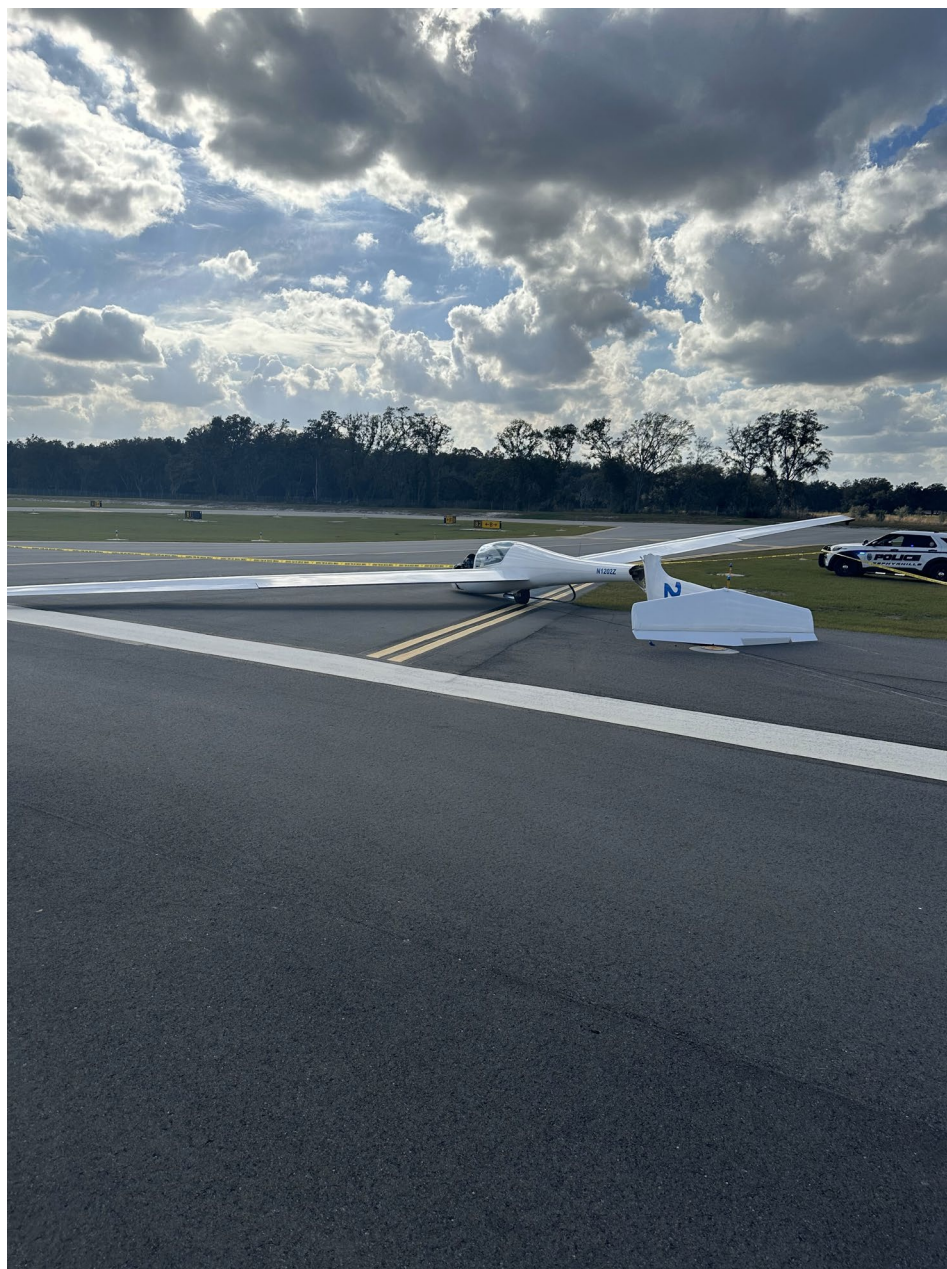
**Photo 2 – View from Departure Runway of Glider’s Fractured Tail (FAA)**

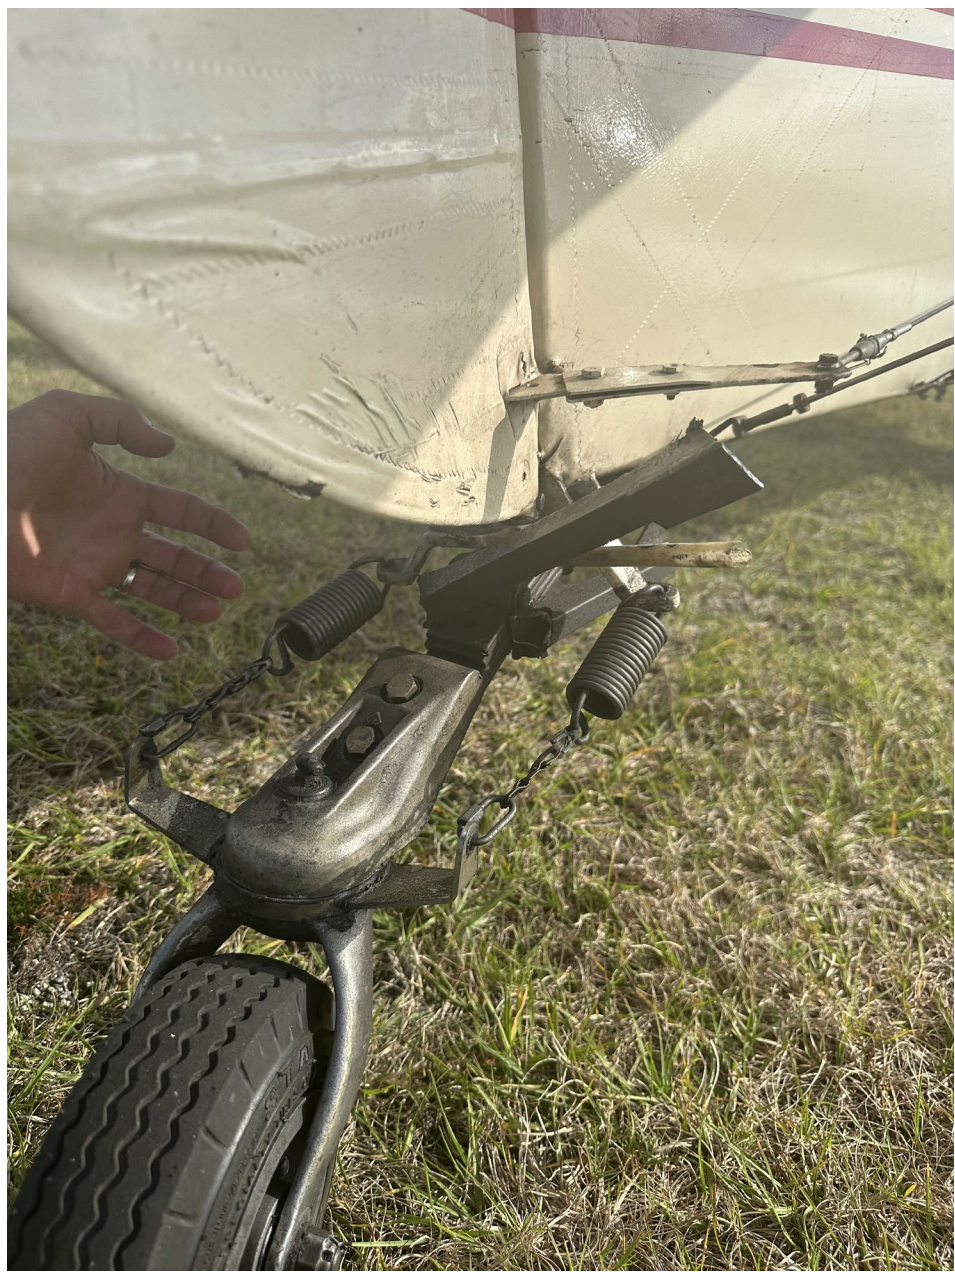
**Photo 3 – View of Fractured TOST Tow Support Mount (FAA)**
