# National Transportation Safety Board

ERA24LA099

## **ENGINE TEST RUN REPORT**

Location: LaGrange, GA  
Date: 01/18/2024  
Time: 1123 EST  
1623 UTC  
UAS/Drone: SwissDrones SDO 50 V2

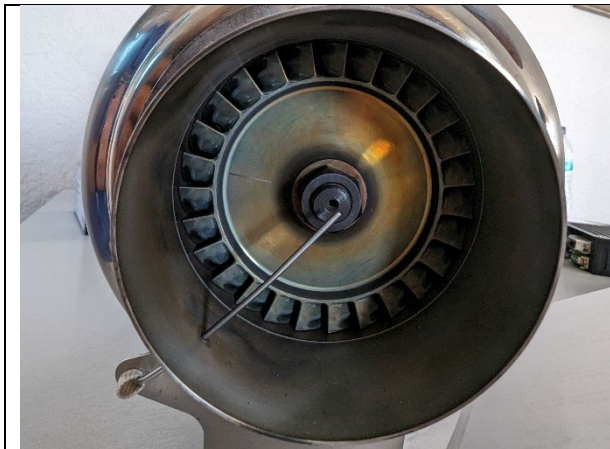
Figure 5: Engine Turbine

The engine casing, turbine, and compressor were all observed to be undamaged. The turbine was rotated by hand and it was noted to still be connected to the compressor and there was no binding noted during rotation. The engine starter was connected to the ECU and the ECU was connected to the EDT. The EDT commanded the ECU to test the engine starter, during the test the starter engaged, and the engine turbine, compressor, and the output shaft rotated normally.

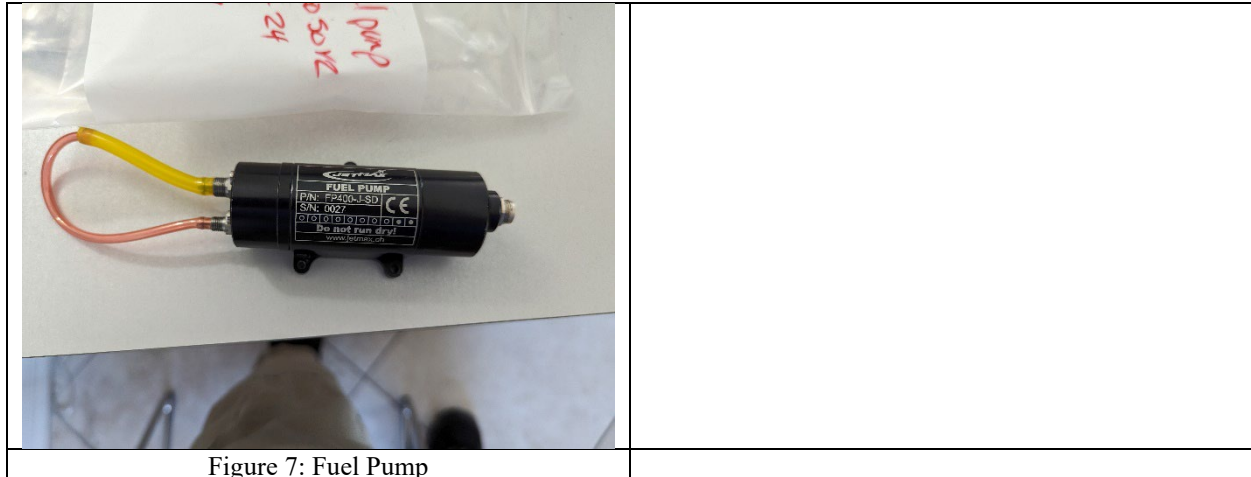
The electrically driven fuel pump and both fuel solenoids were observed to be undamaged. The fuel solenoids were connected to the ECU and the ECU was connected to the EDT. The ECU was commanded to test each solenoid and it was noted that both solenoids activated normally. The fuel pump was connected to the ECU and the ECU was commanded to test the fuel pump, it was noted that the fuel pump could faintly be heard operating. According to the manufacturer, the engine is equipped with an inline last-chance fuel filter that was not shipped with the engine and associated components.

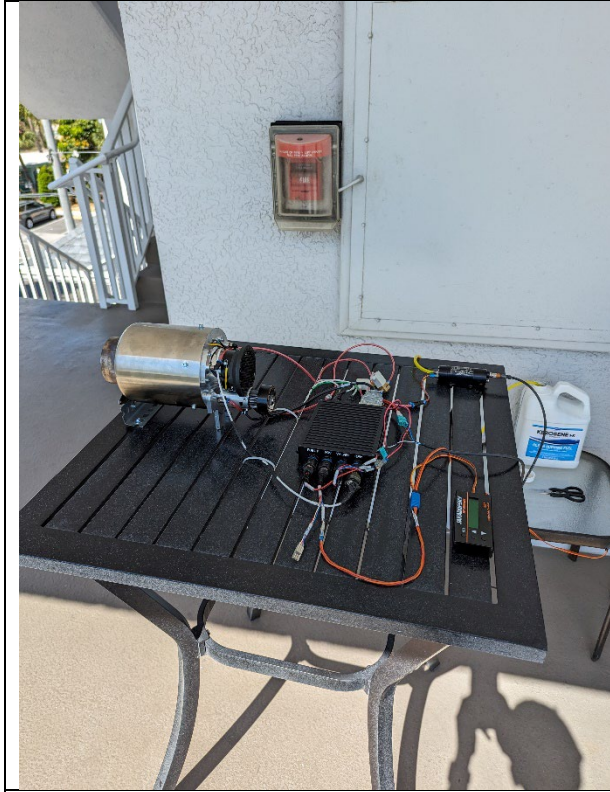
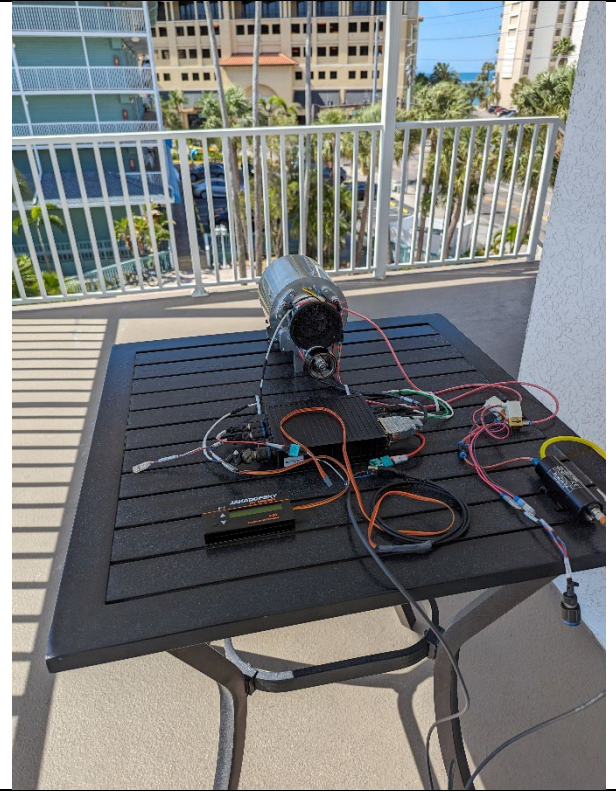
Figure 8: Engine Run Setup

The engine, ECU, fuel pump, two exemplar fuel solenoids and a recording laptop were connected to new fuel lines and the EDT wiring harness. A mix of kerosene and lubricating oil and a new fuel pick-up screen was utilized to facilitate the engine run. The EDT commanded the engine to start and the engine started on the first attempt and the engine RPM was stable at idle power. There were no vibrations noted during idle operation and the fuel pump voltage was stable in the normal operating range. The EDT then commanded the engine to accelerate to 100% power; the engine accelerated smoothly up to 100% power. The engine remained at 100% power for approximately 1 minute before the EDT commanded the engine to shutdown. During the engine run all of the engine indications were in the normal range, there were no signs of abnormal vibrations, and the output shaft rotated normally. After the engine shutdown and was allowed to cool another engine run was performed. The engine started and accelerated to 100% normally and all of the indications were in the normal operating range. The fuel pick-up screen was lifted out of the fuel/oil mix and it was observed that the fuel pump voltage quickly rose to 5 volts and the engine quickly lost RPM and shut down a few seconds after the initial loss of RPM.
