ERA24LA099

## UAS EXAMINATION

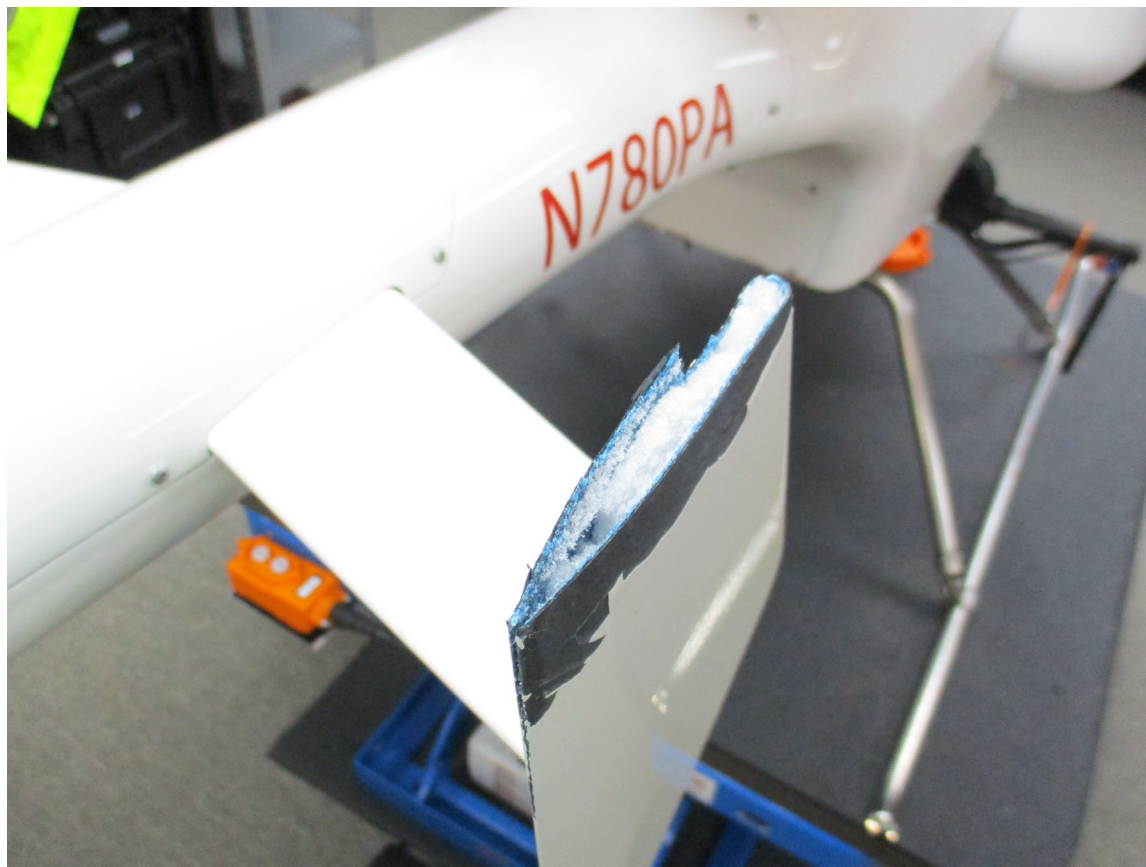
Photograph 3: Damage to vertical stabilizer (Source: FAA)

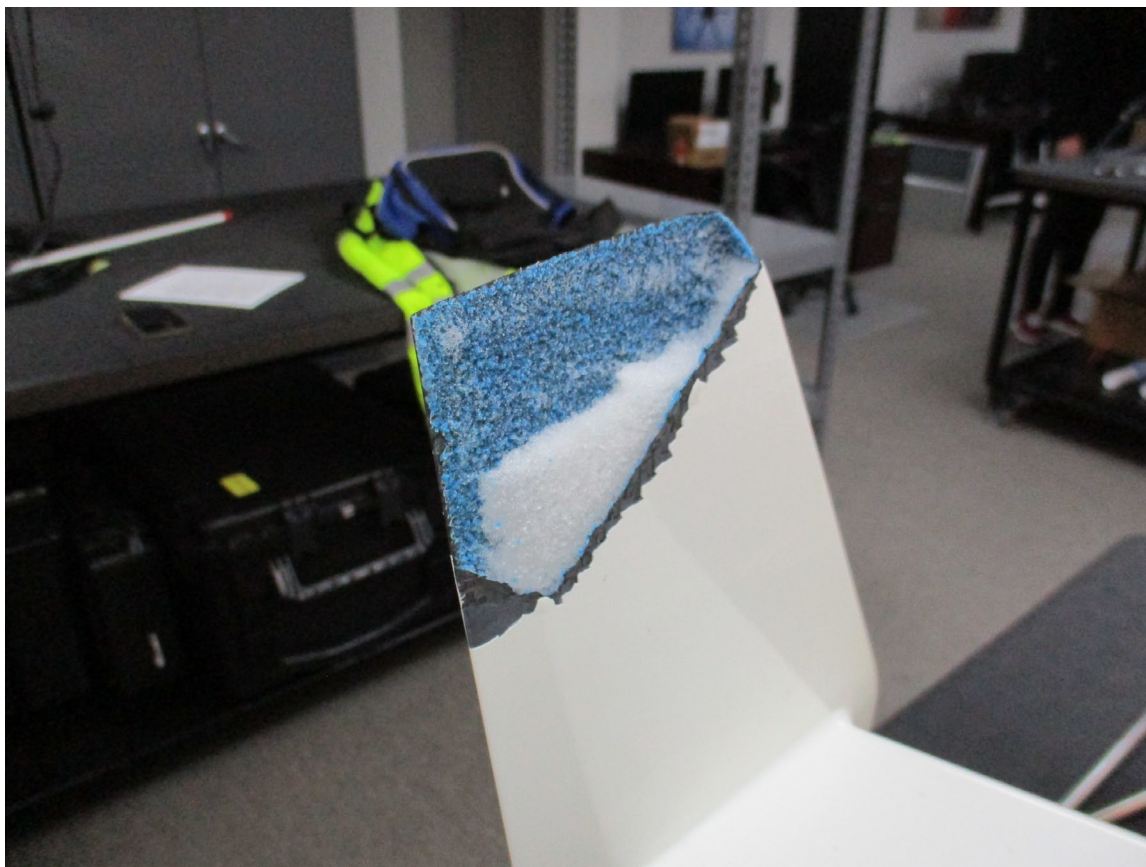
Photograph 4: Vertical Stabilizer Damage (Source: FAA)

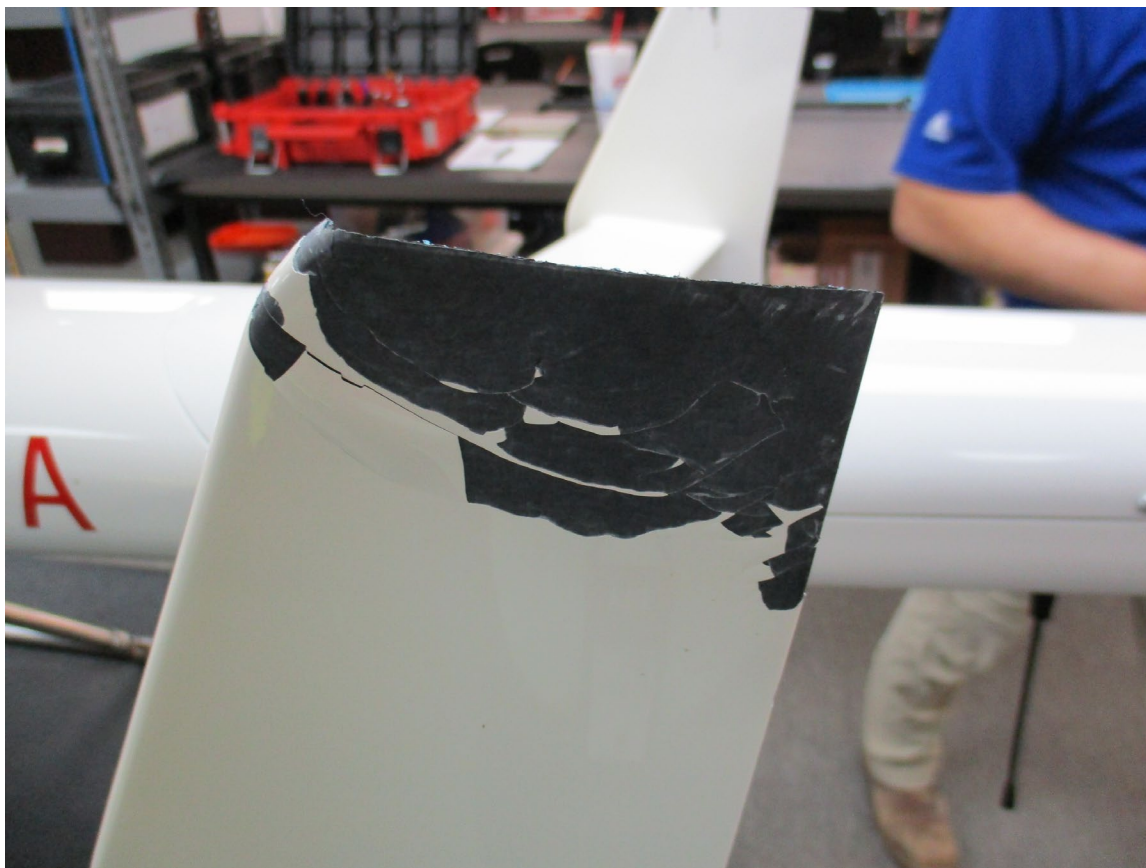
Photograph 5: Vertical Stabilizer Damage (Source: FAA)

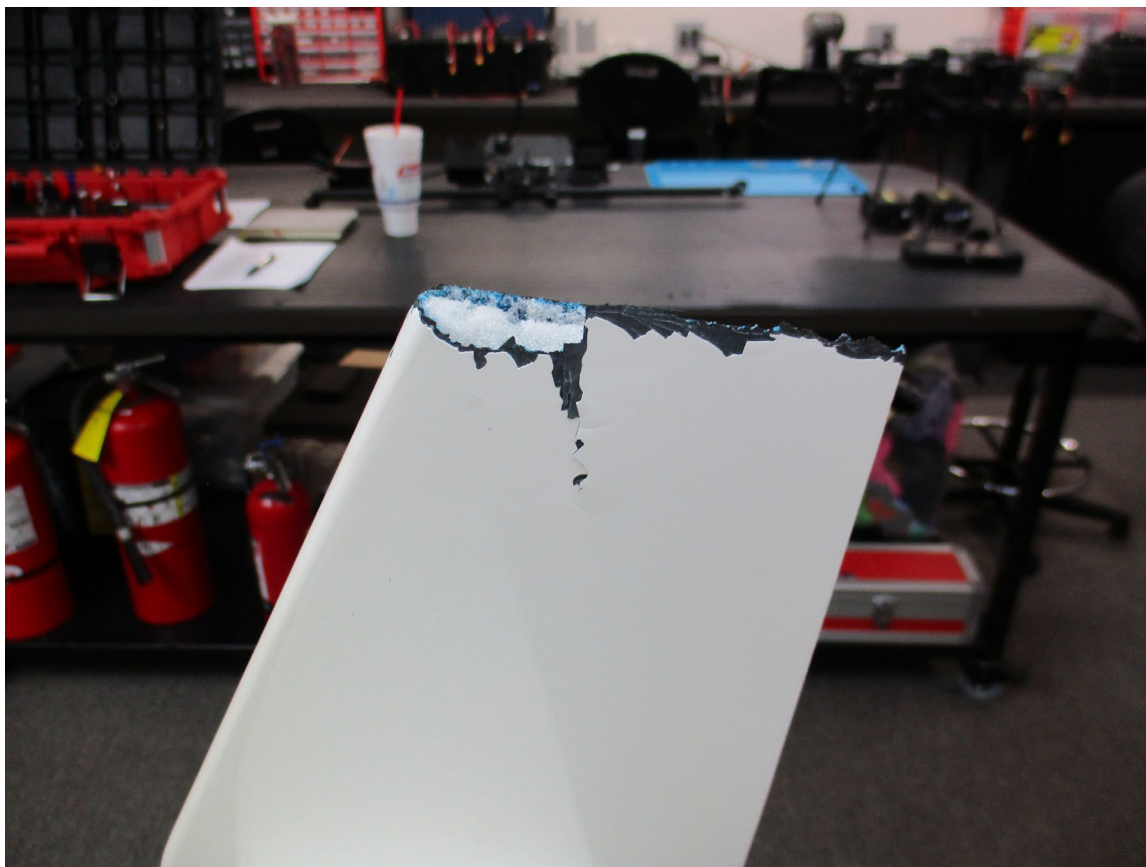
Photograph 6: Vertical Stabilizer Damage (Source: FAA)

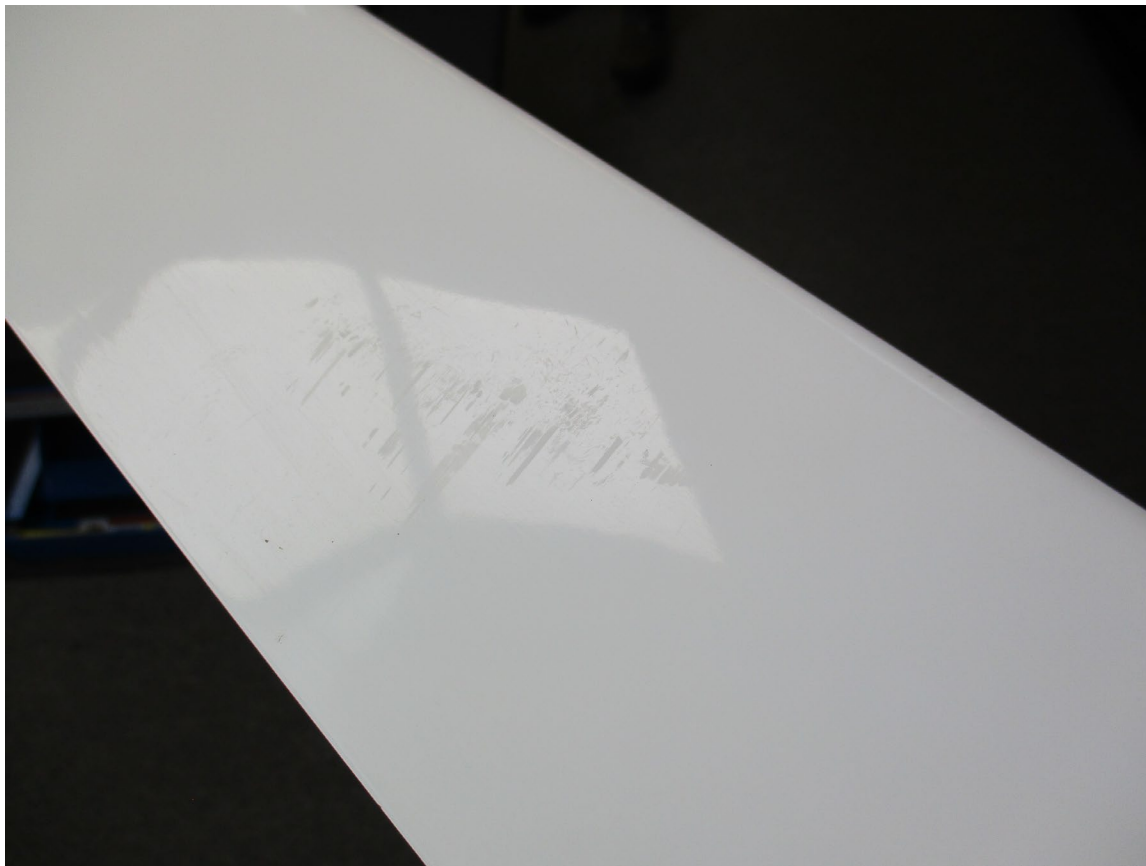
Photograph 37: Rotor blade with scuffing (Source: FAA)

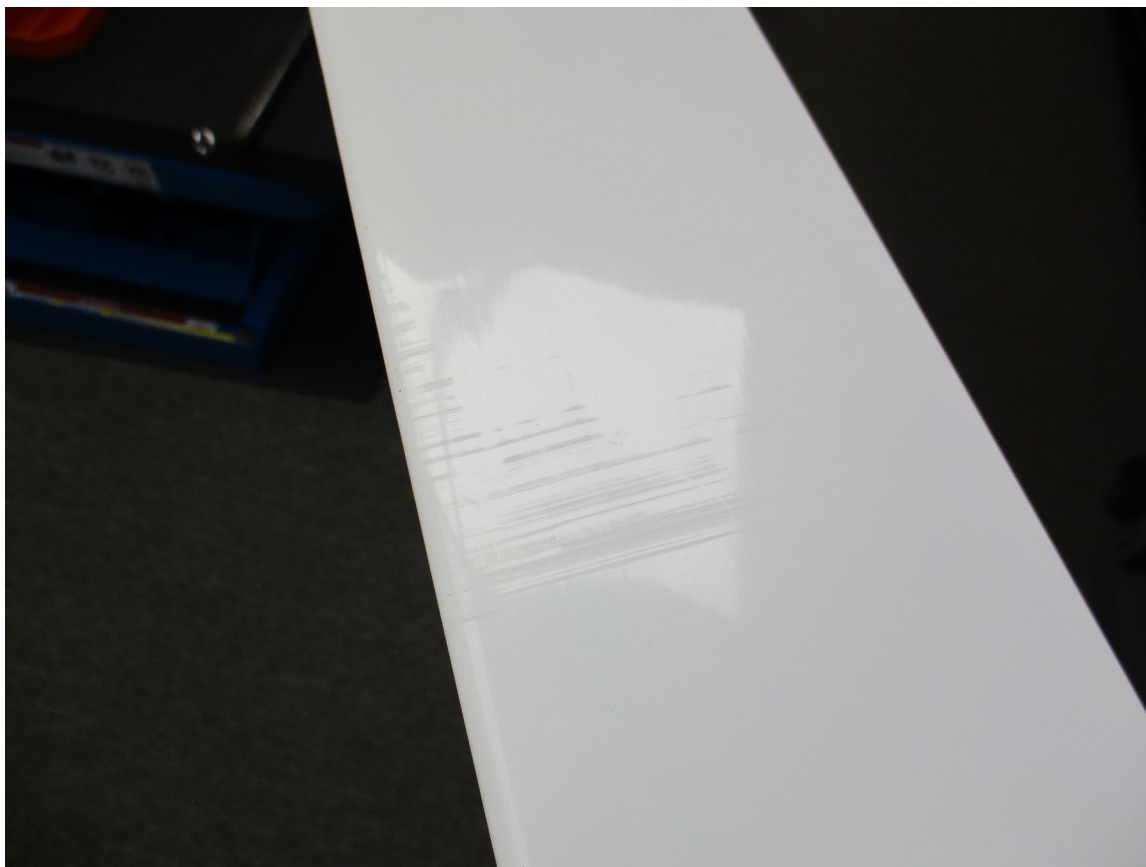
Photograph 38: Rotor blade with scuffing (Source: FAA)
