Kurt Gibson  
Aviation Accident Investigator  
AS-ERA

**Subject:** ERA24LA099 – Fuel Pump Examination (Report: 02371-AA)

The following are excerpts from report 02371-AA that was produced by SwissDrones in regard to the fuel pump examination for the accident UAS:

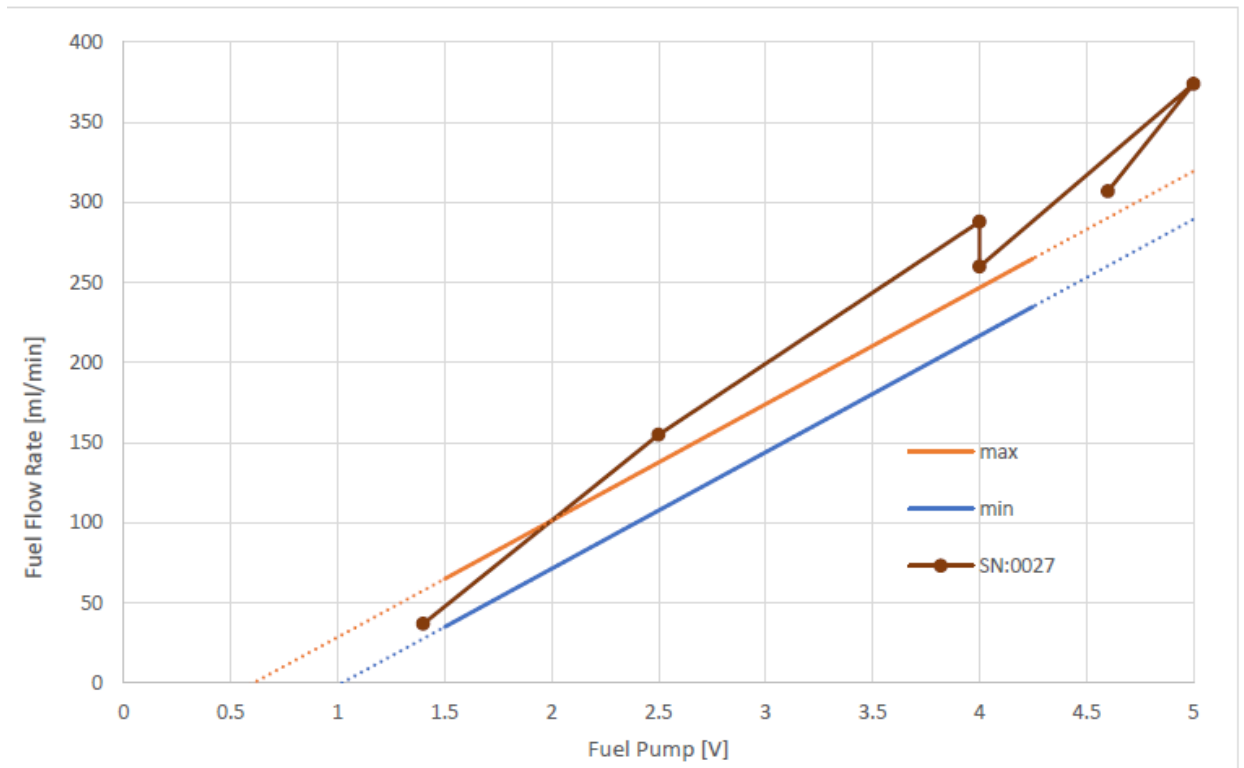
Figure 2: fuel flow w.r.t. fuel pump voltage 551024 N780PA during the investigation

“The investigation confirmed that the fuel pump delivers fuel without any fluctuations or interruptions.”

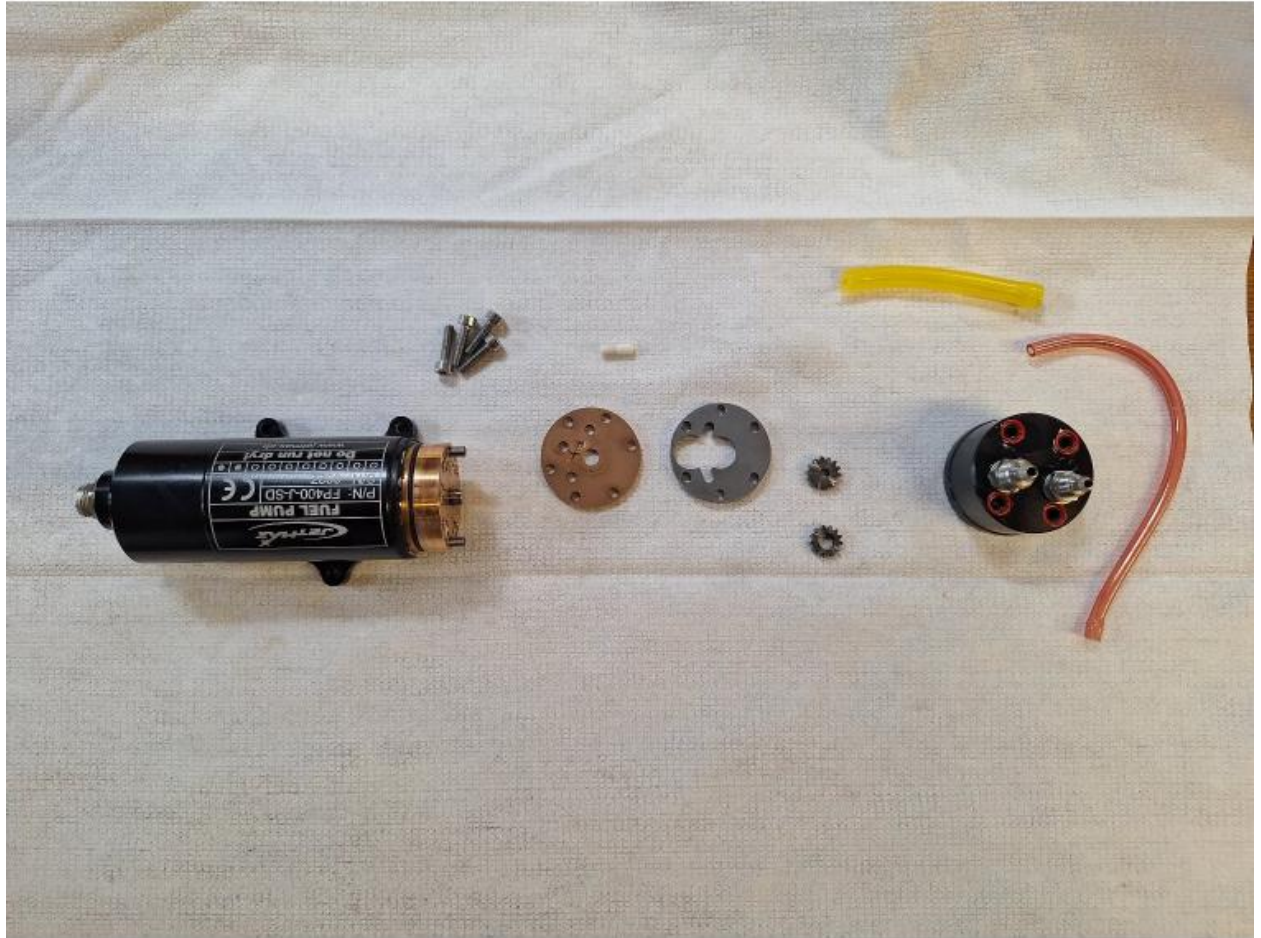
Figure 4 Disassembled Pump Head SN0027

“Some wear in the gear cage as well as some potential micro cracks in the teeth of the pump gears were found.”

“When disassembling the pump head, one part (brass) right next to the pump gears showed markings of the gear teeth as can be seen in Figure 4 marked in red.”

“Additionally, some markings in the gear cage have been found indicating wear and friction between the gears and the cage.”
