ERA24LA100

## INVESTIGATION PHOTOGRAPHS

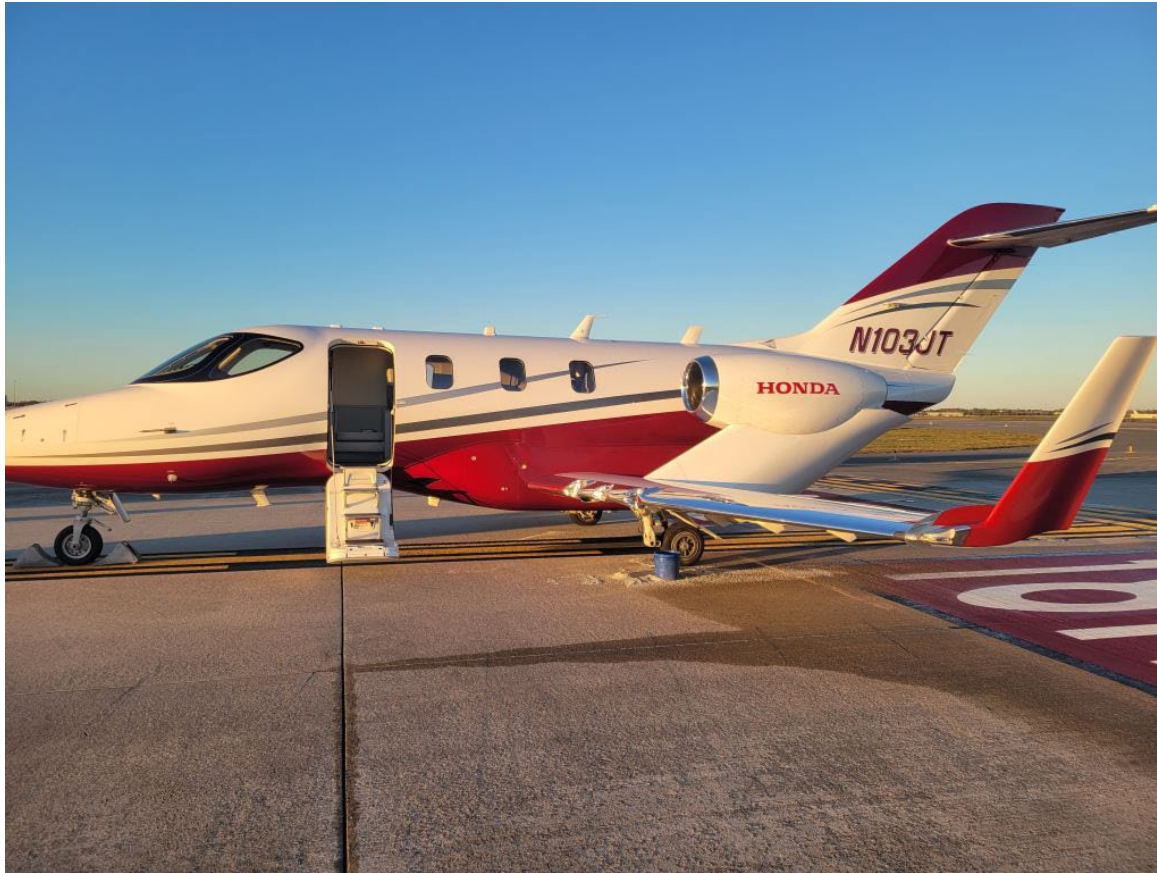
Photograph 1 - Left Side View of the Airplane Where Evacuated (Courtesy of FAA)

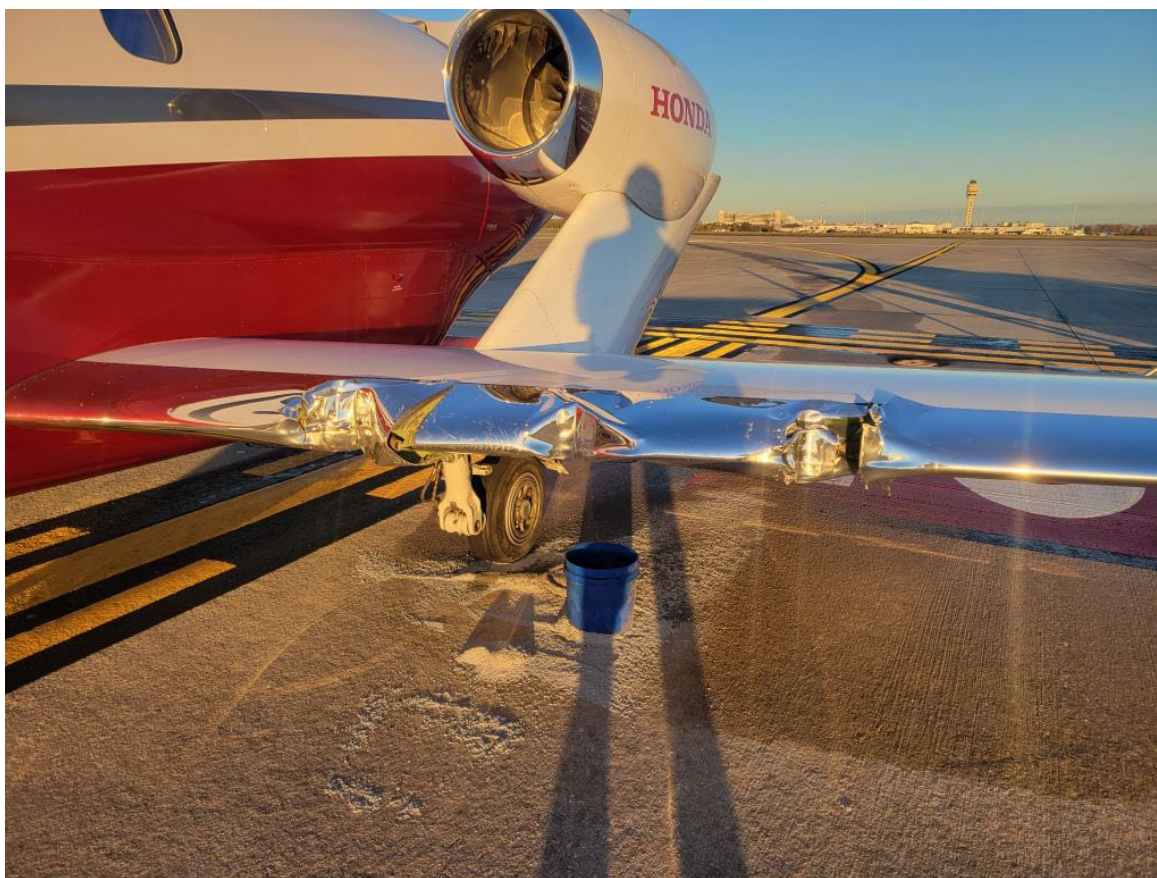
Photograph 2 - Frontal View of the Inboard Section of Left Wing, Portion of Fuselage, Left Engine. Note dents in leading edge (Courtesy of FAA)

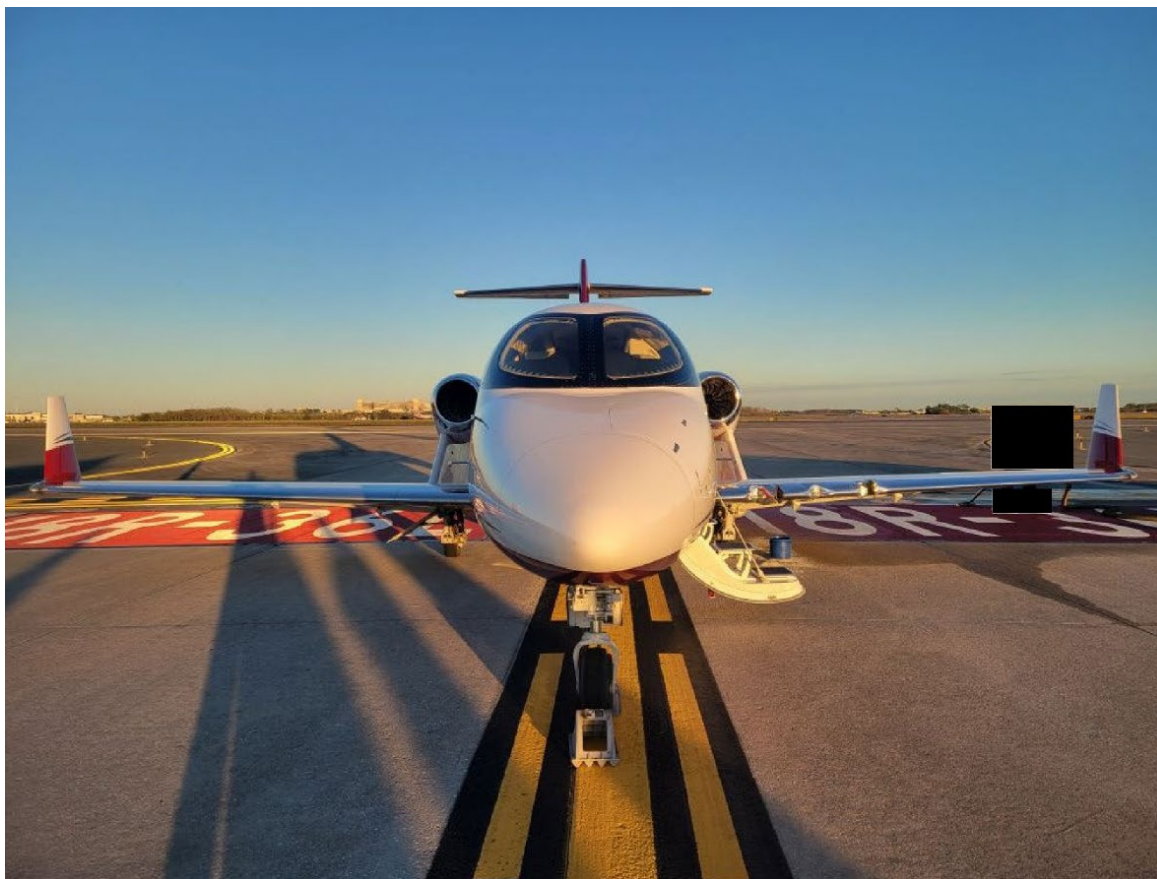
Photograph 3 - Frontal View of the Airplane Where Evacuated (Courtesy of FAA)

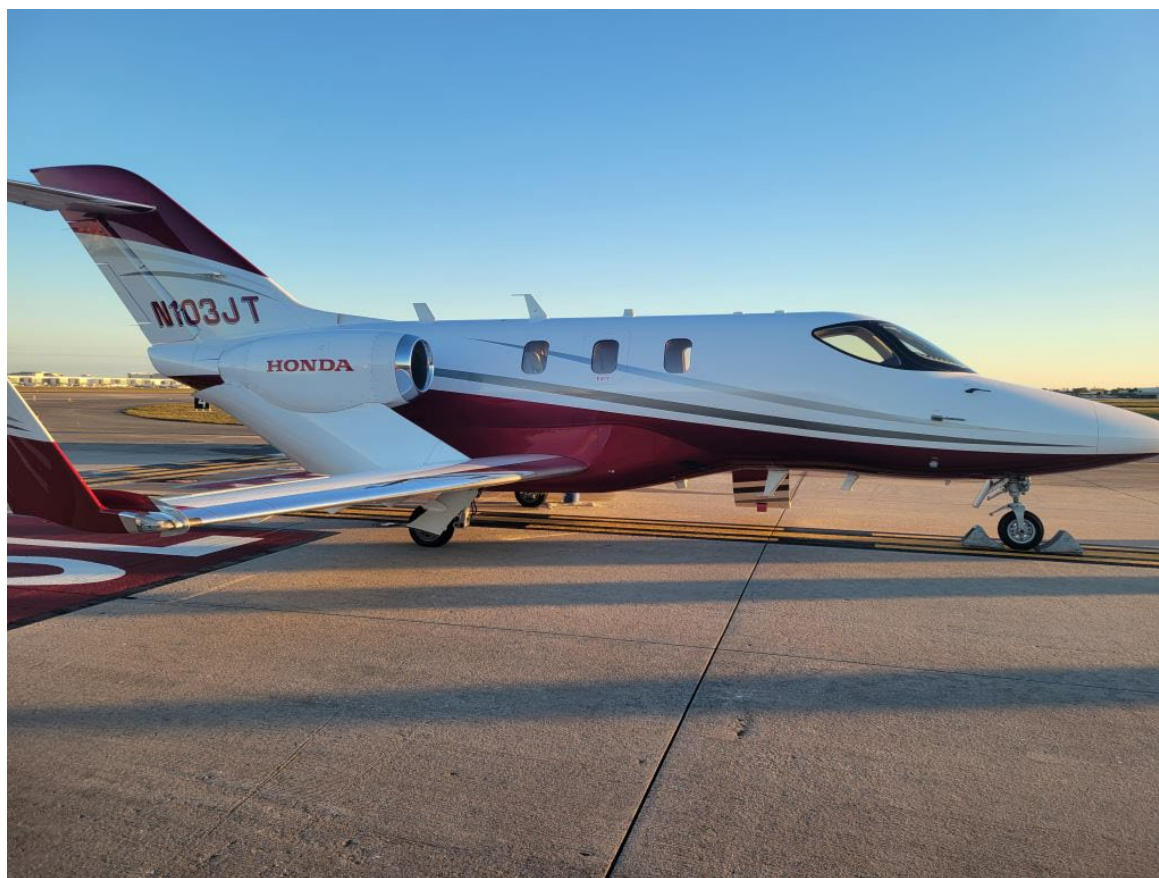
Photograph 4 - Right Side View of the Airplane Where Evacuated (Courtesy of FAA)

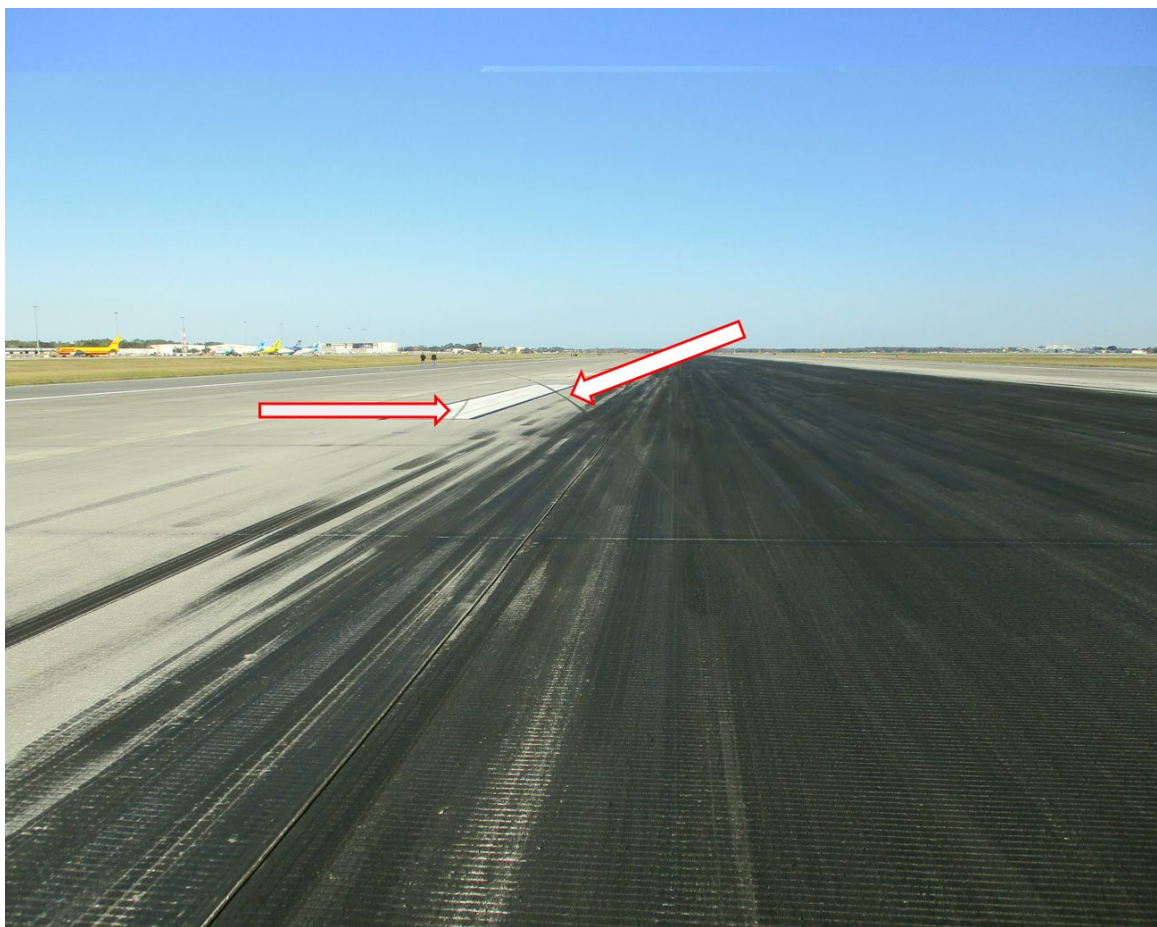
Photograph 5 - Arrows Point to Skid Marks From Left and Right Main Landing Gear Tires  
(Courtesy of FAA)

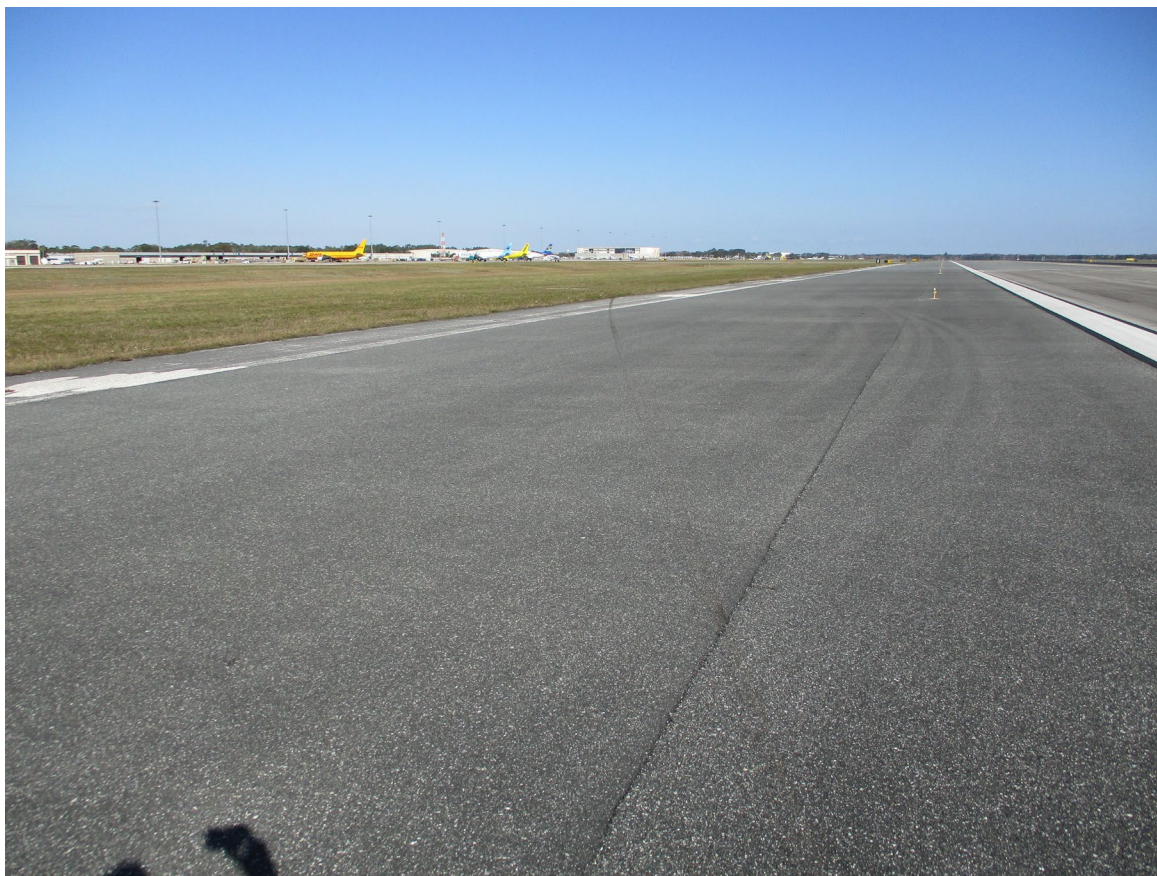
Photograph 6 - View of a Skid Mark Going Off the Left Side of the Runway (Courtesy of FAA)

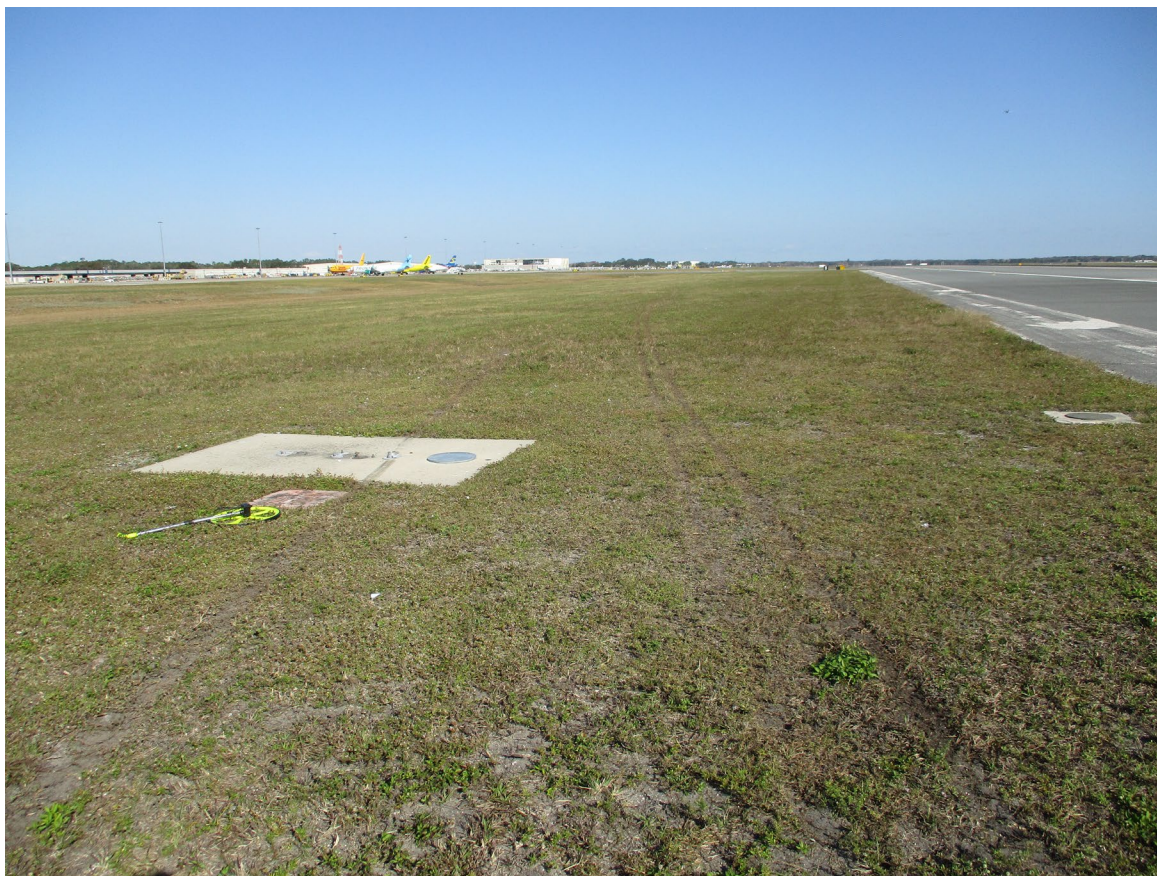
Photograph 7 - View of the Tire Marks in Grass and On Concrete Pad of Impacted Runway Marking Sign (Courtesy of FAA)

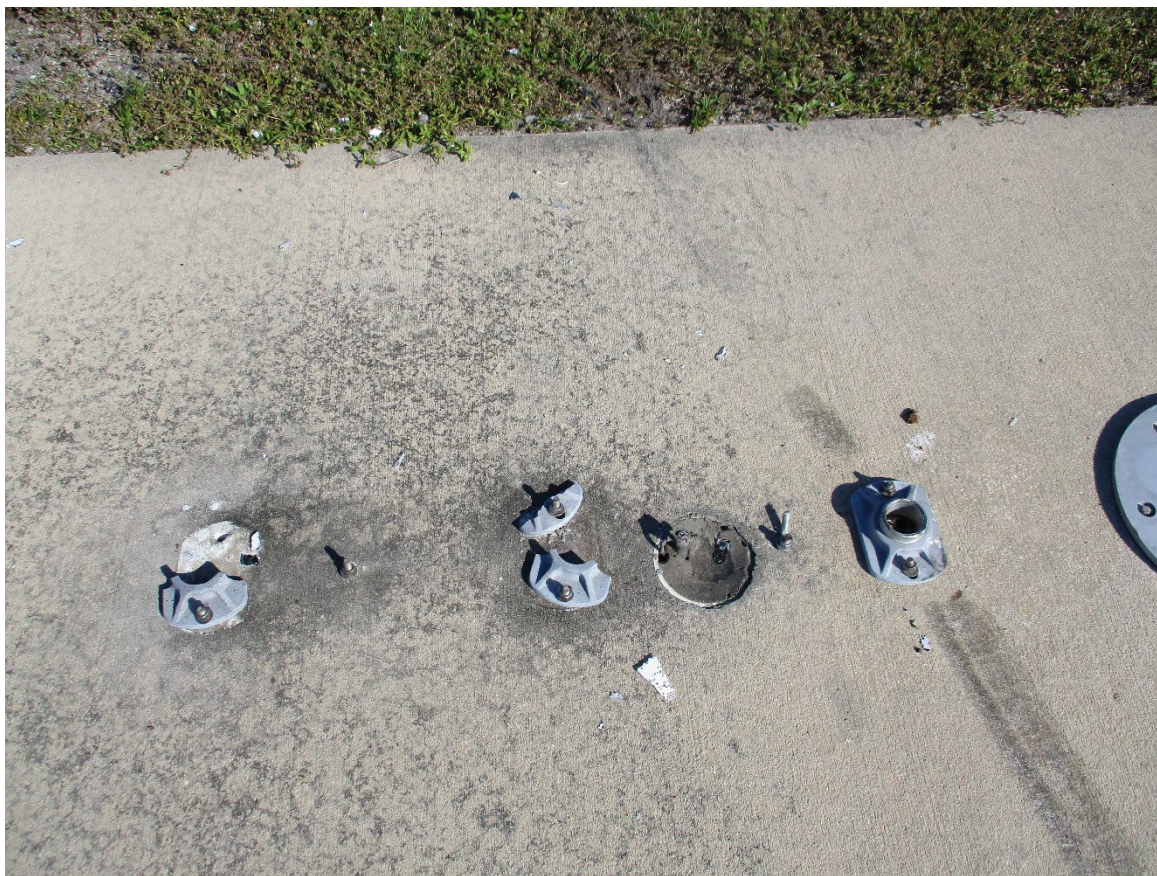
Photograph 8 - View of the Concrete Pad For the Runway Distance Remaining Impacted Sign, Sign Retention Mounts, and Skid Mark From the Left Main Landing Gear Tire (Courtesy of FAA)

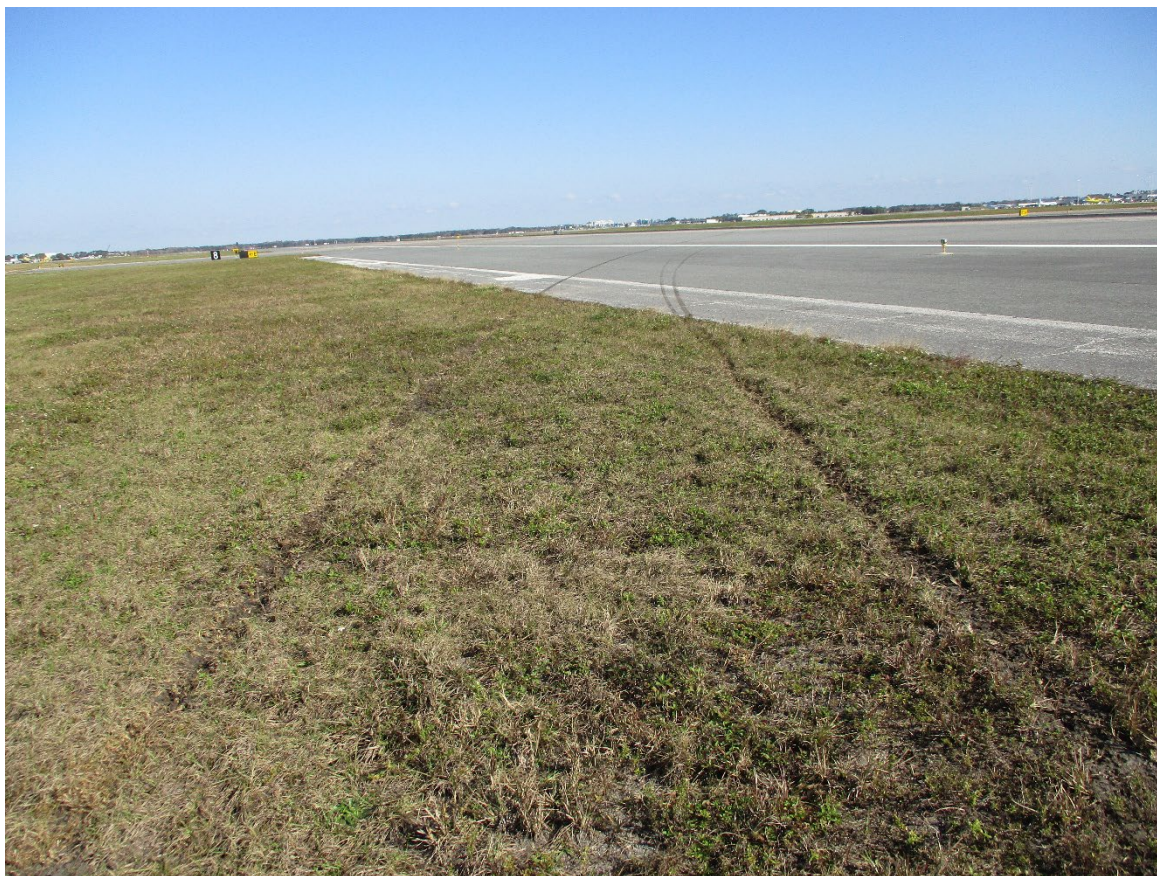
Photograph 9 - View of the Tire Marks in Grass and Returning to the Runway (Courtesy of FAA)

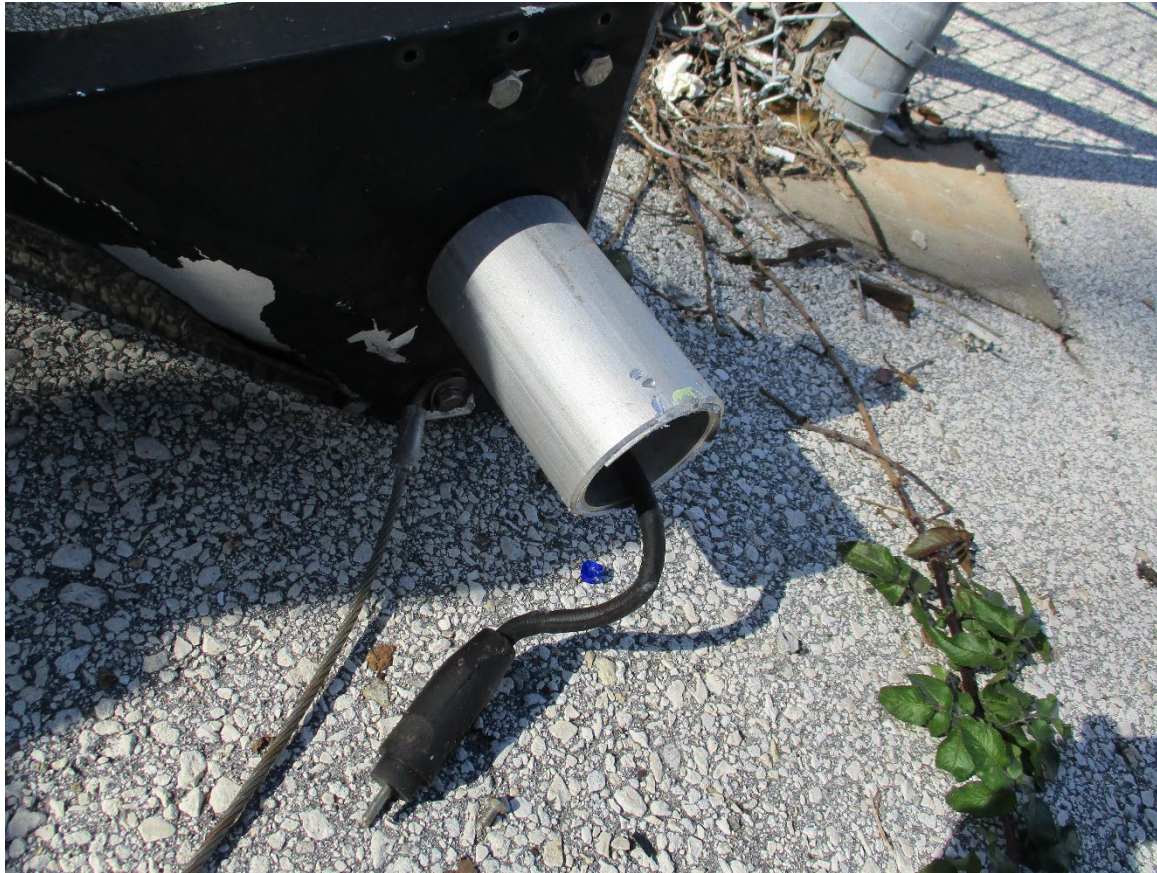
Photograph 10 - View of One Post of the Runway Distance Remaining Sign that Fractured at the Reduced Diameter (Courtesy of FAA)

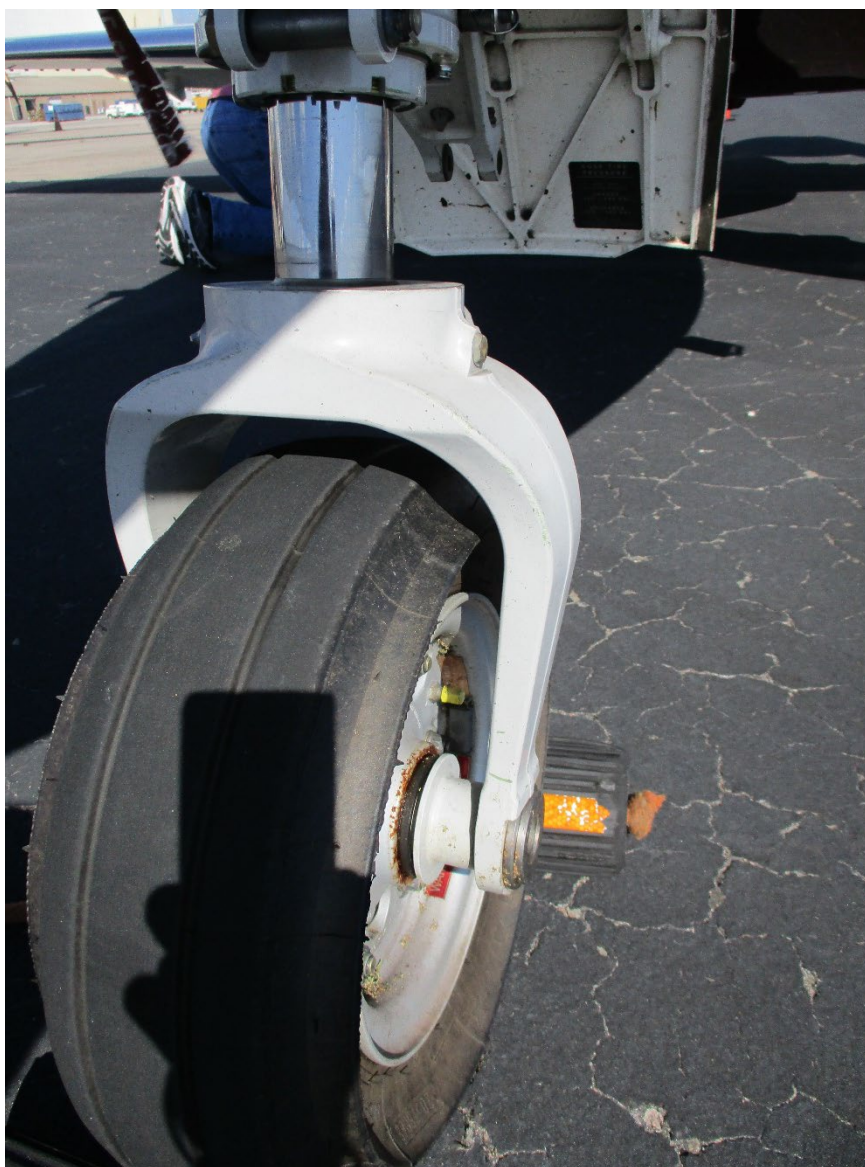
Photograph 11 - View of the Nose Landing Gear Tire (Courtesy of FAA)

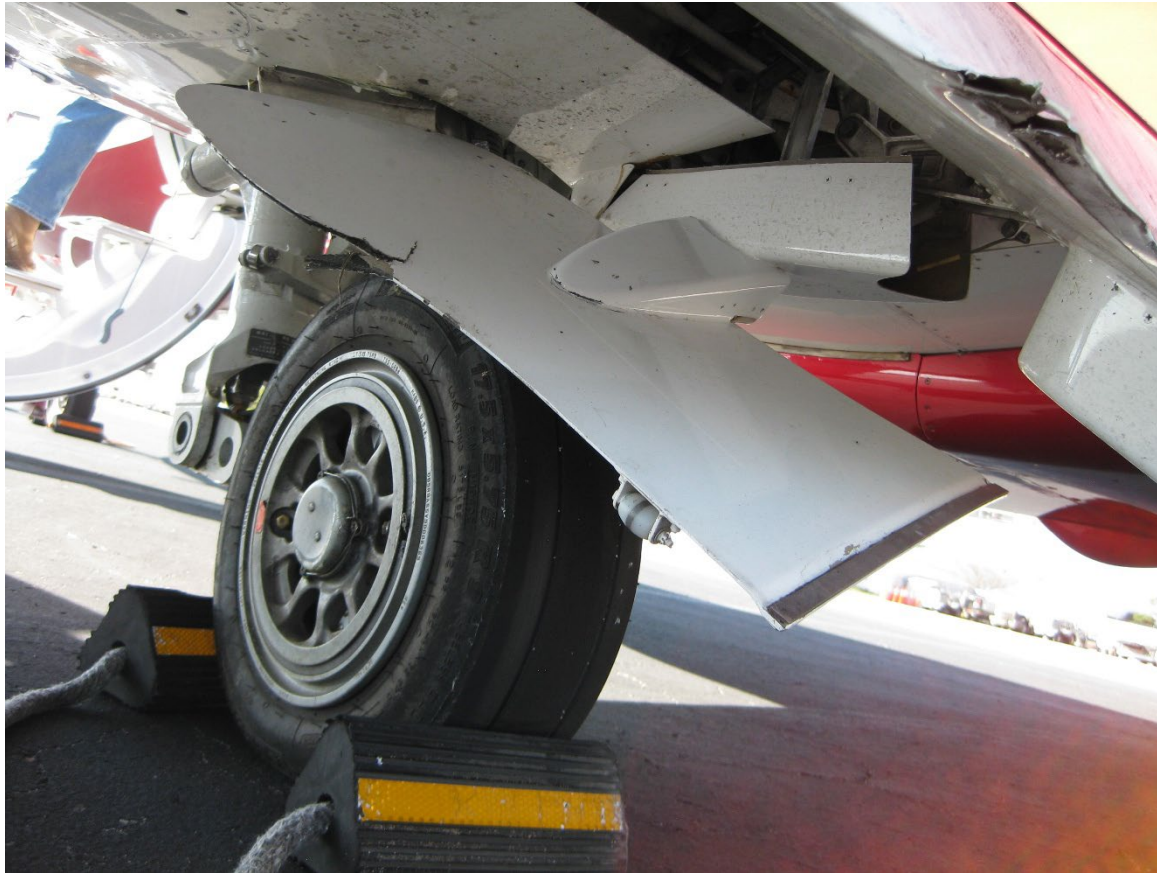
Photograph 12 - View of the Left Main Landing Gear Assembly and Bottom Portion of the Left Wing (Courtesy of FAA)

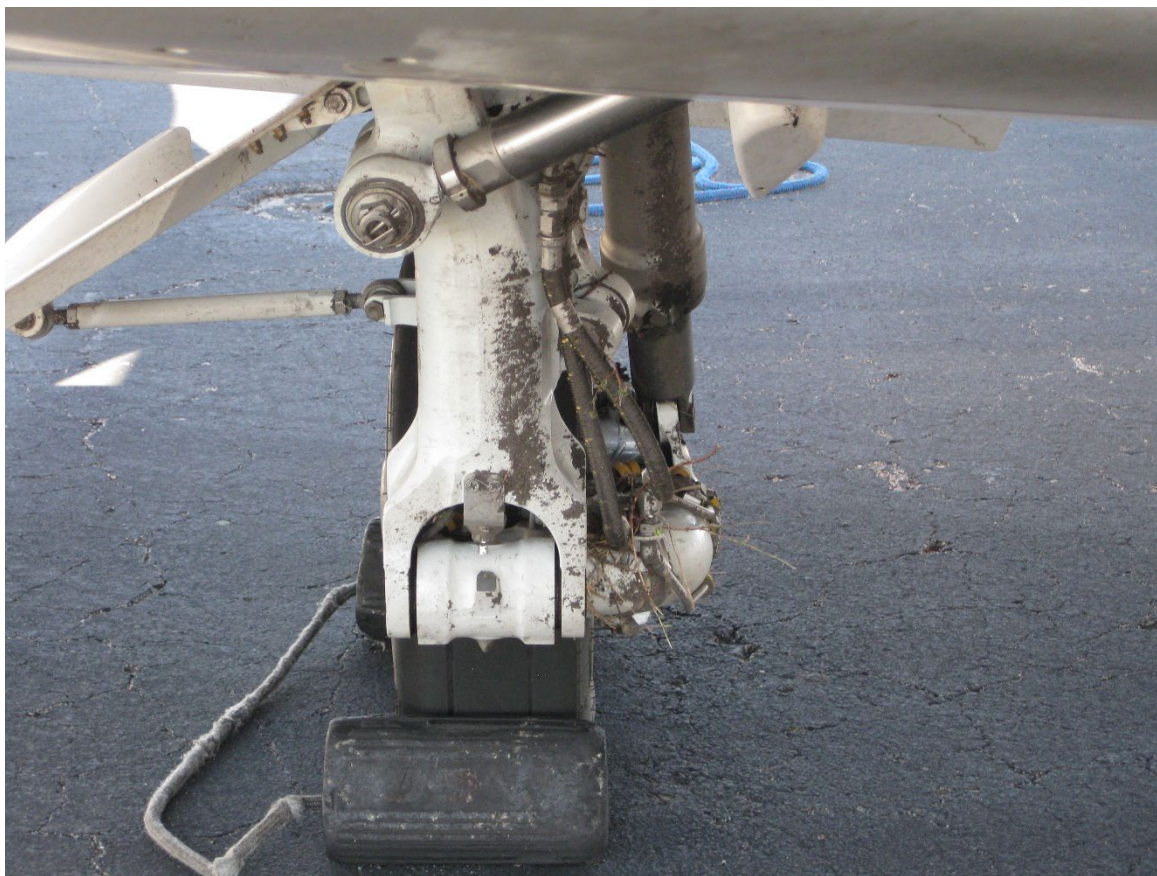
Photograph 13 - View of the Right Main Landing Gear Assembly (Courtesy of FAA)

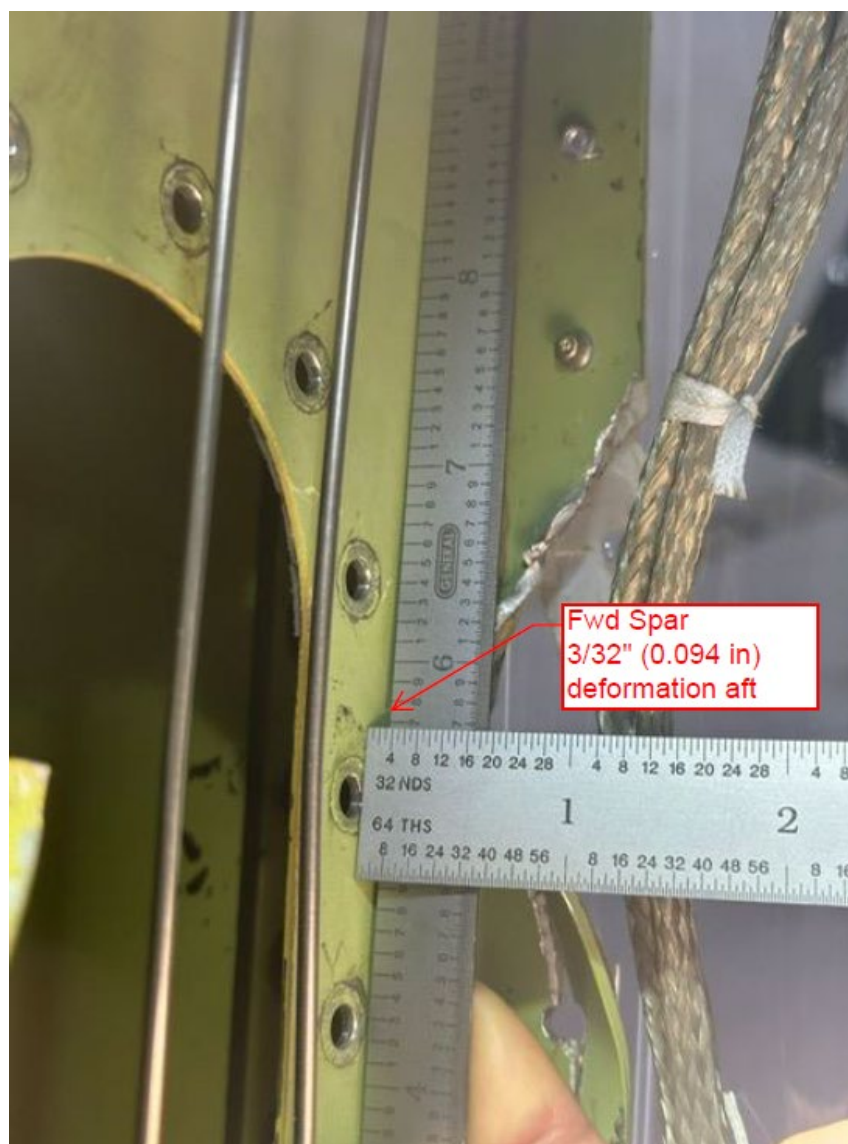
Photograph 14 - Depicting Damage to the Left Main Spar (Courtesy of Airplane Manufacturer)
