ERA24LA101

## INVESTIGATION PHOTOGRAPHS

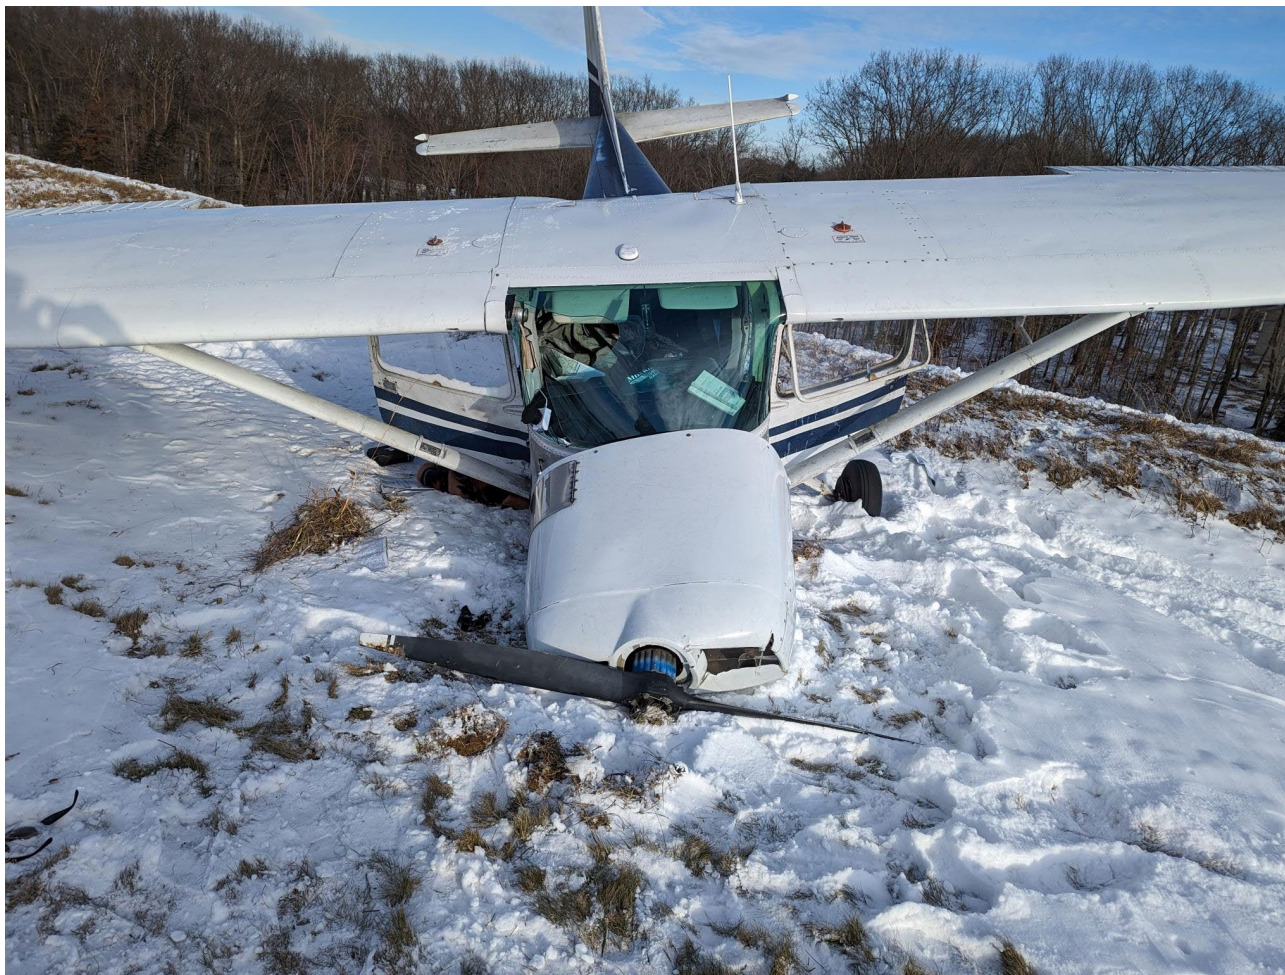
**Photograph 1 - Front view of wreckage. (Courtesy of Airport Operations)**

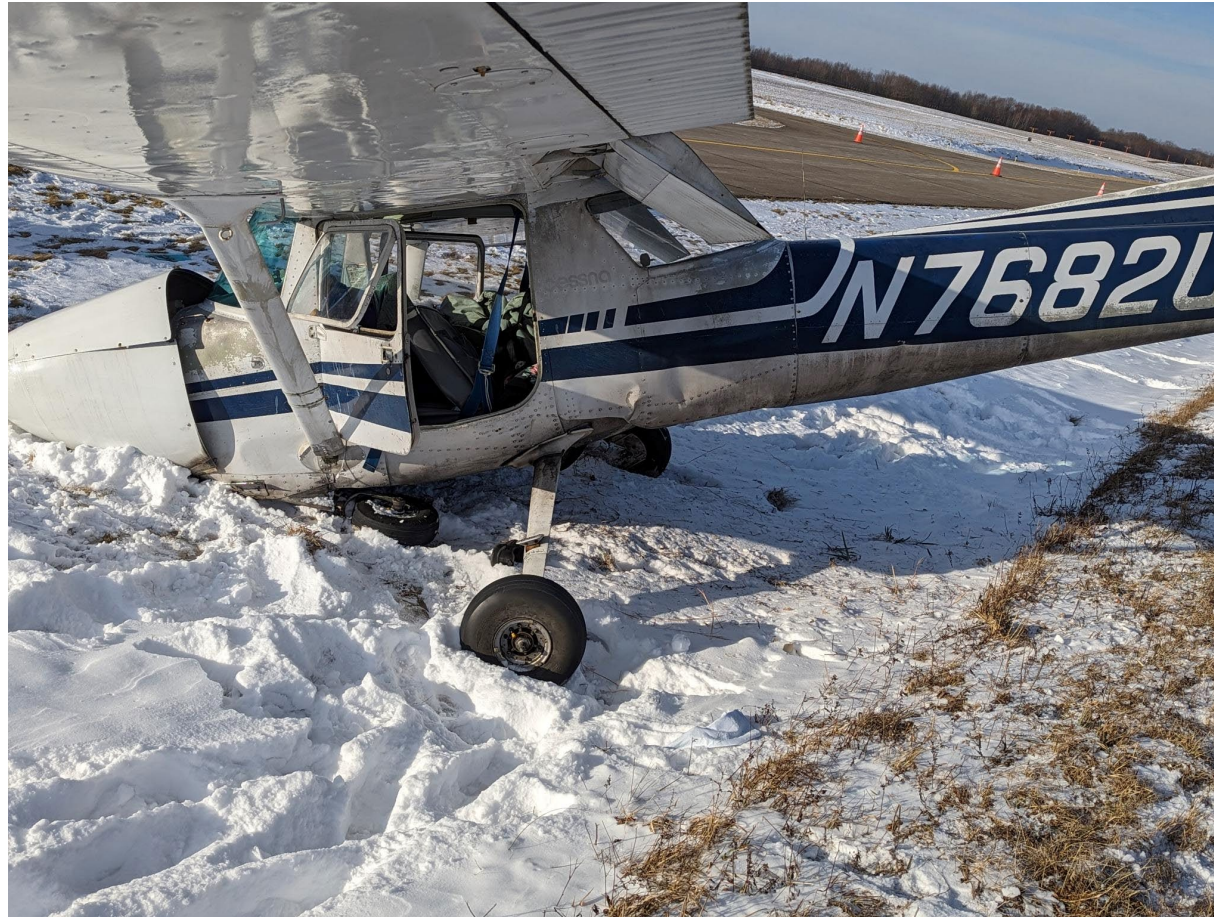
**Photograph 2 - Left side profile view of wreckage. (Courtesy of Airport Operations)**

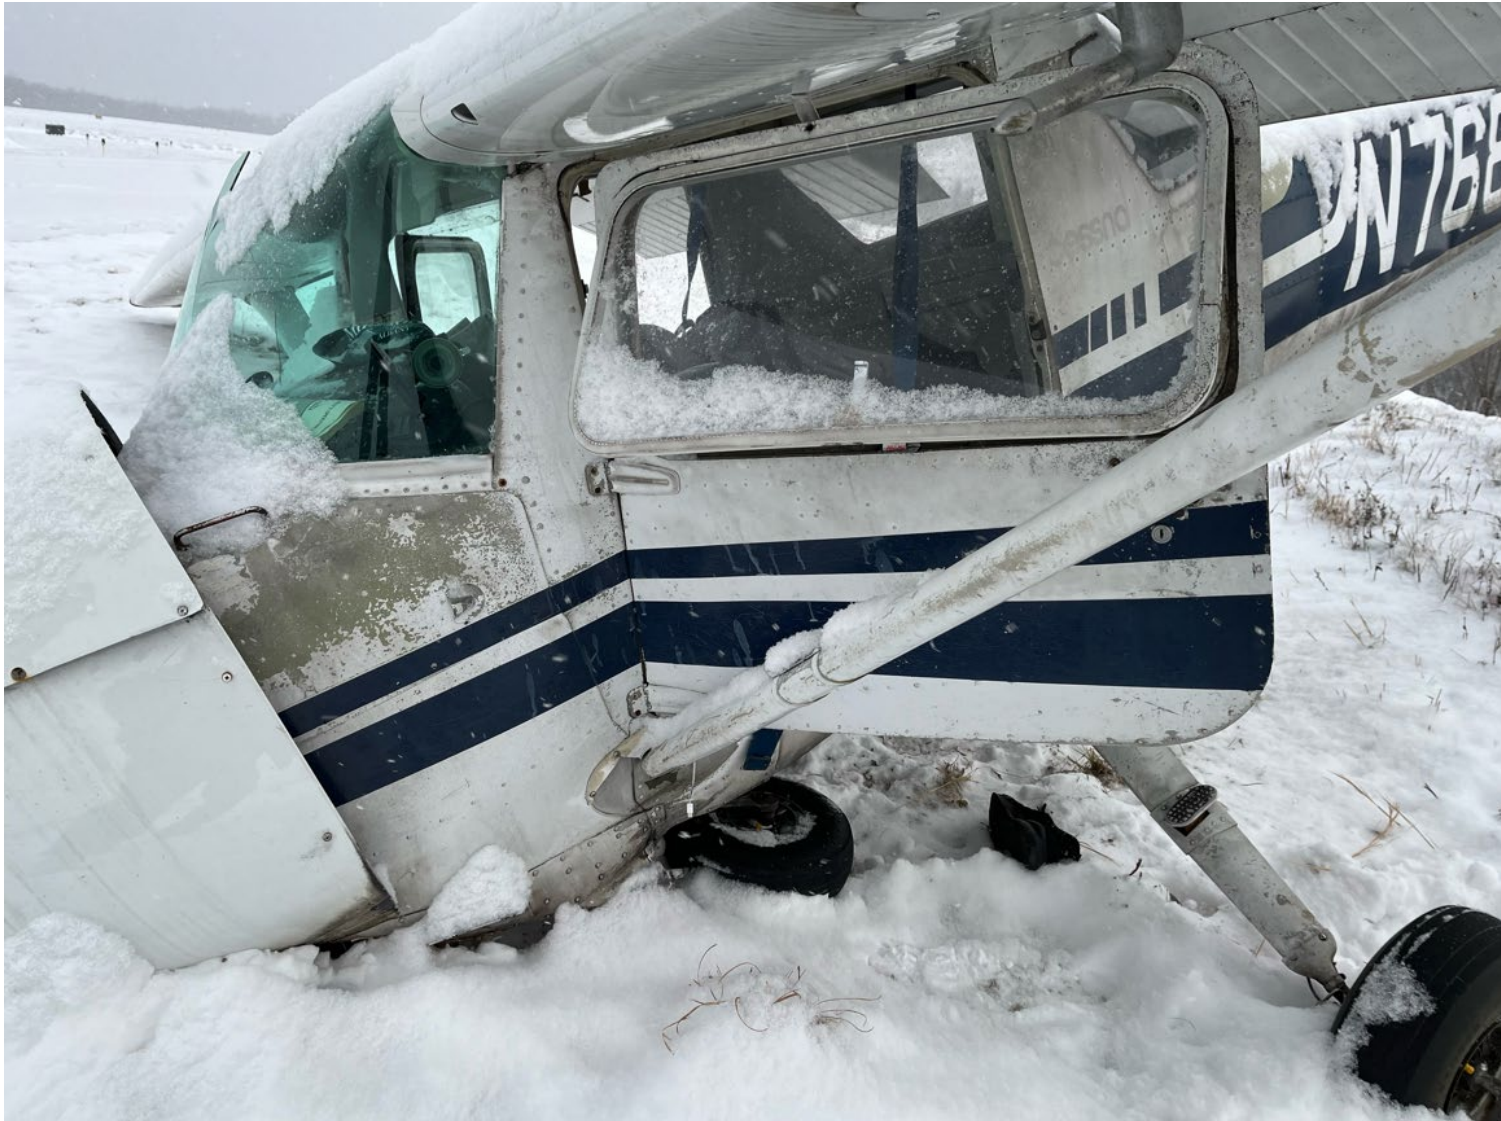
**Photograph 3 - Left side of fuselage damage. Note, snow occurred post-accident. (Courtesy of FAA)**

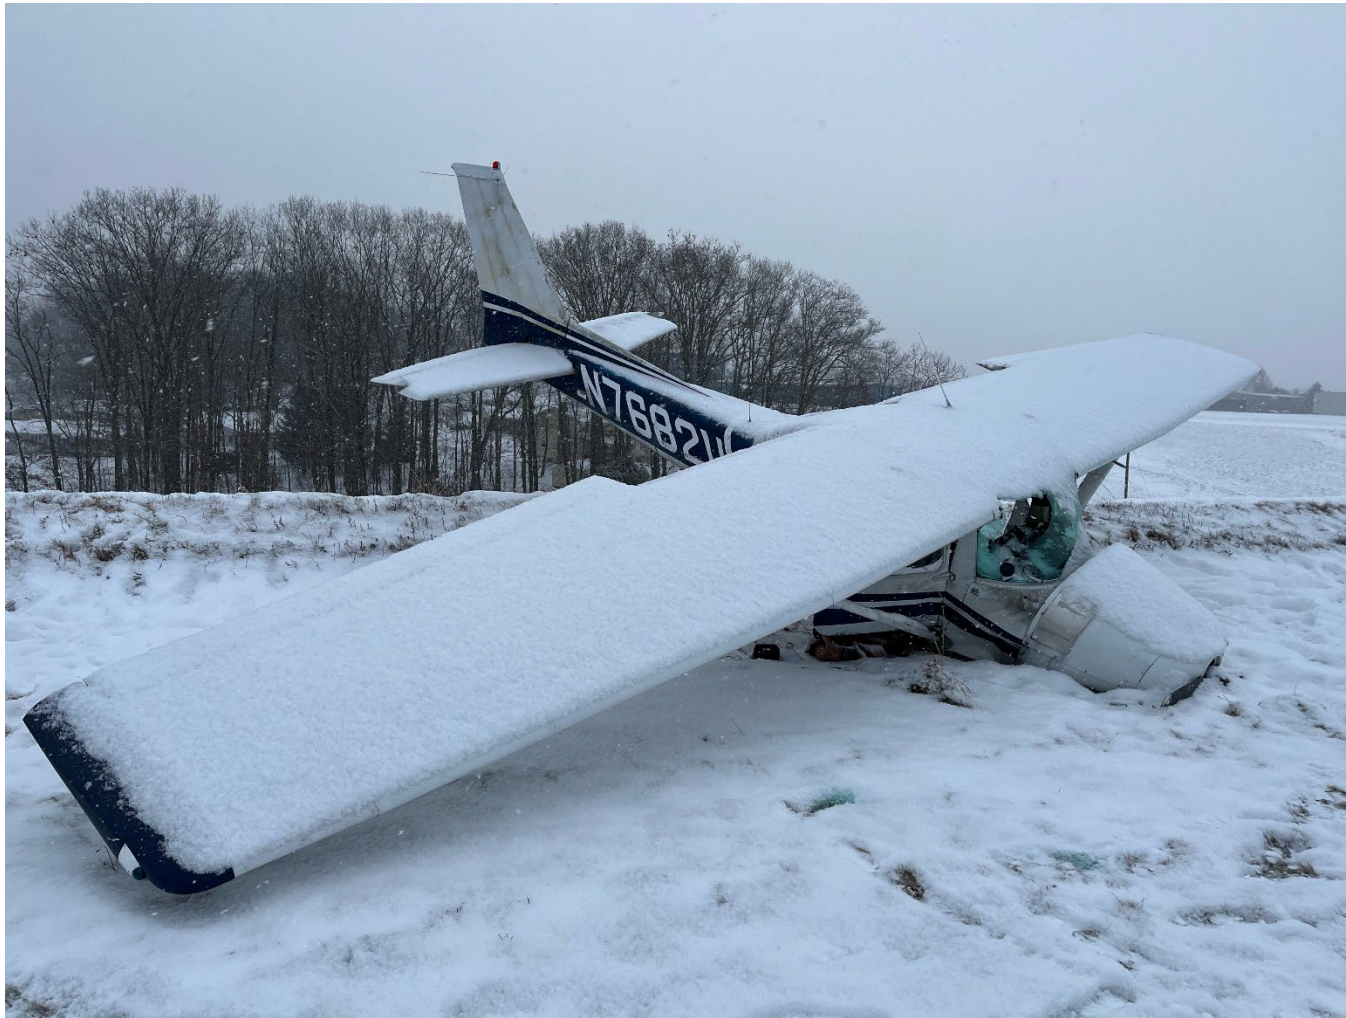
**Photograph 4 - Right profile view of airplane damage. Note, snow occurred post-accident.  
(Courtesy of FAA)**
