ERA24LA105

## INVESTIGATION PHOTOGRAPHS

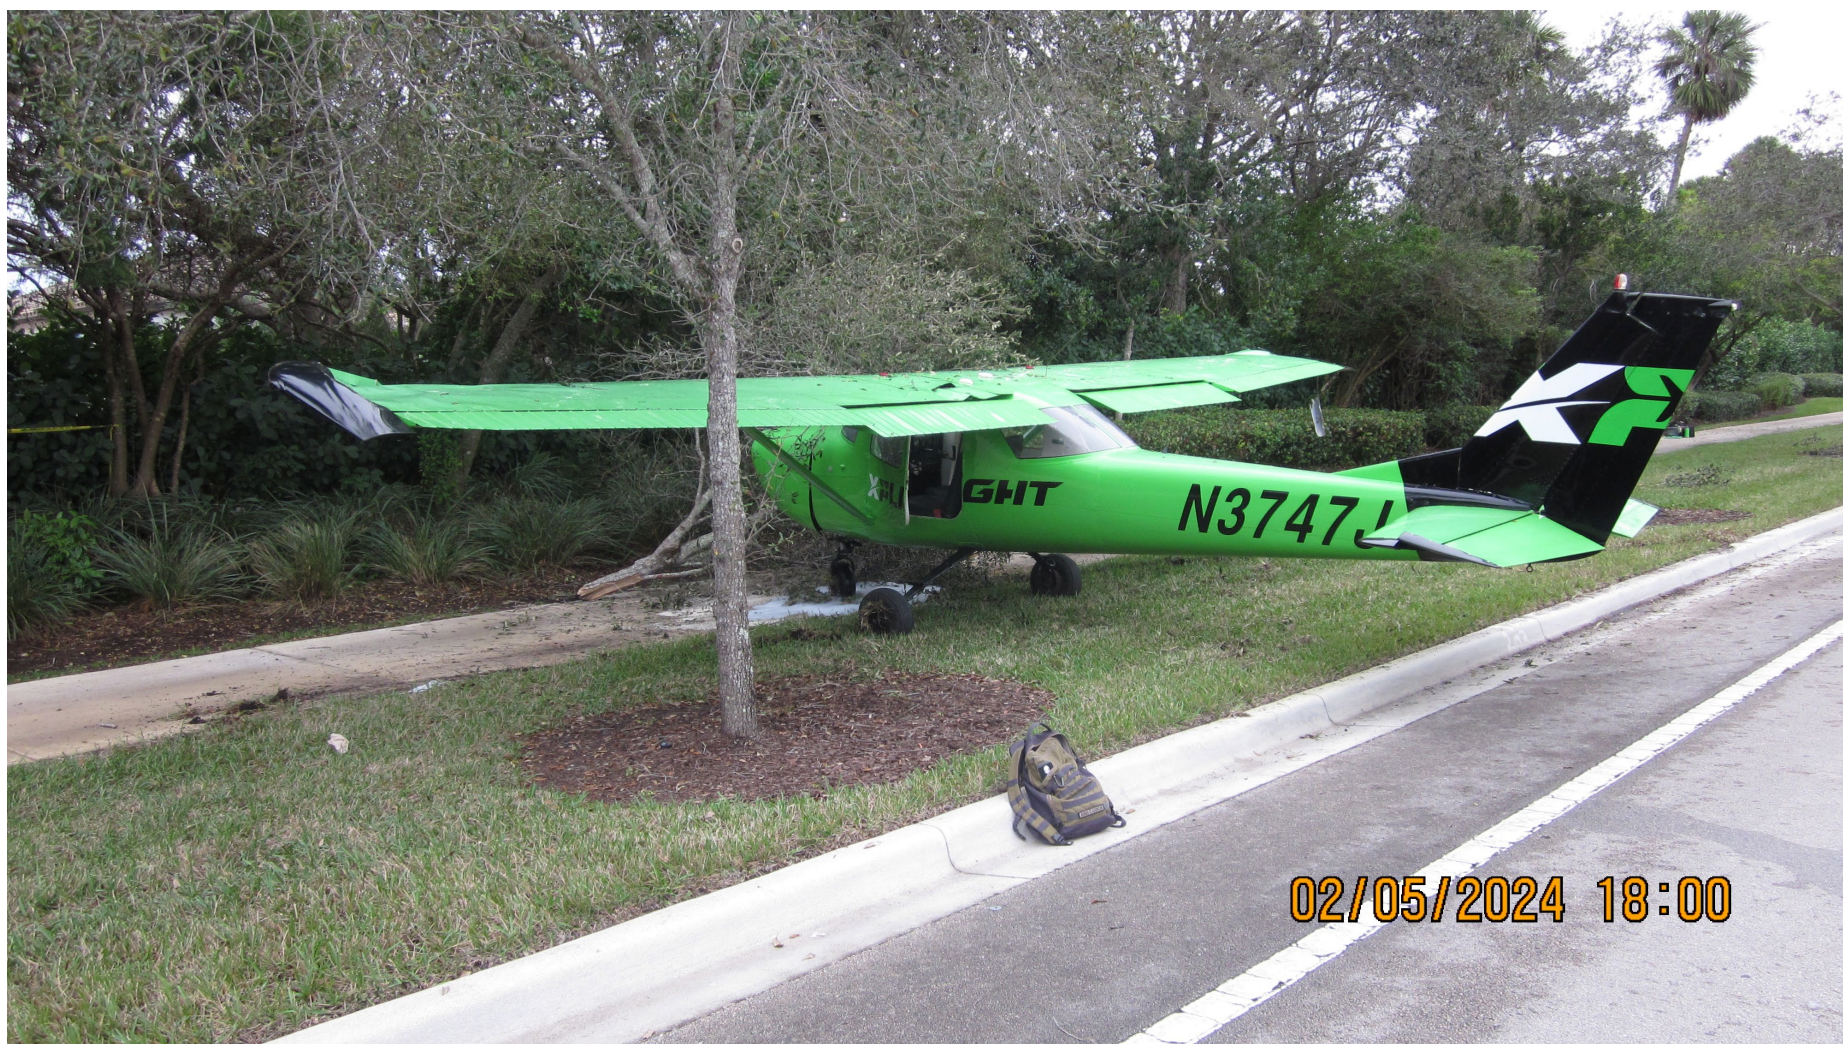
**Photograph 1 - Main Wreckage (Courtesy of FAA)**

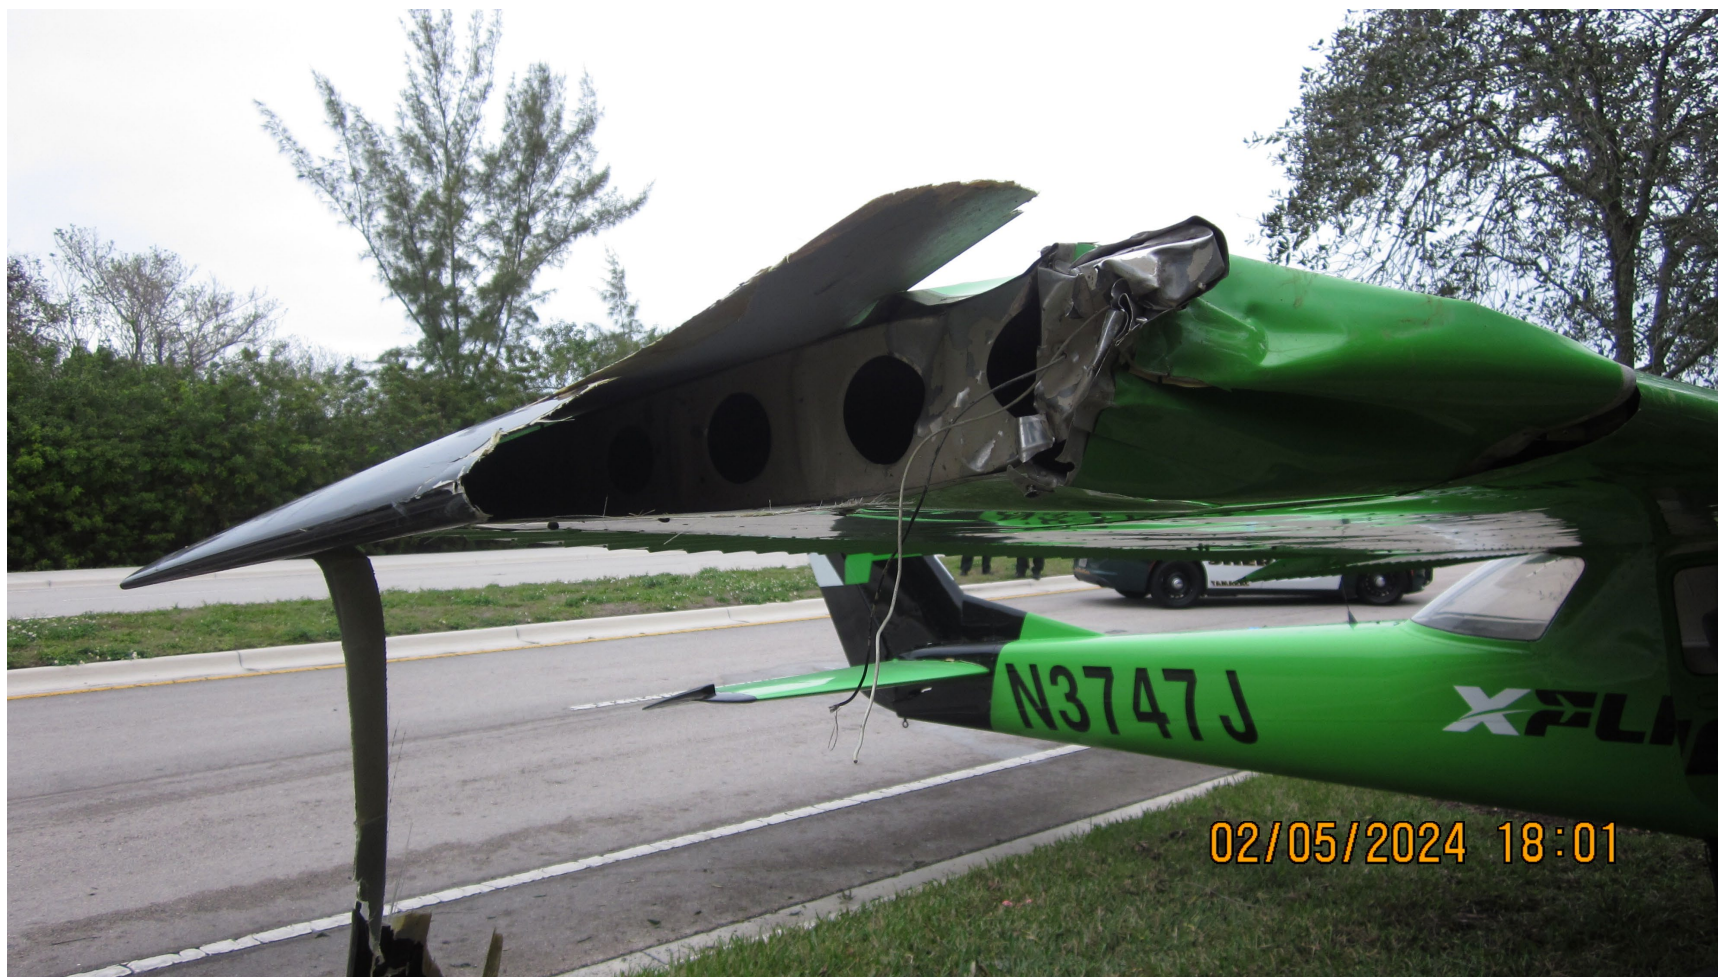
**Photograph 2 - Right wing damage (Courtesy of FAA)**

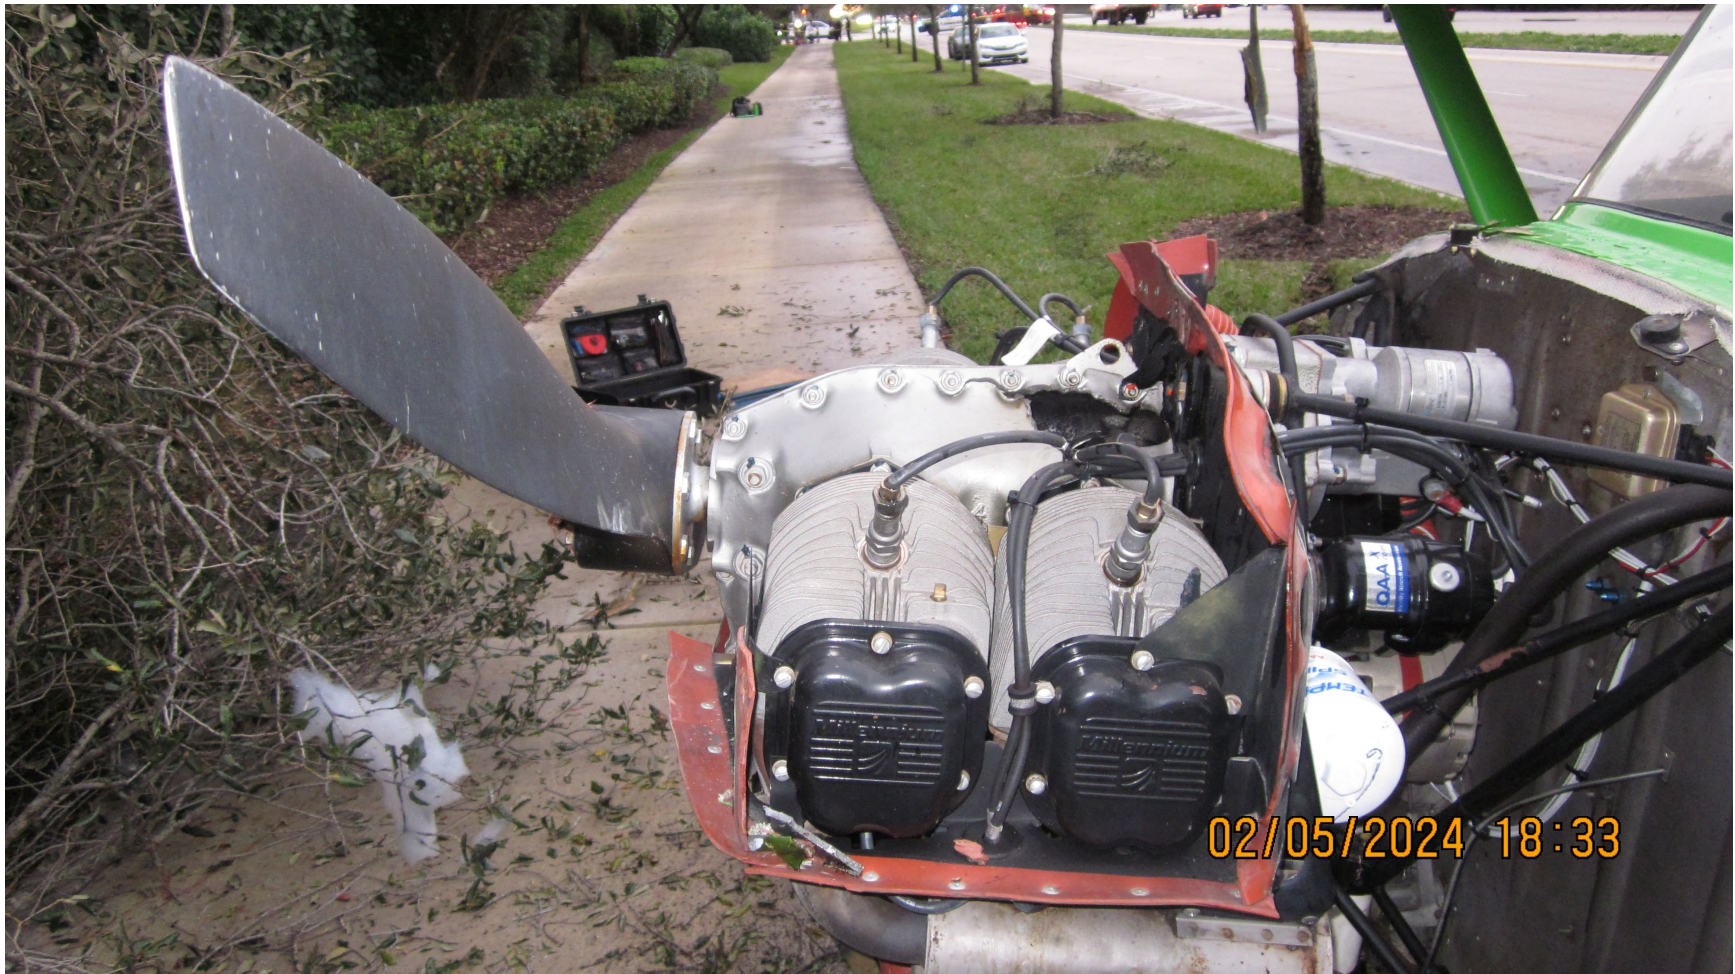
**Photograph 3 - Engine Note: hole in case half (Courtesy of FAA)**

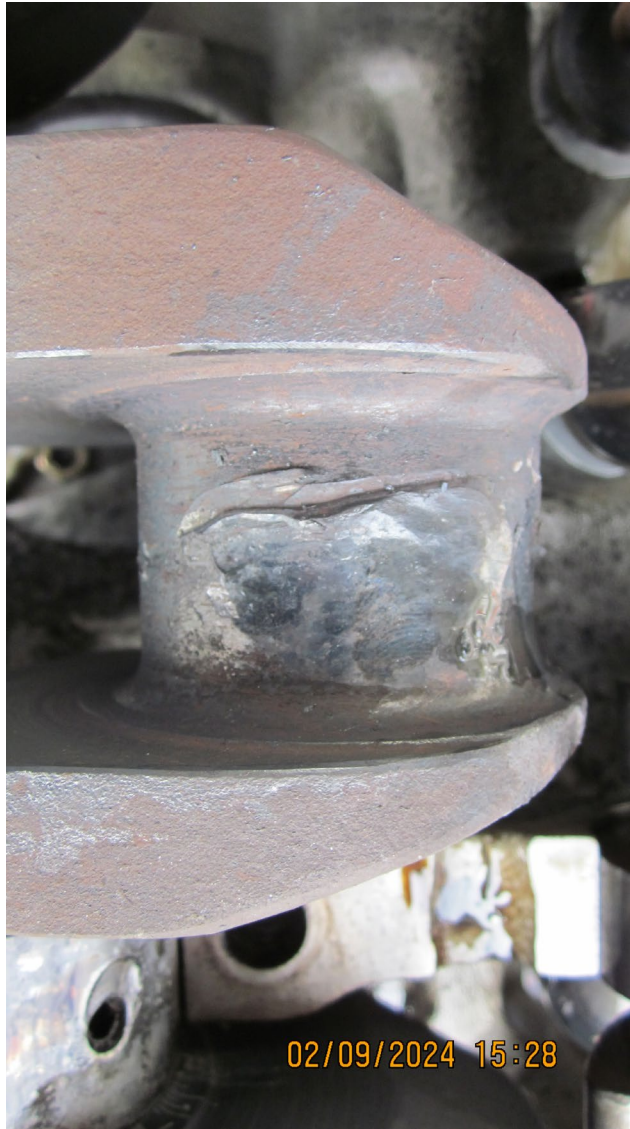
**Photograph 4 - No. 2 main journal**

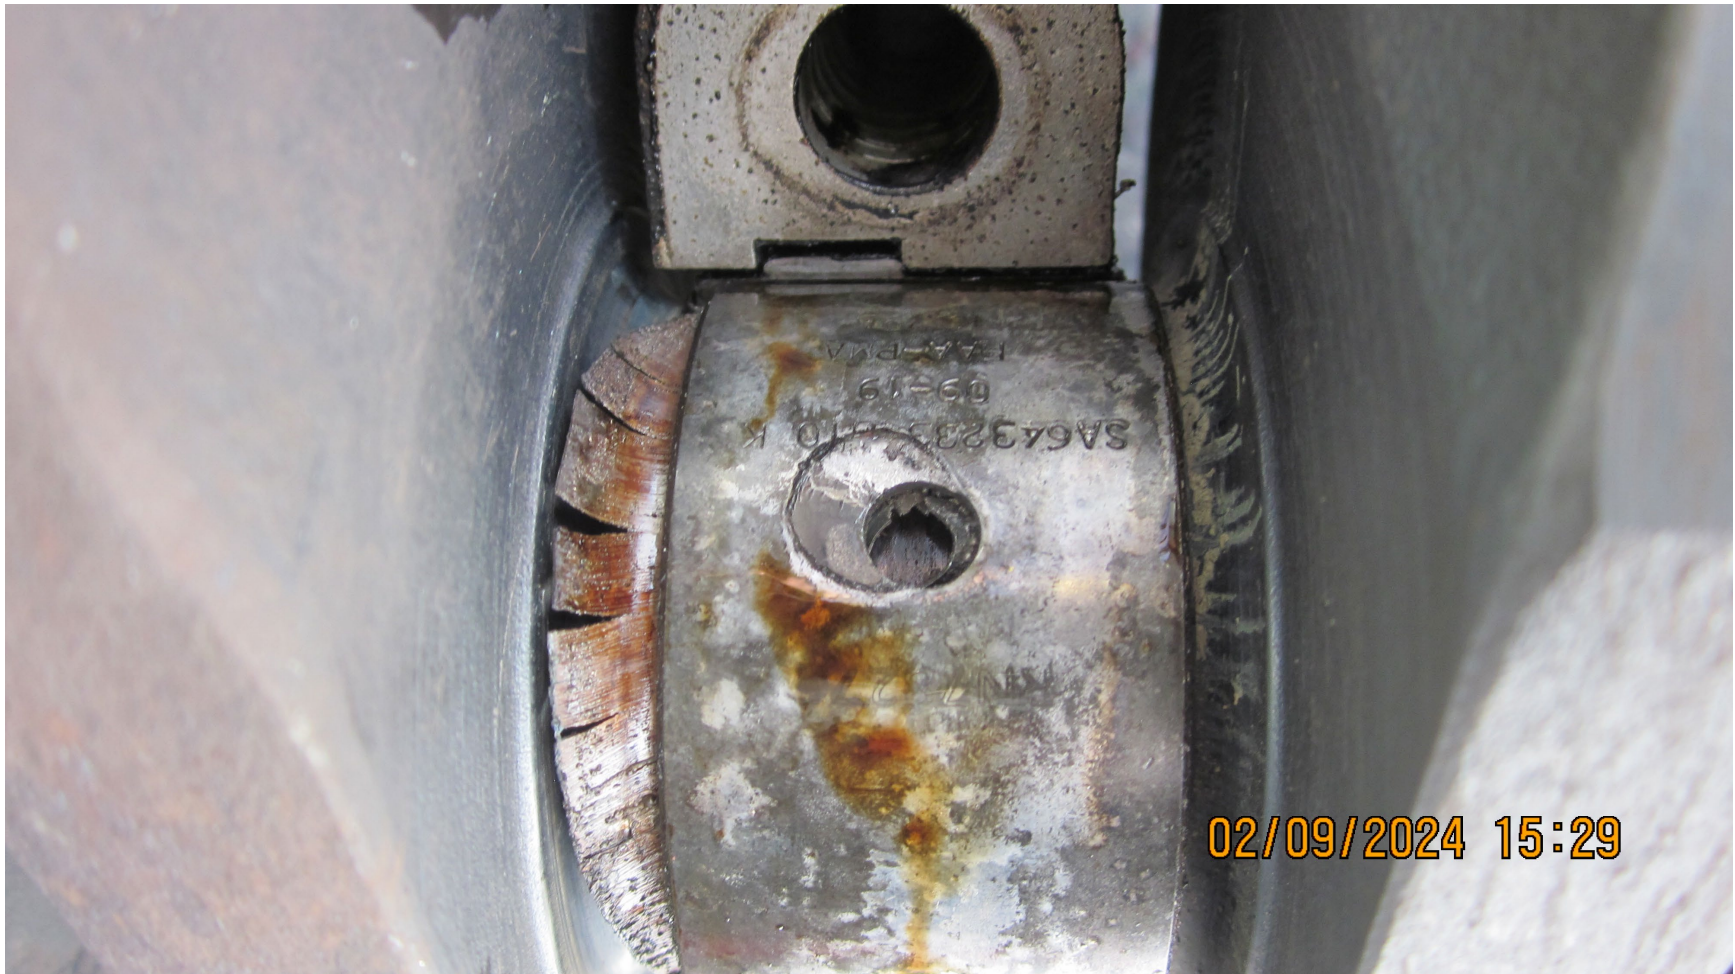
**Photograph 5 - Bearing material**

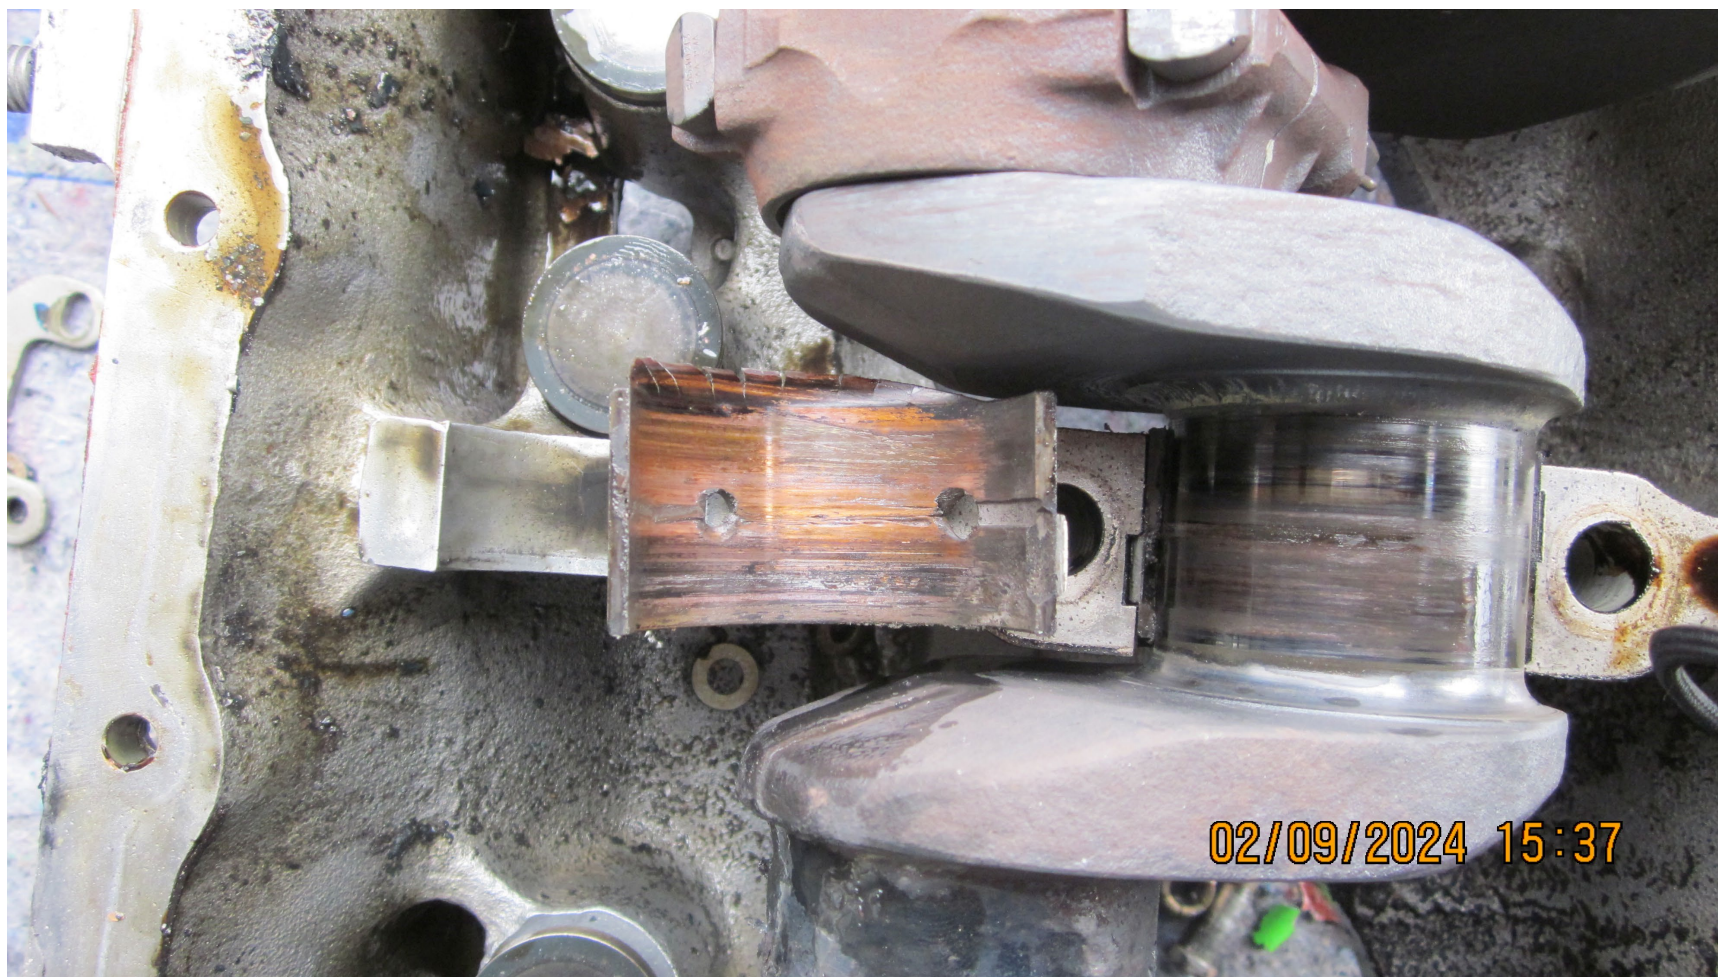
**Photograph 6 - Bearing material**

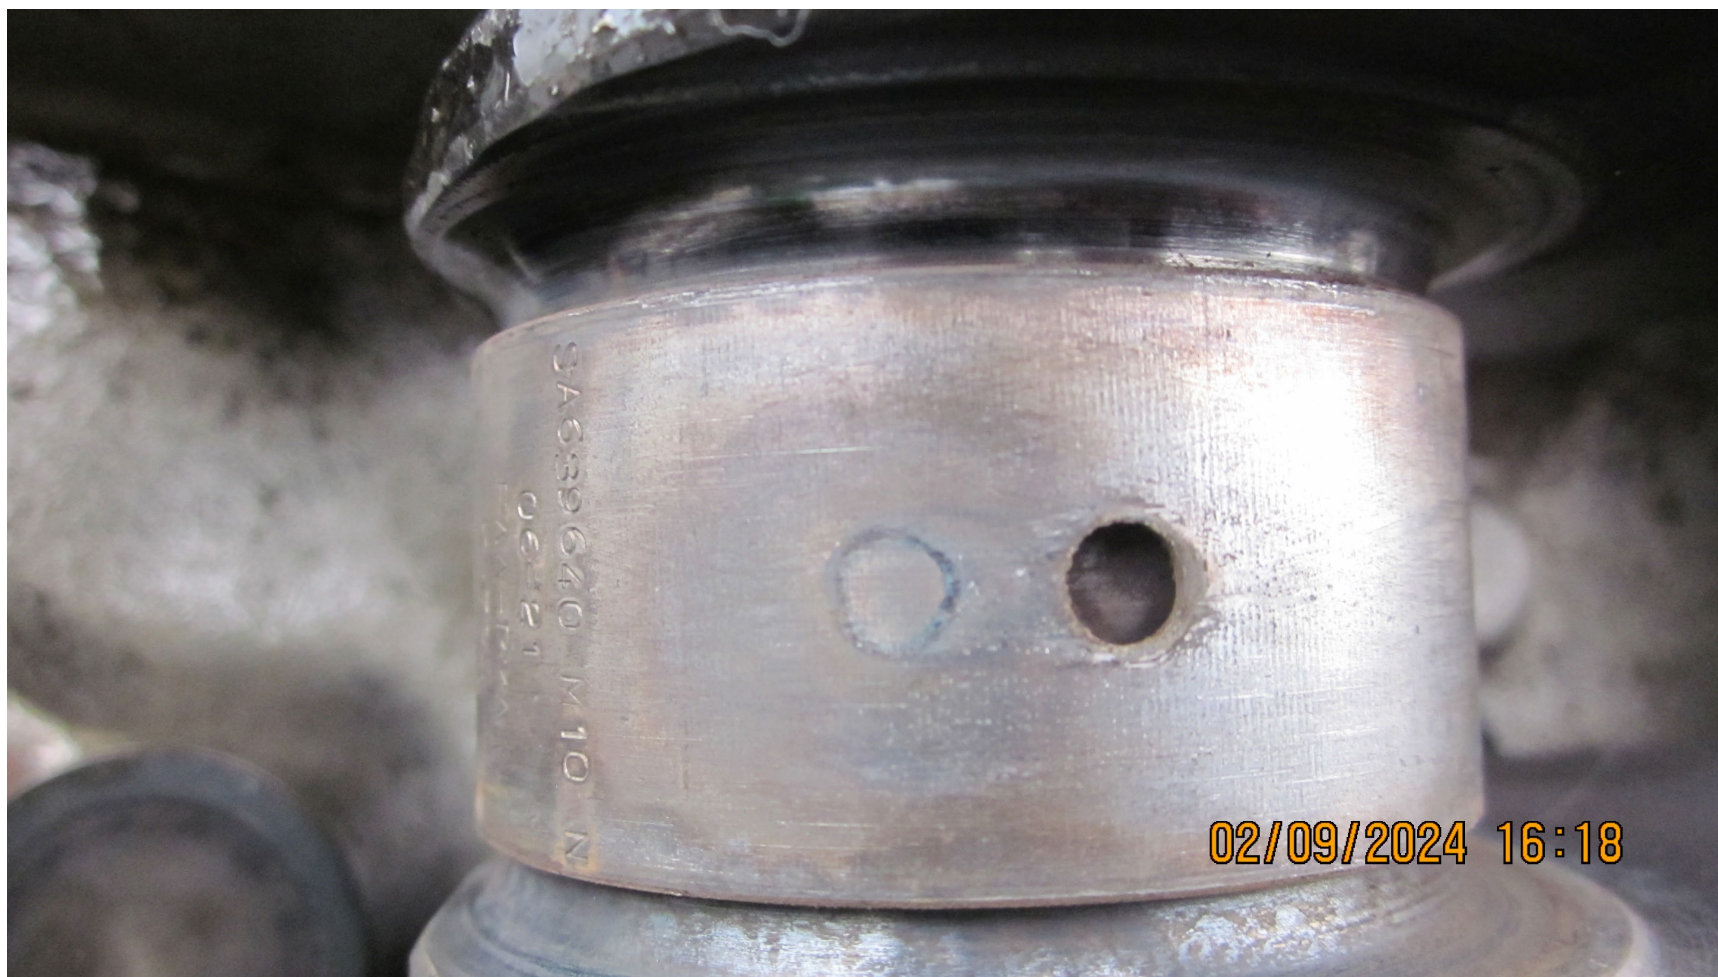
**Photograph 7 - Bearing Note: alignment hole with Rod slippage.**
