ERA24LA111

## INVESTIGATION PHOTOGRAPHS

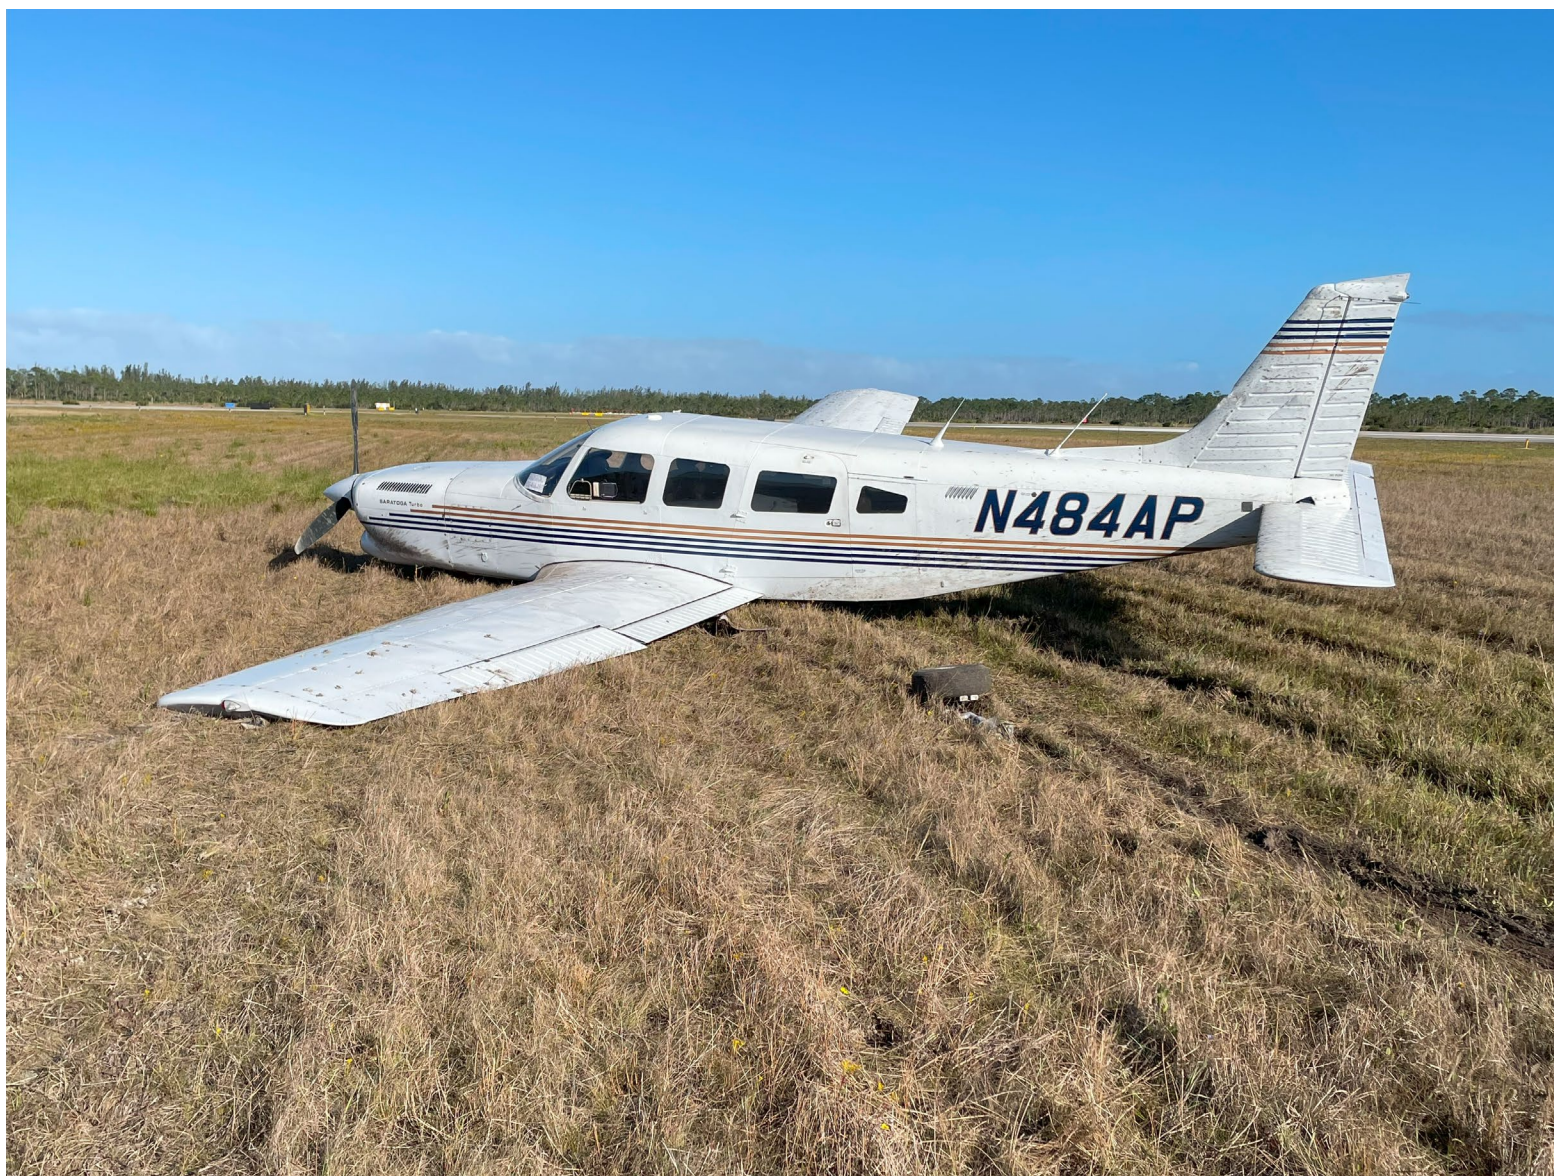
**Photograph 1 - Airplane at the accident site (Courtesy of FAA)**

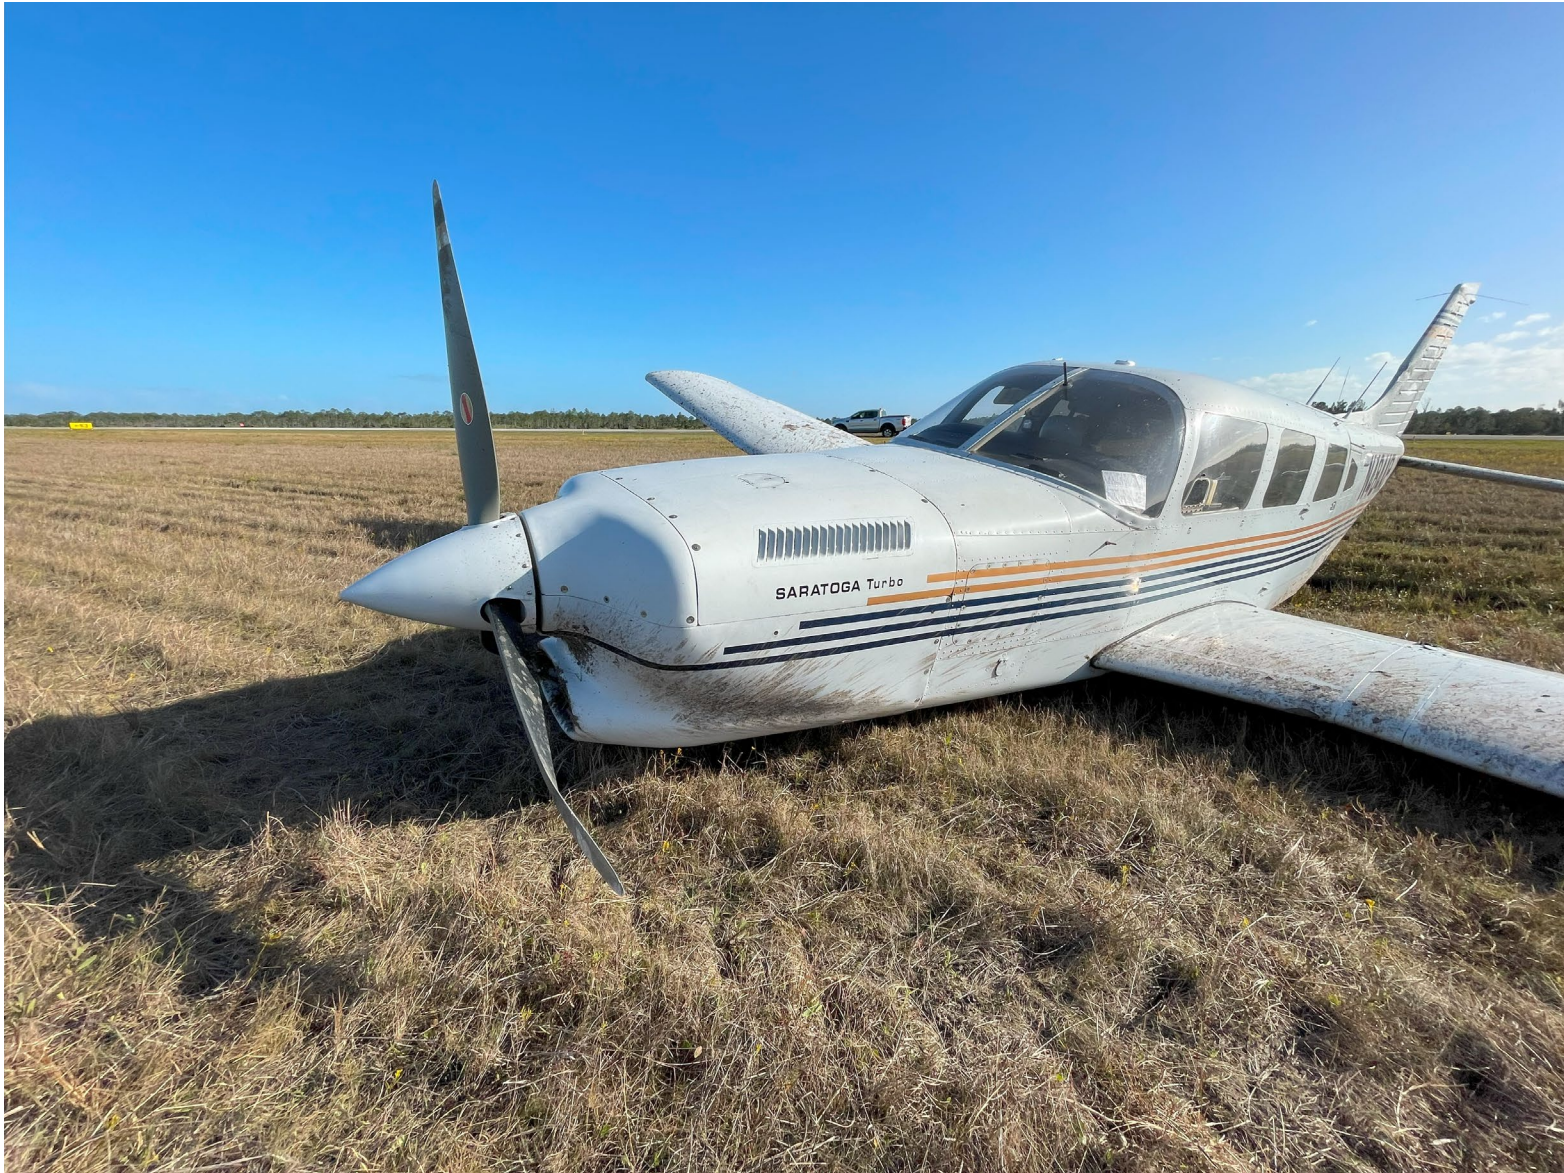
**Photograph 2 - Airplane at accident site (Courtesy of FAA)**

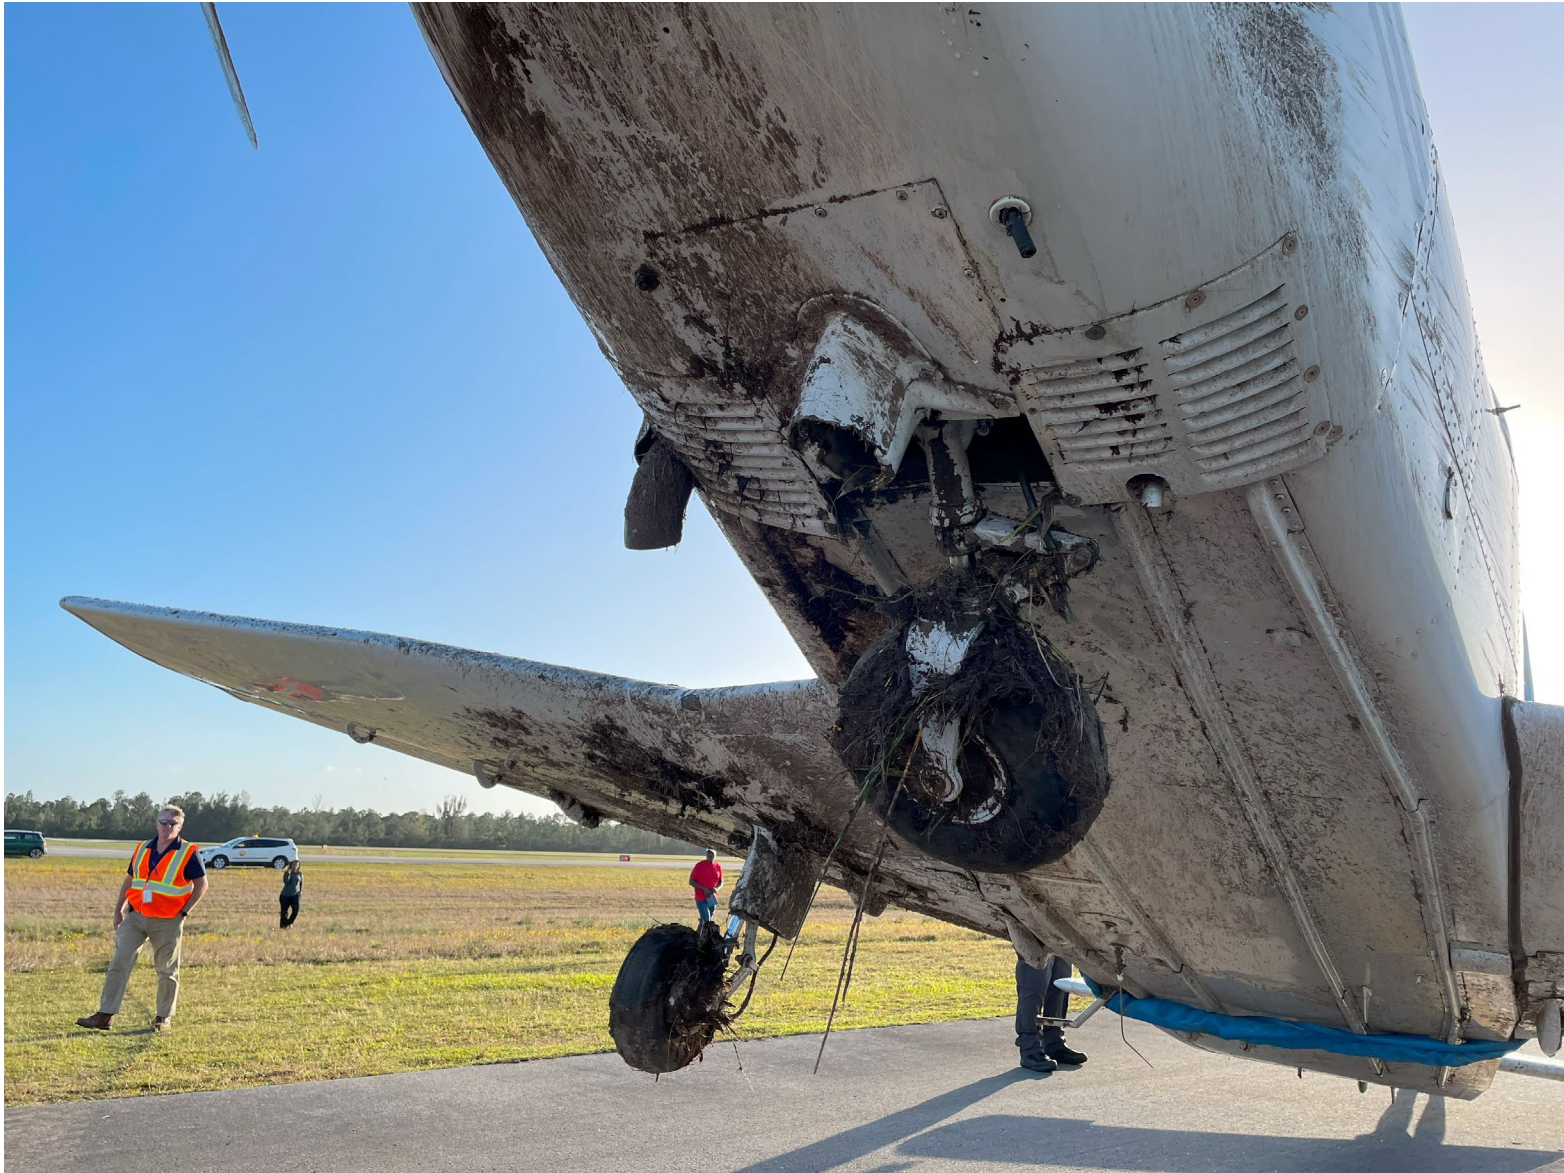
**Photograph 3 - Photo of the airplane's underside (Courtesy of FAA)**

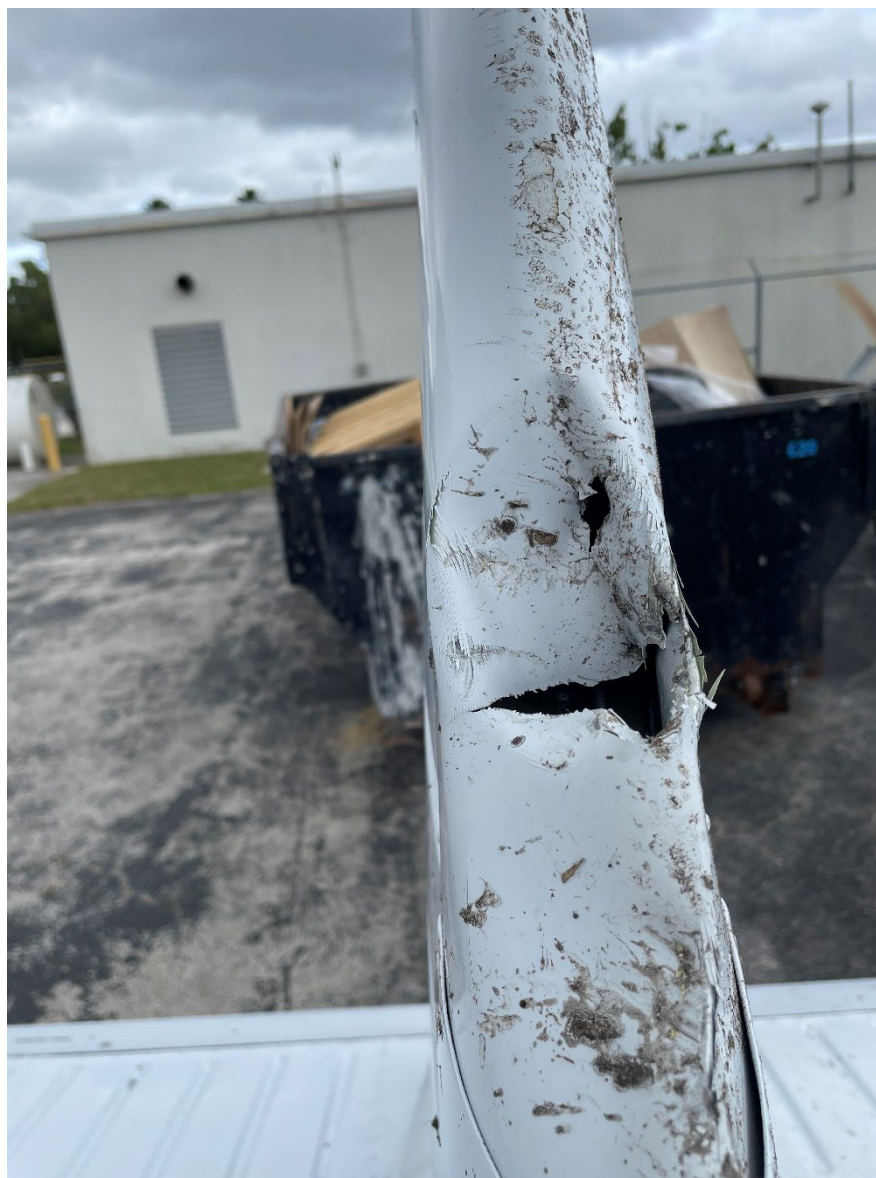
**Photograph 4 - Damage to the vertical stabilizer (Courtesy of FAA)**

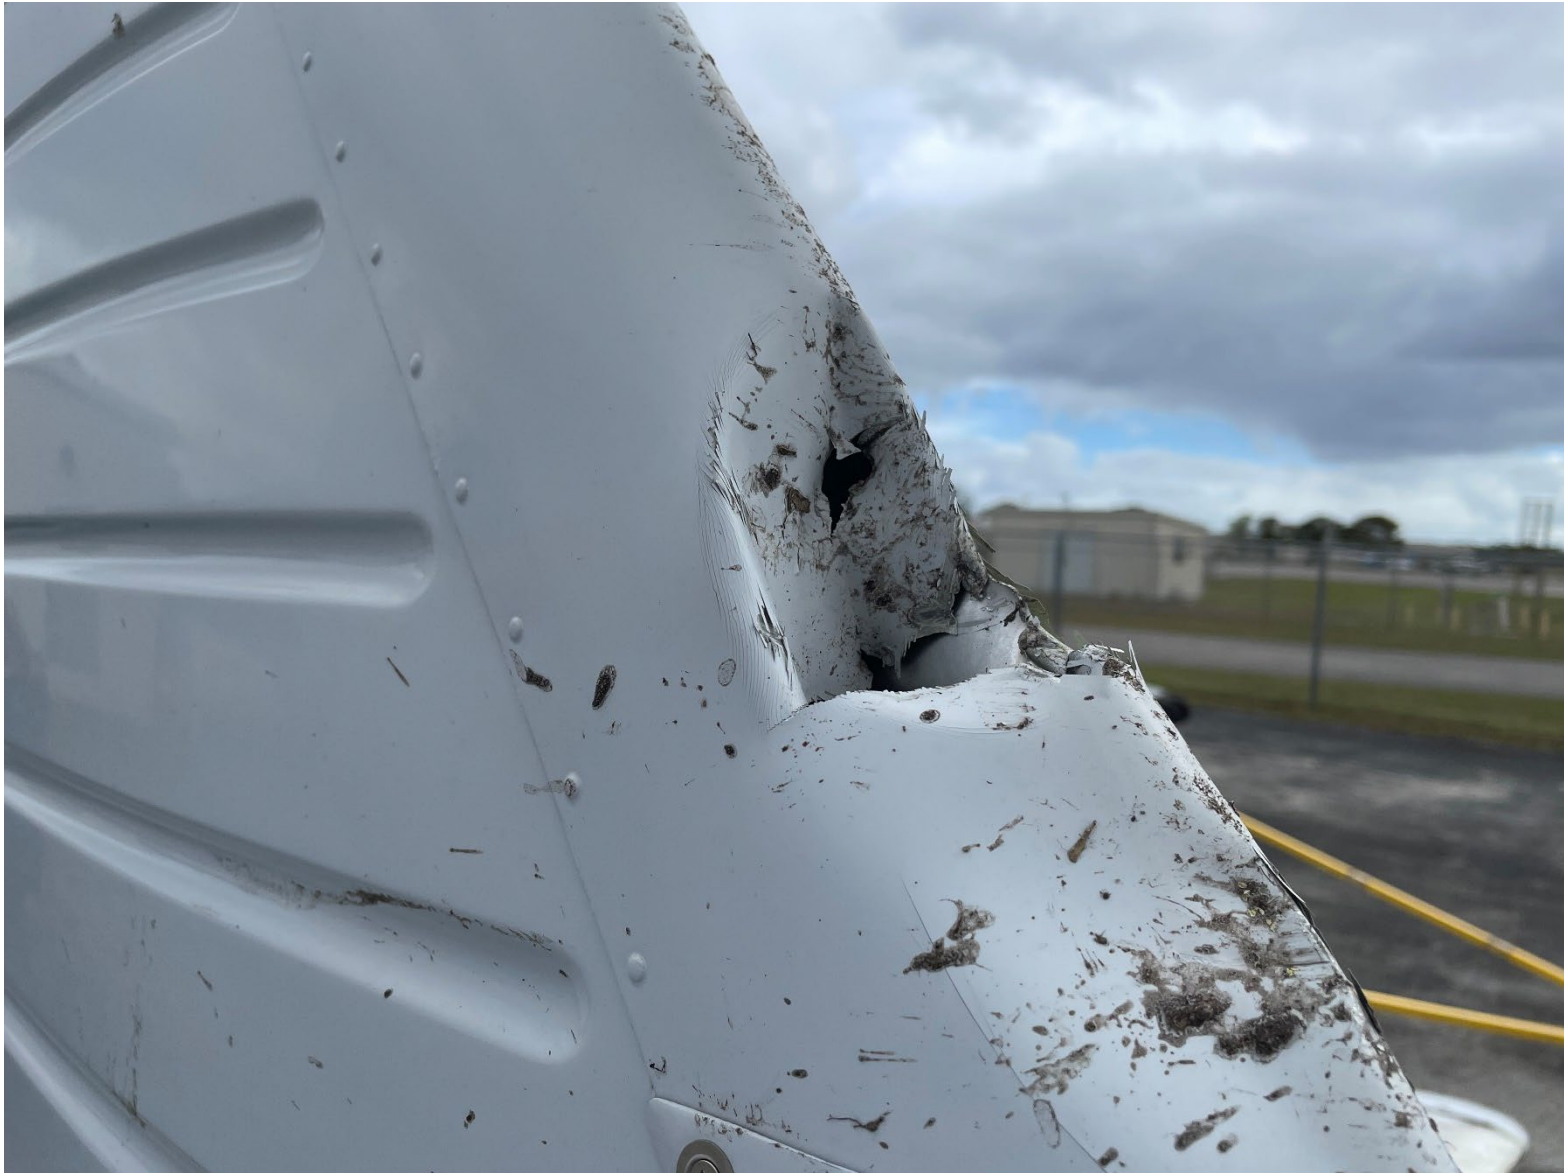
**Photograph 5 - Damage to the vertical stabilizer (Courtesy of FAA)**
