# National Transportation Safety Board

ERA24LA112

## **NOSE STEERING EXAMINATION**

Location: Stevensville, MD  
Date: February 7, 2024  
Time: 1200 EST  
1700 Z  
Airplane: N39818, Bellanca 17-30A, SN 73-30511

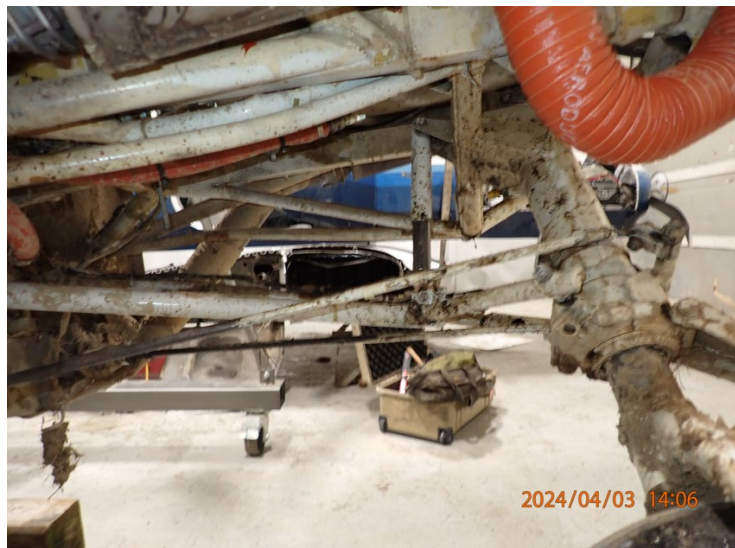
**View of the Nose Gear Steering System from the Right**

The nose landing gear was displaced to the right-hand side as a result of the accident. The upper leg of the nose gear was bent and fractured near the nose gear

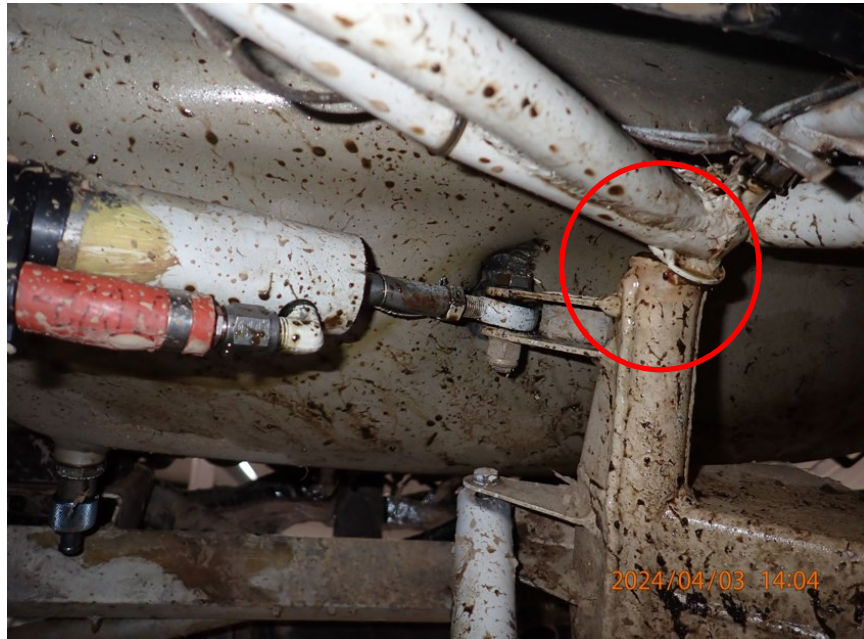
**Damage to the Upper Leg of the Nose Gear**

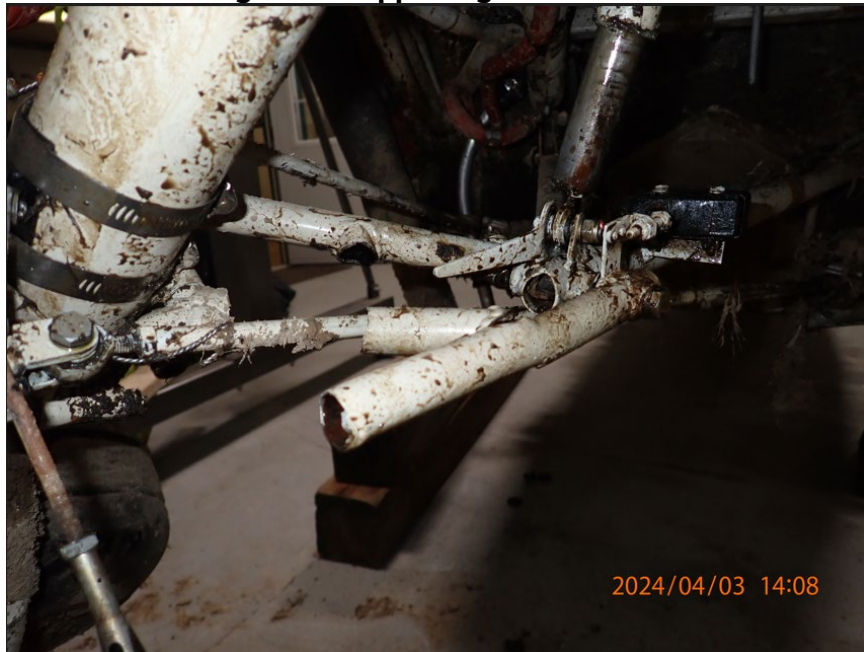
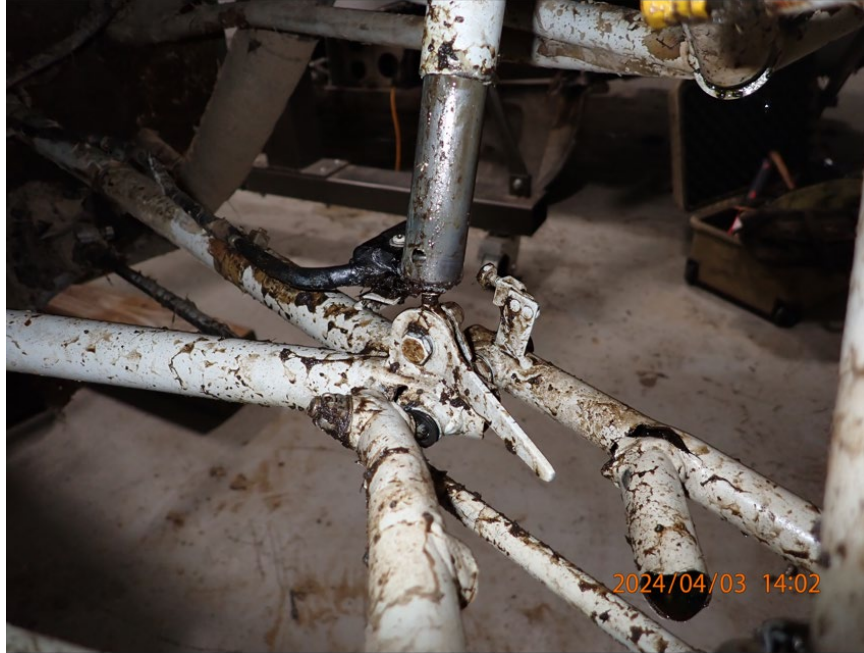
cylinder assembly. The lower drag strut was fractured in the middle and displaced partially to the right. The right-hand lower steering rod was broken forward of the rod end nut.

**Lower Drag Strut Damage**

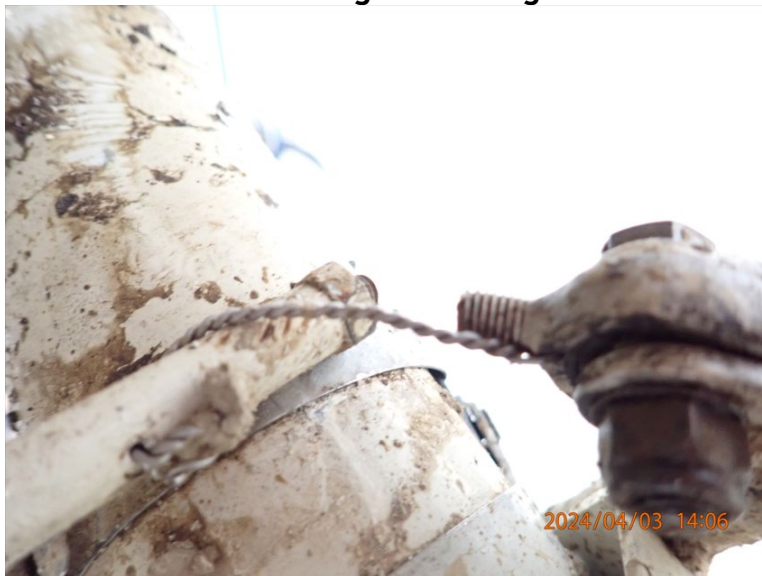
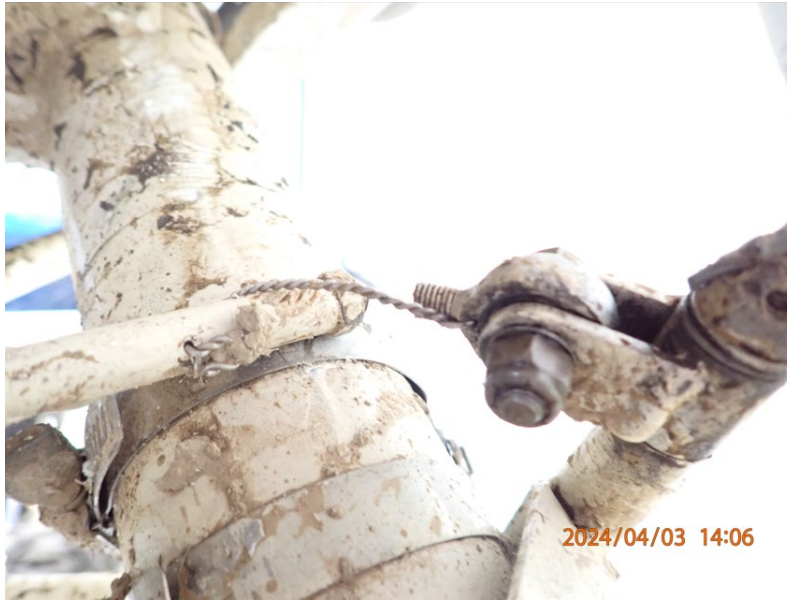
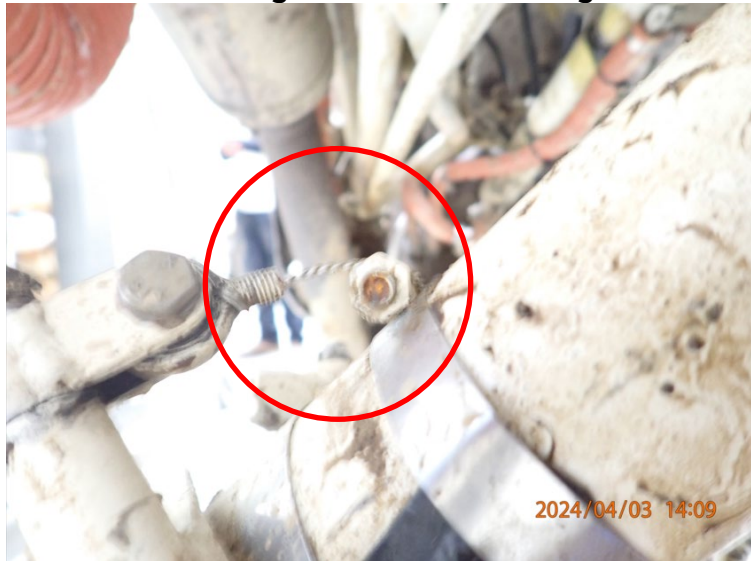
**Fractured Right Hand Lower Steering Rod**
