ERA24LA113

## INVESTIGATION PHOTOGRAPHS

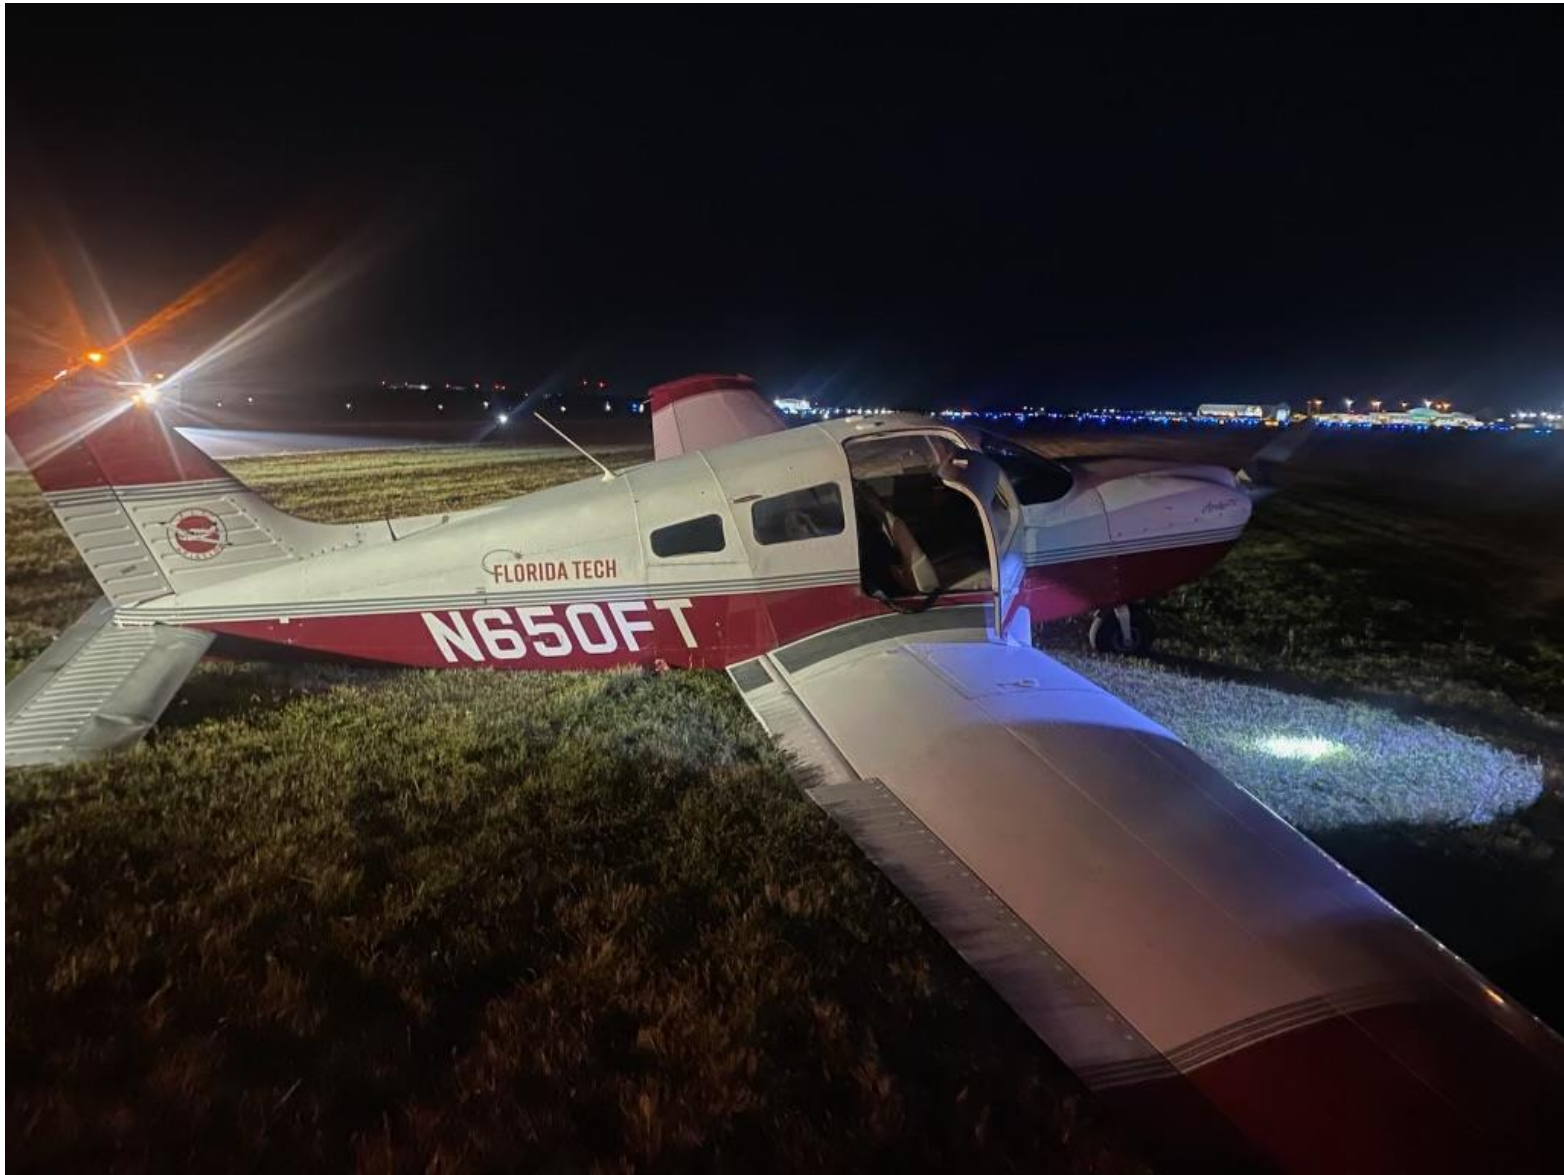
**Photograph 1 - Airplane at accident site (Courtesy of FAA)**

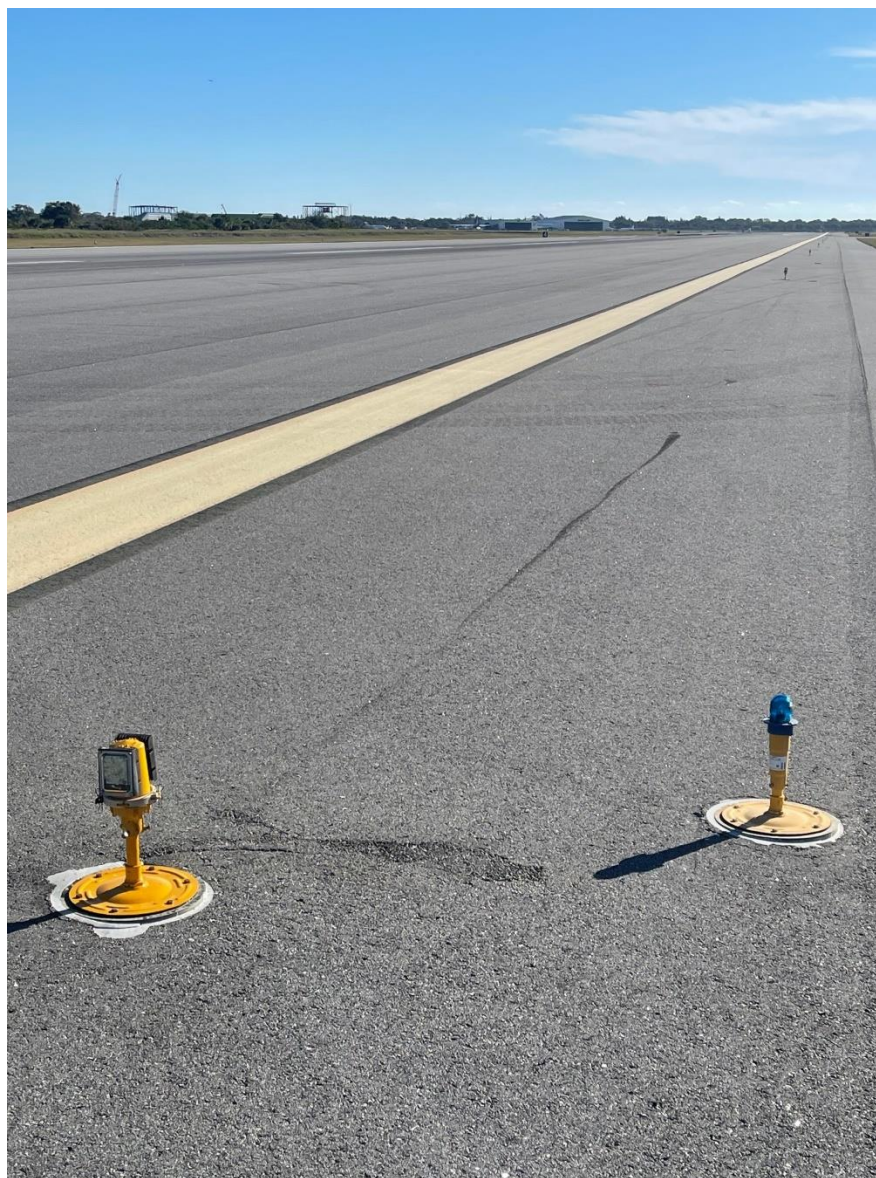
**Photograph 2 - Impacted runway light location (Courtesy of FAA)**

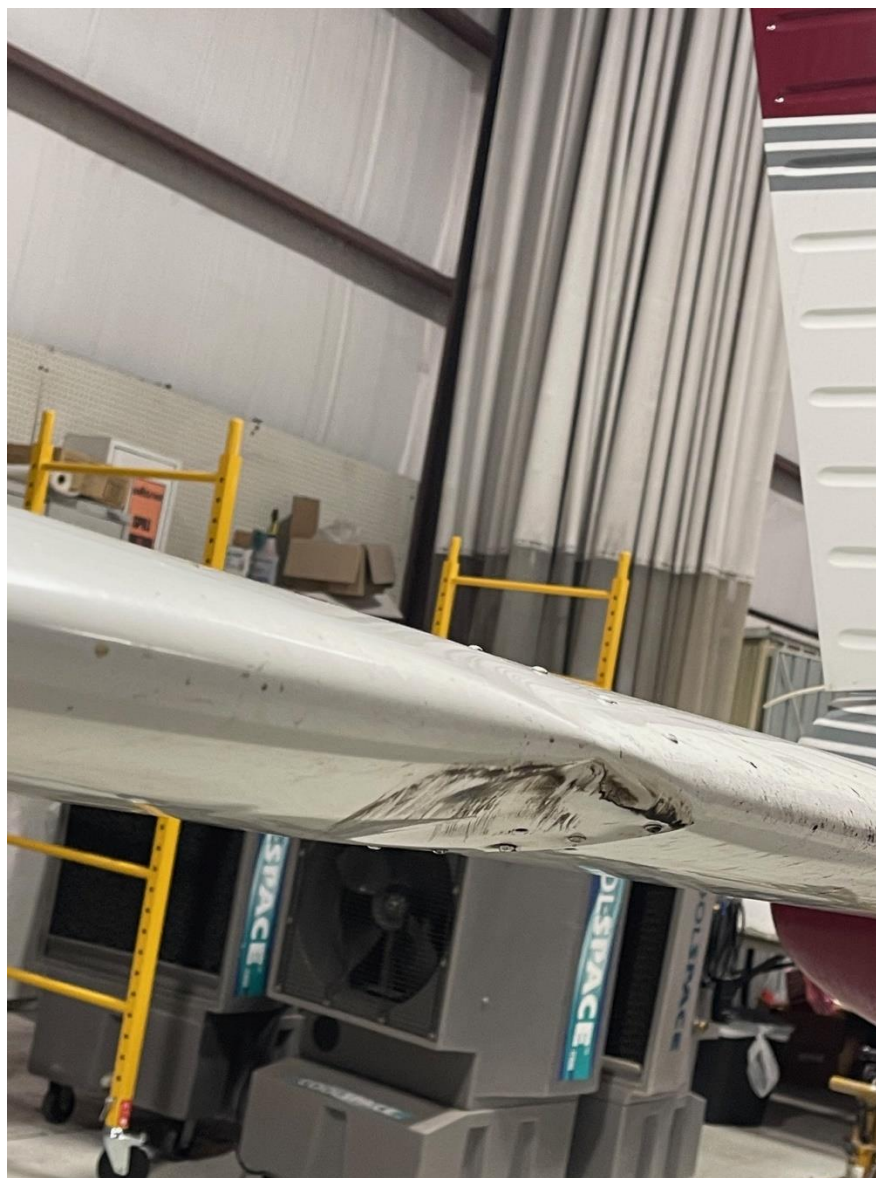
**Photograph 3 - Damage to the stabilator (Courtesy of FAA)**

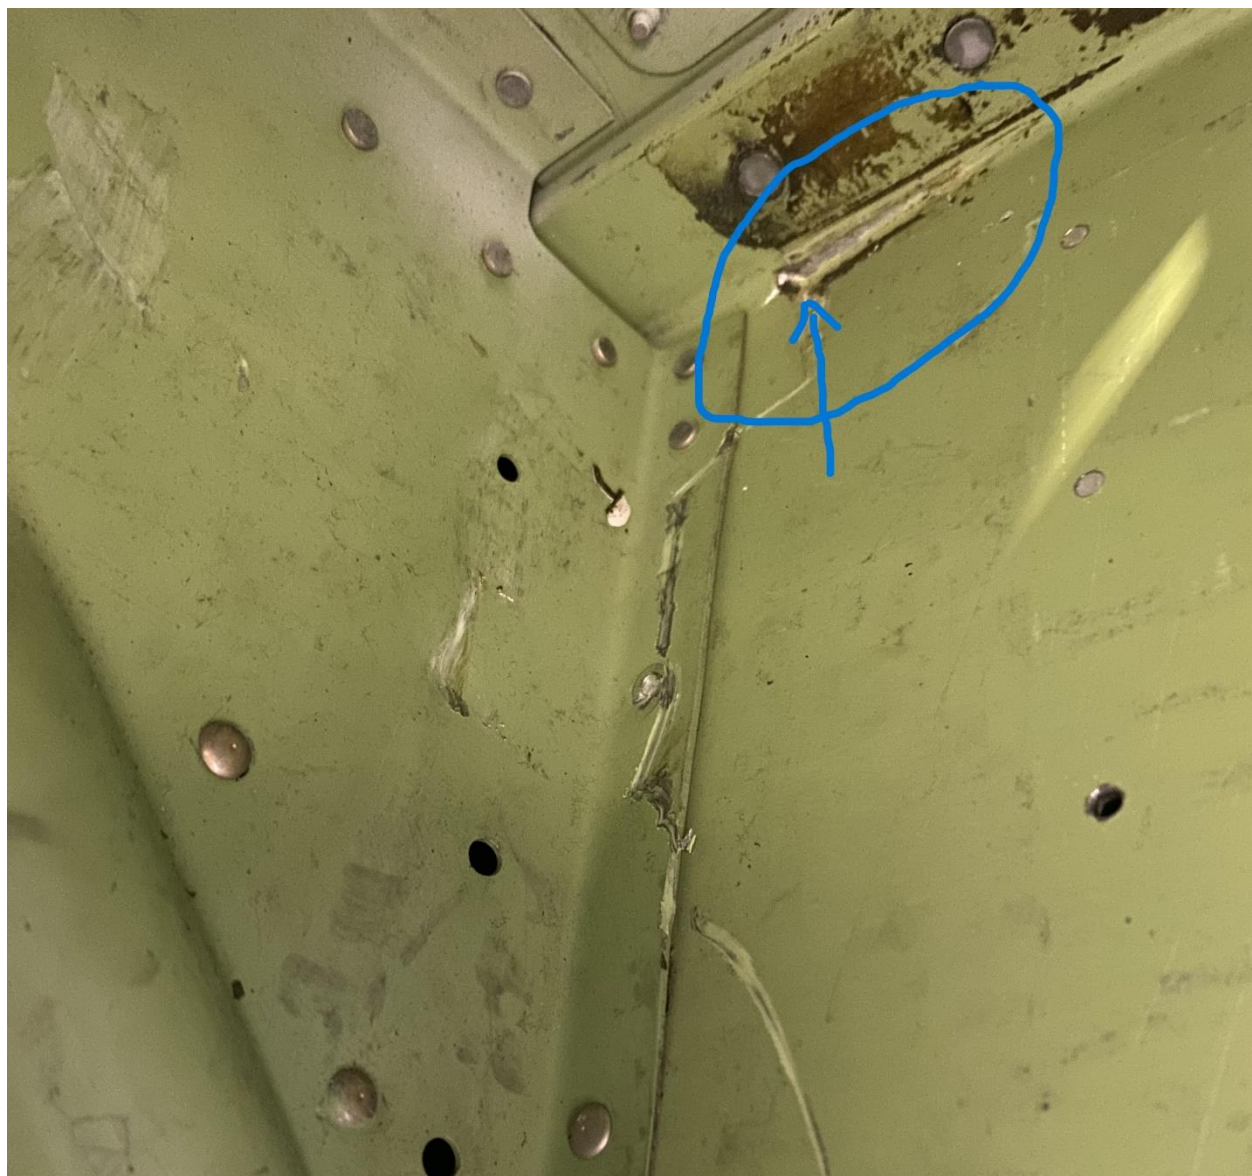
**Photograph 4 - Crack found in the right-wing structure (Courtesy of FAA)**
