ERA24LA117

## INVESTIGATION PHOTOGRAPHS

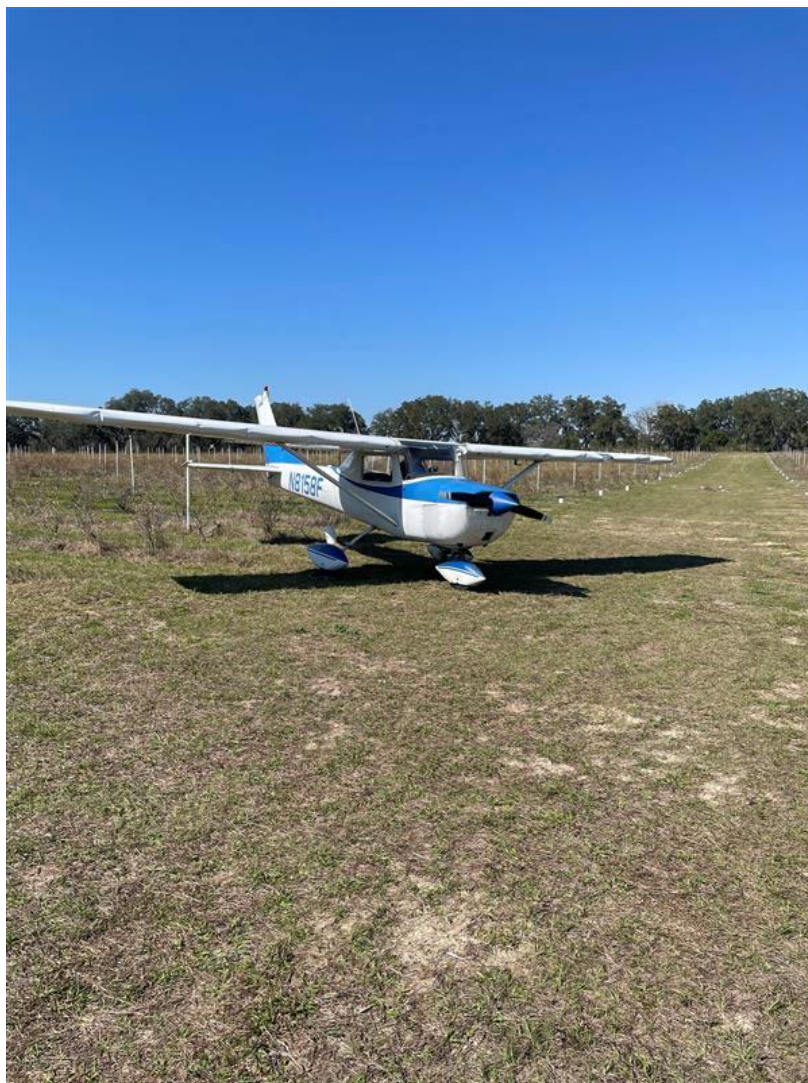
**Photograph 1 - Airplane in the Blueberry Field with PVC Piping (Courtesy of FAA)**

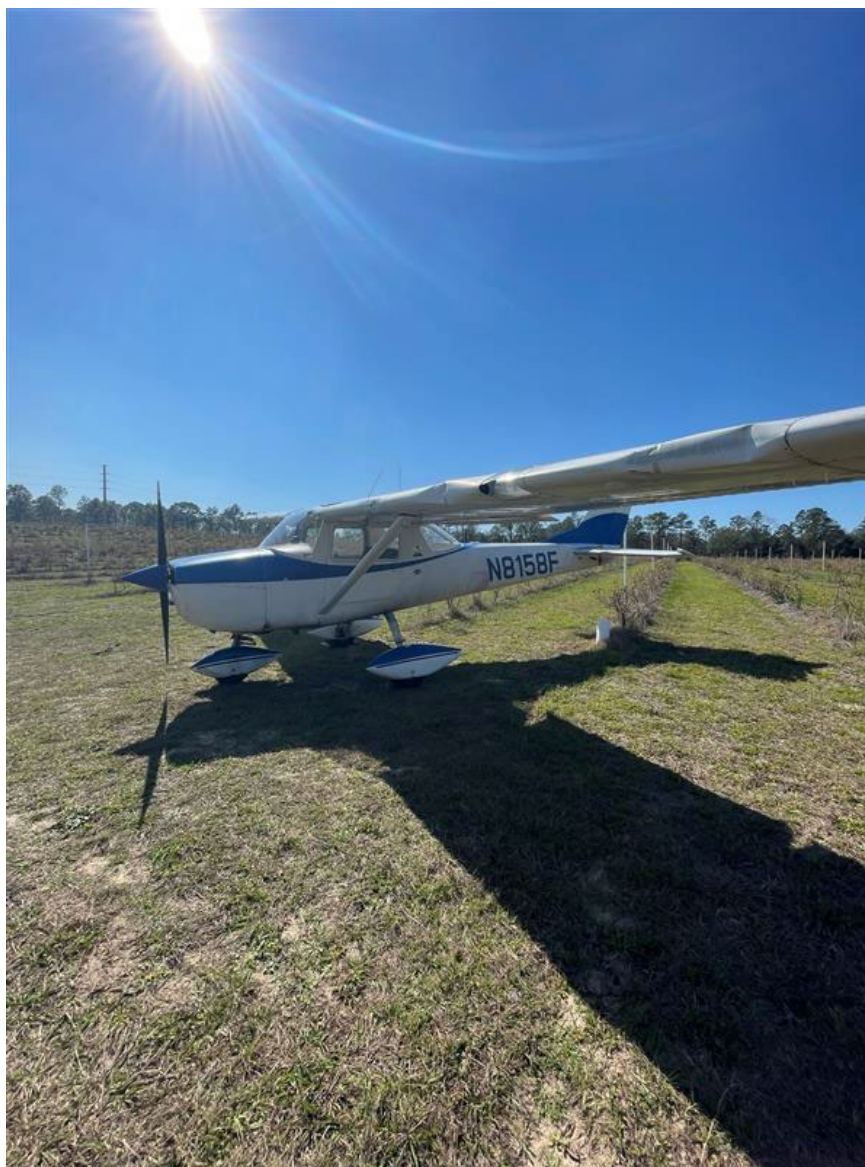
**Photograph 2 - Leading Edge Damage to Left Wing (Courtesy of FAA)**

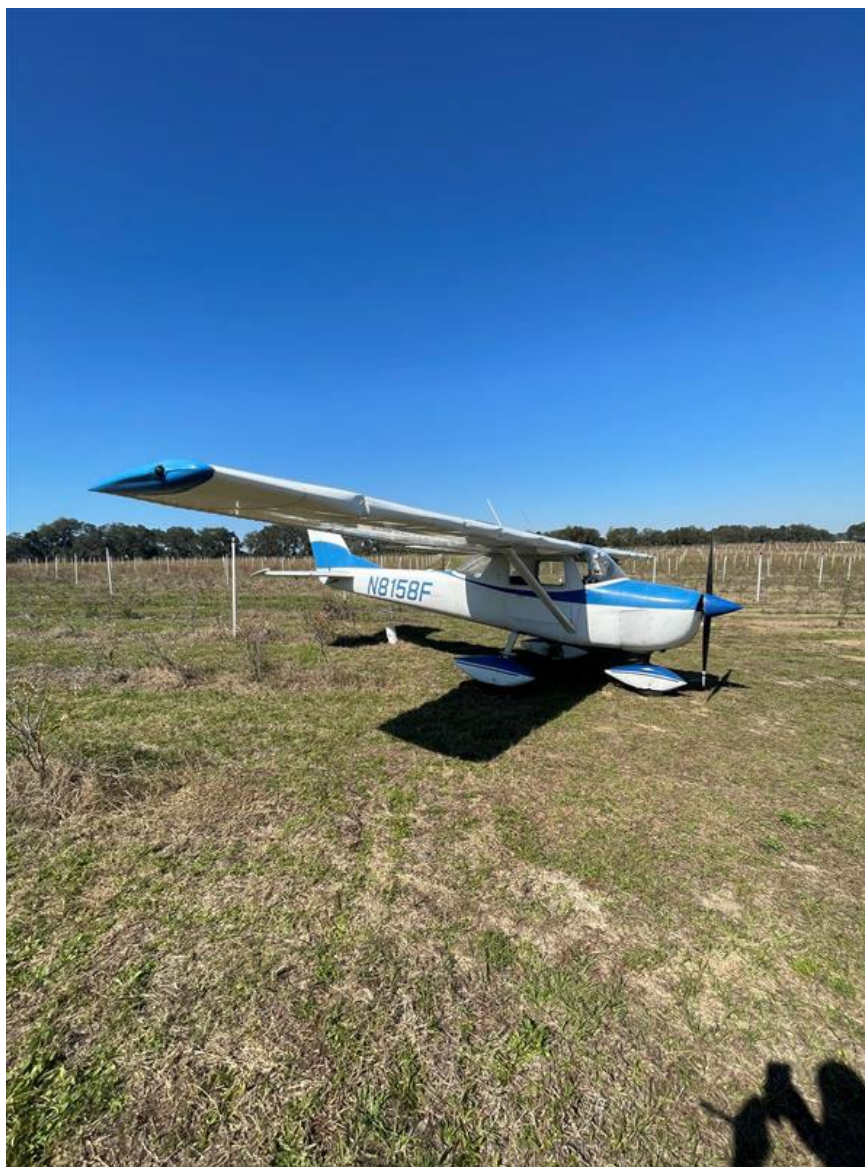
**Photograph 3 - Damage to Right Wing (Courtesy of FAA)**

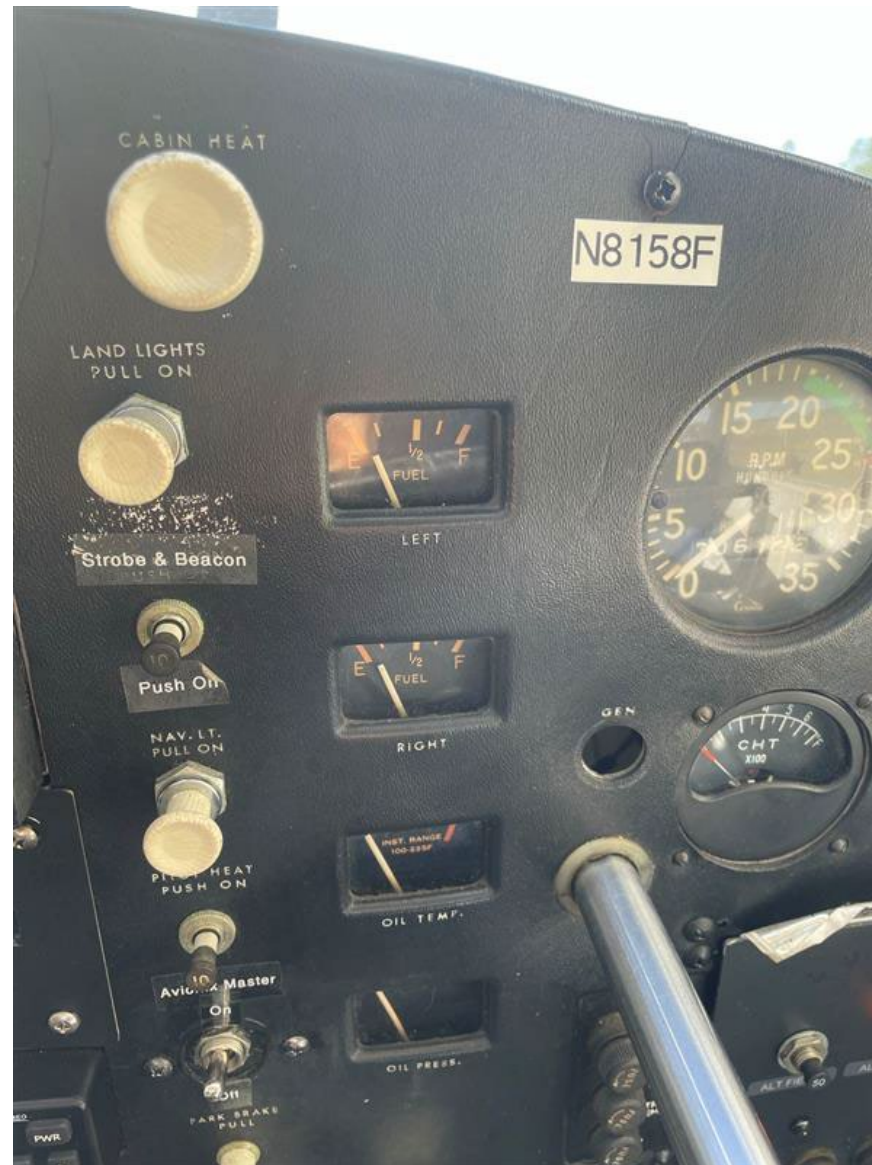
**Photograph 4 - Fuel Gauges (Courtesy of FAA)**
