ERA24LA118

## INVESTIGATIVE PHOTOS

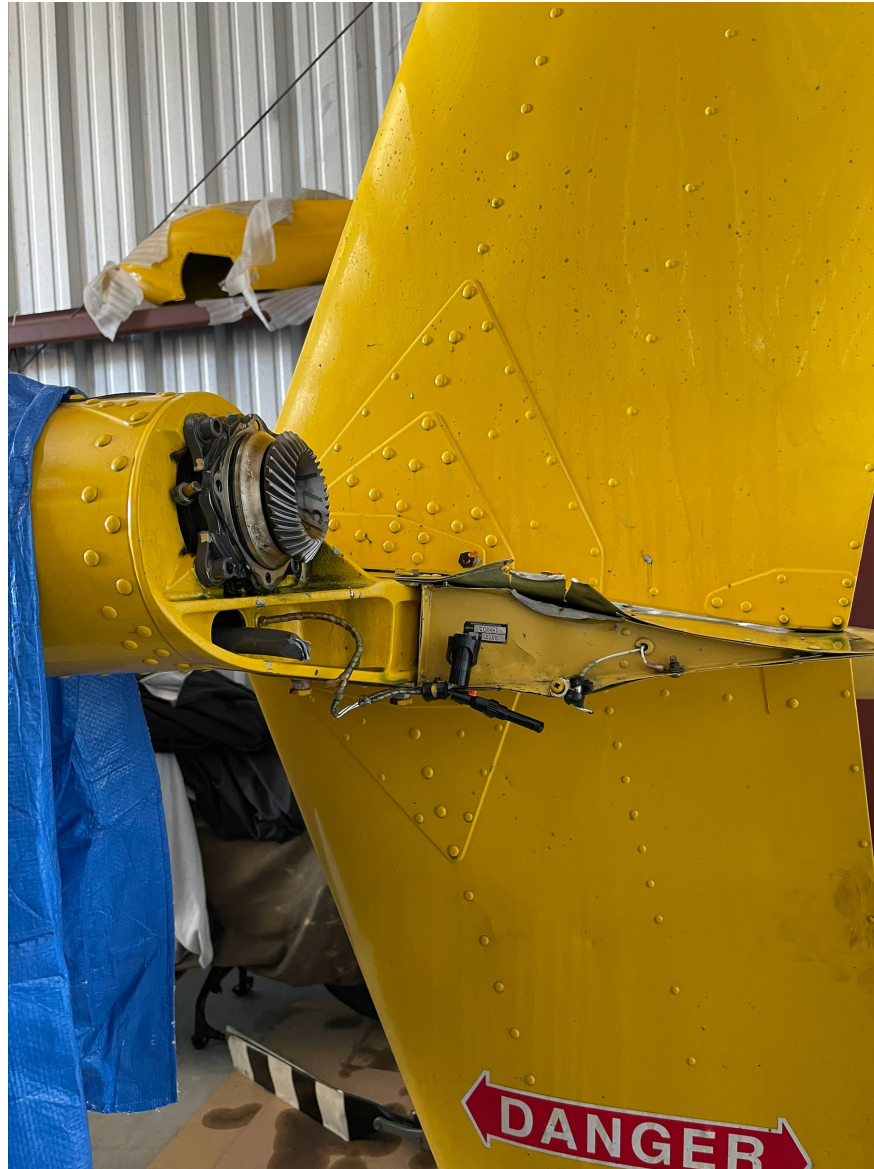
**Photograph 1 - Tail rotor assembly with fracture tail rotor.**

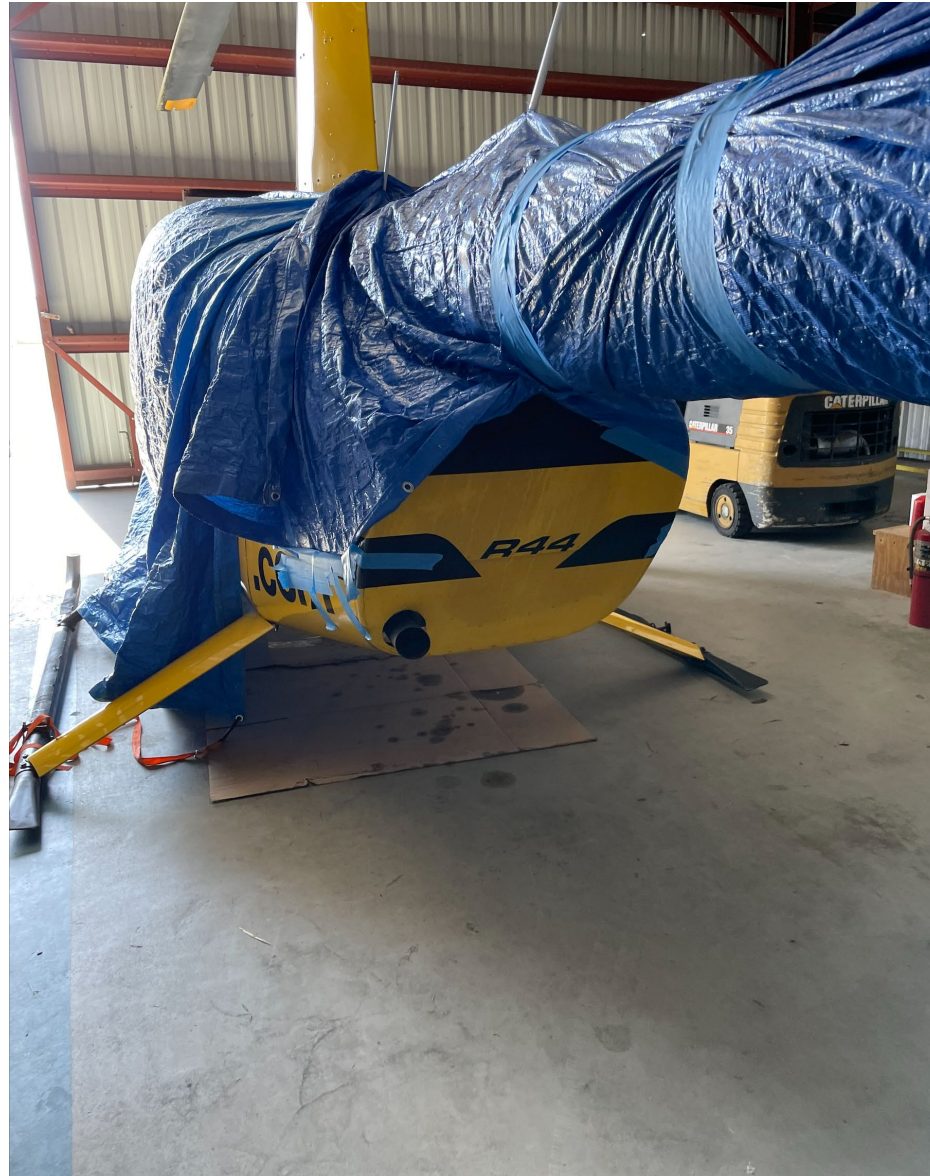
**Photograph 2 - Helicopter with displaced skids**

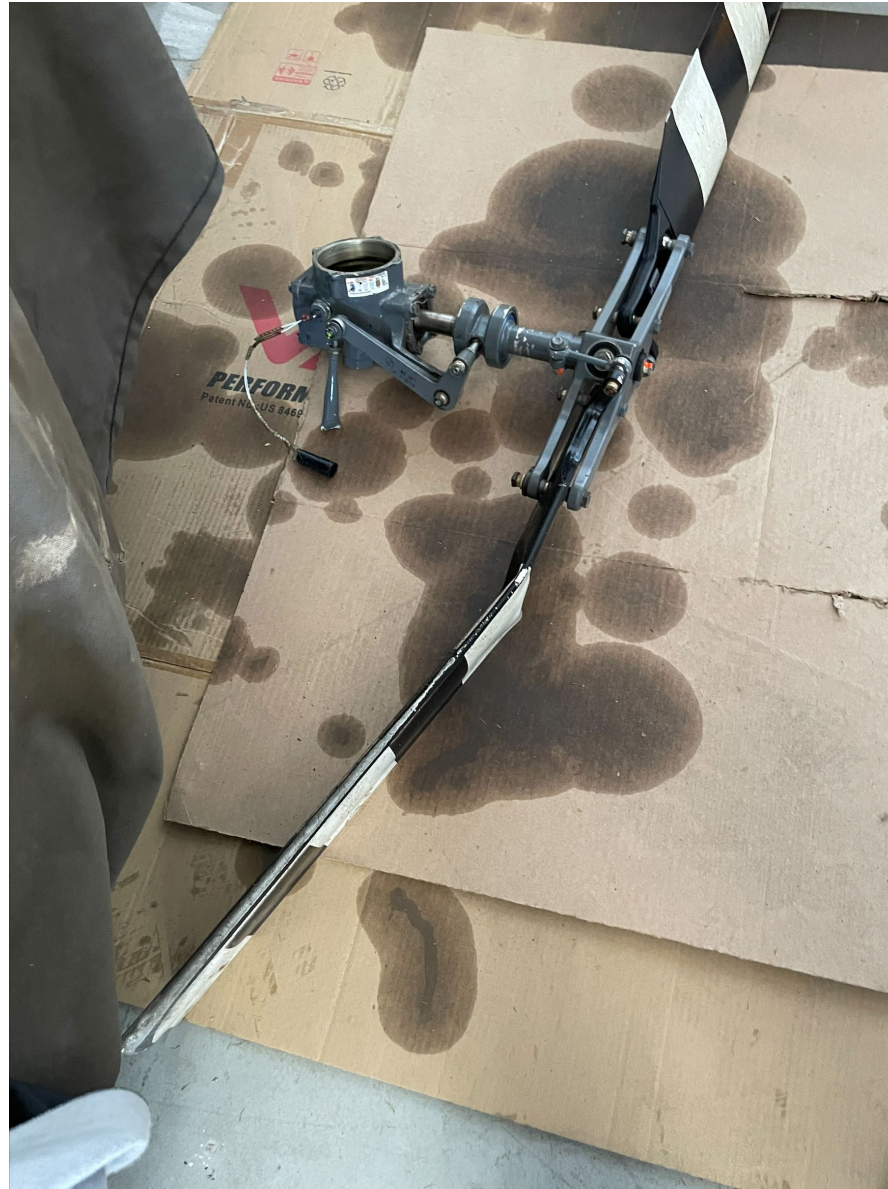
**Photograph 3 - Fractured tail rotor**
