ERA24LA122

## INVESTIGATION PHOTOGRAPHS

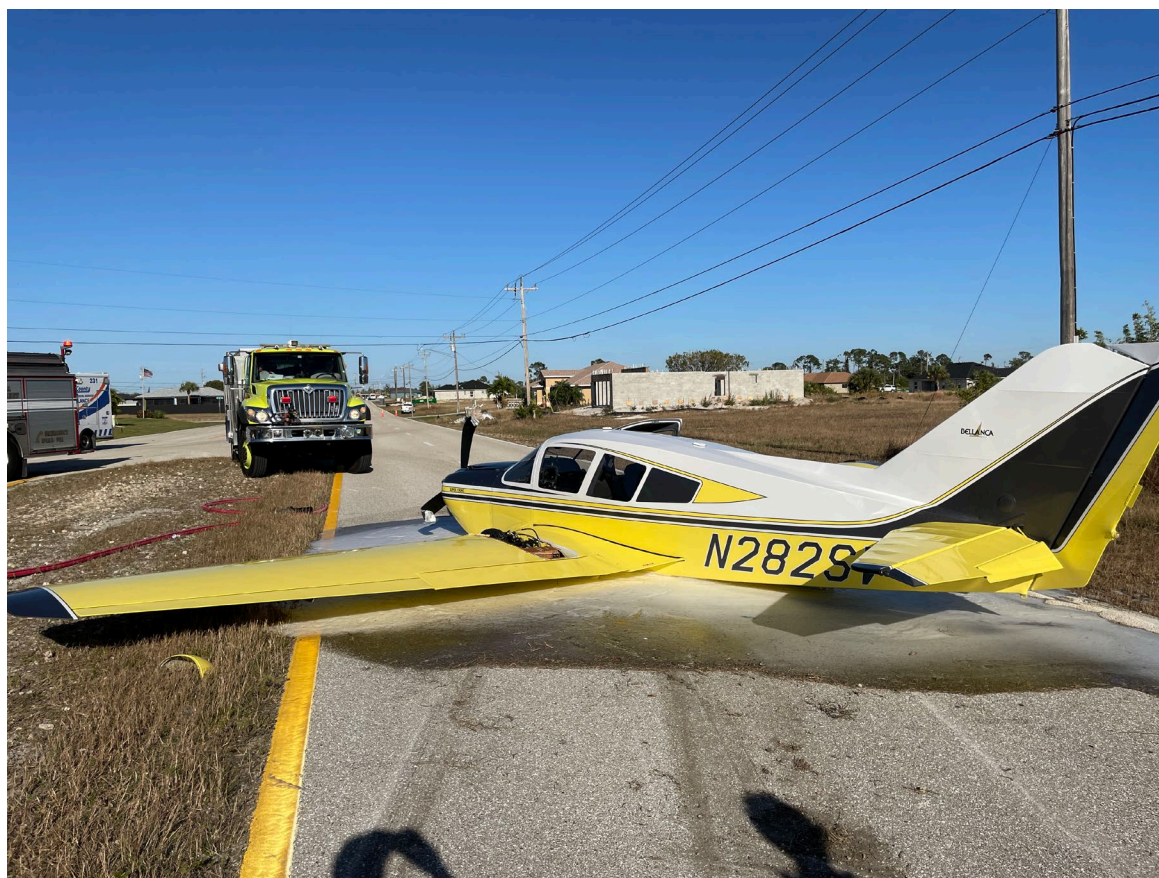
**Photograph 1 - Airplane at the Accident Location (Courtesy of FAA)**

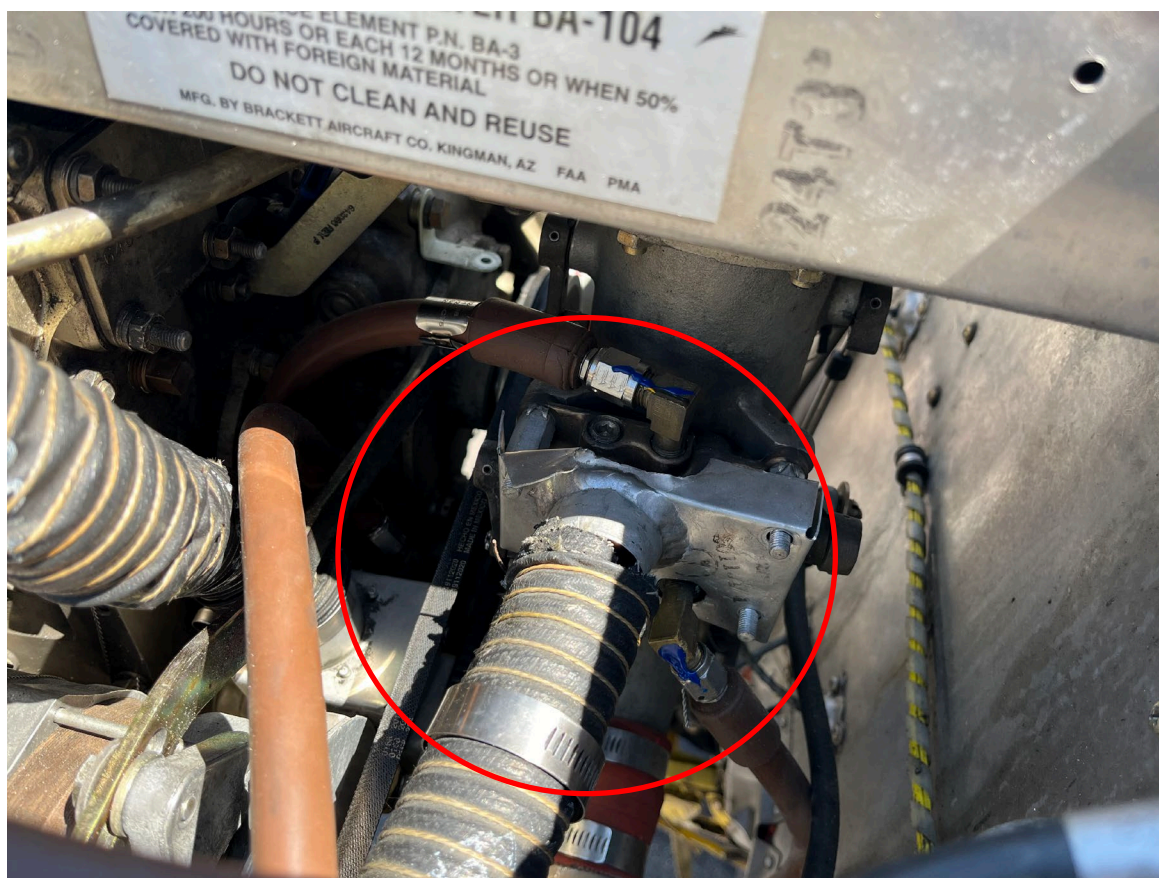
**Photograph 2 - Location of the Leaking Fuel**

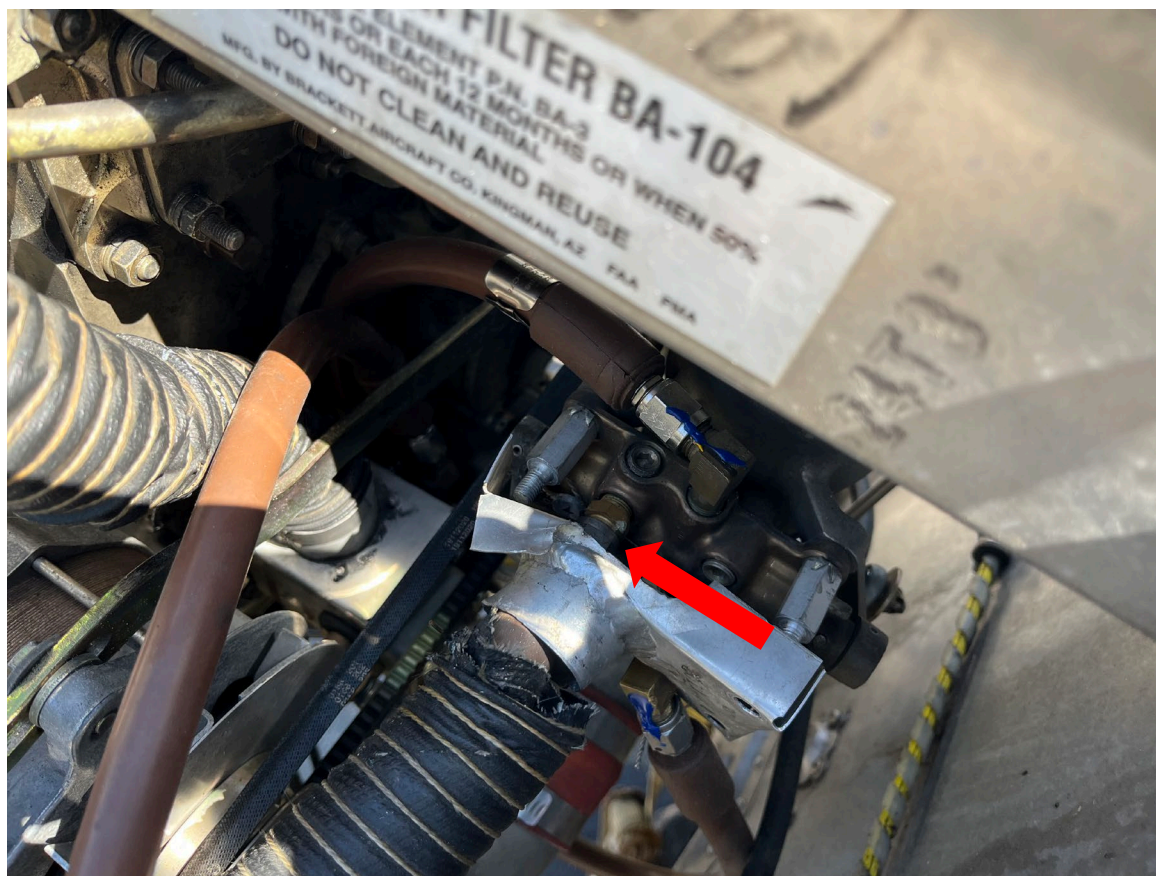
**Photograph 3 - Fitting Where the Fuel was Leaking**

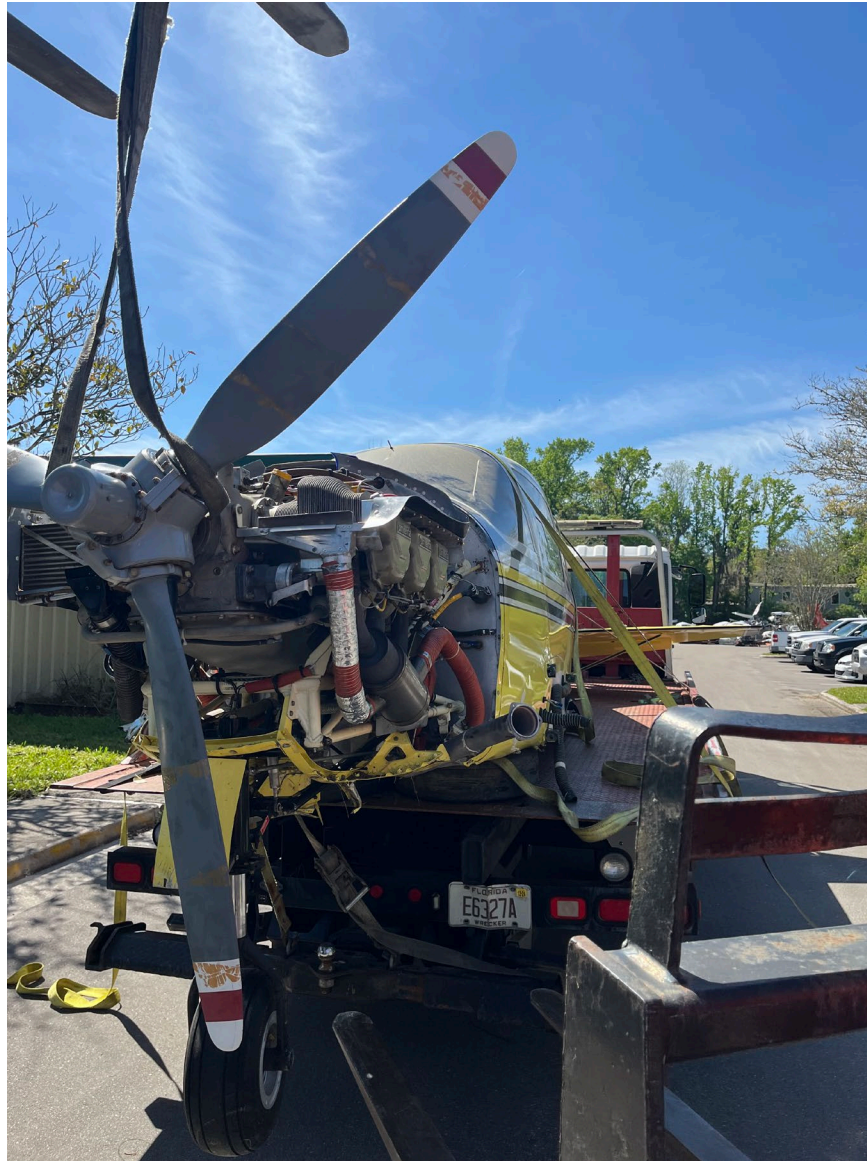
**Photograph 5 - Airplane Test Run Set-up with Test Propeller**
