# National Transportation Safety Board

ERA24LA122

## **WRECKAGE EXAMINATION SUMMARY**

Location: Cape Coral, FL  
Date: February 24, 2024  
Time: 1003 EST  
1503 Z  
Airplane: N282SV, BELLANCA 17-30A, SERIAL NUMBER 98-301026

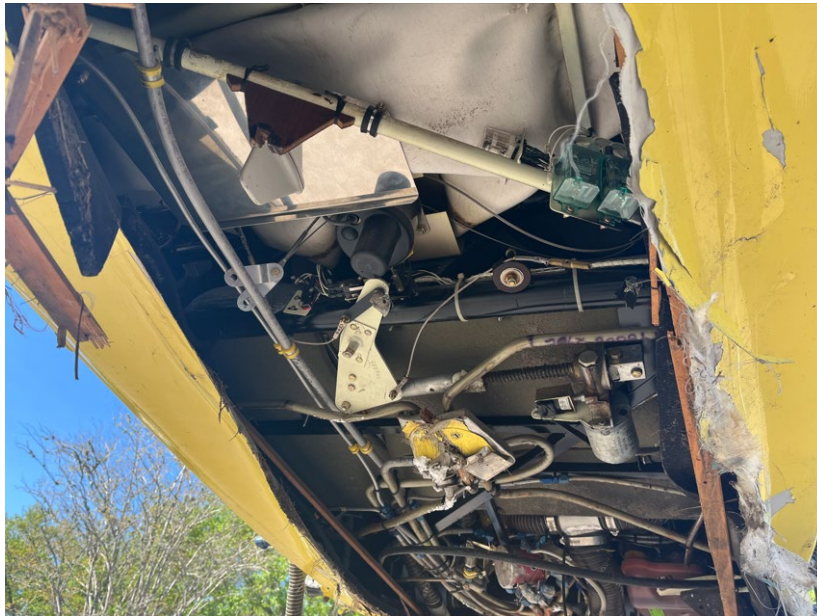
The fuselage sustained substantial damage to the belly, below the cockpit area, as a result of the accident sequence. The remainder of the fuselage was intact and undamaged.

**Belly Damage**

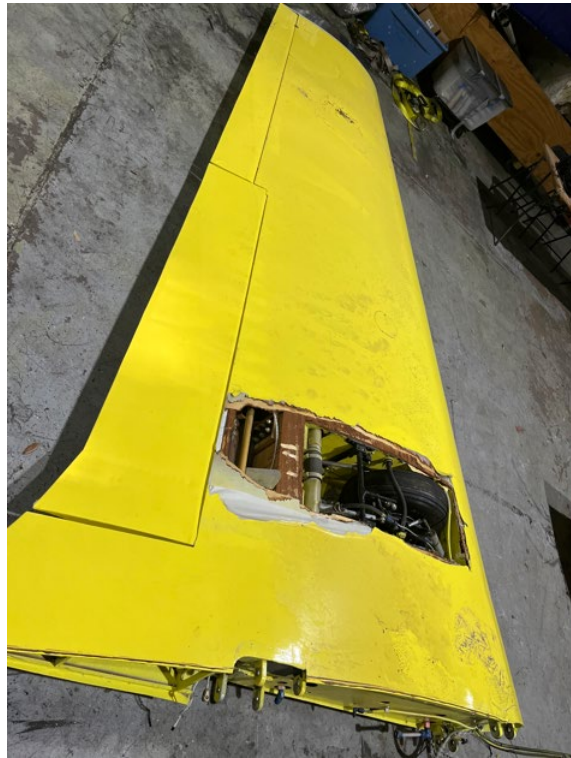
Both wings were removed to facilitate the recovery efforts. The right fuel tank was breached during the accident. The left-wing was not breached. The remaining fuel was drained from the airplane by recovery personnel. Recovery personnel noted that almost no fuel was found in either tank when they attempted to drain the wings. Substantial damage to both wings was present around the retractable landing gear.

The landing gear collapsed during the accident and was partially pushed through both wings. Flight control continuity from the cockpit to the ailerons was visually established.

**Left Wing Viewed from the Top**

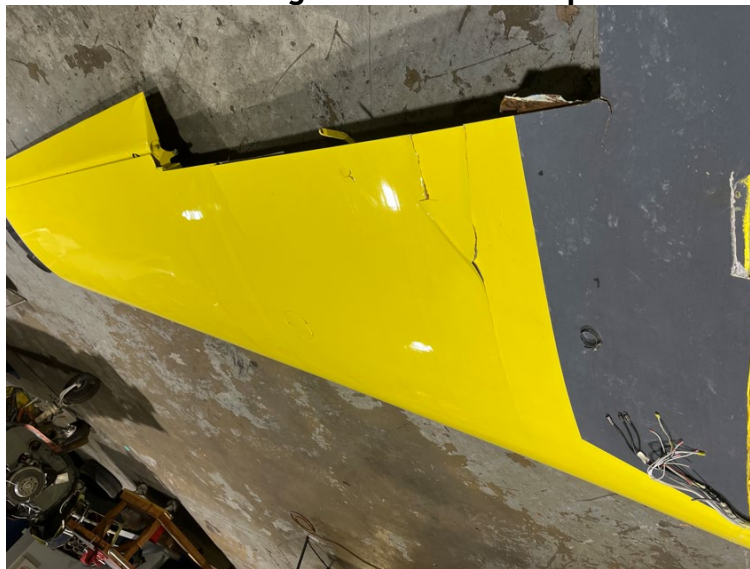
**Right Wing Viewed from the Top**

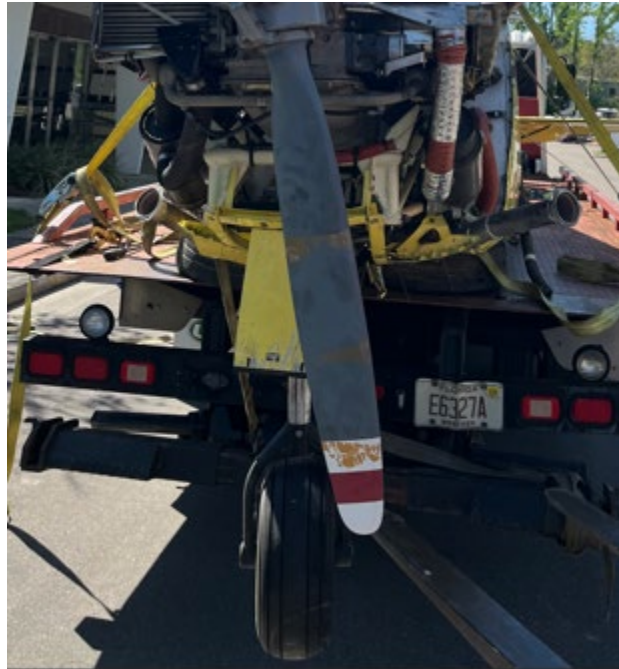
The retractable tricycle landing gear collapsed during impact sequence and punctured holes in the wing structures. The nose gear extended and locked when the

airframe was hoisted onto a flatbed trailer. The gear position was “down” in the cockpit.

**Nose Gear Down and Locked**

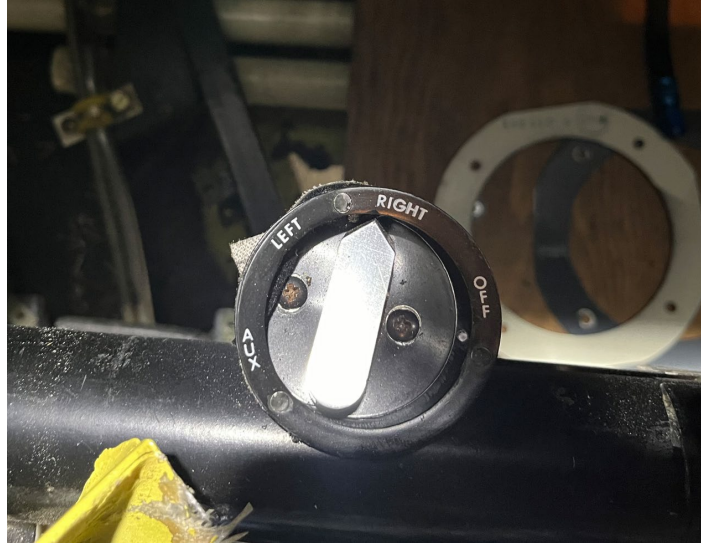
Continuity of the throttle, mixture, and propeller controls was confirmed from the cockpit to their respective accessories. Full control travel was observed. As observed, all three controls were in the full forward position. The fuel selector was broken just below the indicator, but the selector was stuck in the right tank orientation. The Garmin accessories were removed by the recovery personnel to prevent damage during storage. The units were undamaged. No SD cards were present in any of the devices. The remaining instrumentation in the cockpit was undamaged. The remained installed in the fuselage and the aircraft powered on when the master switch was activated.

The fuel selector was stuck in the right tank position. The fuel lines appeared to be oriented correctly. The fuel injector lines were tight from the manifold to the cylinder heads.

**Fuel Selector**

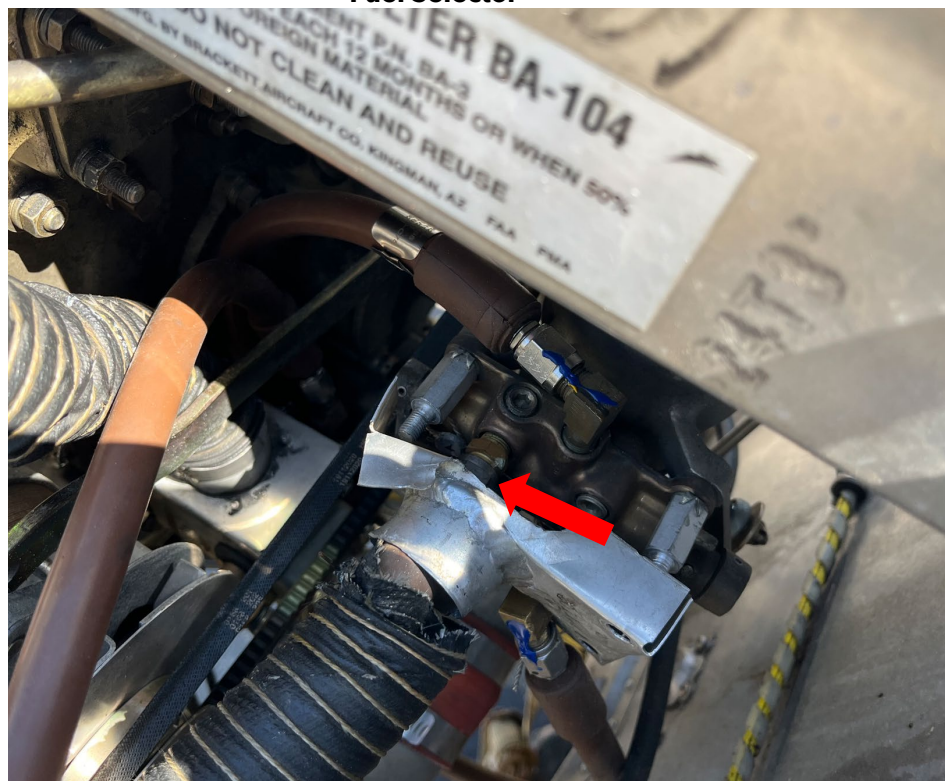
During the engine run attempt, a substantial fuel leak was observed near the fuel metering throttle body and the engine would not start. The cooling shroud for the fuel metering throttle body was removed and the fuel line from the throttle body

to the fuel manifold was found to be less than finger tight. The line was tightened, and an engine run was attempted. The engine started immediately.

**Location of the Loose Fuel Line**

The pilot stated that the purpose of the flight was to test that the newly installed engine mounts, STC electronic magneto, engine fuel pump and engine fuel lines that were satisfactory. The pilot noted that he installed the fuel lines and provided the log book entries.

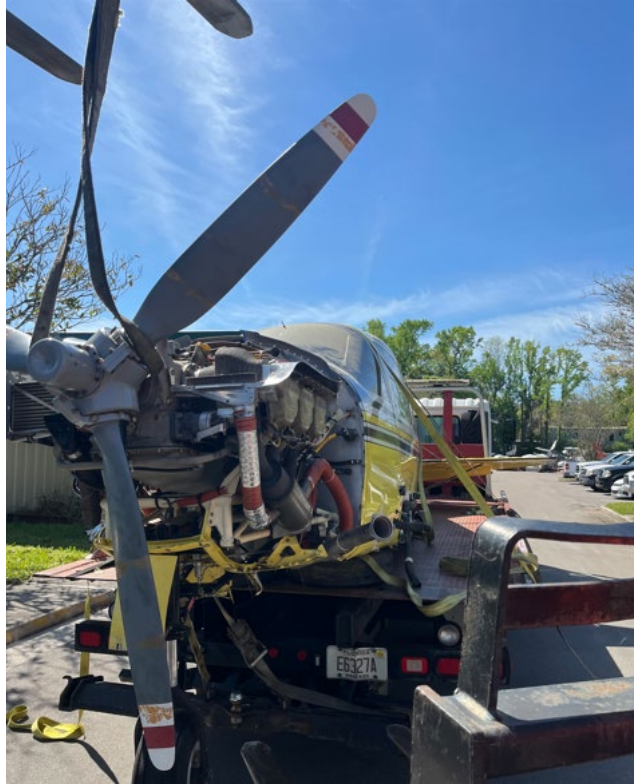
The fuselage and engine were secured to a flat-bed trailer. Fuel was supplied at the fuel pump inlet from an external source with automotive gasoline. The fuel pump return was re-routed to the external source. The engine would not start, and a fuel leak was observed from the back of the engine. Further inspection revealed that fuel was leaking from the cooling shroud of the fuel metering throttle body. The cooling shroud was removed and the fuel line from the throttle body to the fuel manifold was found to be less than finger tight. The line was tightened. An engine start was attempted, and the engine started immediately. The engine idled smoothly. The throttle was advanced to 1700RPM, and a magneto check was performed. Both magnetos produced an acceptable RPM drop. Throttle was advanced to approximately 2000 RPM. The engine ran smoothly, and oil pressure was documented. The engine was brought back to idle to conclude the test.

**Airplane Strapped to Trailer for Testing with Substitute Propeller**
