# National Transportation Safety Board

ERA24LA124

## **WRECKAGE EXAMINATION**

Location: Sanford, FL  
Date: February 27, 2024  
Time: 1622 EST  
2122 Z  
Airplane: Cirrus SR20

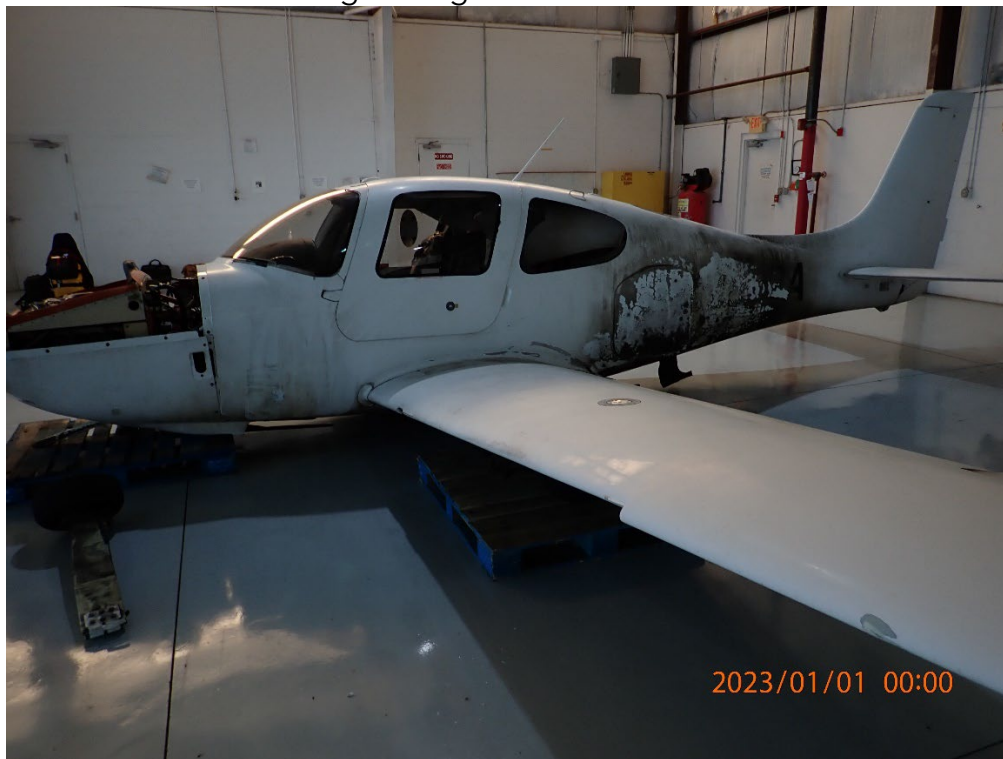
**Airplane Overview from the Left Side**

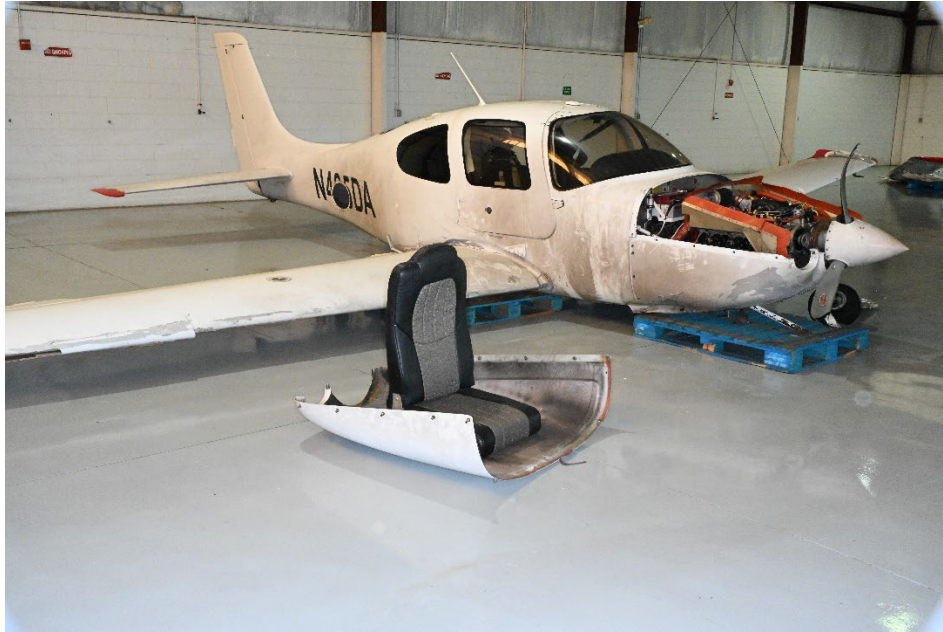
An airframe examination was conducted by the Cirrus Air Safety investigator. Flight control continuity was confirmed to the rudder, elevator, and ailerons. No mechanical defects or discrepancies were noted with the airframe prior to the accident events.

**Airframe Overview (Courtesy of Cirrus Aircraft)**

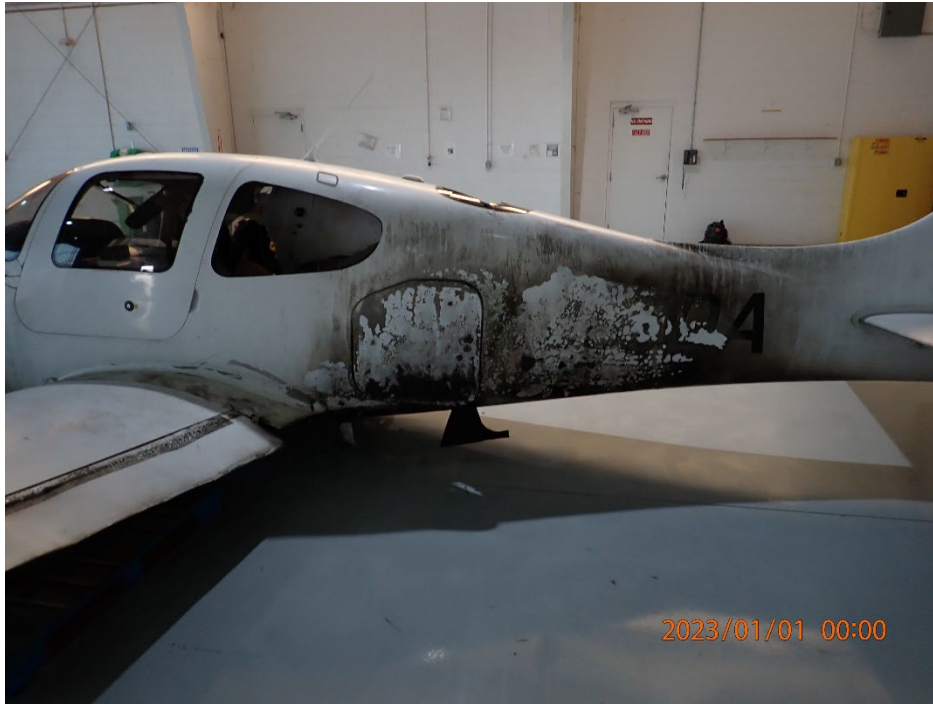
Extensive thermal damage was observed on the aft left portion of the fuselage structure. Damage to the bottom of the fuselage was observed from the airplane skidding as a result of the landing gear collapsing. Cracking was found at the spar tunnel on the right hand side of the fuselage.

**Thermal Damage to the Fuselage**

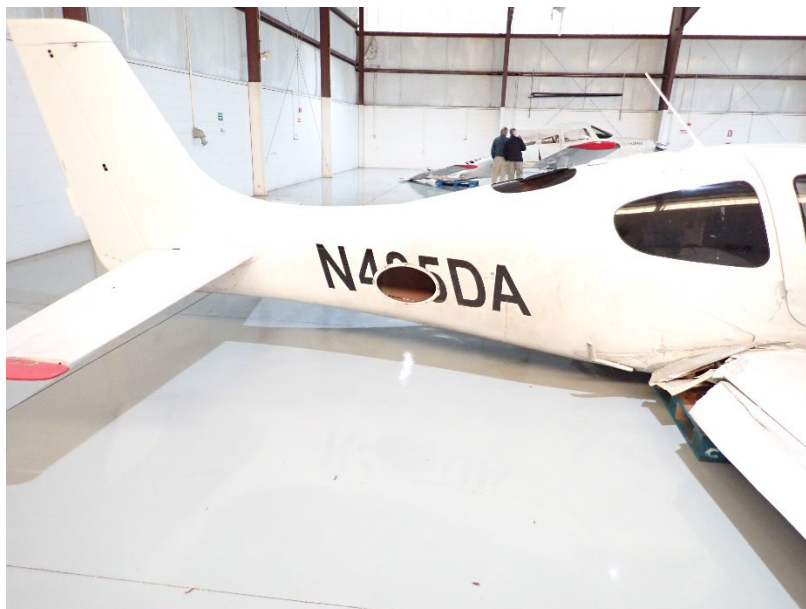
The empennage was mostly undamaged with minor thermal signatures noted from the post-accident fire. The vertical stabilizer, rudder, horizontal stabilizer, and elevators remained intact.

**Right Side of the Empennage**

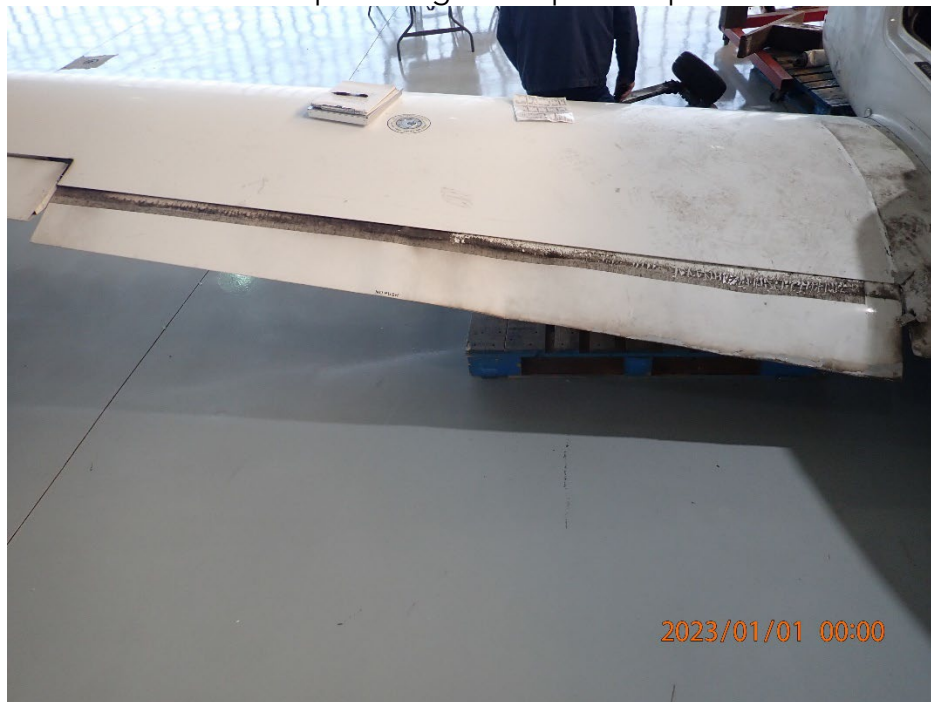
The left wing was damaged at the bottom near the wing root as a result of the left main landing gear shearing. The damage to the left wing resulted in a breach of the left fuel tank and source for the post impact fire. The right wing was damaged on the bottom near the wing root. Leading edge damage was observed on the last three feet of the outboard portion of the leading edge. The right wing was tested for breaches by adding 5 gallons of water to the tank. There was no evidence of a breached right fuel tank. The right wing displayed significant damage as a result of contacting the parked PA-28. The right wing flap had been pushed towards the right wing tip and was jammed against the aileron.

The flap actuator measured just under 4", indicating that the flaps were in the "up" position at the time of the impact. The end of the actuator had been broken off as the flaps moved above "full up" during the impact sequence.

**Inner Left Wing and Flap**

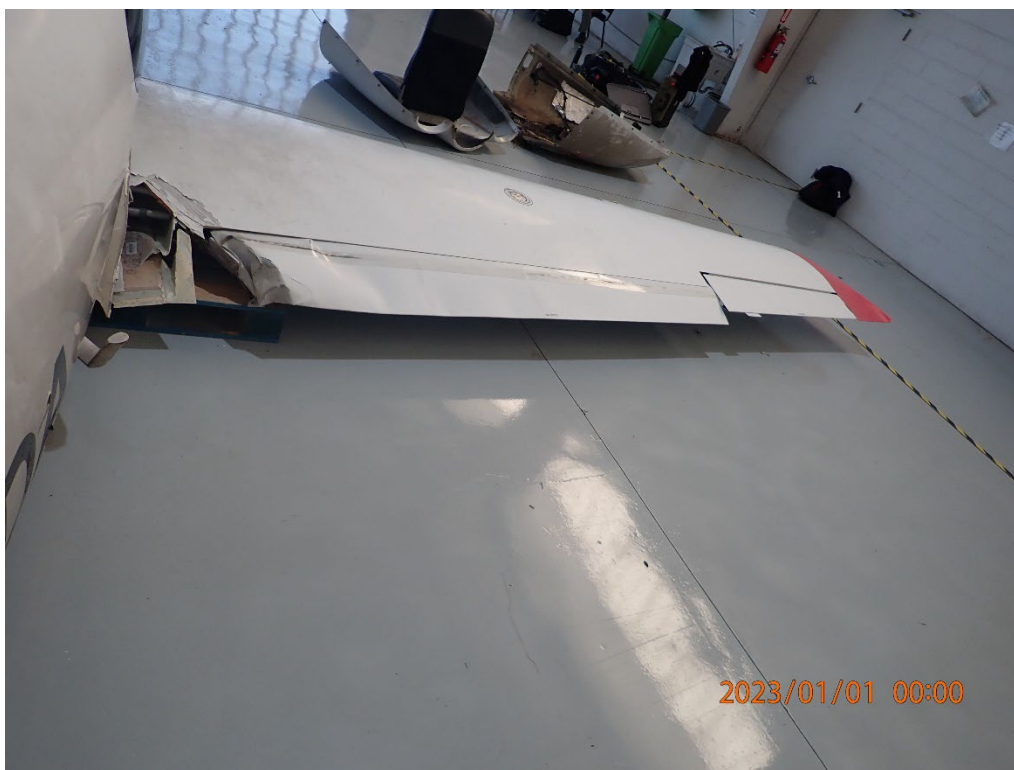
**Right Wing**

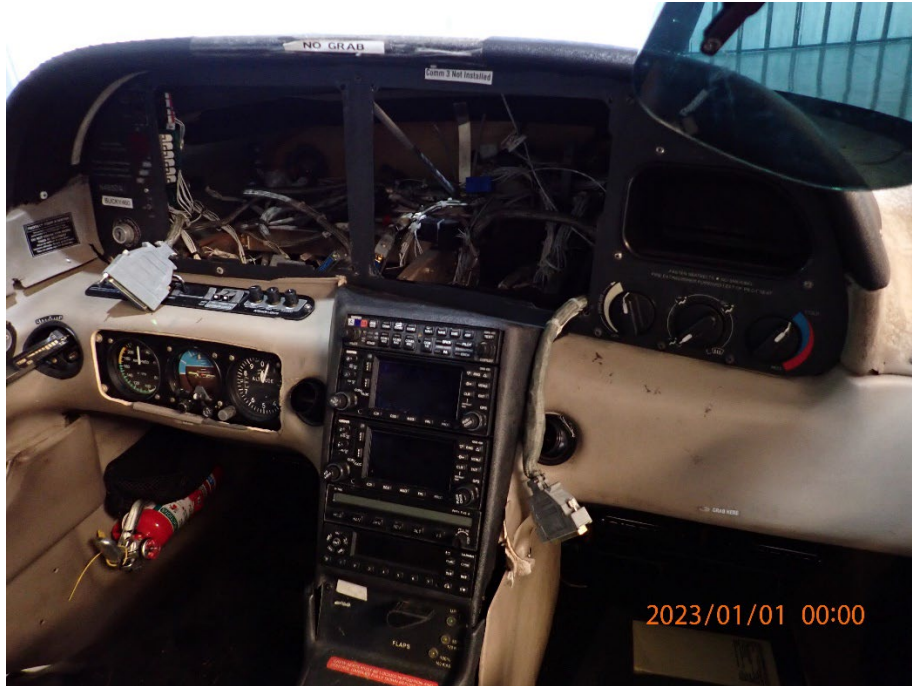
The airplane MFD and PFD were previously sent to the lab in Washington D.C. The Hobbs meter reading is 5914 and the Flight meter reading is 2424. The flaps selector is at 0, but the physical flaps position is at 50%. The throttle and the mixture levers were found in the idle positions. Cable continuity of the throttle, mixture, and propeller were confirmed with full travel verified. The fuel pump toggle lever was in the off position. The fuel selector was on the right tank. The head liner was removed to facilitate cutting the parachute rocket cable. A fire extinguisher remained installed and unused by the rudder controls of the front left pilot seat. The front seats were equipped with 4-point shoulder harness' with airbags that did not deploy. The rear seats are equipped with a lap and shoulder restraint.

**Cockpit Overview**

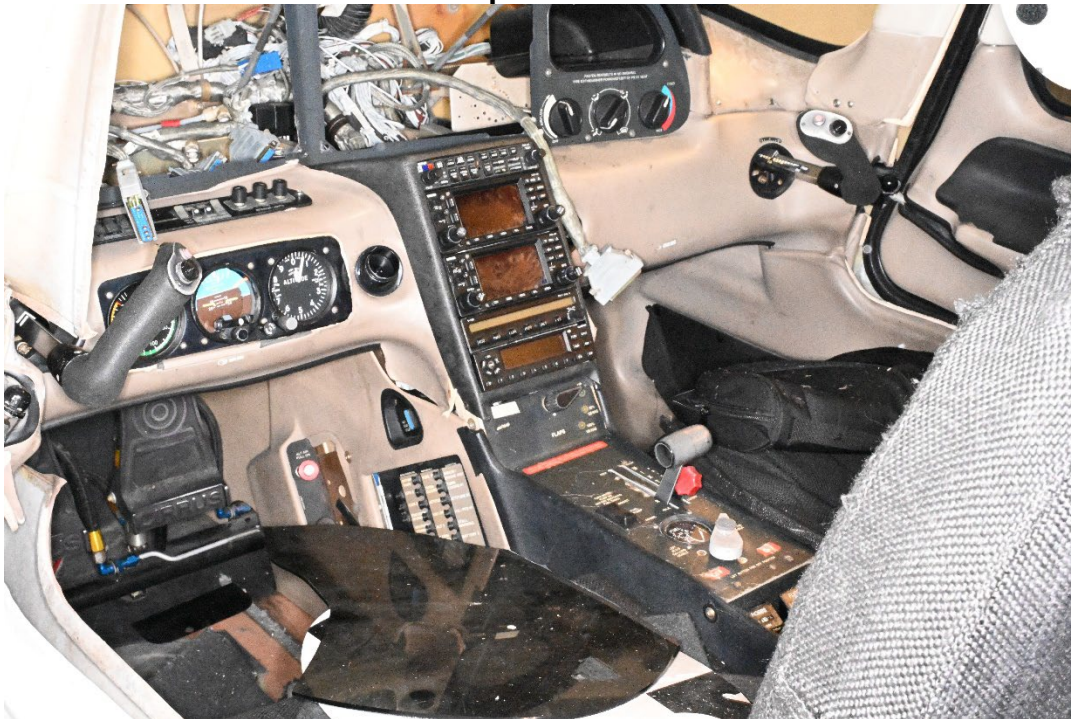
**Cockpit from Pilot's Side (Courtesy of Cirrus Aircraft)**

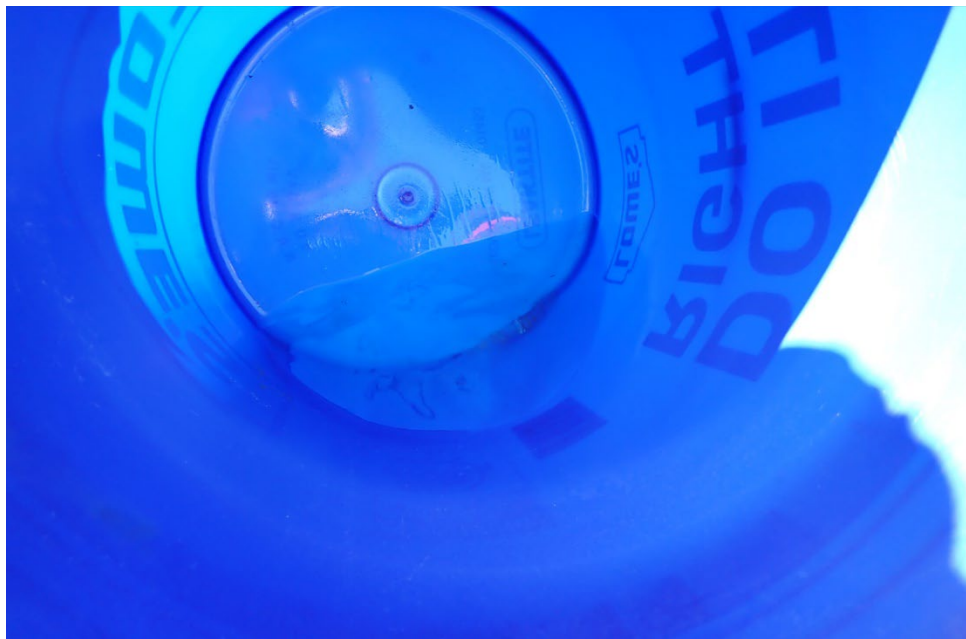
The left-wing fuel tank was breached during the impact sequence. Fuel quickly escaped from the breach in the left wing and ignited during the accident sequence based on the thermal signatures on the fuselage. The right-wing fuel tank was not breached. One quarter of a gallon of fuel was removed from the right fuel tank. The fuel tank was tested for a possible breach by adding approximately 5 gallons of water into the wing and the water did not escape.

**Total Fuel Collected from the Right Wing**

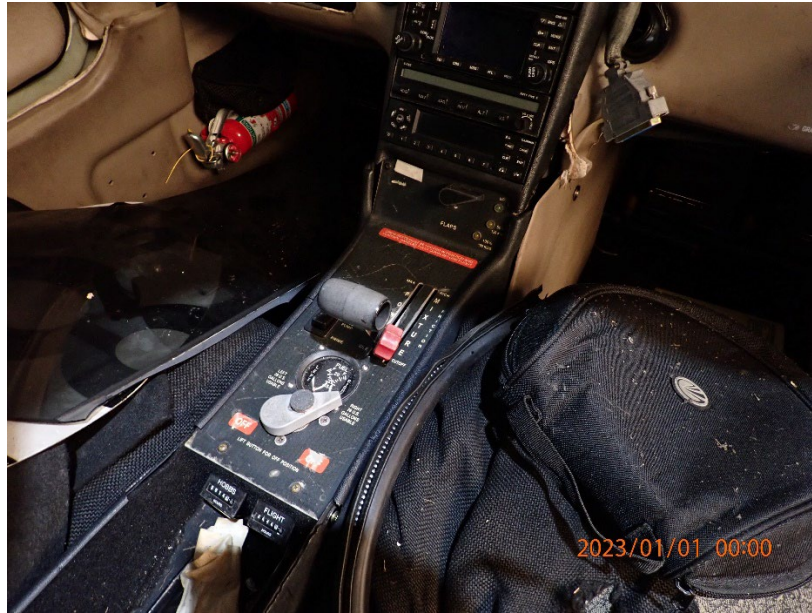
As observed, the fuel boost pump was off, and the mixture control was at the idle cutoff position. An interview with first responders confirmed that the aircraft was secured by putting the boost pump "off" and moving the mixture knob to cutoff. The first responder did not manipulate the fuel selector valve. The fuel selector valve was positioned for the right tank.

**Fuel Controls as Found**

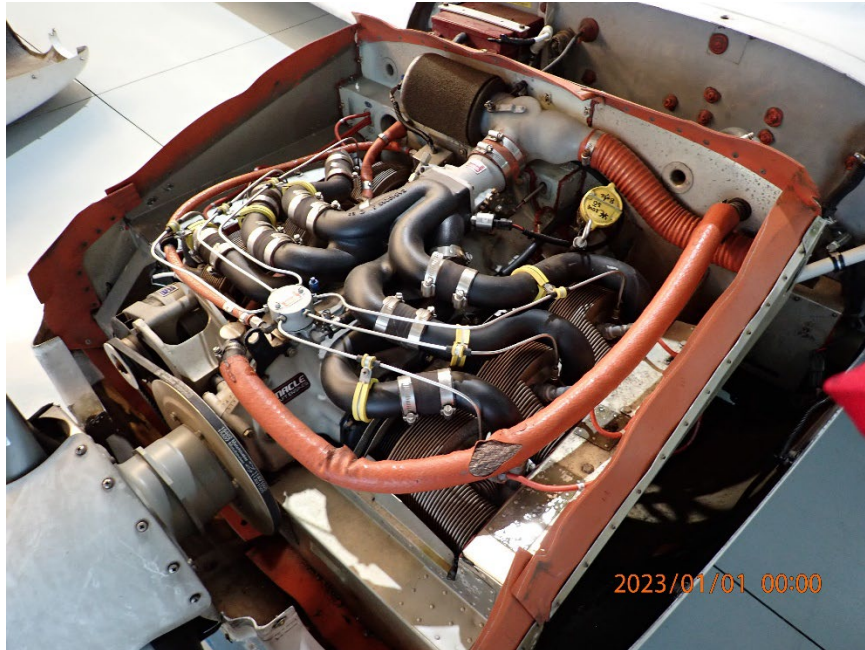
The engine rotated 720 degrees when force was applied to the propeller. Thumb compressions were established on all six cylinders. Continuity of the crankshaft to the camshaft was established throughout the engine. The oil filter housing was impact separated from the accessory housing. The filter was examined, and no contamination was noted in the element. The spark plugs were removed, and the coloration was consistent with normal engine operation. The wear was normal when compared to the Champion Aviation Check-A-Plug chart. The fuel injector nozzles were removed, and no obstructions were noted. Visual examination of the mufflers revealed no blockages. Both magnetos produced spark at the leads. The dipstick measured approximately 6 and ½ quarts of clean oil. No mechanical defects or discrepancies were noted with the engine.

**Engine Overview**

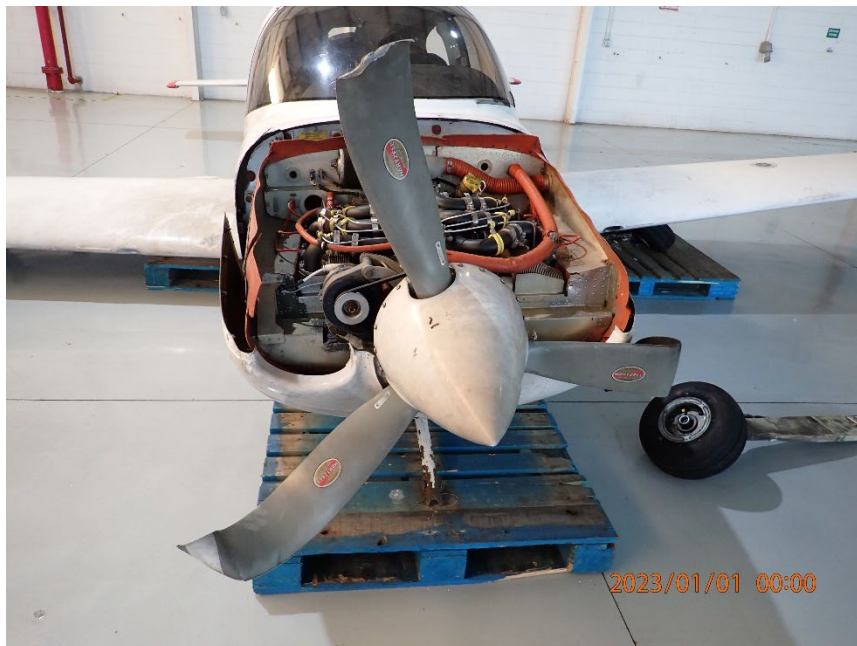
The three bladed Hartzell propeller remained attached to the crankshaft flange. All three blades were bent slightly forward and "S" bending consistent with engine power was observed. The propeller was not removed for further examination. The propeller governor control cable remained attached and full travel was observed.

**Propeller Overview**
